Inspection Photos
Location Name: Dry Creek Unit 3-22
Location ID: 316758

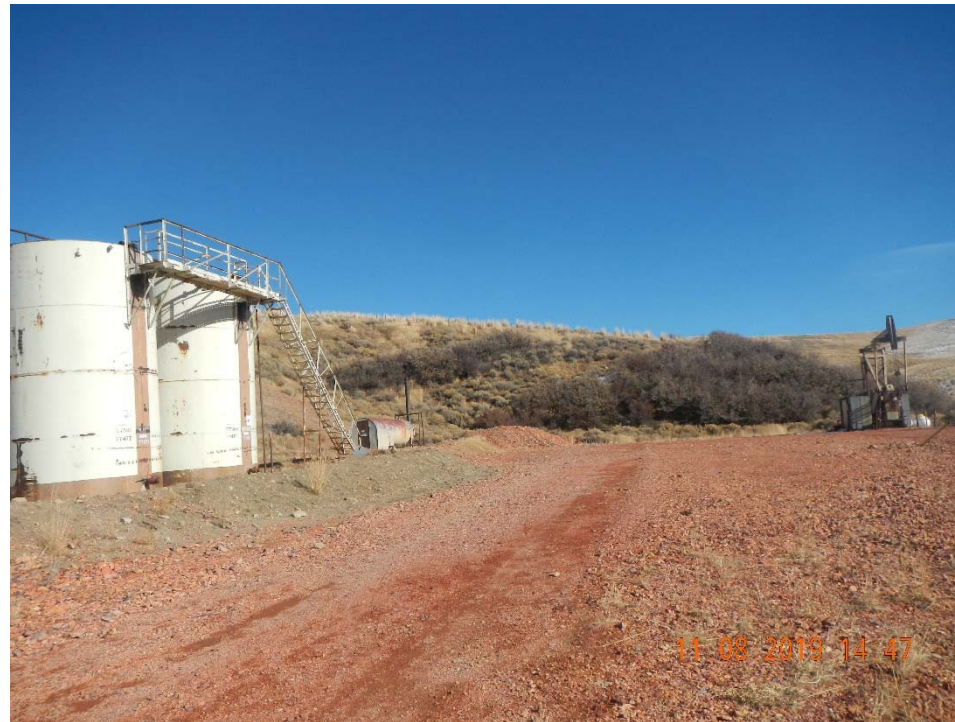
Photo 1. Overview of location taken facing east.

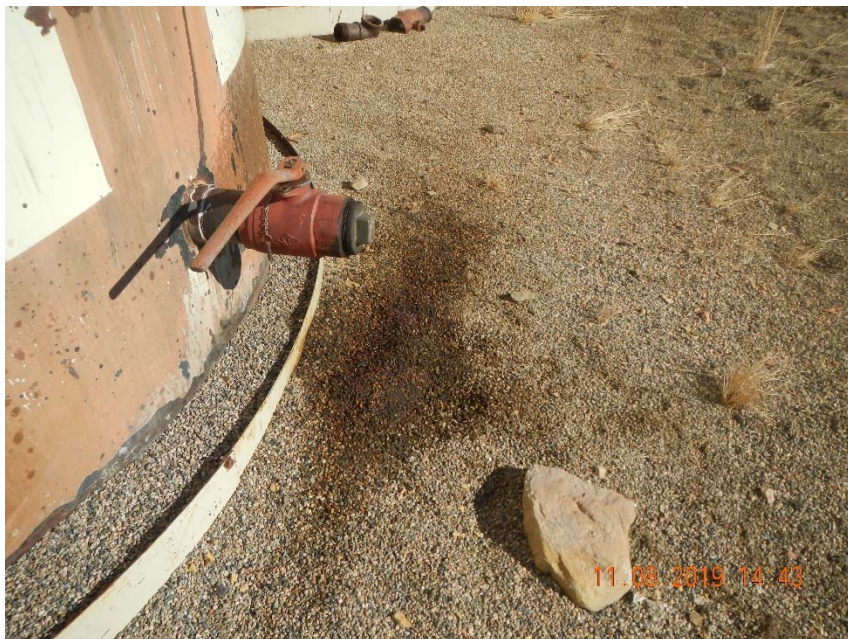
Photo 2. Stained soil at loadout valve.

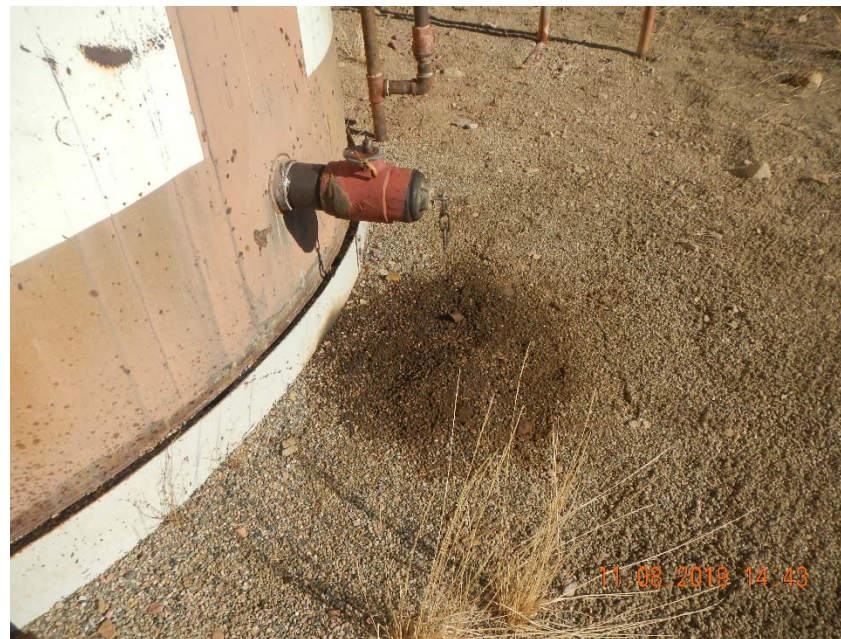
Photo 3. Stained soil at loadout valve.

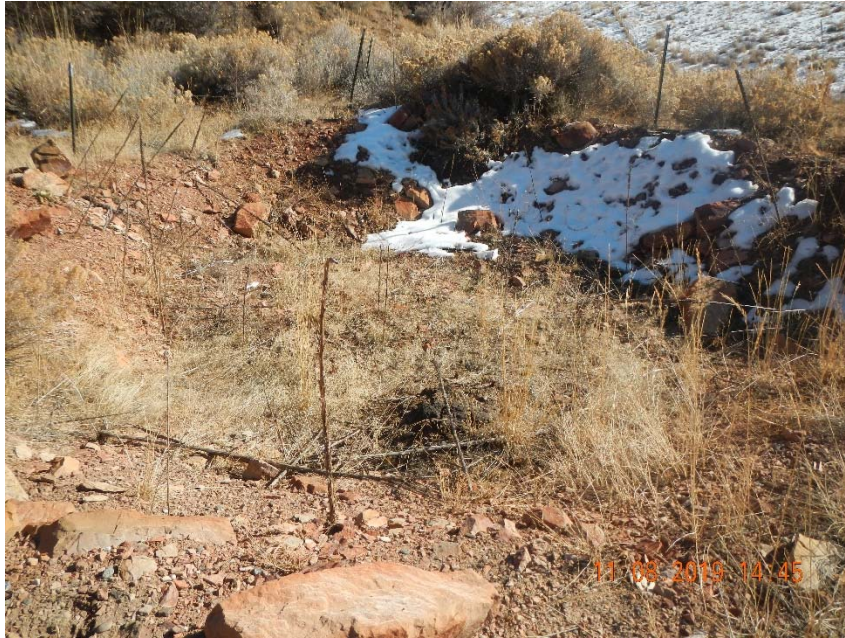
Photo 4. Depression with oily soil.

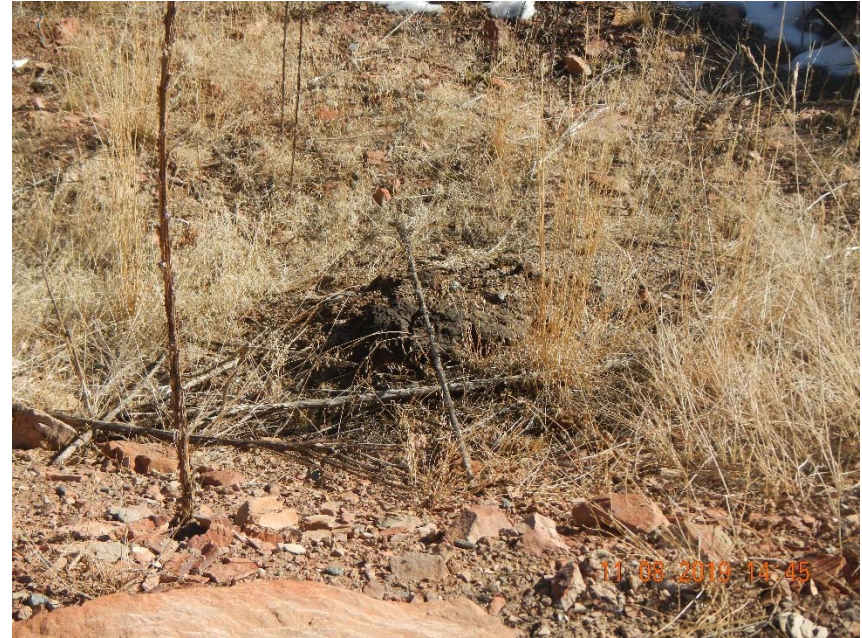
Photo 5. Close-up of oily soil in depression behind pump jack.
