Inspection Photos  
Operator: Catamount Energy  
Location/API #: 067-08767  
Date: 11-12-2019

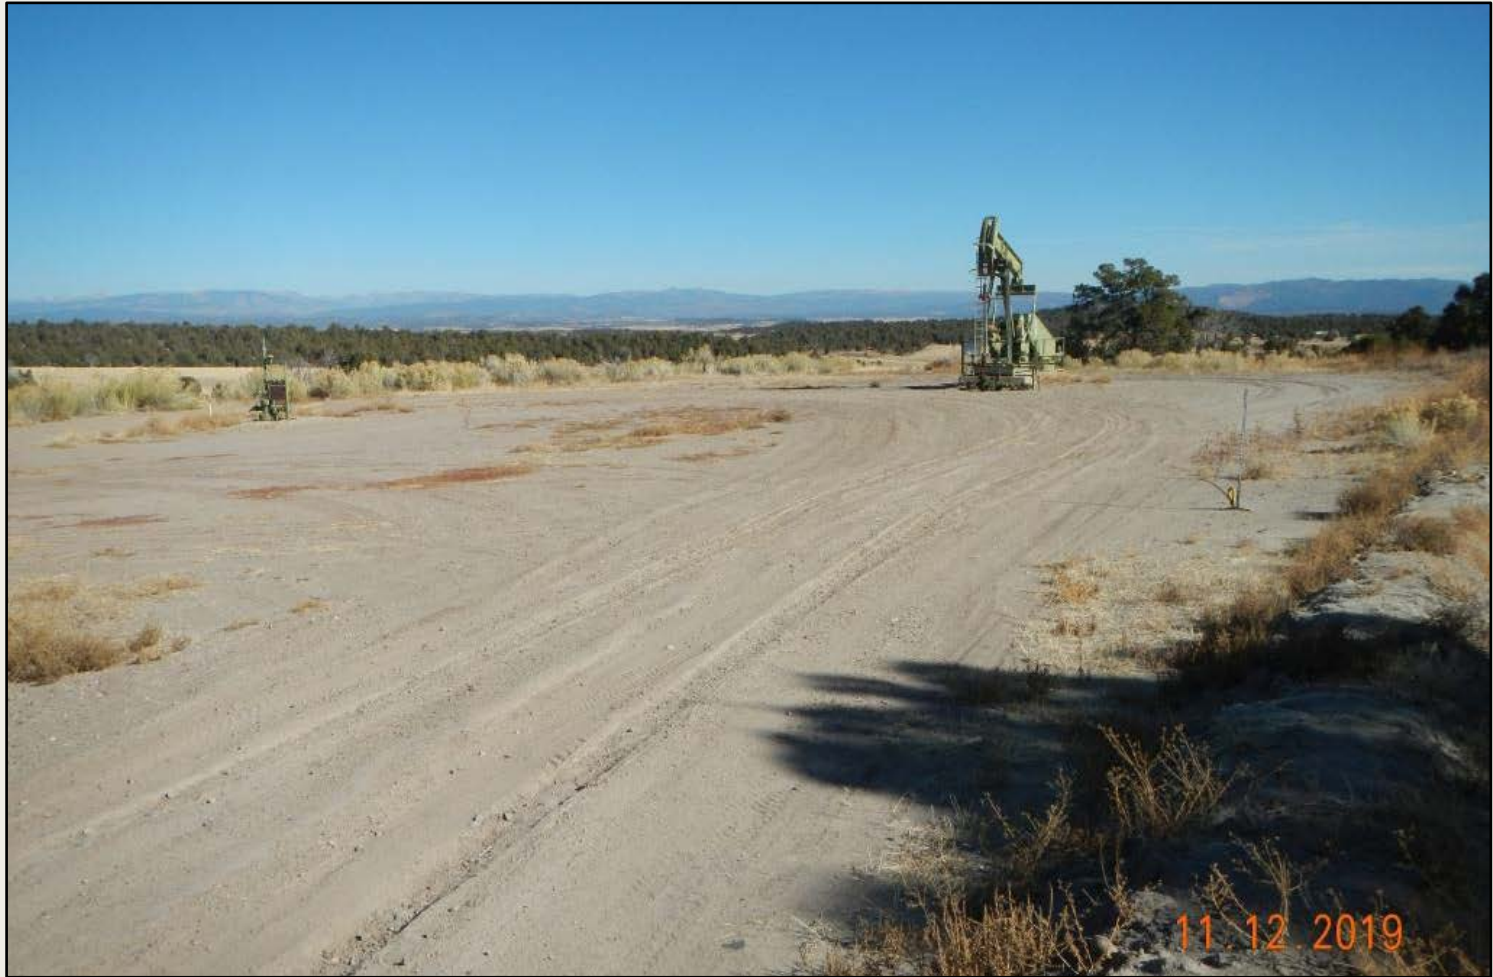
Photo 1. View of the project area from the well pad entrance facing center.

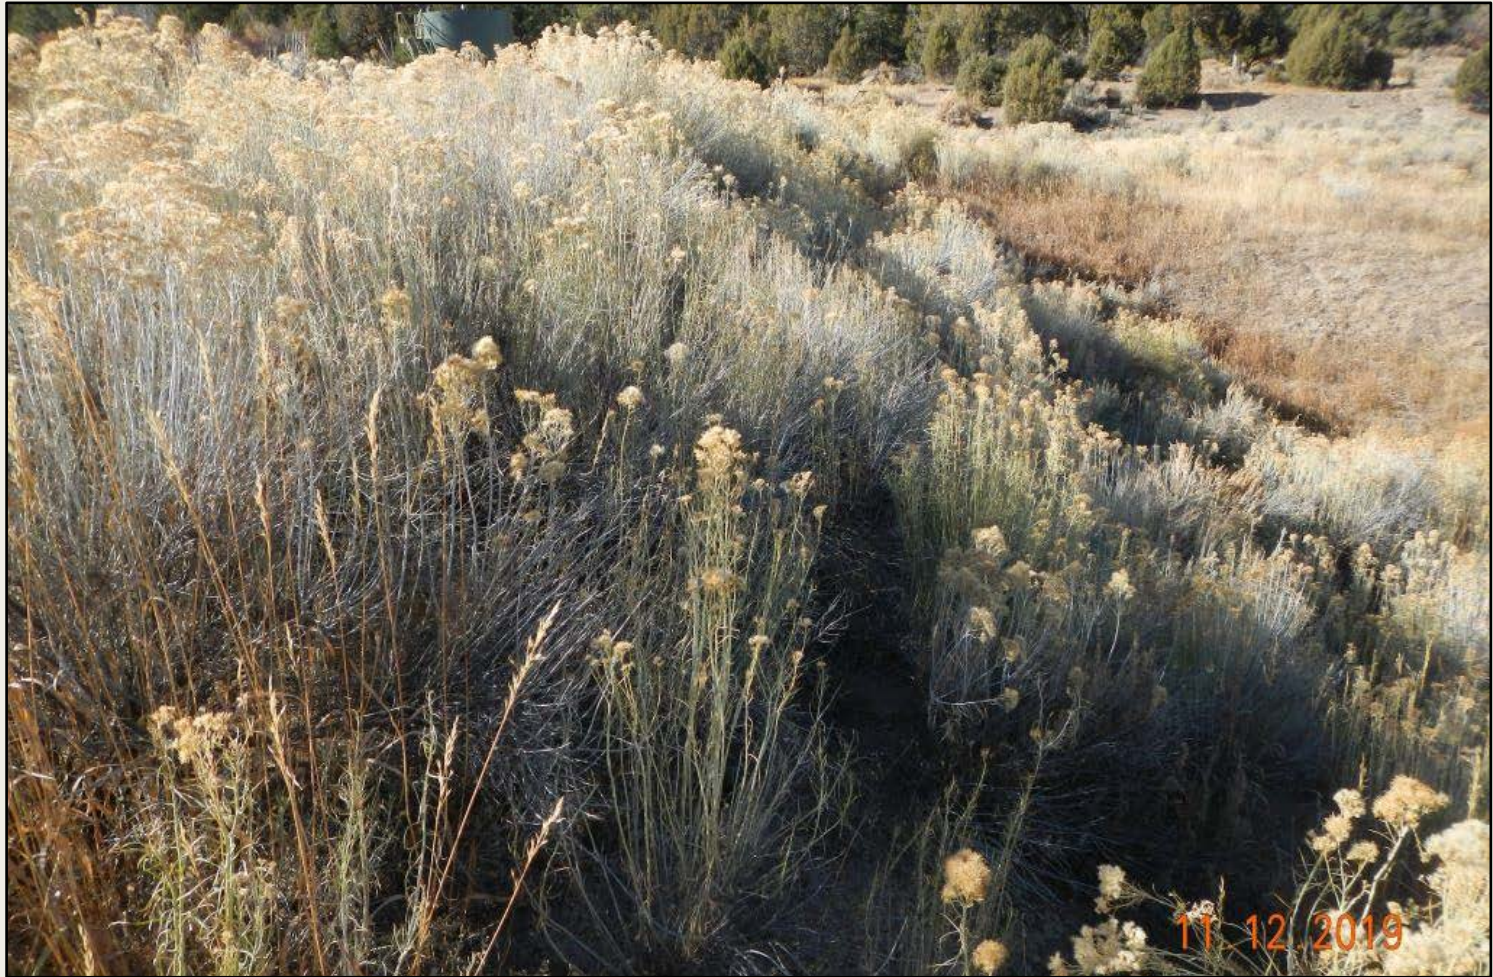
Photo 2. View of the northern project area from the northeastern corner facing westward. Revegetation is progressing with dense rubber rabbitbrush and grasses such as smooth brome.

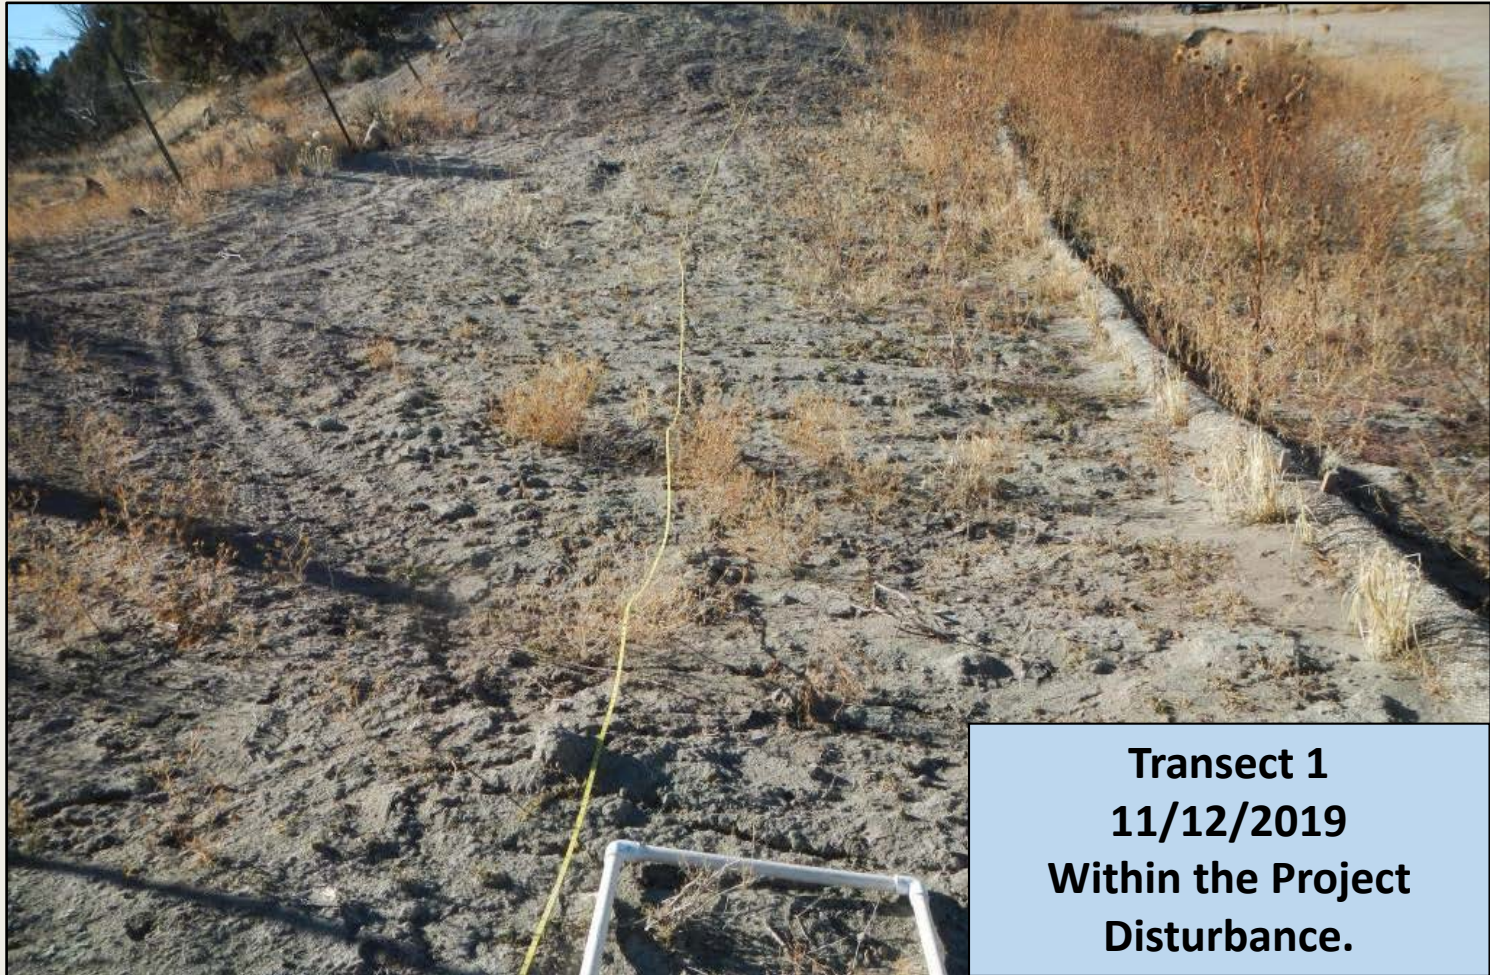
Photo 3. View from the beginning of the germination Transect 1, along the southern cut-slope, facing westward.

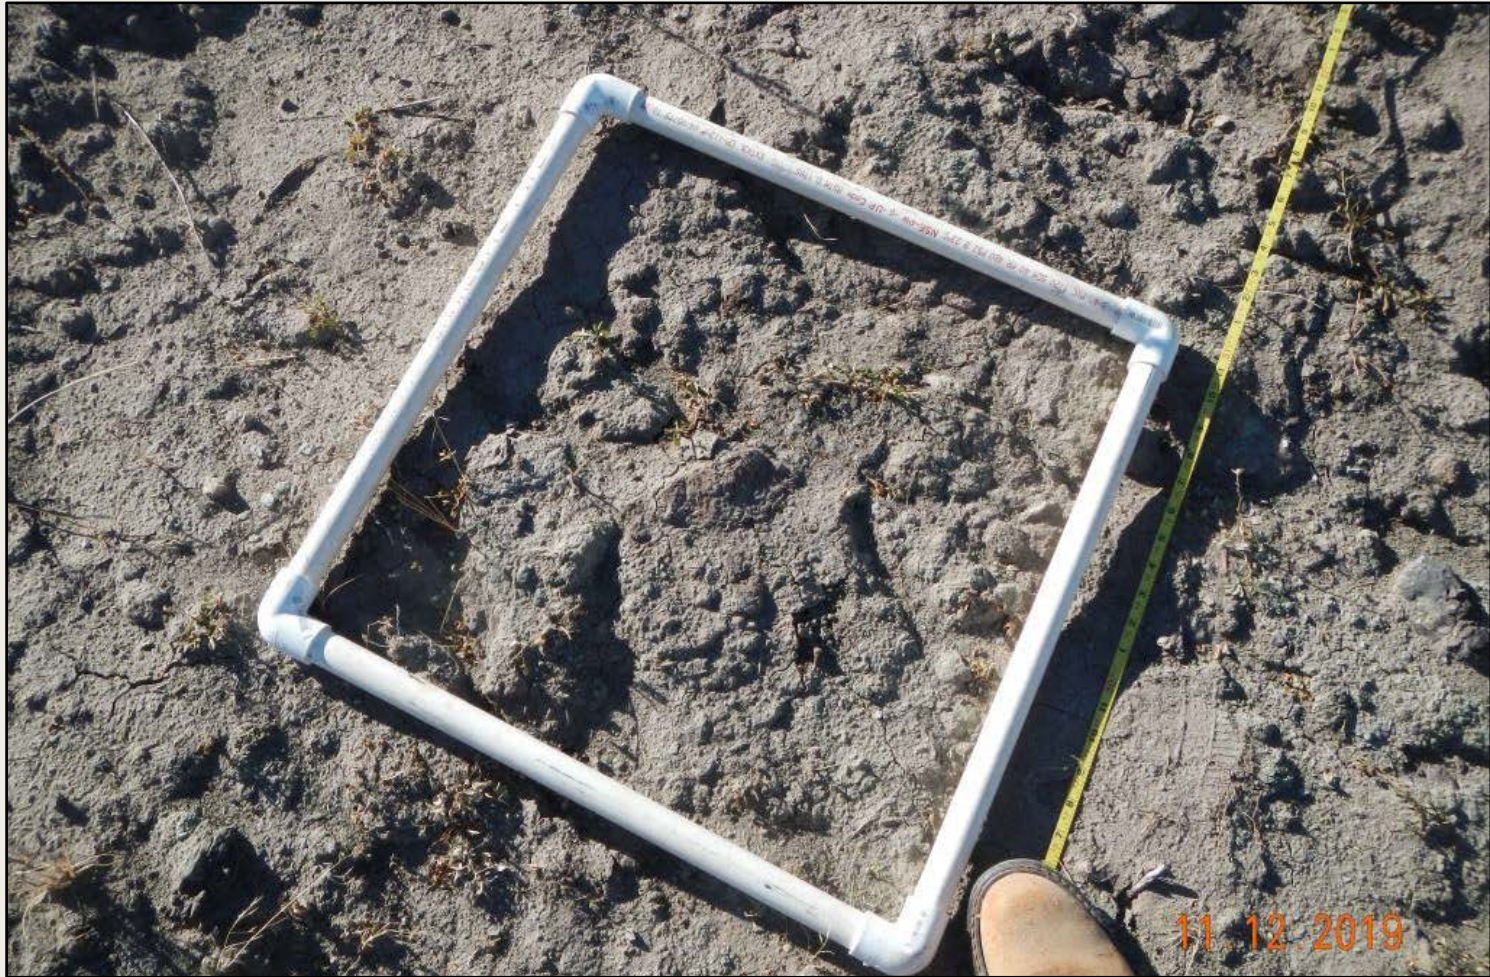
Photo 4. Birdseye view of vegetation in quadrat at the midpoint along the quadrat. Sparse desirable vegetation observed along the cut-slope. Common vegetation is largely annual weeds such as bird's beak and annual sunflower. Desirable seedlings observed appear to be largely Indian ricegrass and rubber rabbitbrush.

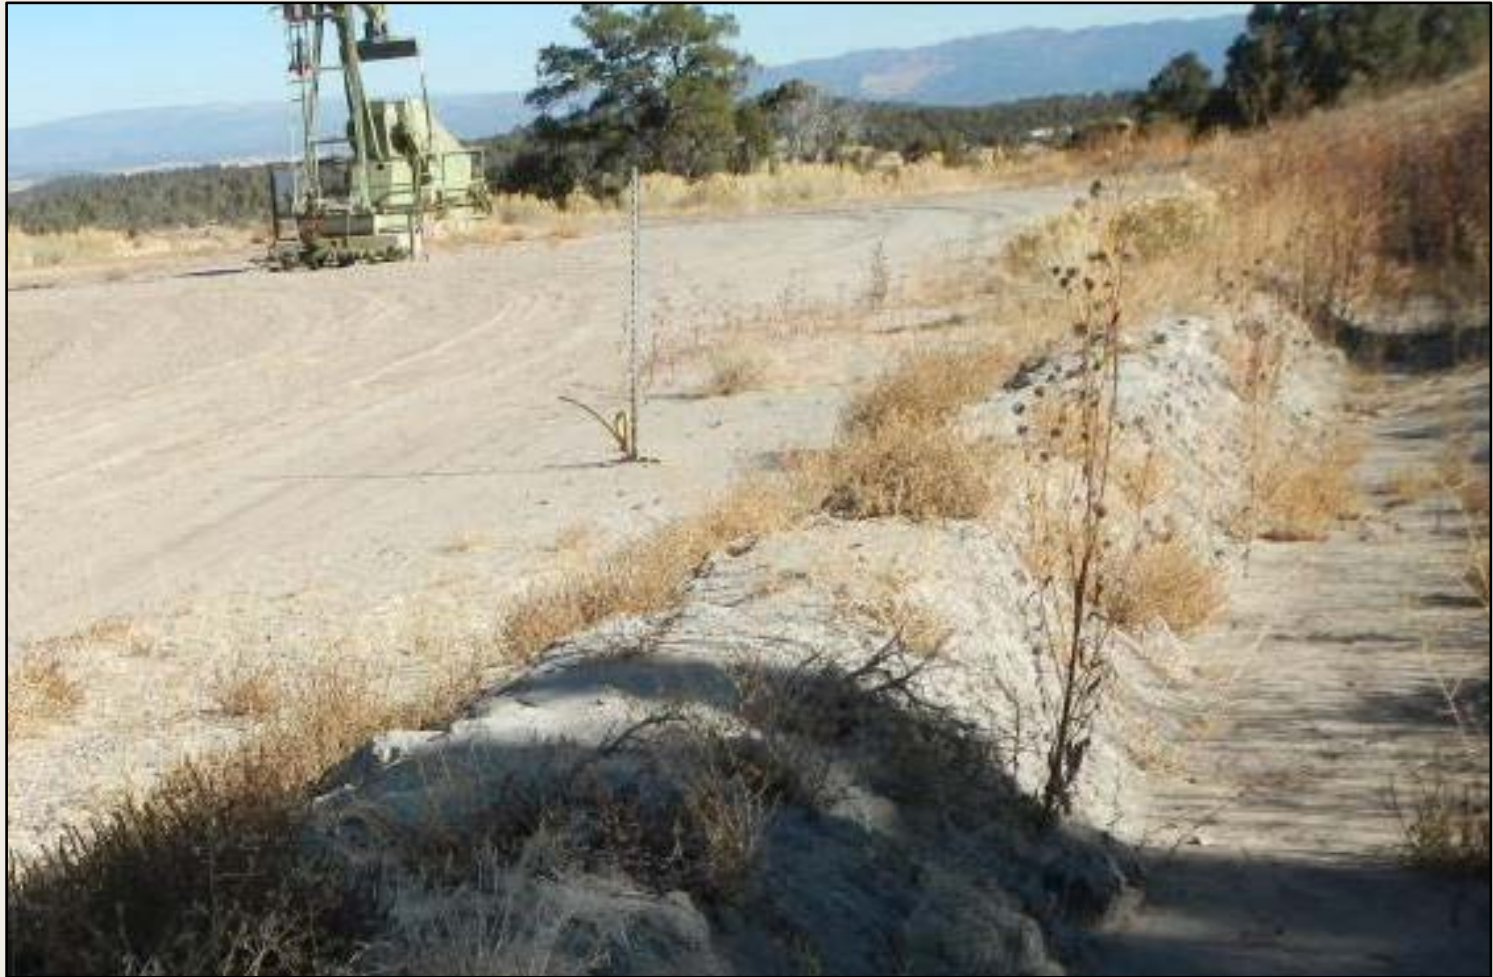
Photo 5. View of berms in the southern project area that are not stabilized and eroding. Vegetation on berms is largely annual weeds such as Russian thistle.

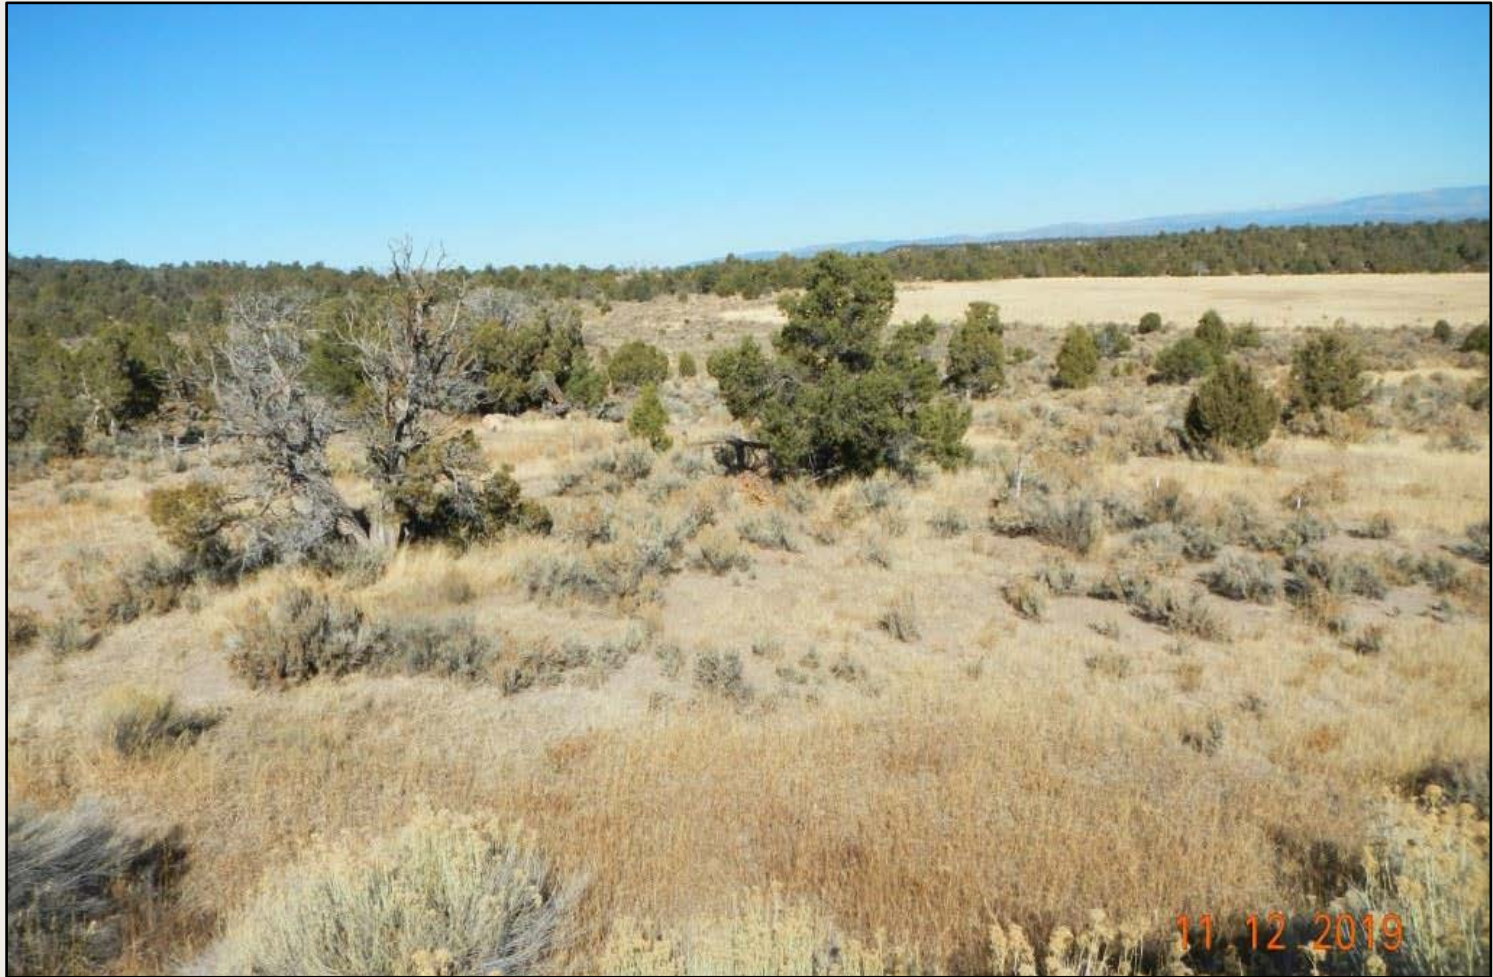
Photo 6. View of reference area vegetation, comprised of open sagebrush shrubland and open pinyon juniper woodland.
