Inspection Photos

Operator: Catamount Energy
Location/API #: 067-05279
Date: 11-12-2019

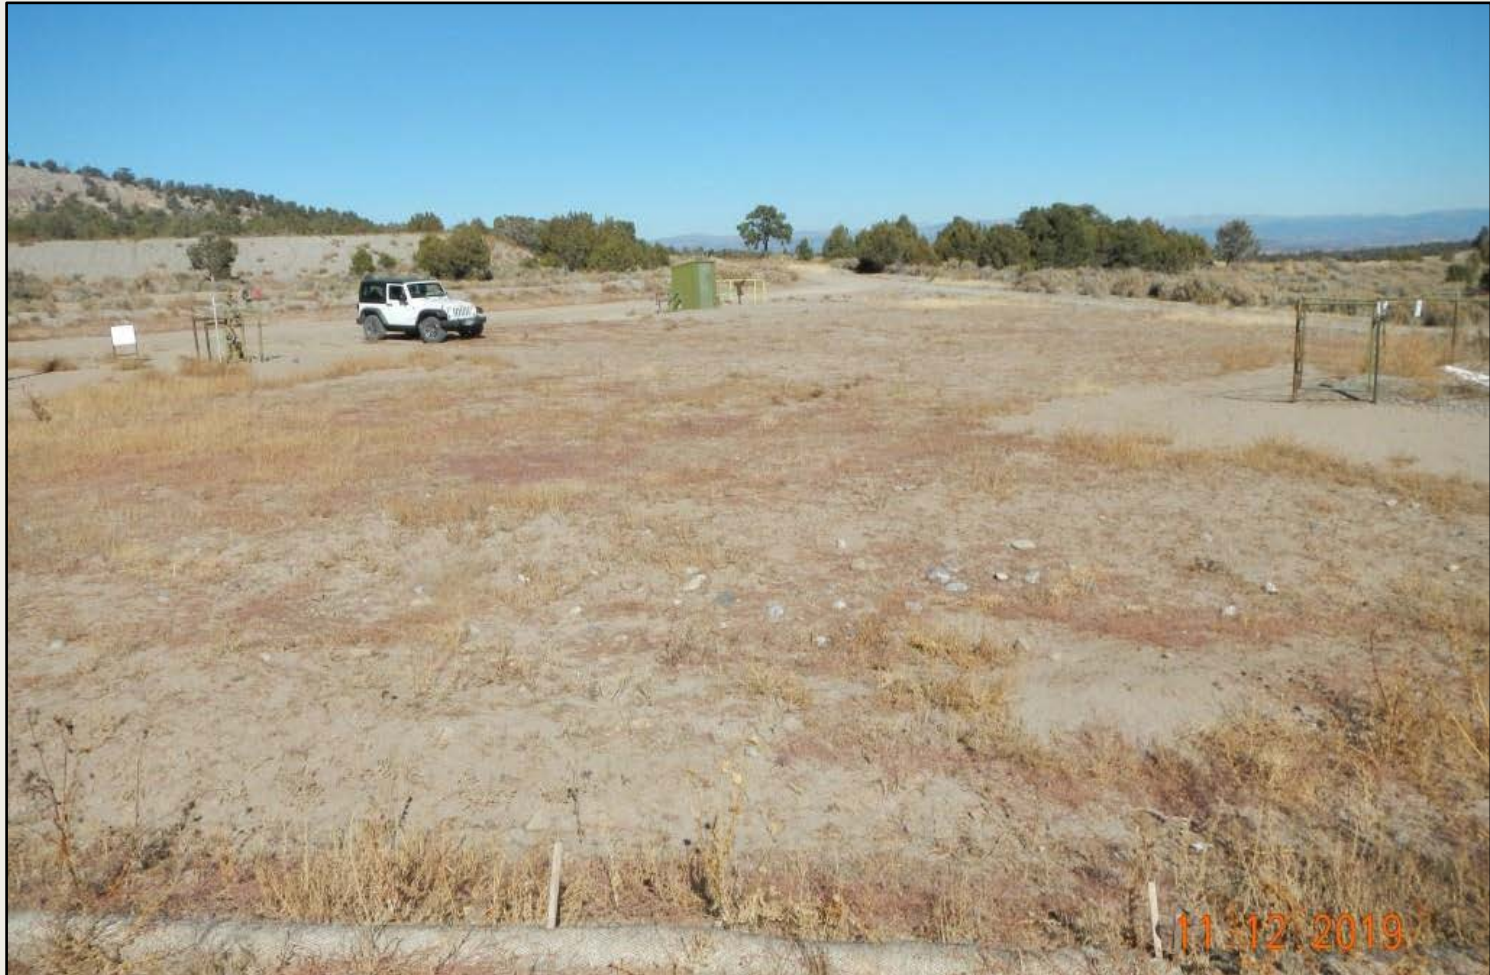
Photo 1. View of the project area from the southern edge facing center. Little desirable vegetation present in areas not in use for production.

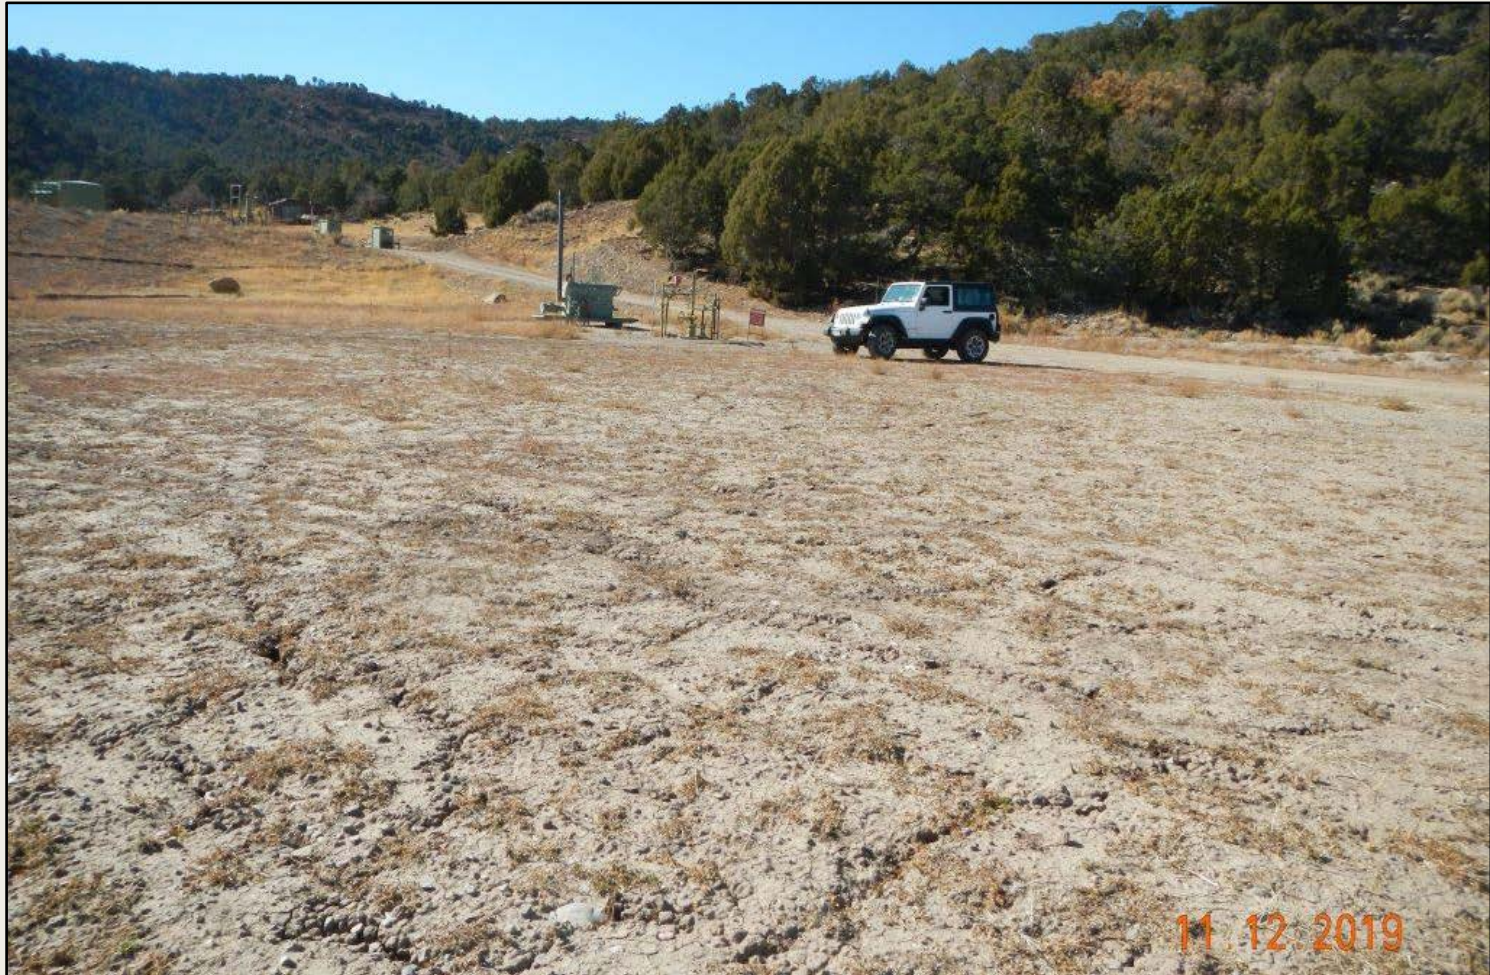
Photo 2. View of the project area from the northeastern corner facing center.

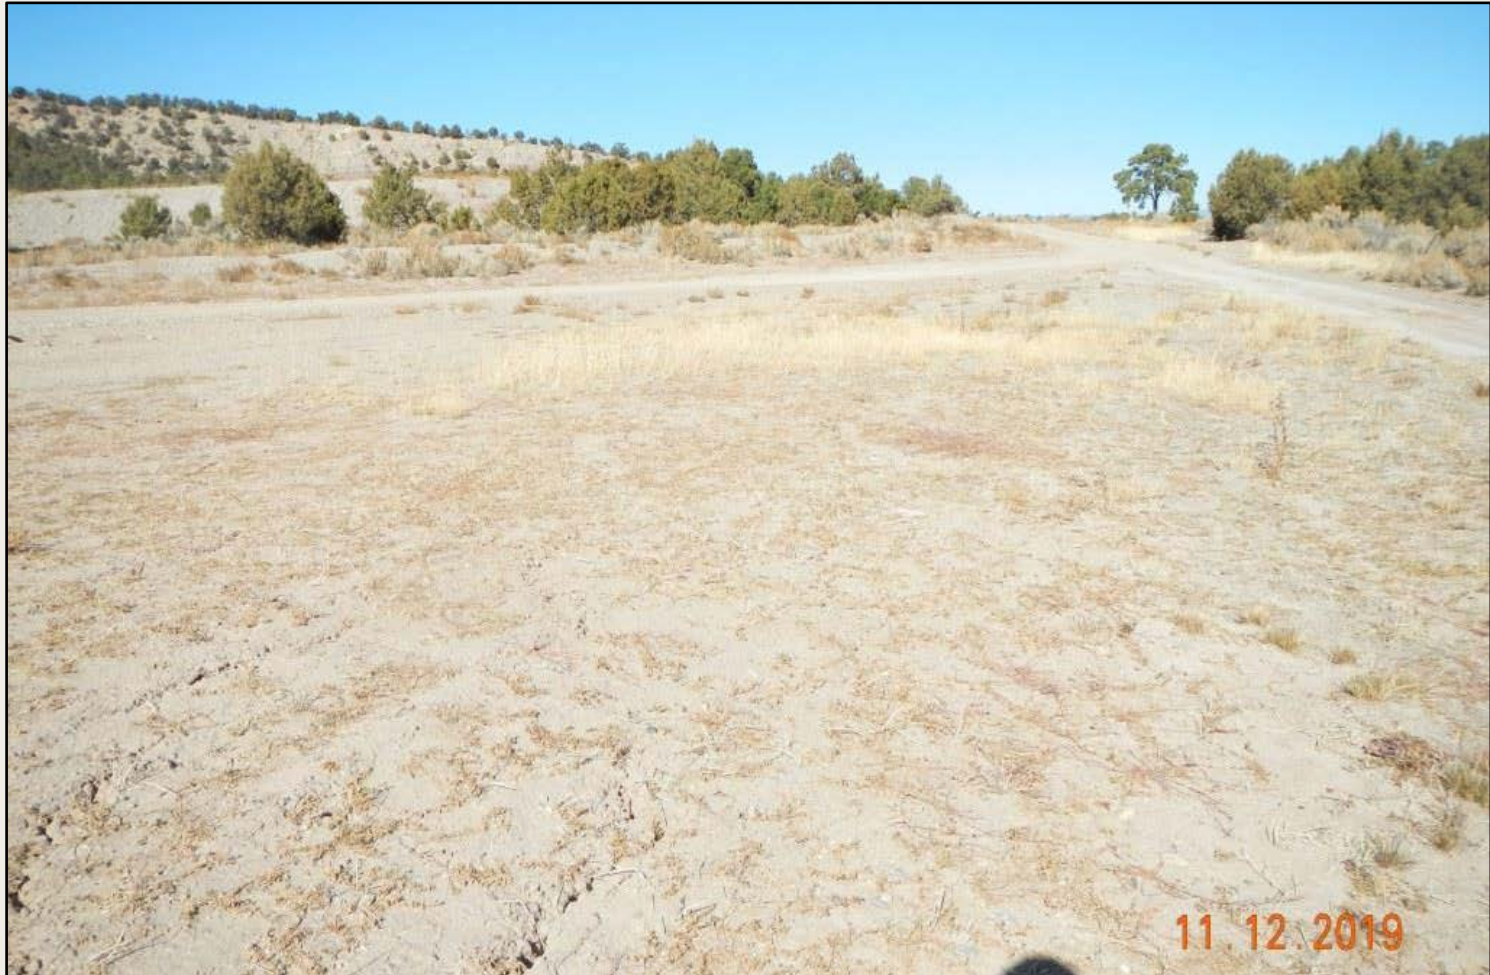
Photo 3. View of the northern project showing areas that need revegetation around a small patch of perennial grass that is established.
