Inspection Photos
Operator: Catamount Energy
Location/API #: 067-07692
Date: 11-12-2019

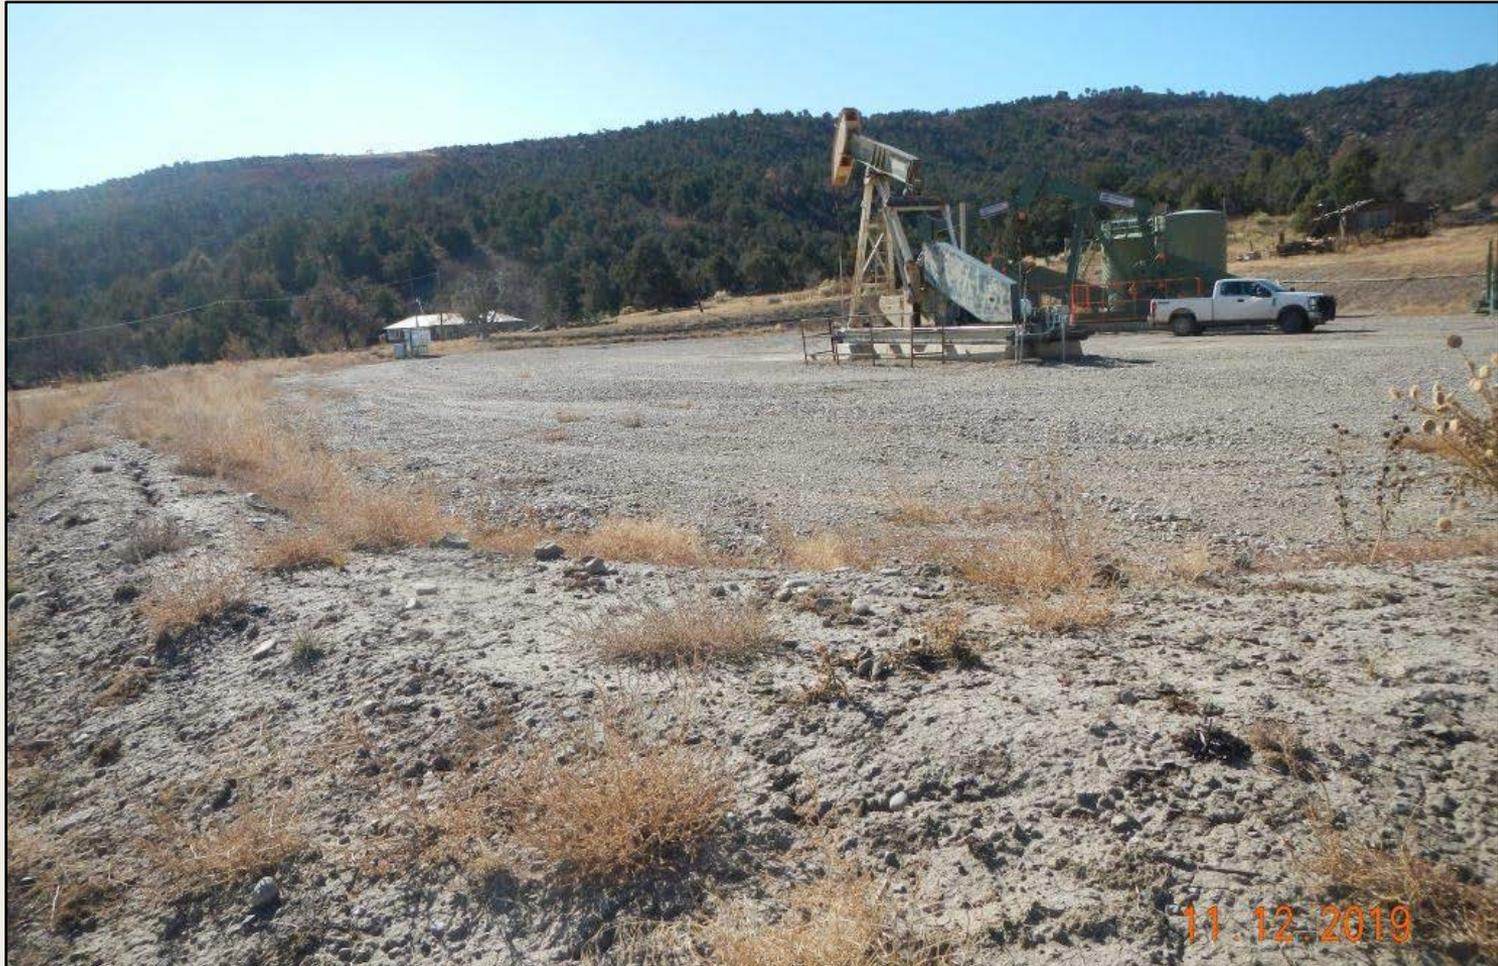
Photo 1. View of the project area from the northeastern corner facing center.

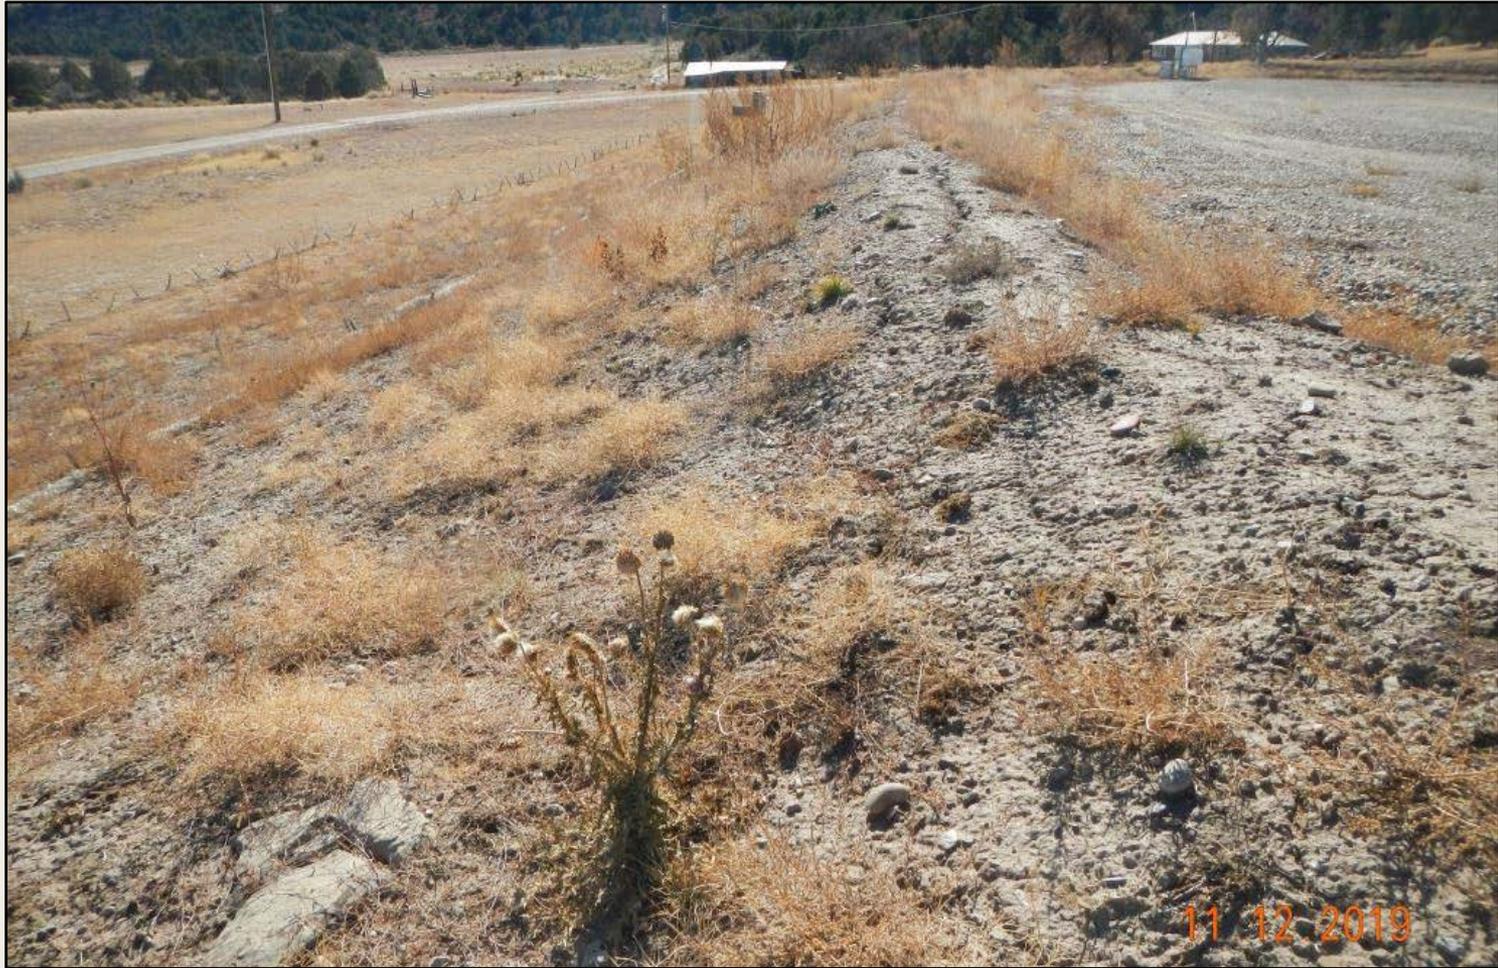
Photo 2. View of the eastern fill slope from the northeastern corner facing southward. Well pad berms and slopes are not stabilized. Observable vegetation is largely weeds and annual species such as musk thistle, Russian thistle, annual mustards, and field bindweed.

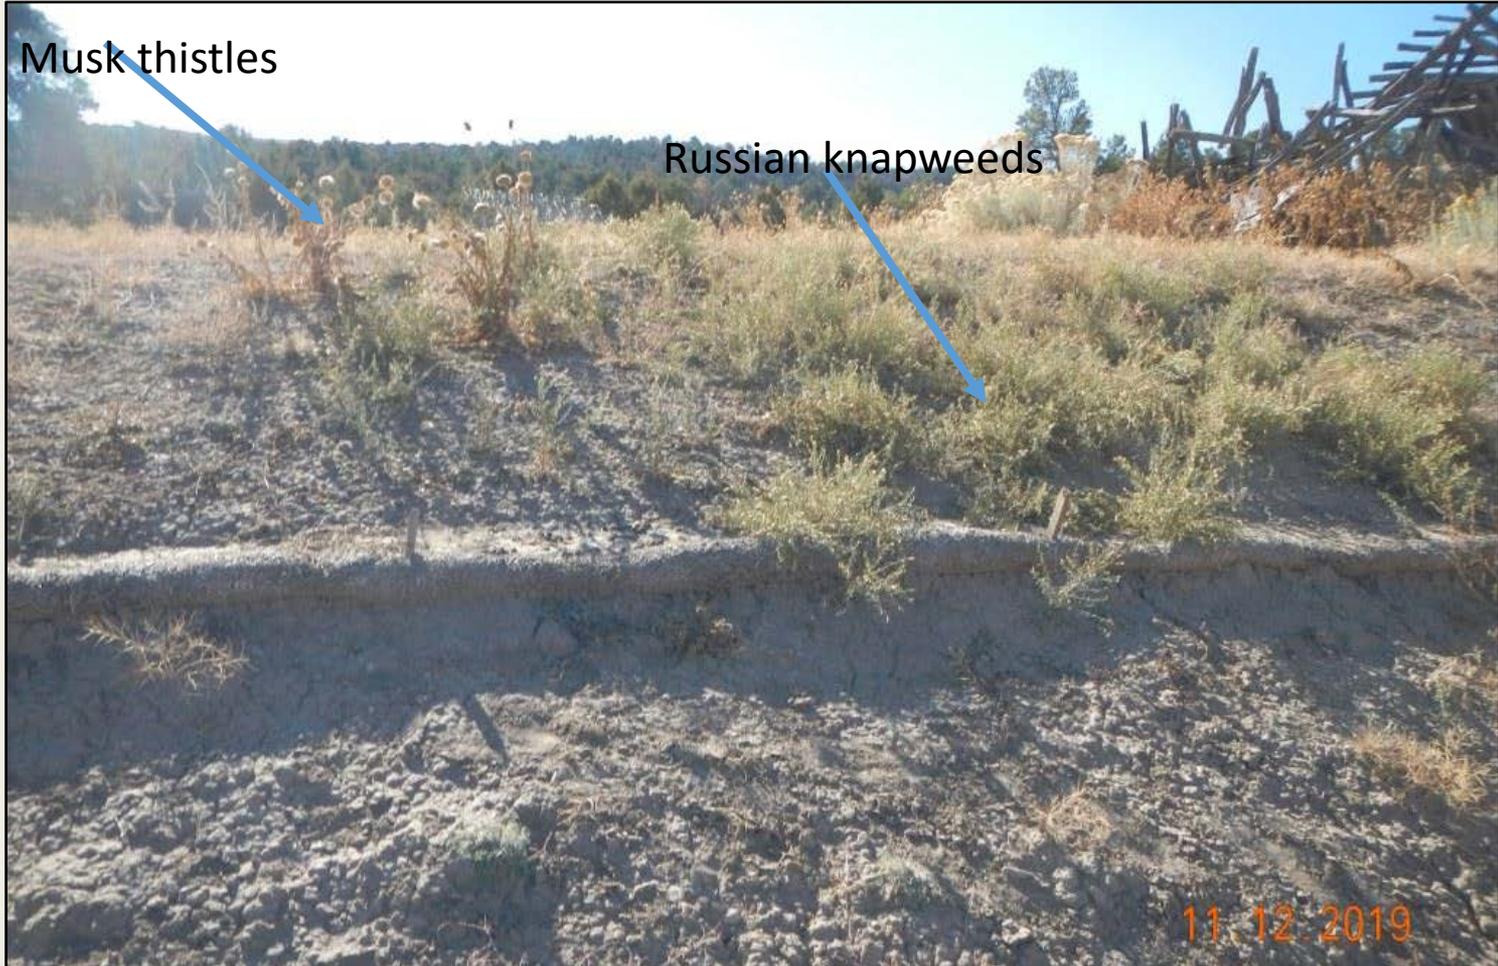
Photo 3. View of musk thistles and Russian knapweeds within the southwestern project area.

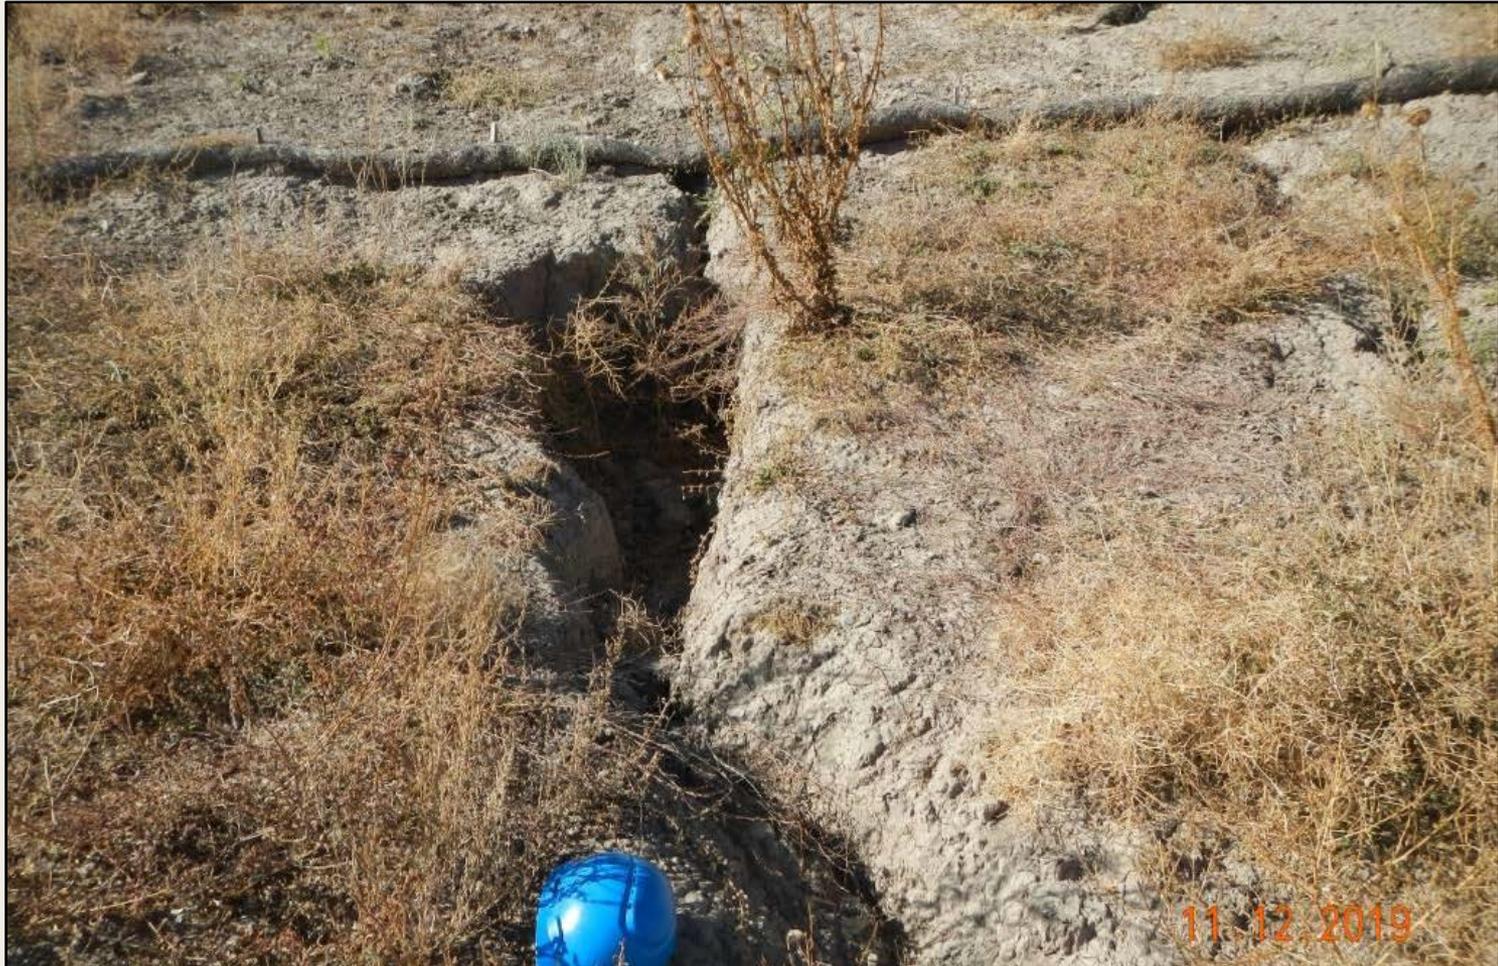
Photo 4. View of erosional channel, approximately 2 feet wide and deep, forming within the western cut-slope.

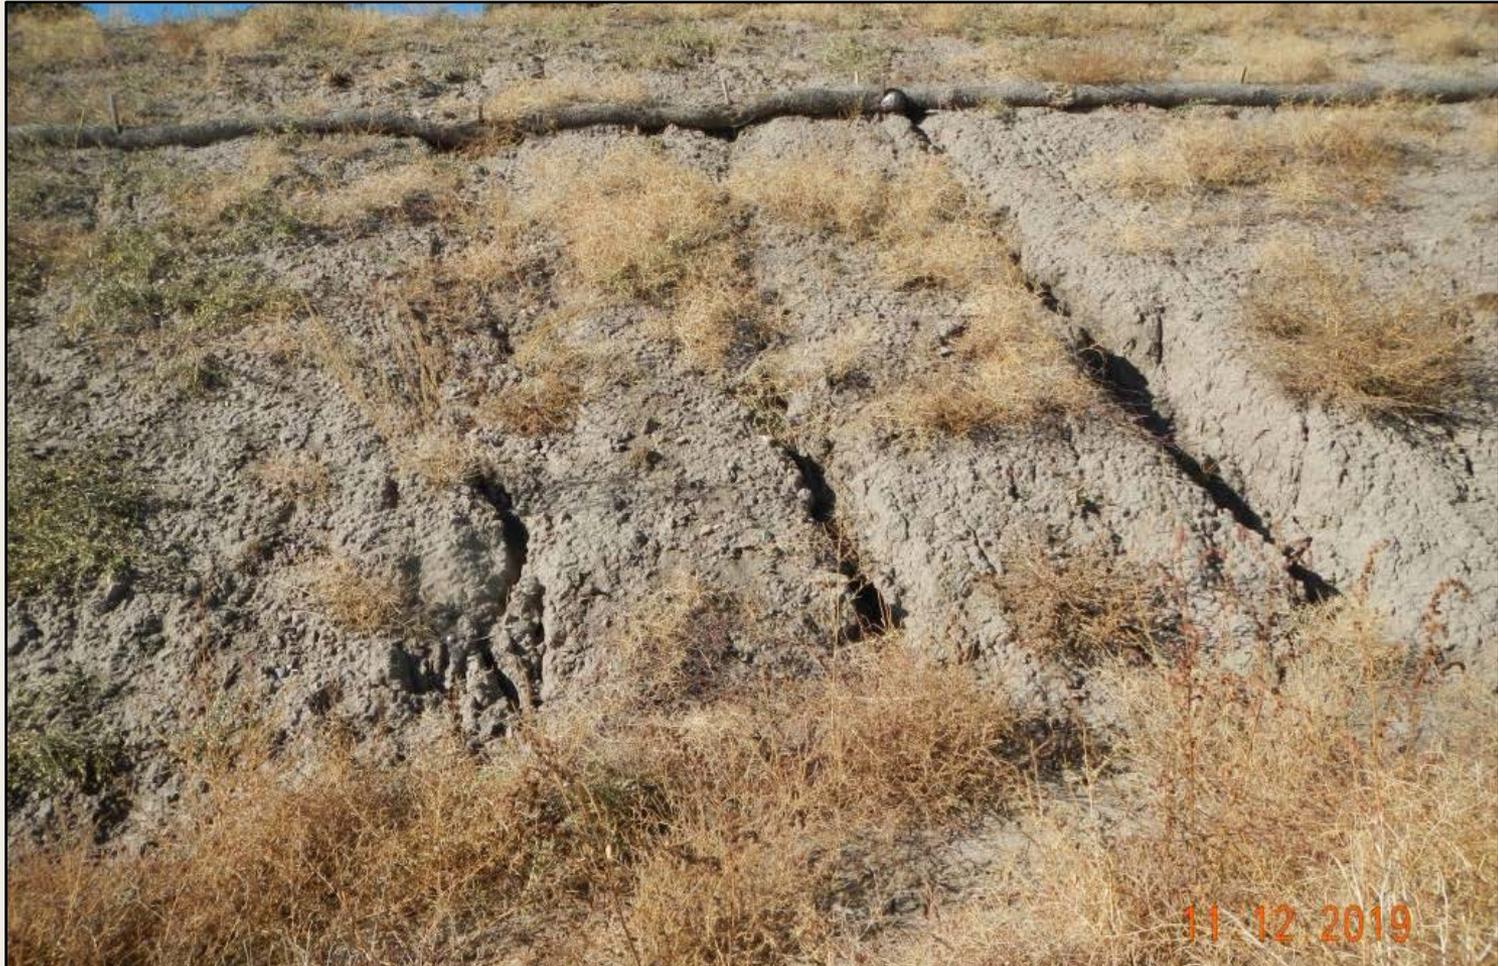
Photo 5. View of more erosional channeling and rilling within the western cut-slope. Vegetation is largely weeds such as those described in Photos 3 and 4.

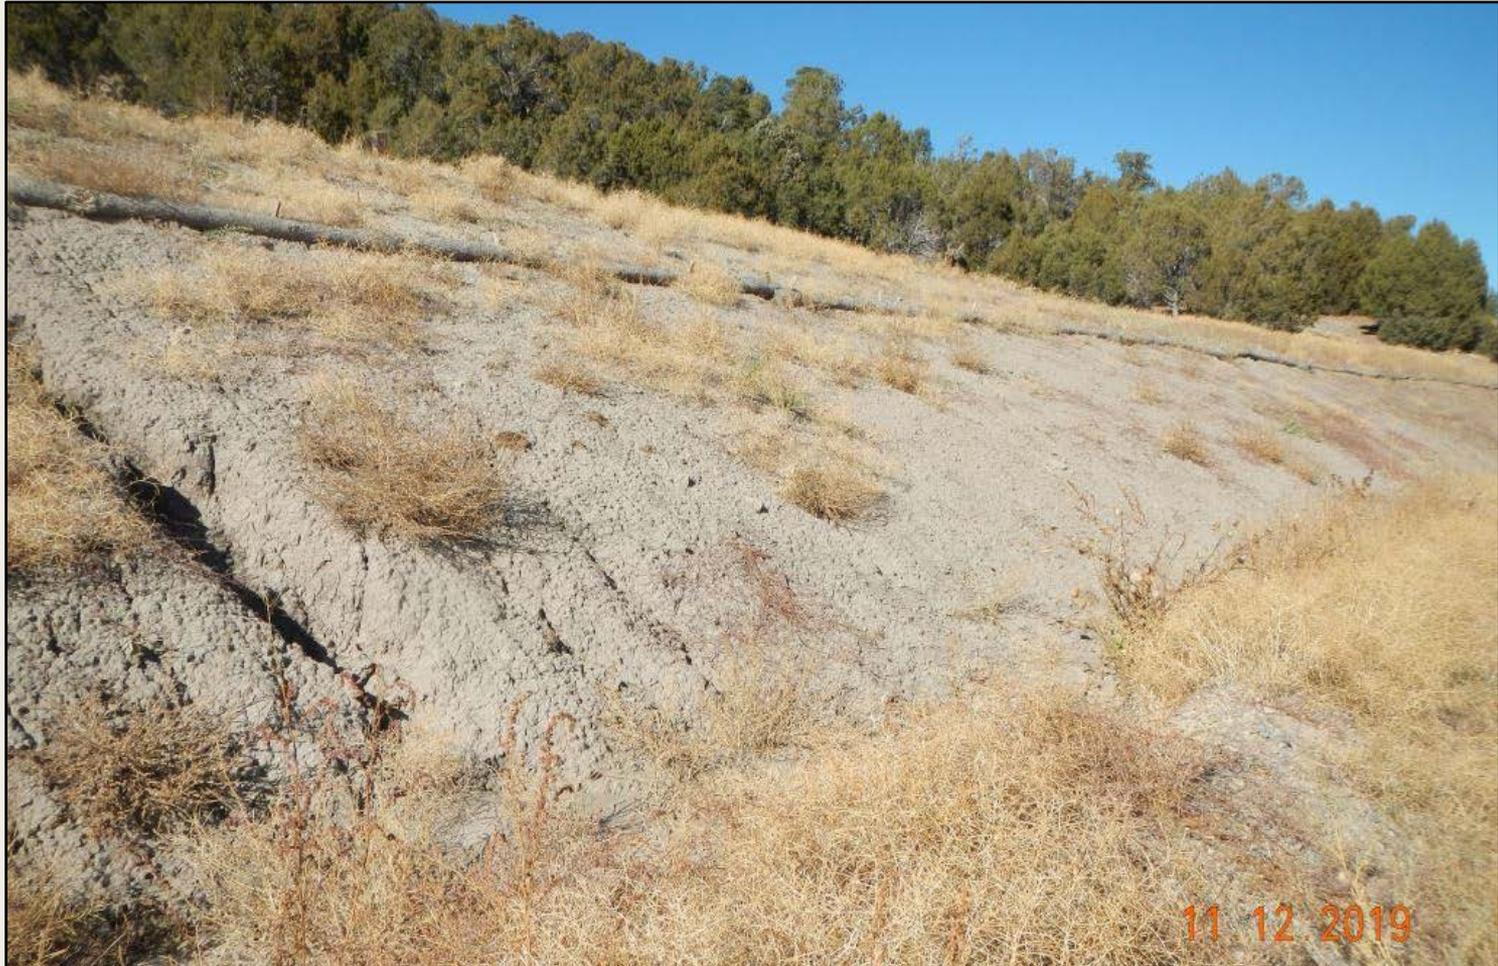
Photo 6. Another view of the western cut-slope.

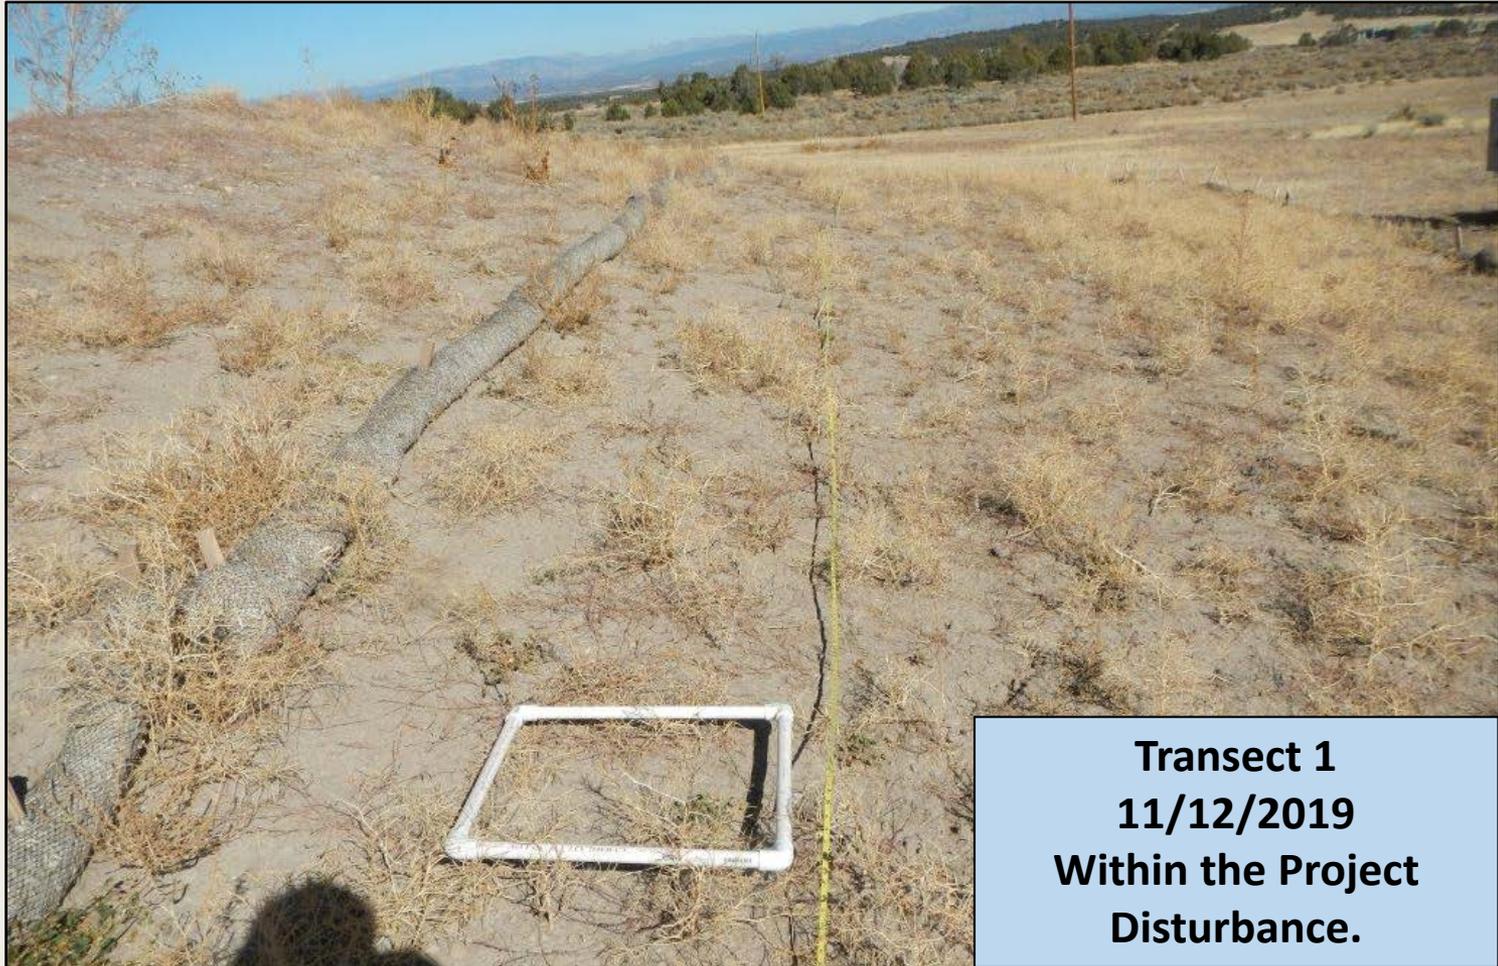
Photo 7. View of the beginning of germination Transect 1, facing northward.

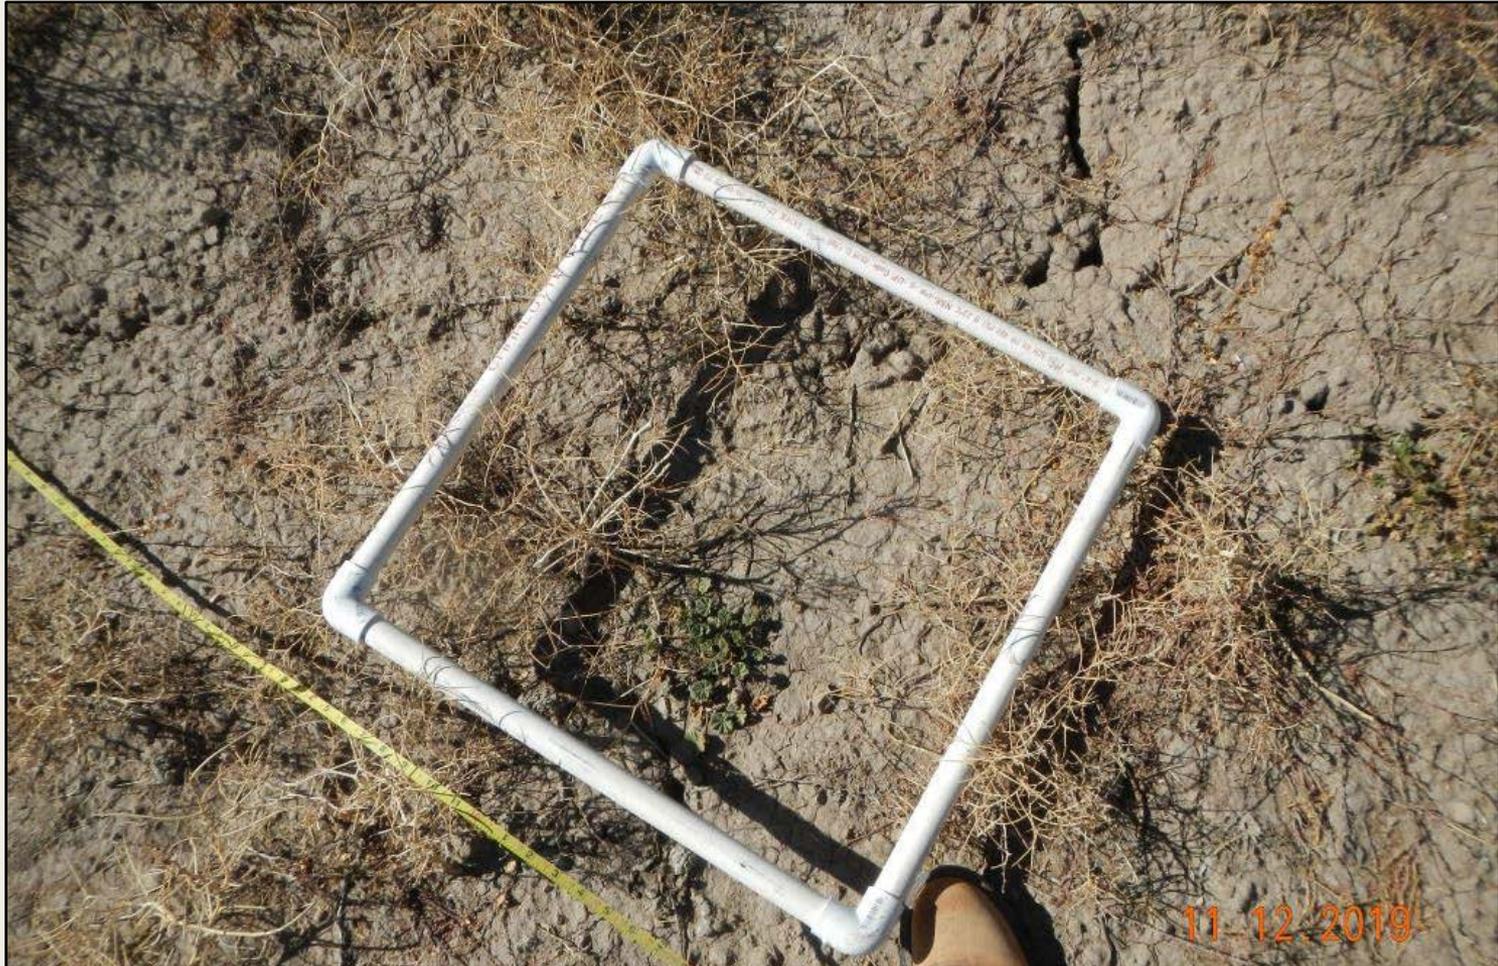
Photo 8. Birdseye view of typical quadrat along Transect 1, vegetation present is comprised of weeds such as annual mustard and common mallow.

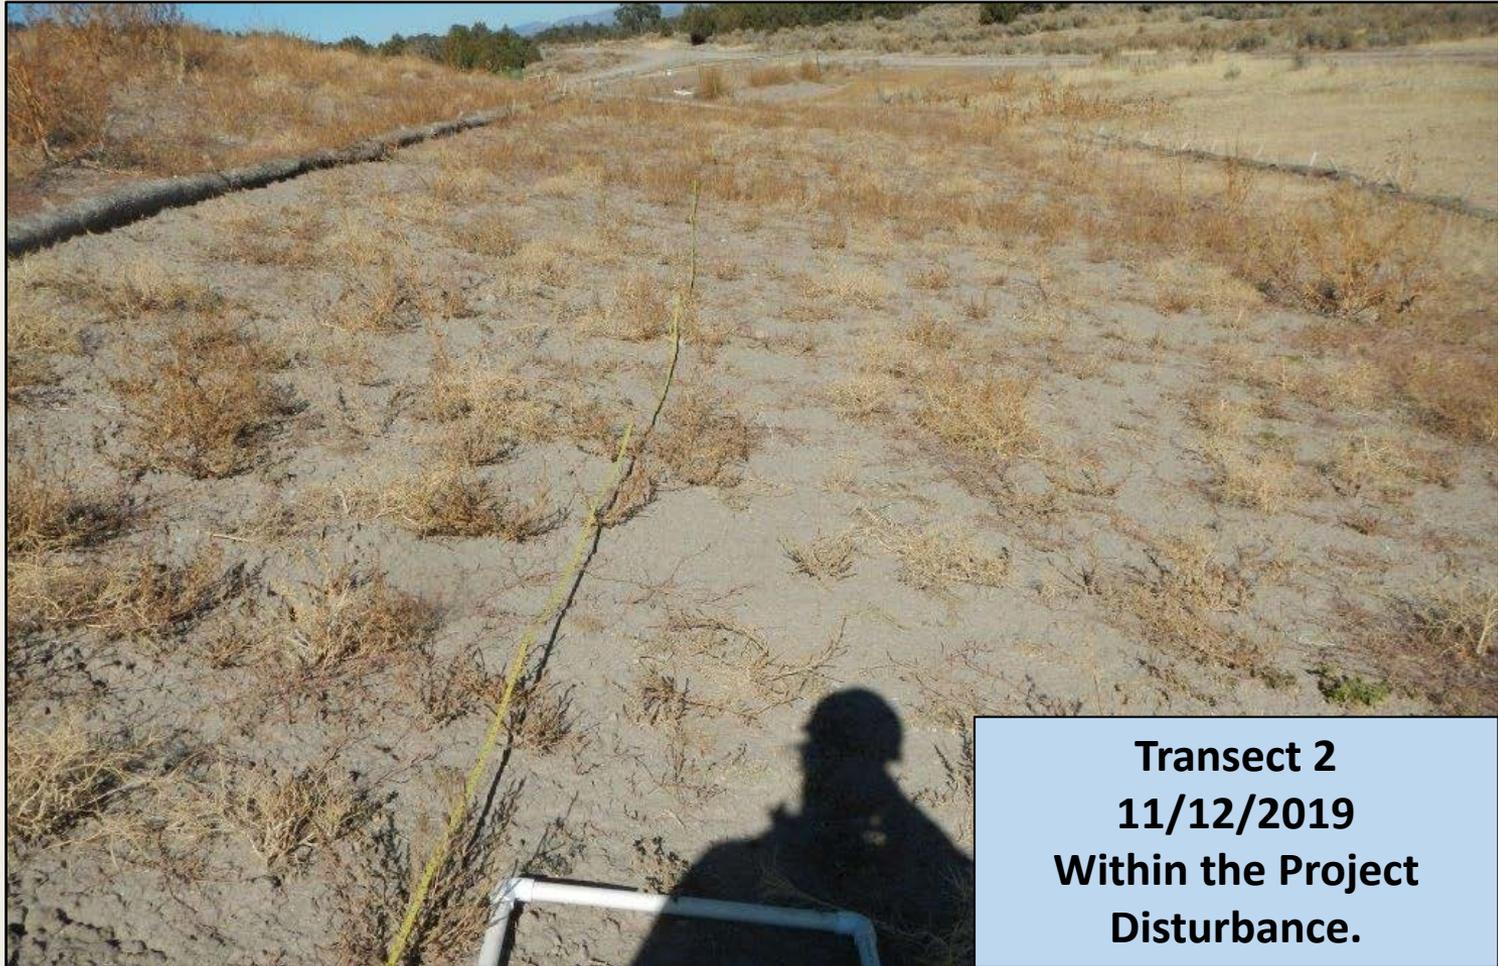
Photo 9. View of the beginning of Transect 2, within the northeastern project area.

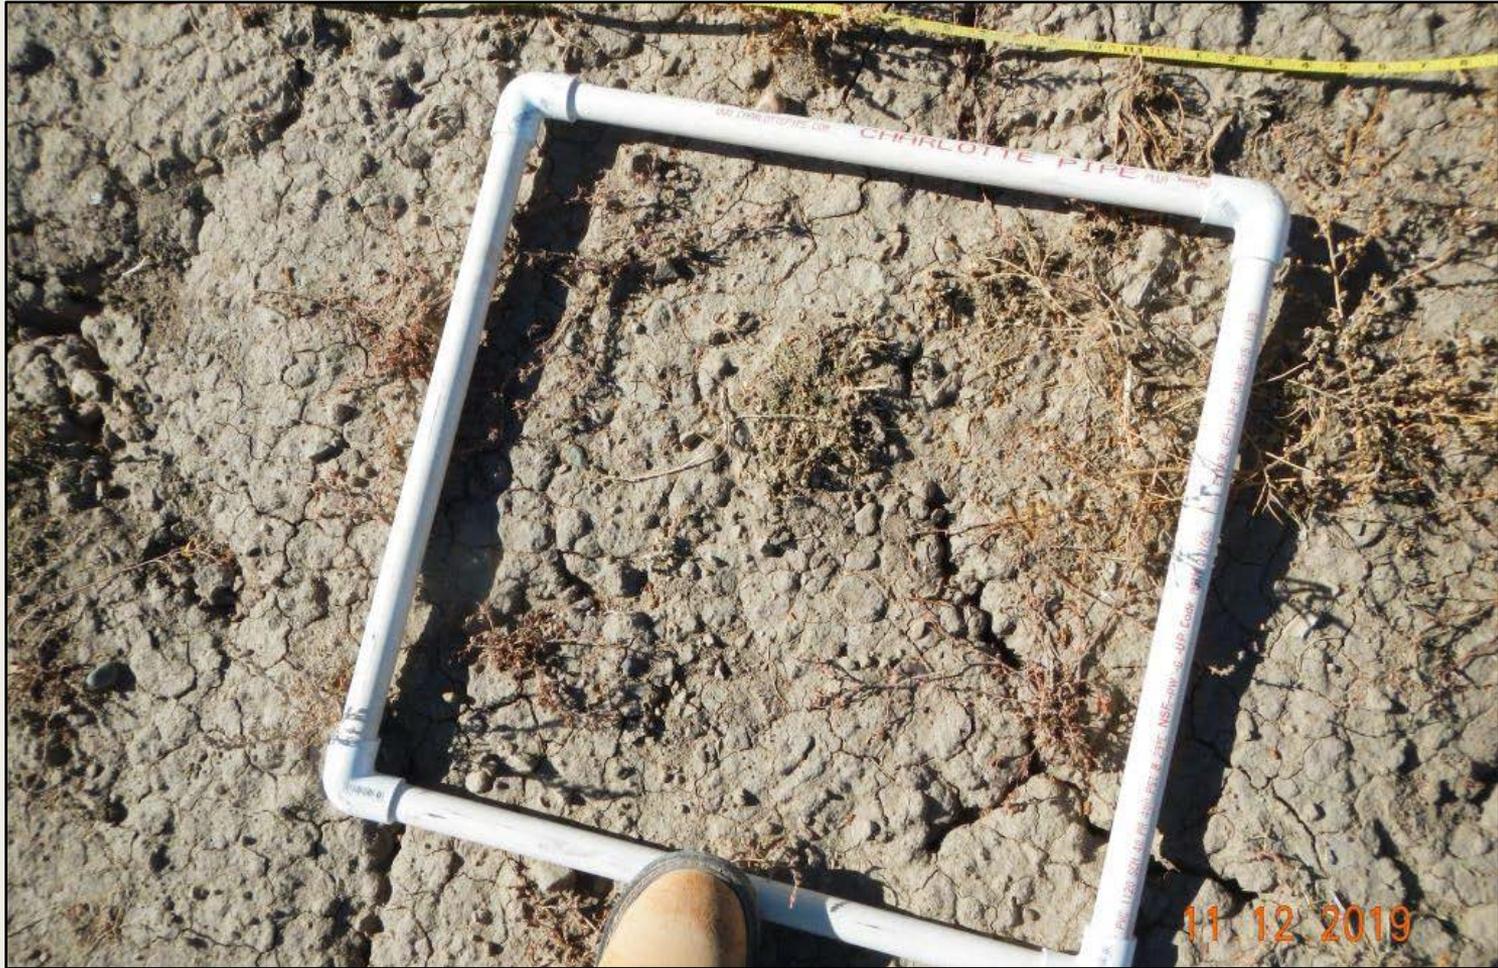
Photo 10. Birdseye view of typical quadrat along Transect 2, observable vegetation is knotweed and prickly lettuce.

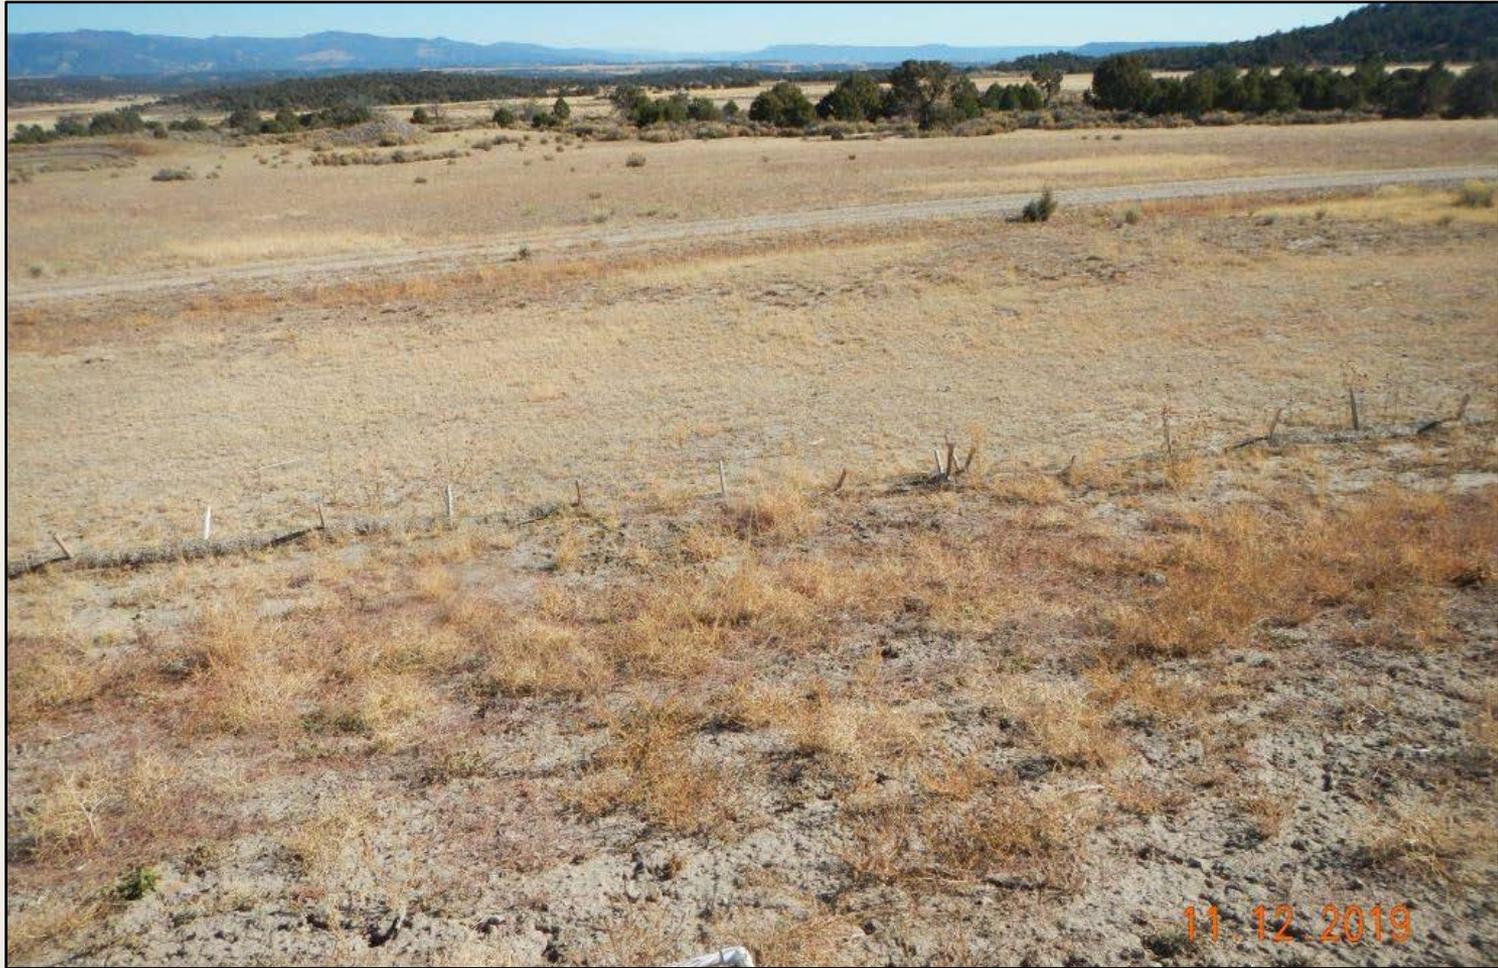
Photo 11. View of reference area (in background), comprised of perennial grasses such as western wheatgrass and sand dropseed, with mixed shrubs such as big sagebrush.
