Inspection Photos
Location Name: CAYLEY 21-24
API#: 05-071-08804
INSP. #: 695101778

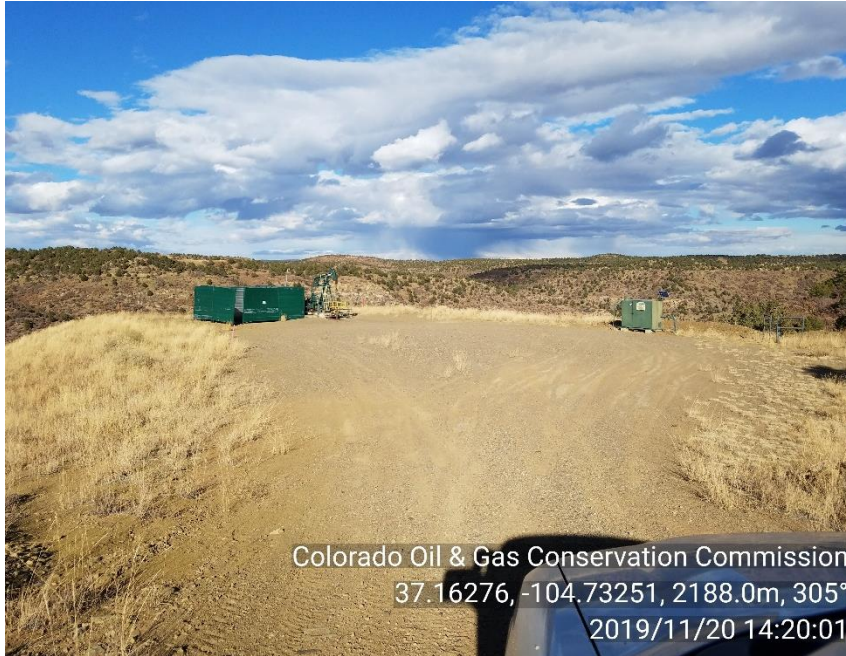
PHOTO 1: LOCATION

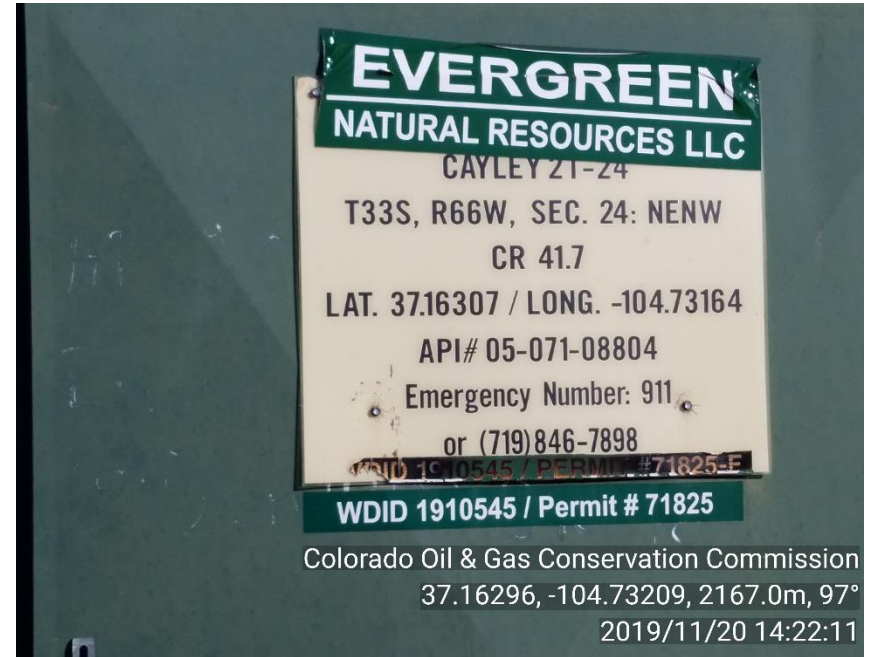
PHOTO 2: WELL SIGN

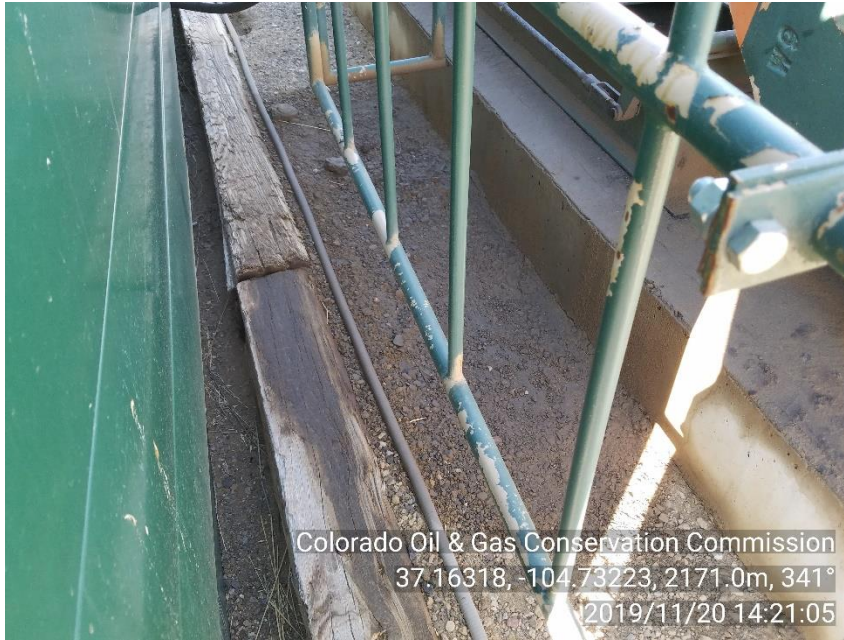
PHOTO 3: AREA OF IMPACTED SOIL BETWEEN PUMPJACK AND SOUND WALL. Remove and dispose impacted material in approved manner, service and maintain equipment and self inspect to prevent recurrence of conditions per 1002.f(2) and 907. CA DATE 12-20-19

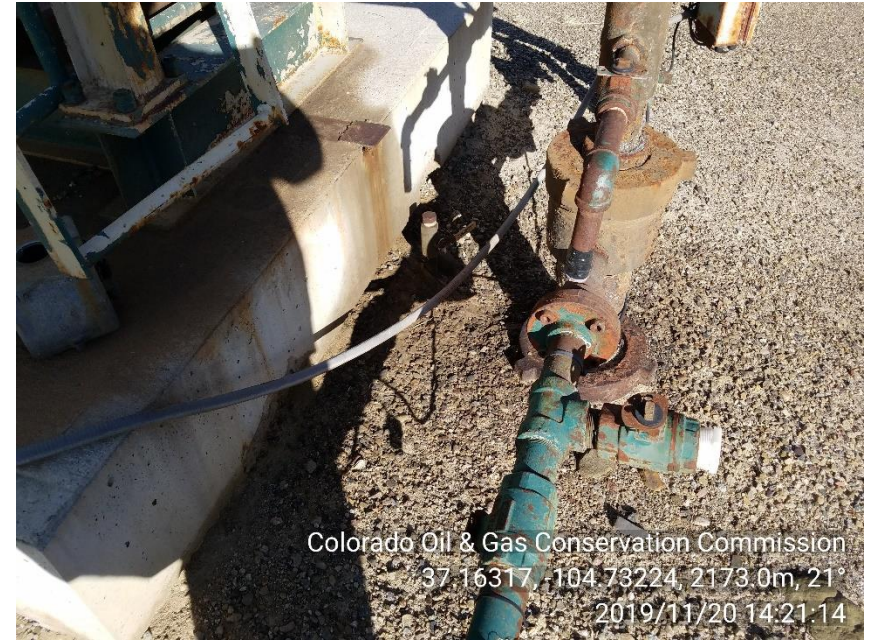
PHOTO 4: AREA OF IMPACTED SOIL AROUND WELLHEAD. Remove and dispose impacted material in approved manner, service and maintain equipment and self inspect to prevent recurrence of conditions per 1002.f(2) and 907. CA DATE 12-20-19
