Inspection Photos
Location Name: MITZI 22-19
API#: 05-071-09044
INSP. #: 695101792

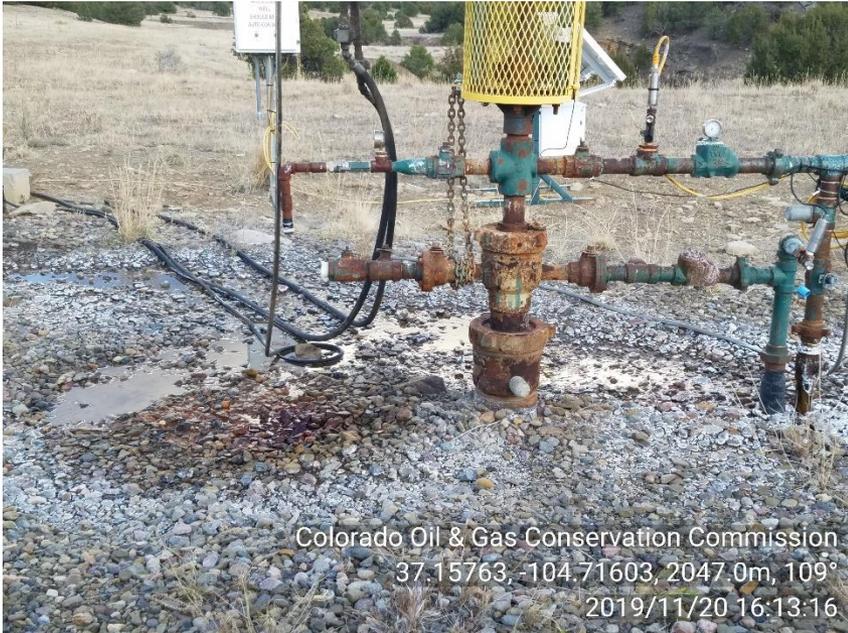
PHOTO 3: 1" VALVE ON TBG TREE IS LEAKING (JUDGING BY THE DISCOLORATION OF THE GRAVEL BELOW THE 1" OUTLET THIS WELL HAS BEEN LEAKING FOR A LENGTHY AMOUNT OF TIME). Securely fasten all valves, pipes, and fittings to ensure good mechanical condition, inspect at regular intervals and maintain in good mechanical condition per Rule 605.d. Report spill or release of E&P waste or produced fluids Remove free fluids and contact COGCC EPS staff per Rule 906.b. 24 hours for notification and 72 hours for Initial Form 19 Report.

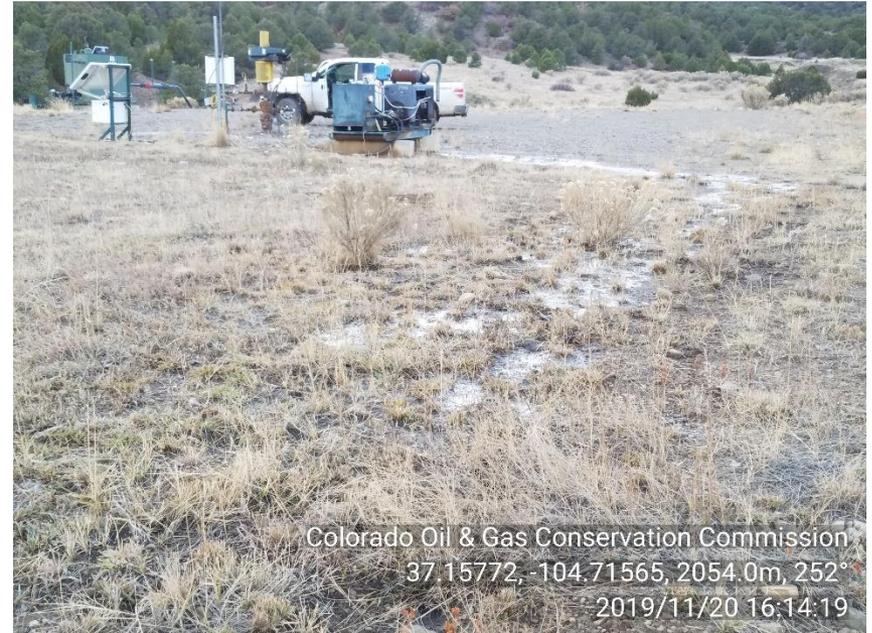
PHOTO 4: FLUID FROM WELL HAS TRAVELED APP. 129' FROM WELLHEAD.

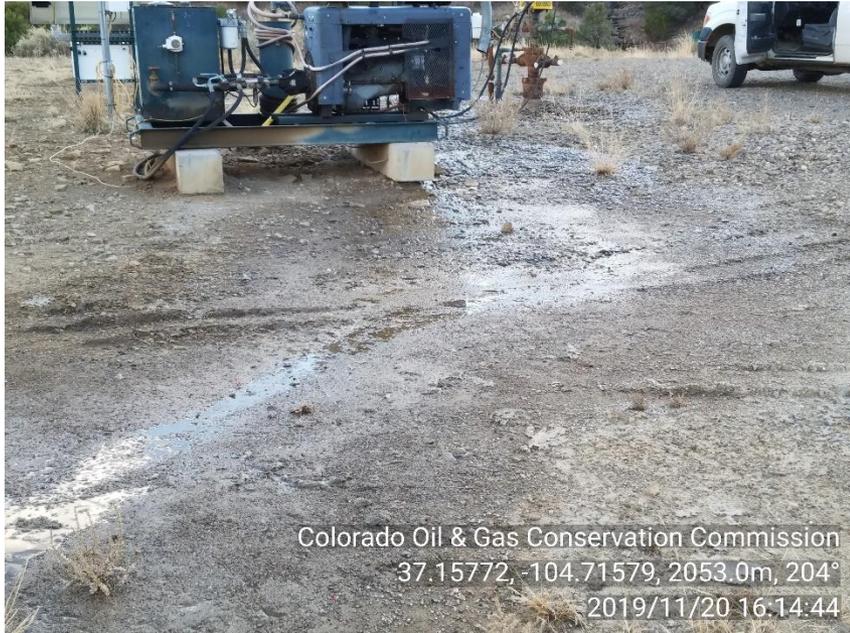
PHOTO 5: ANOTHER IMAGE OF IMPACTED AREA ON LOCATION.

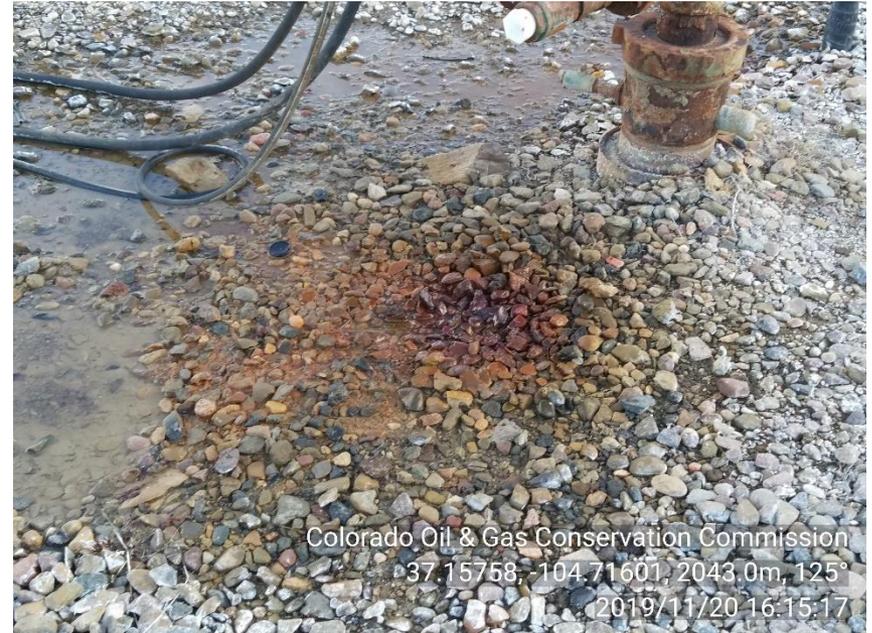
PHOTO 6: DISCOLORATION OF GRAVEL BENEATH LEAKING 1" VALVE INDICATING LEAK HAS BEEN PRESENT FOR A LENGTHY ABOUT OF TIME.
