Inspection Photos

API: 05-071-07956

Operator: PRESCO INC

Inspection Date: 11/19/2019

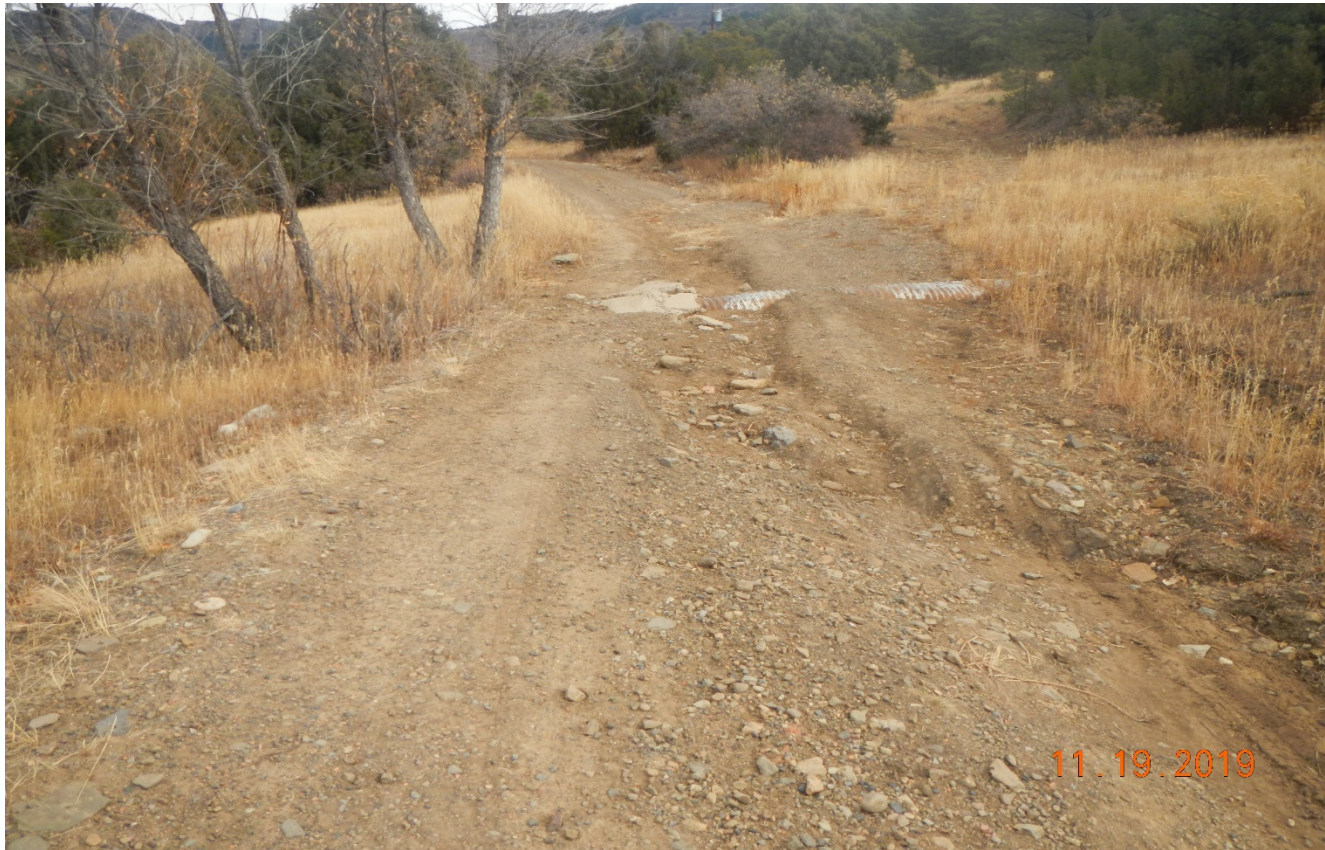
Photo 1. There is erosion issues along the access road and the culvert has filled in with sediment at Lat/Long:37.02025,-104.48562.

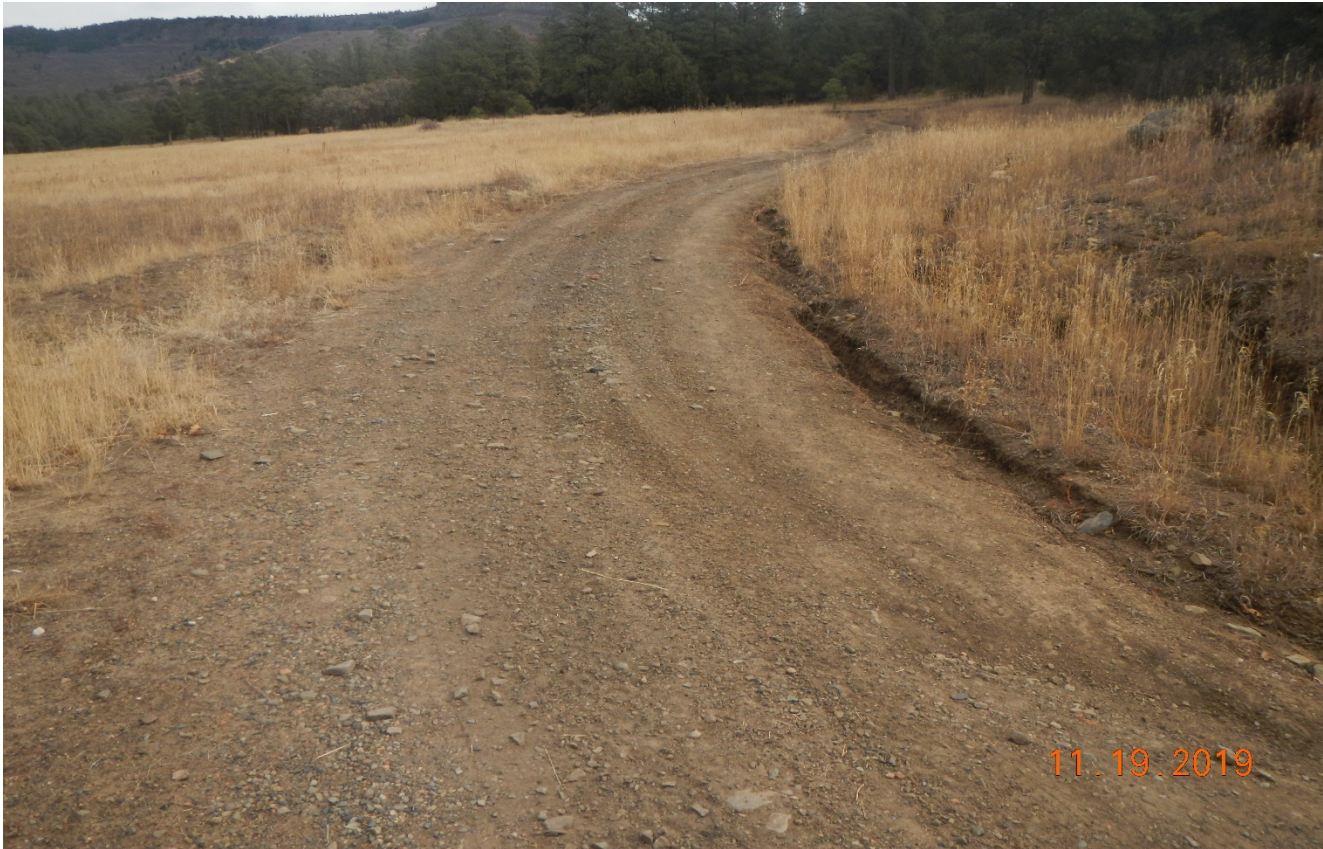
Photo 2. There is erosion issues along the side of the access road near Lat/Long:37.02080,-104.48449.

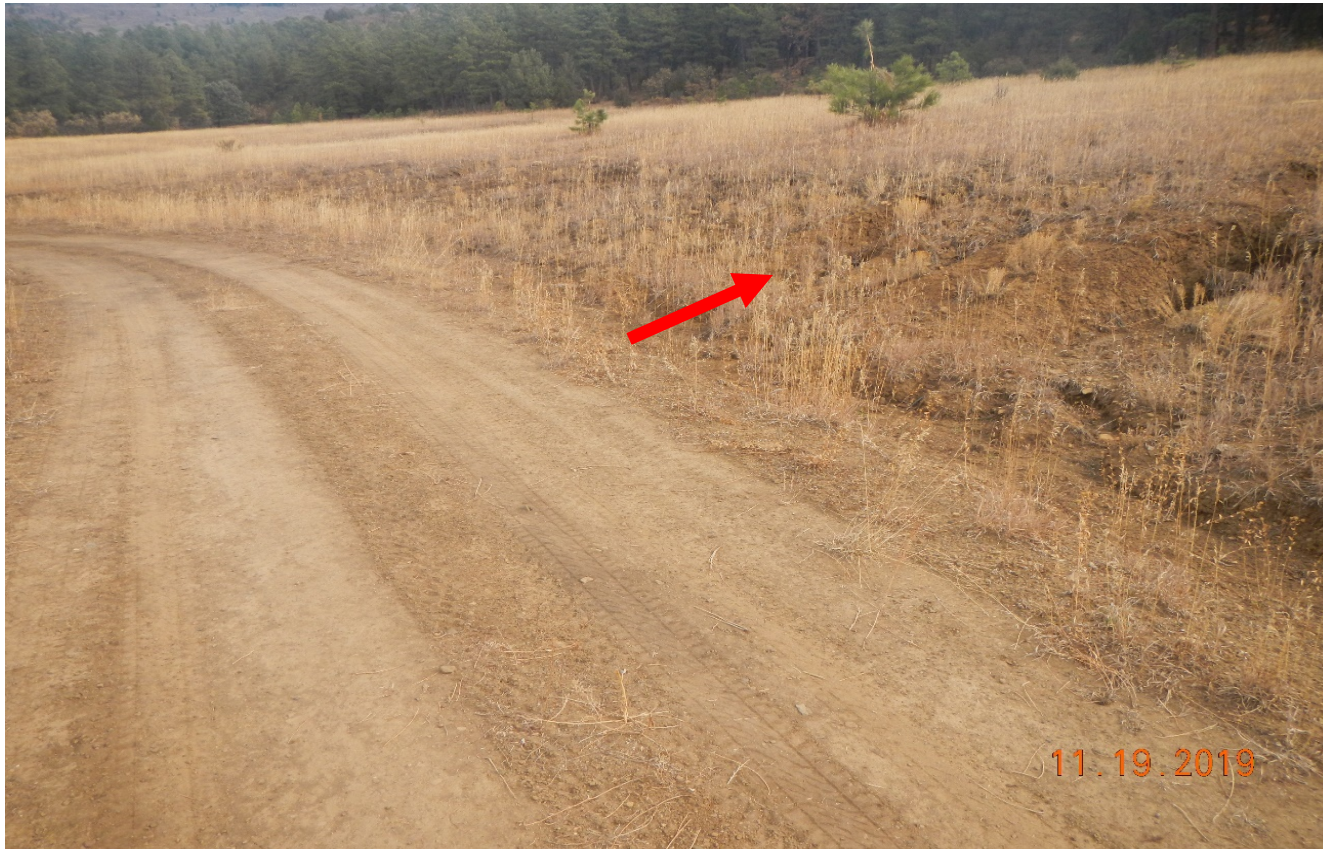
Photo 3. There is erosion occurring along the side of the road which is not stabilized. Lat/Long:37.02183,-104.48203. The pre-existing road was widened during operations.

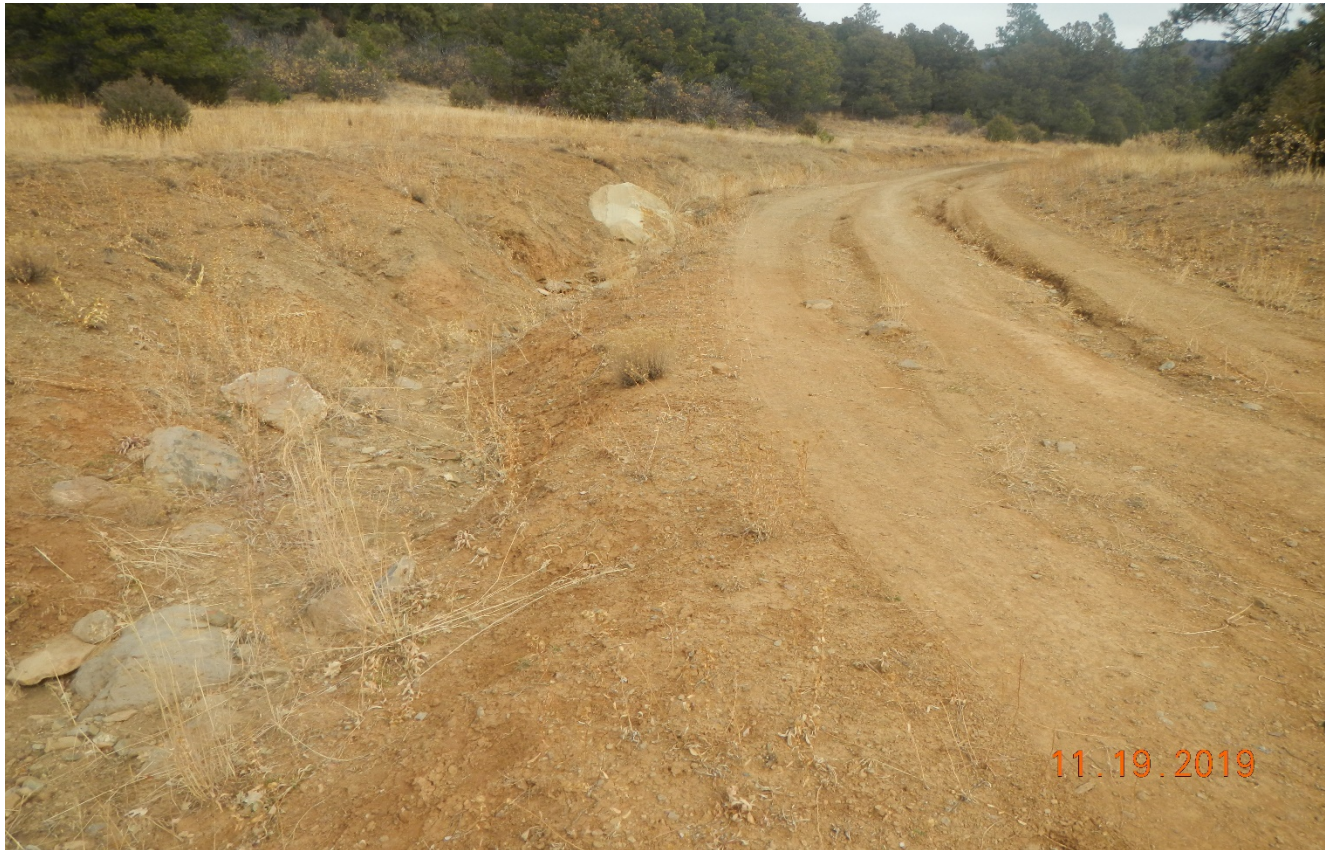
Photo 4. There is erosion issues along the access road traveling to the location. Lat/Long:37.02250,-104.48266. Corrective action of the previous inspection has not been performed.

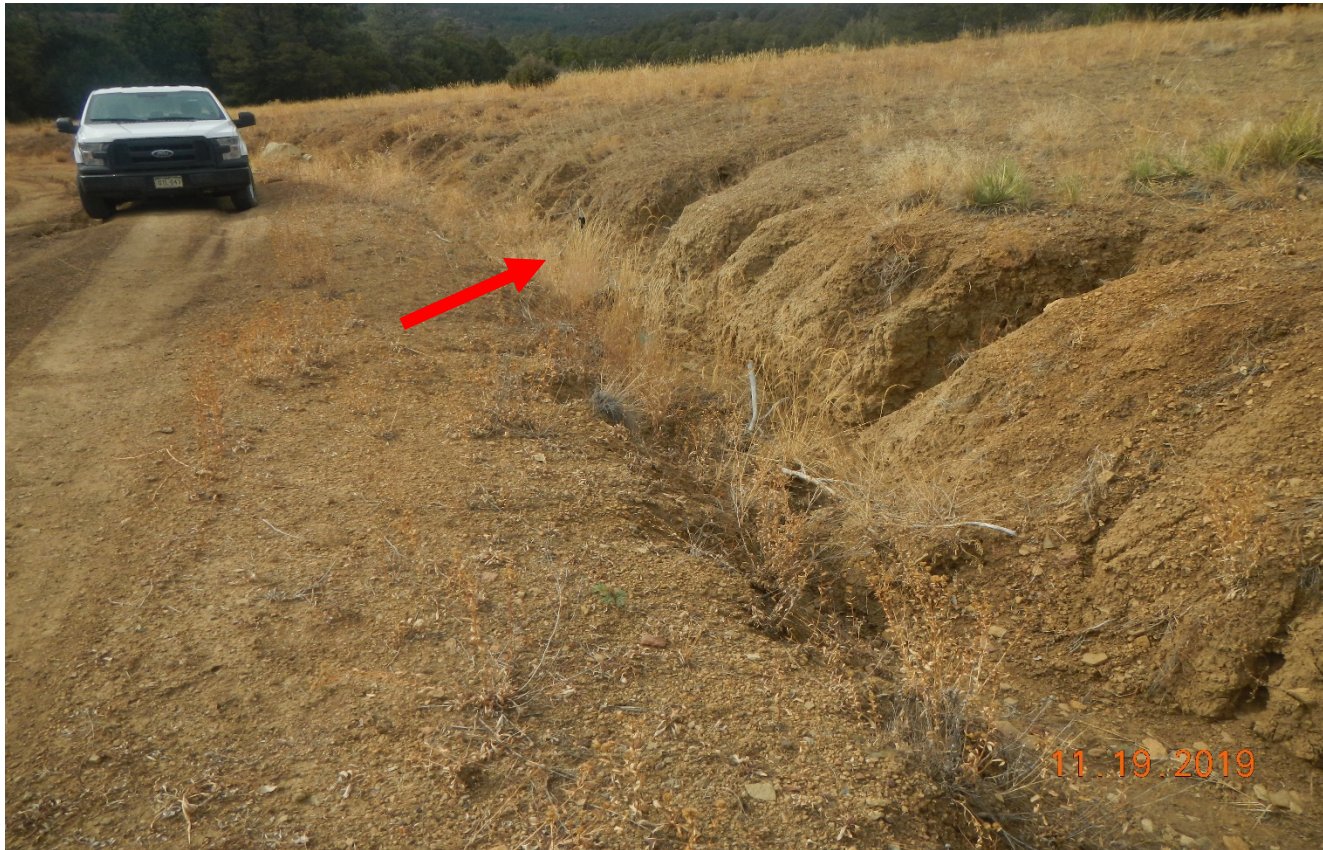
Photo 5. There is severe erosion along the access road. The pre-existing road was widened during operations and has not been maintained. Arrow points to 3.5 ft. shovel to show depth of erosion gully. Lat/Long:37.02250,-104.48266.

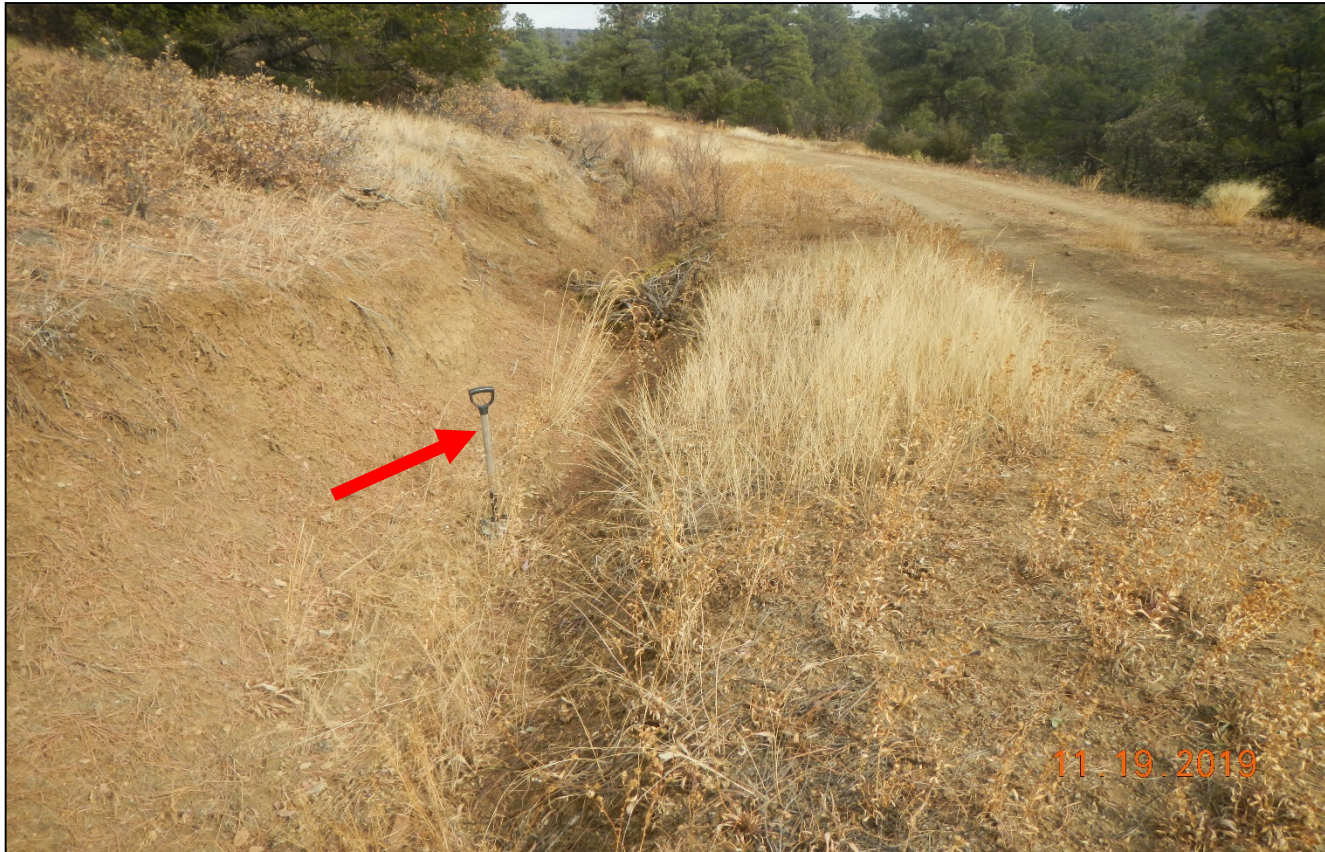
Photo 6. There is a deep channel that developed along the side of the access road. Arrow points to 3.5 ft. shovel to show depth of erosion gully. Corrective action of the previous inspection has not been performed.

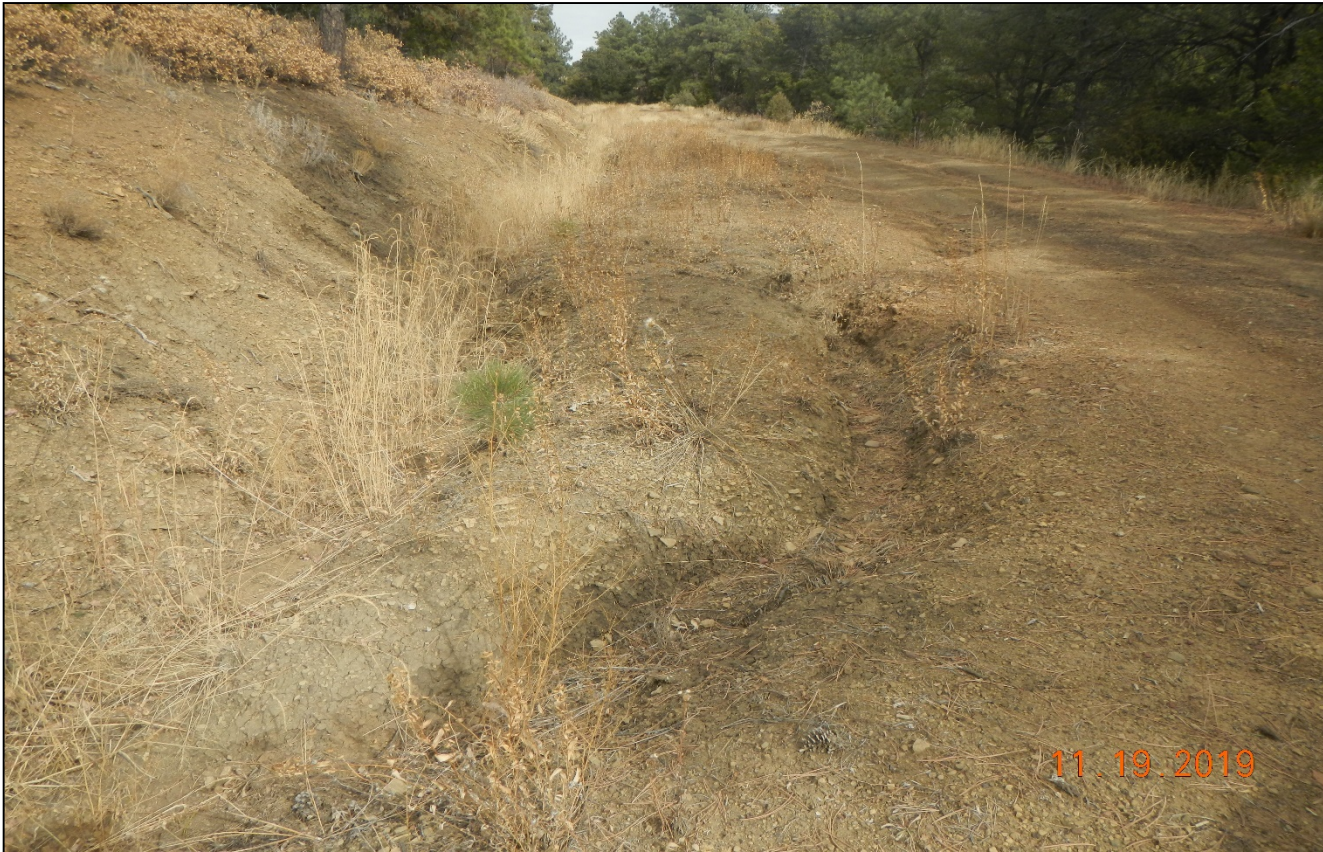
Photo 7. There is erosion issues along the access road traveling toward the location. Corrective action of the previous inspection has not been performed.

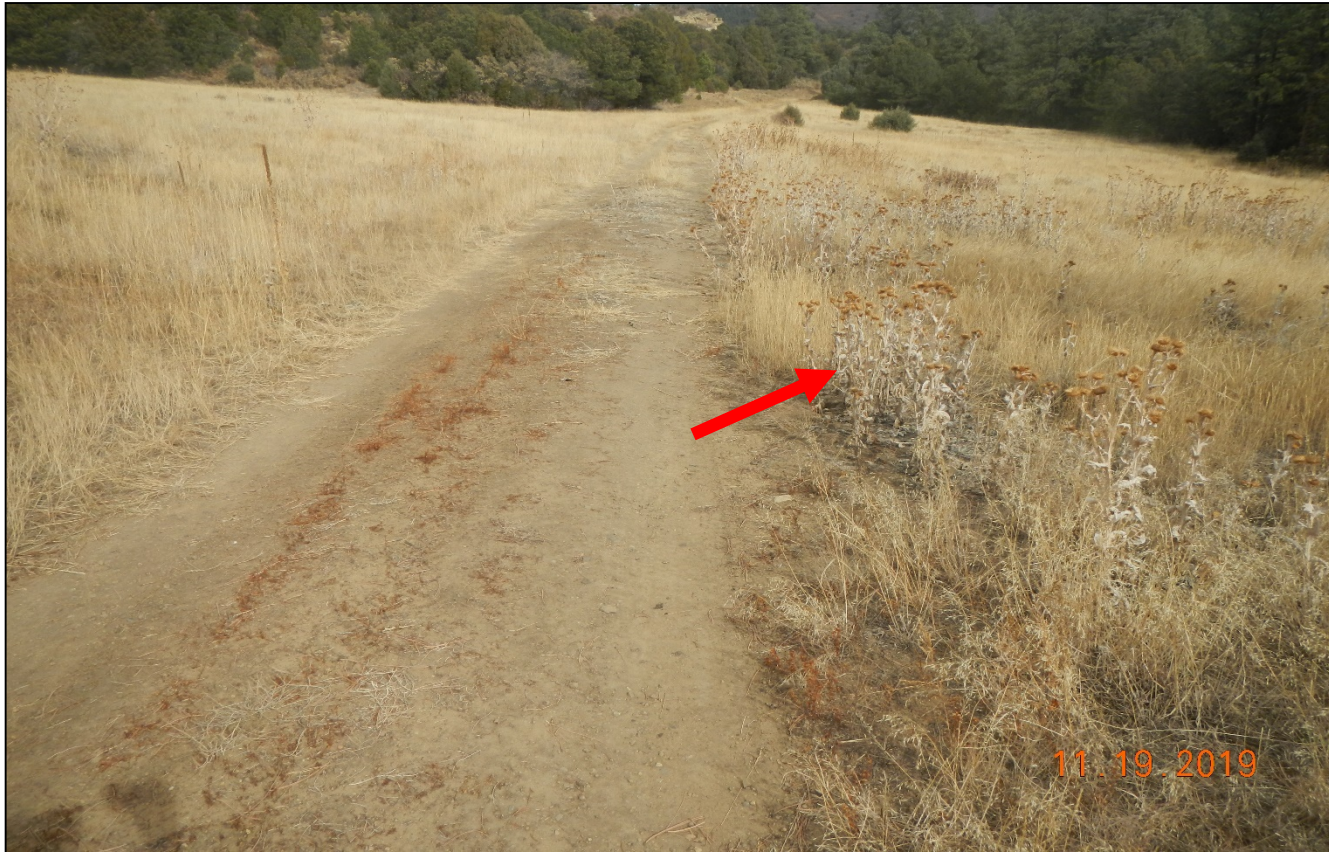
Photo 8. There are numerous noxious weeds along the access road. (Scotch thistle)
Noxious weed control was not performed since previous inspection.

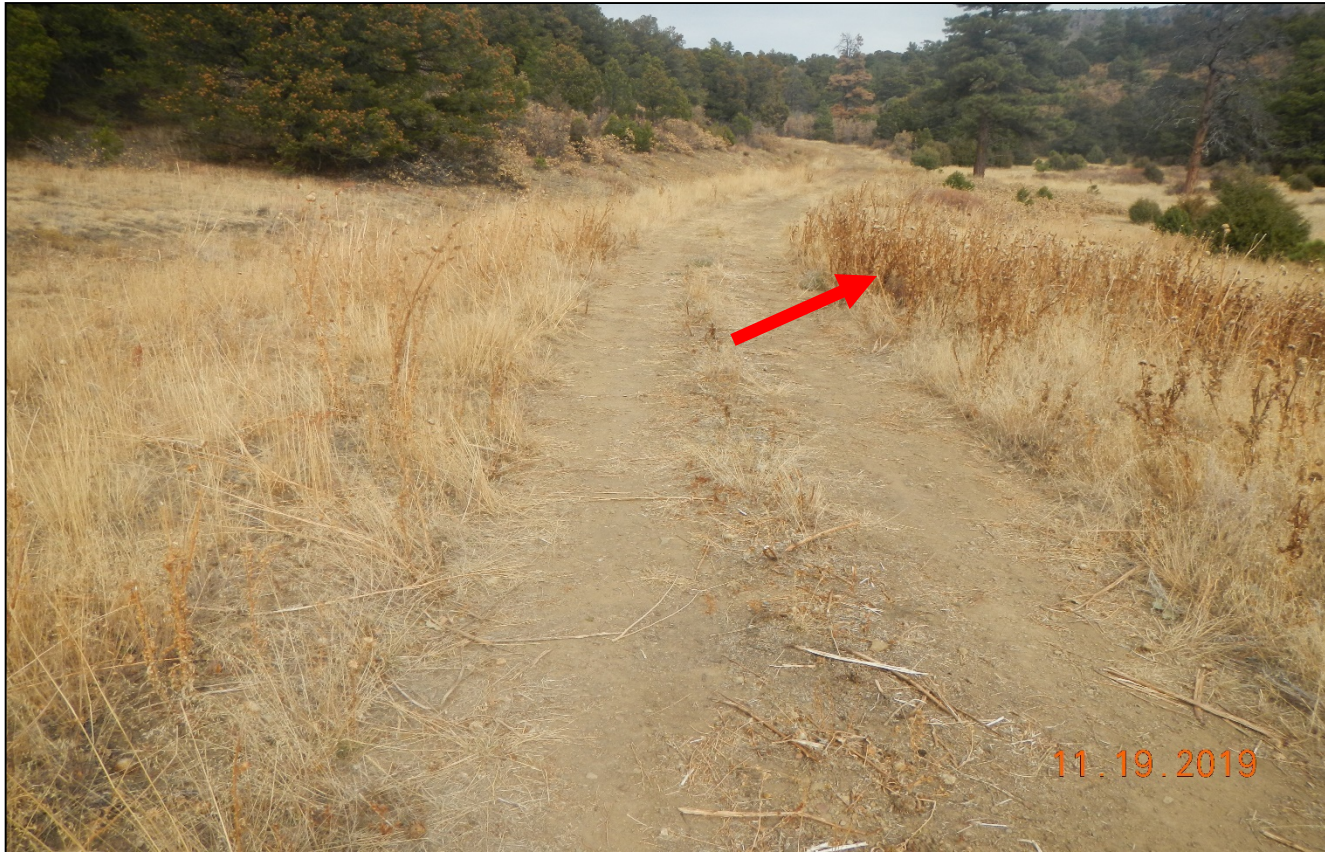
Photo 9. There are numerous noxious weeds along the access road. (Musk thistle)
Noxious weed control was not performed since previous inspection.

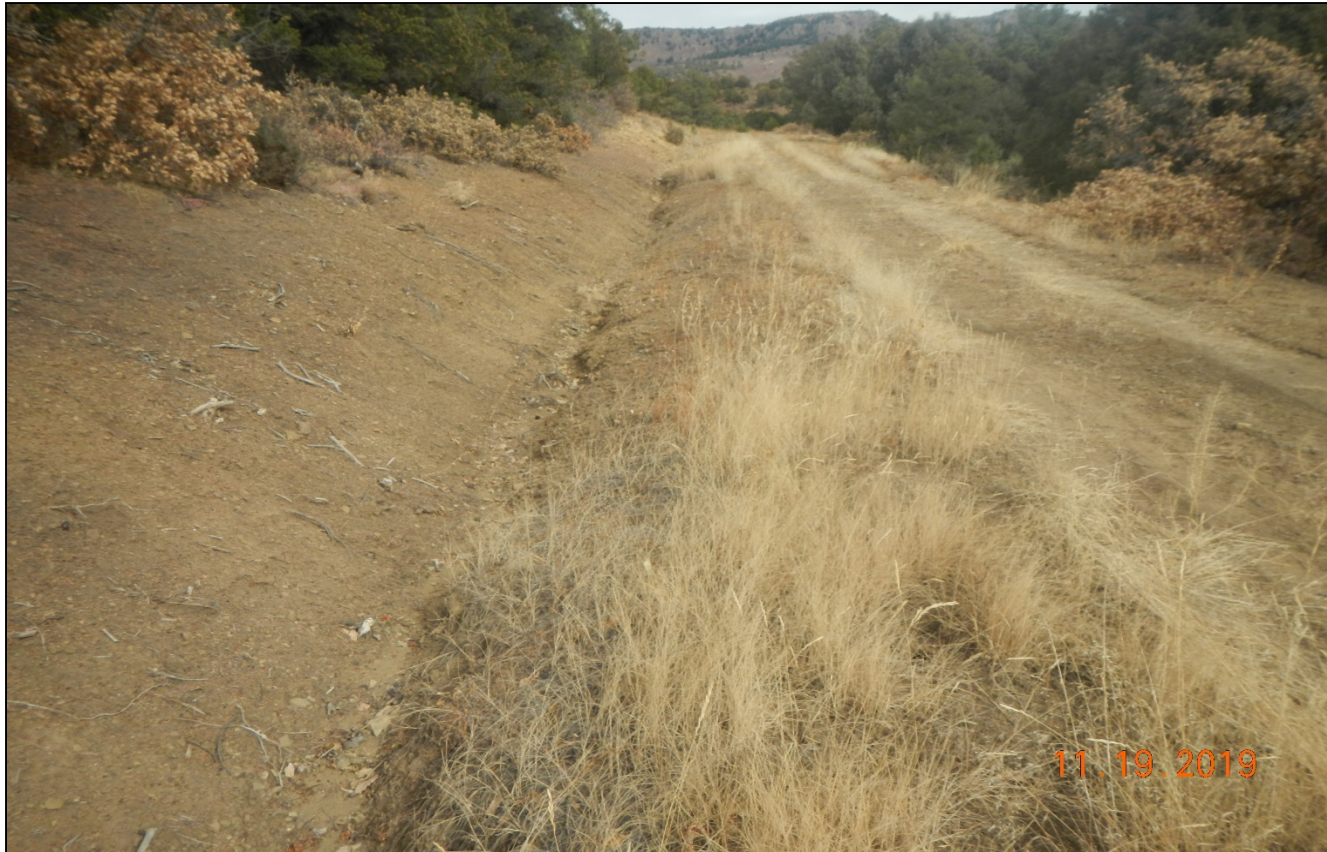
Photo 10. The side of the access road is not stabilized and there is insufficient BMP's along the road to prevent erosion.

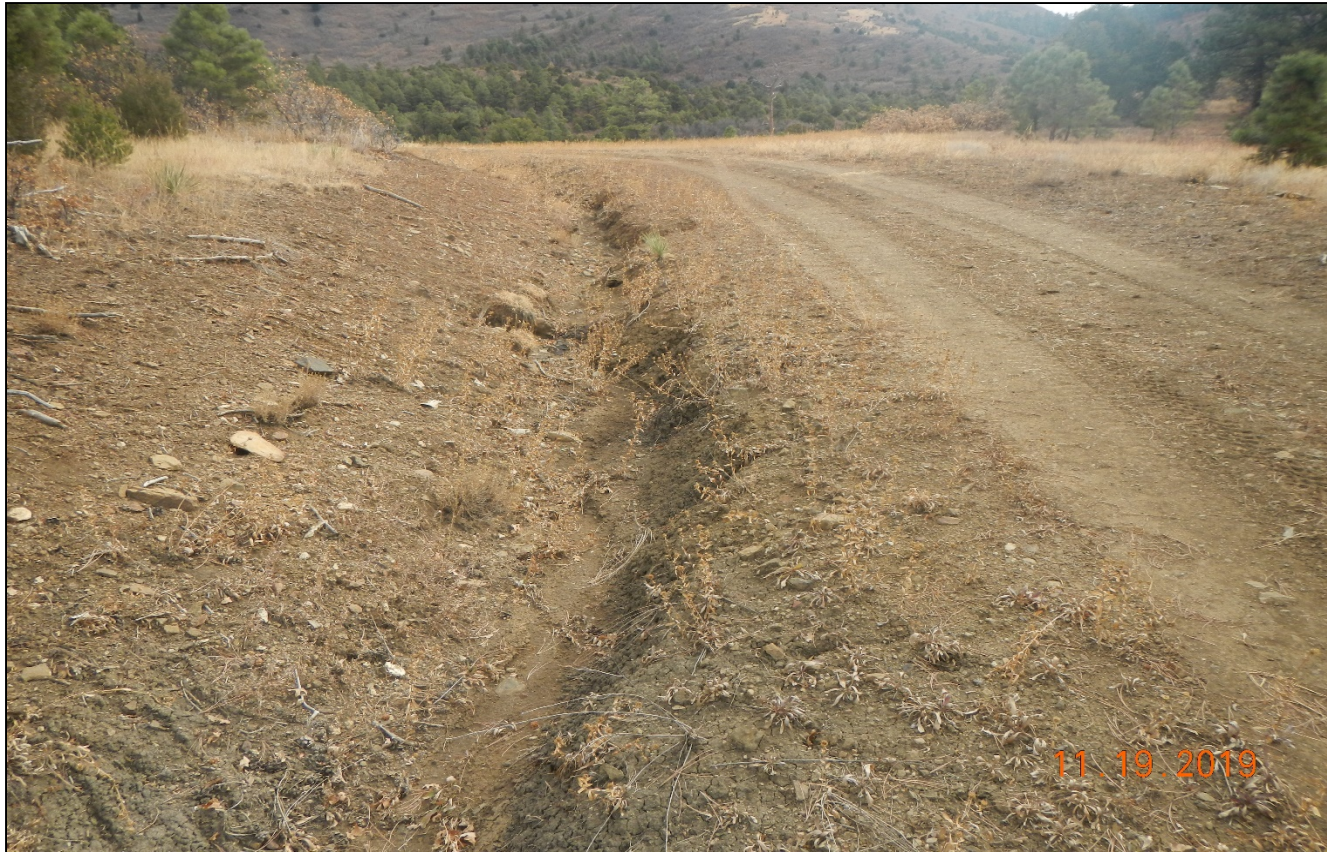
Photo 11. There is an erosion channel near the location along the access road. The erosion channel has not been repaired and the corrective action of the previous inspection was not performed.

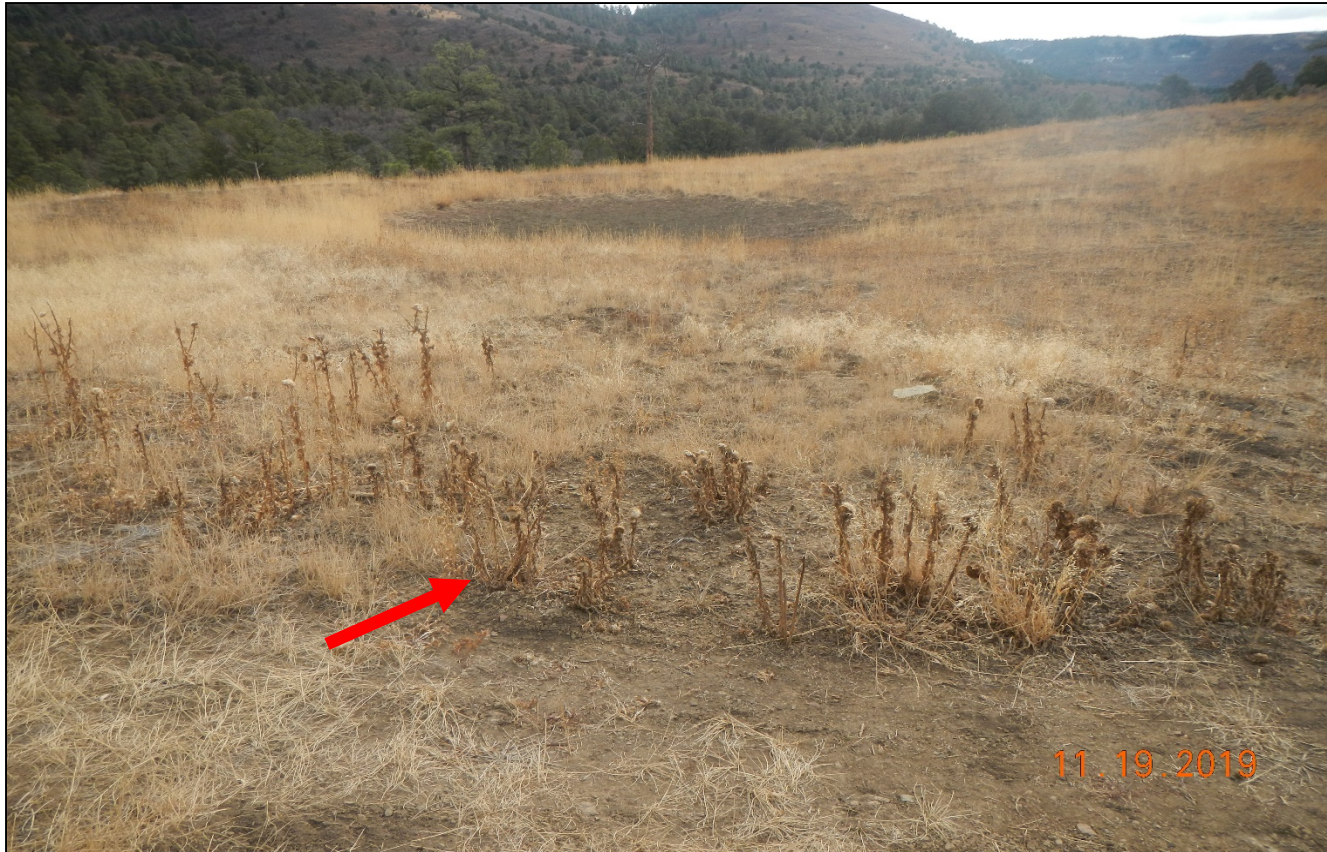
Photo 12. Facing southeast toward the location. There are numerous noxious weeds at the location. Noxious weed control has not been performed.

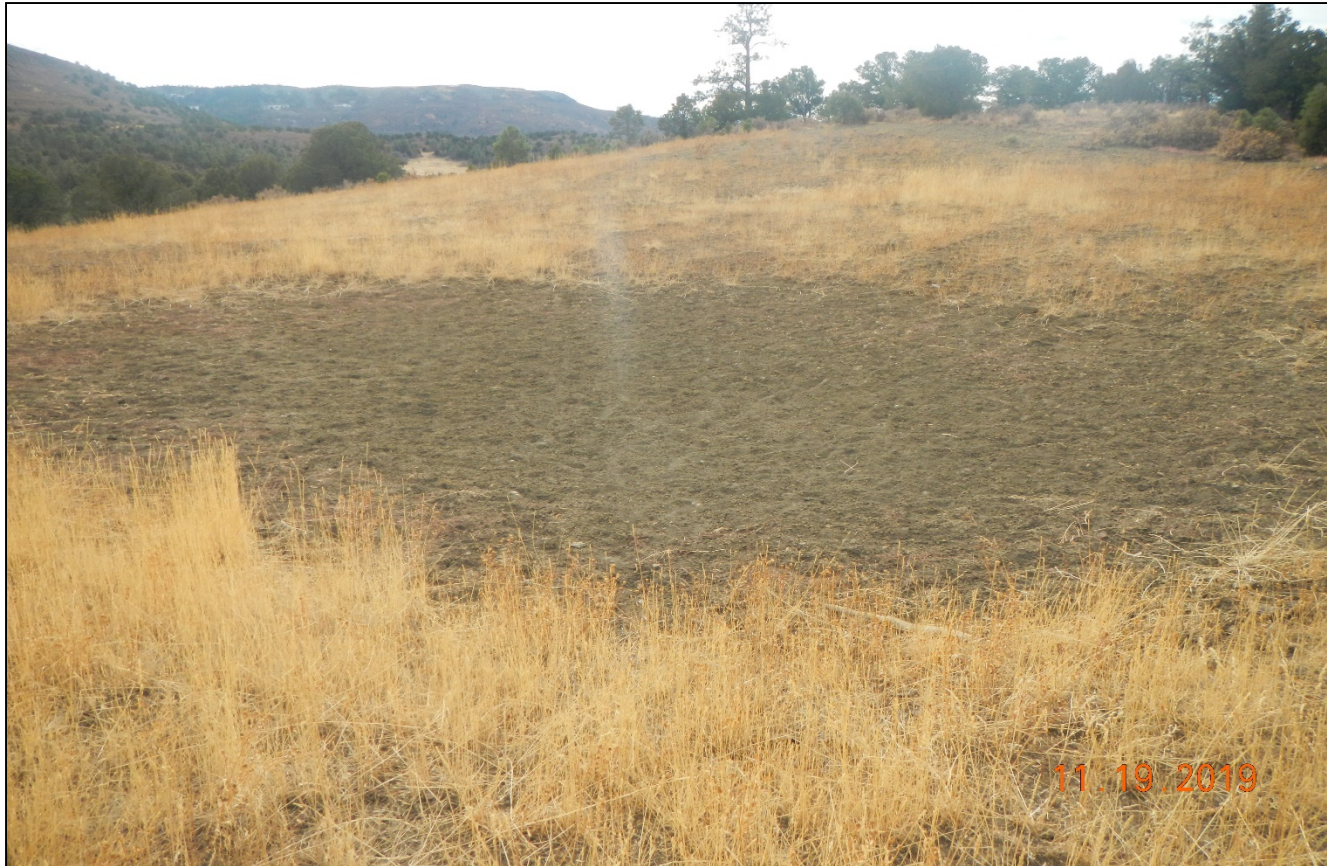
Photo 13. A dry shallow pit remains at the location. Vegetation is not established in this area.

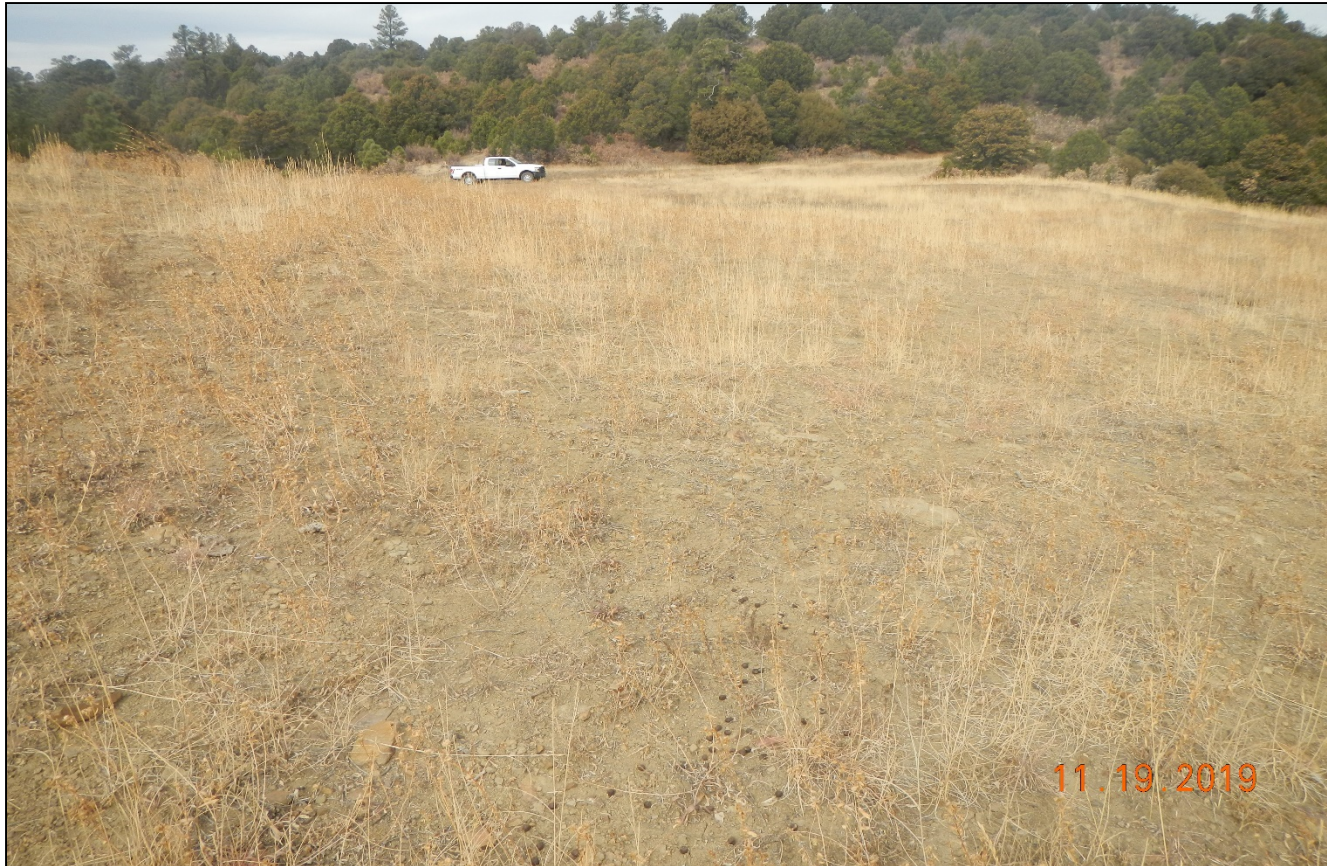
Photo 14. South side of the location facing north. Vegetation has not adequately established at the location.

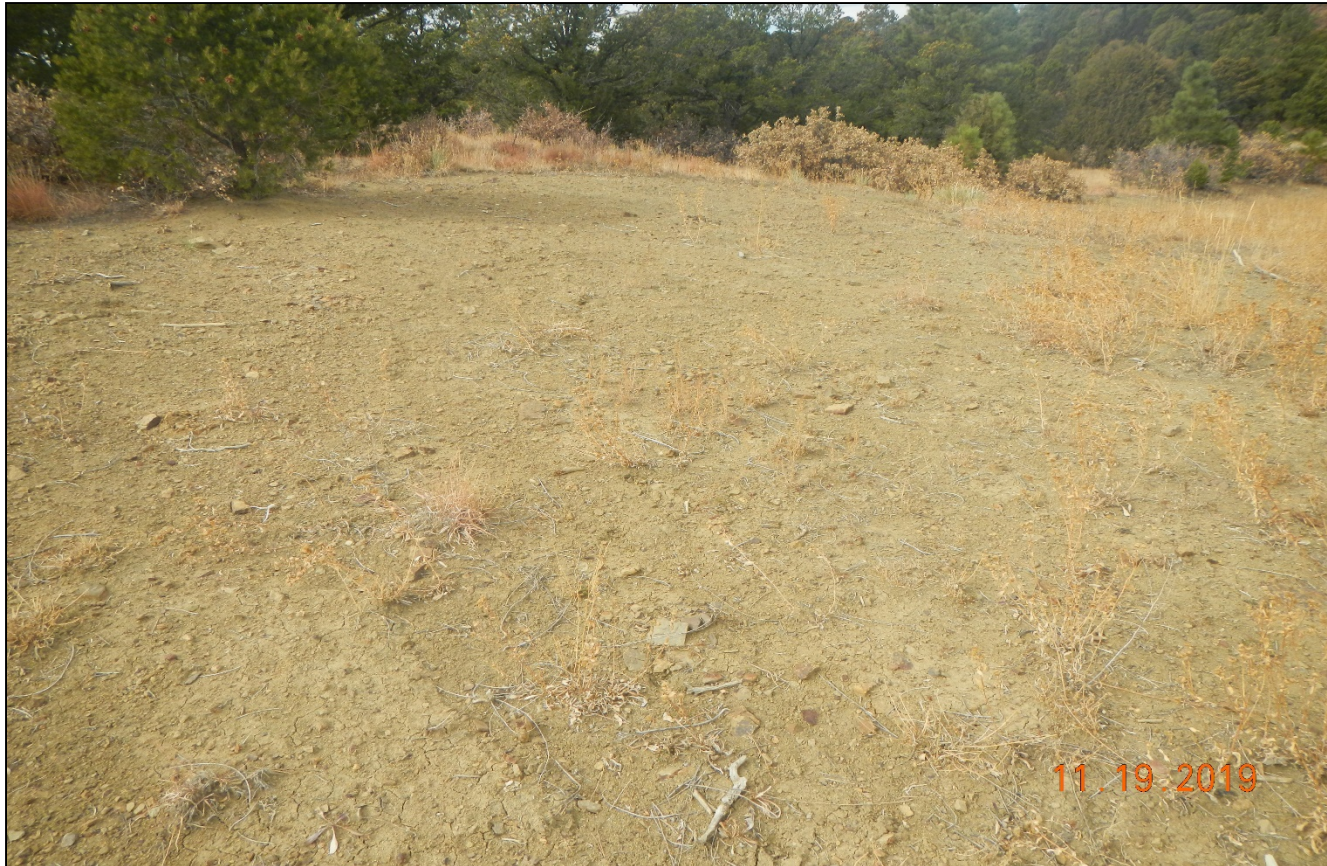
Photo 15. There are areas that are bare of vegetation growth at the location.

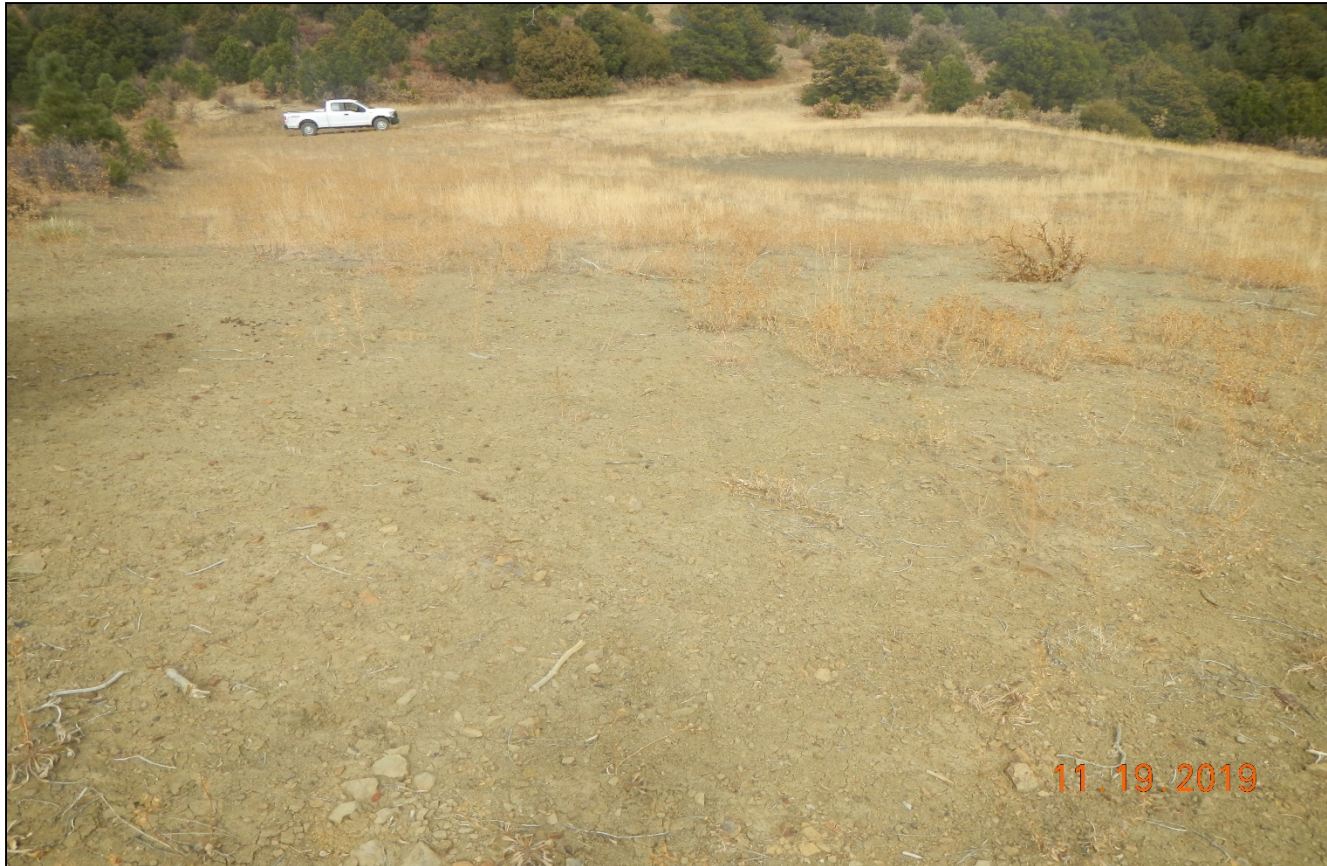
Photo 16. South side of the location facing north. Vegetation has not adequately established at the location.
