Inspection Photos

API: 05-071-07960

Operator: PRESCO INC

Inspection Date: 11/19/2019

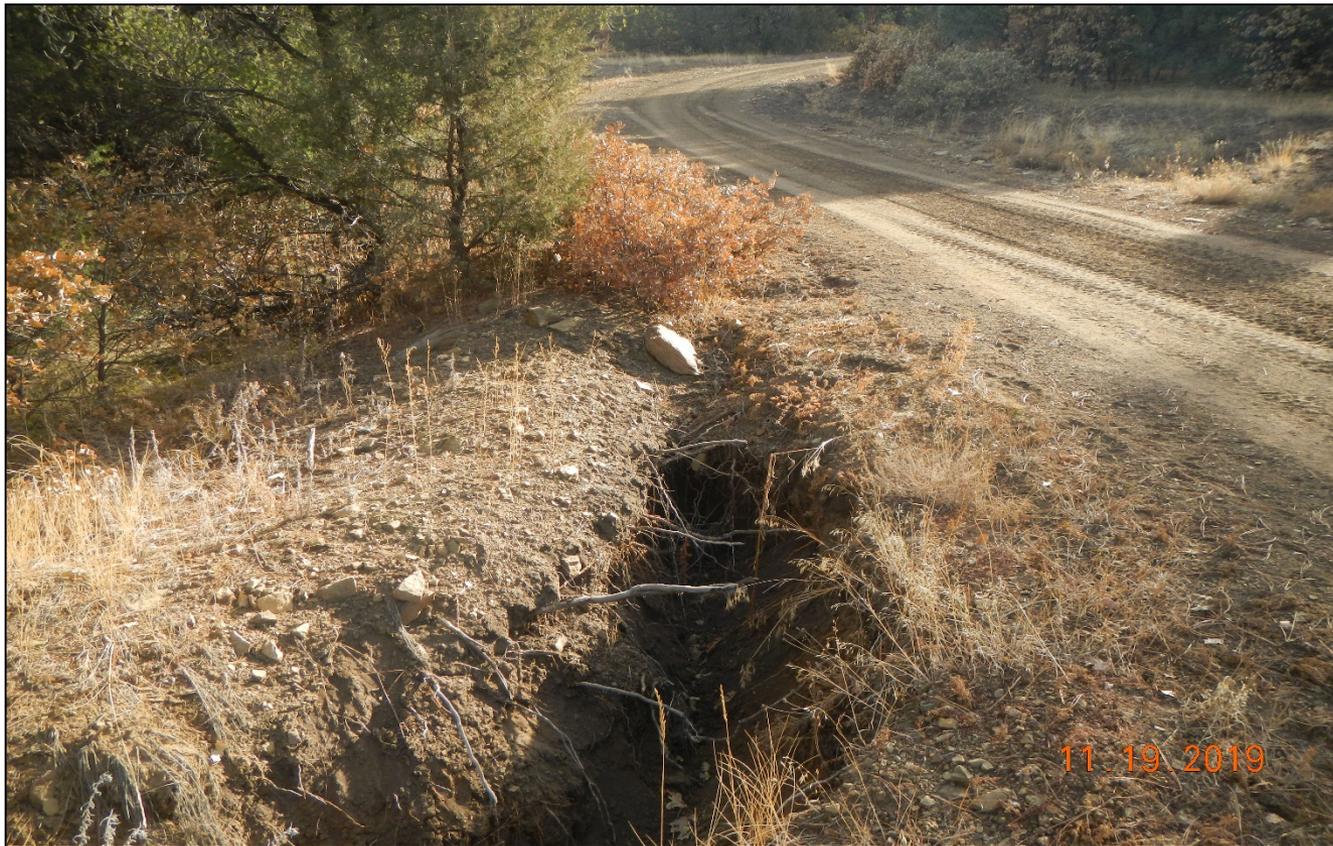
Photo 1. There is an erosion channel head cut that has developed along the access road at Lat/Long:37.07589,-104.50931.

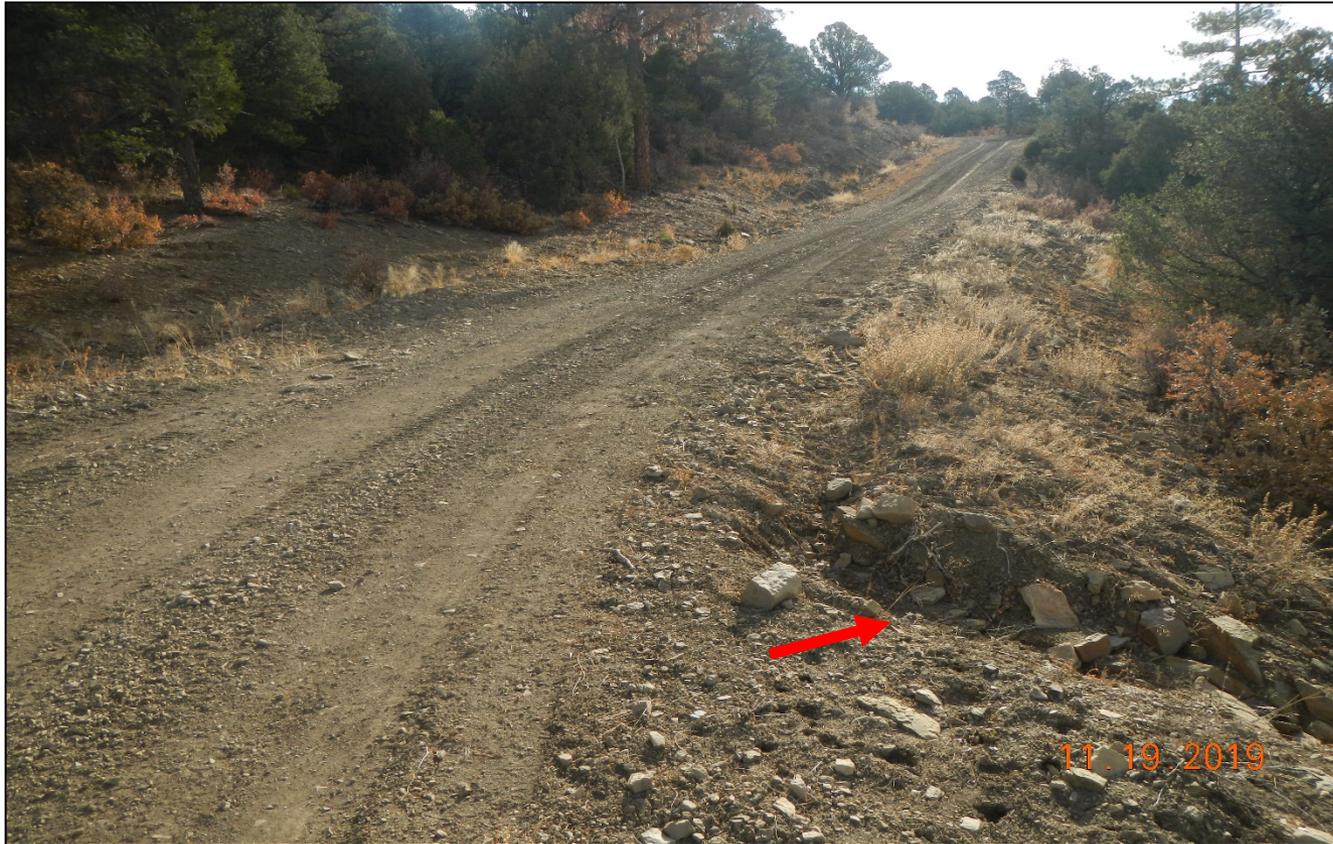
Photo 2. Facing southeast along the access road. The preexisting road was widened during operations. There is erosion along the side of the road.

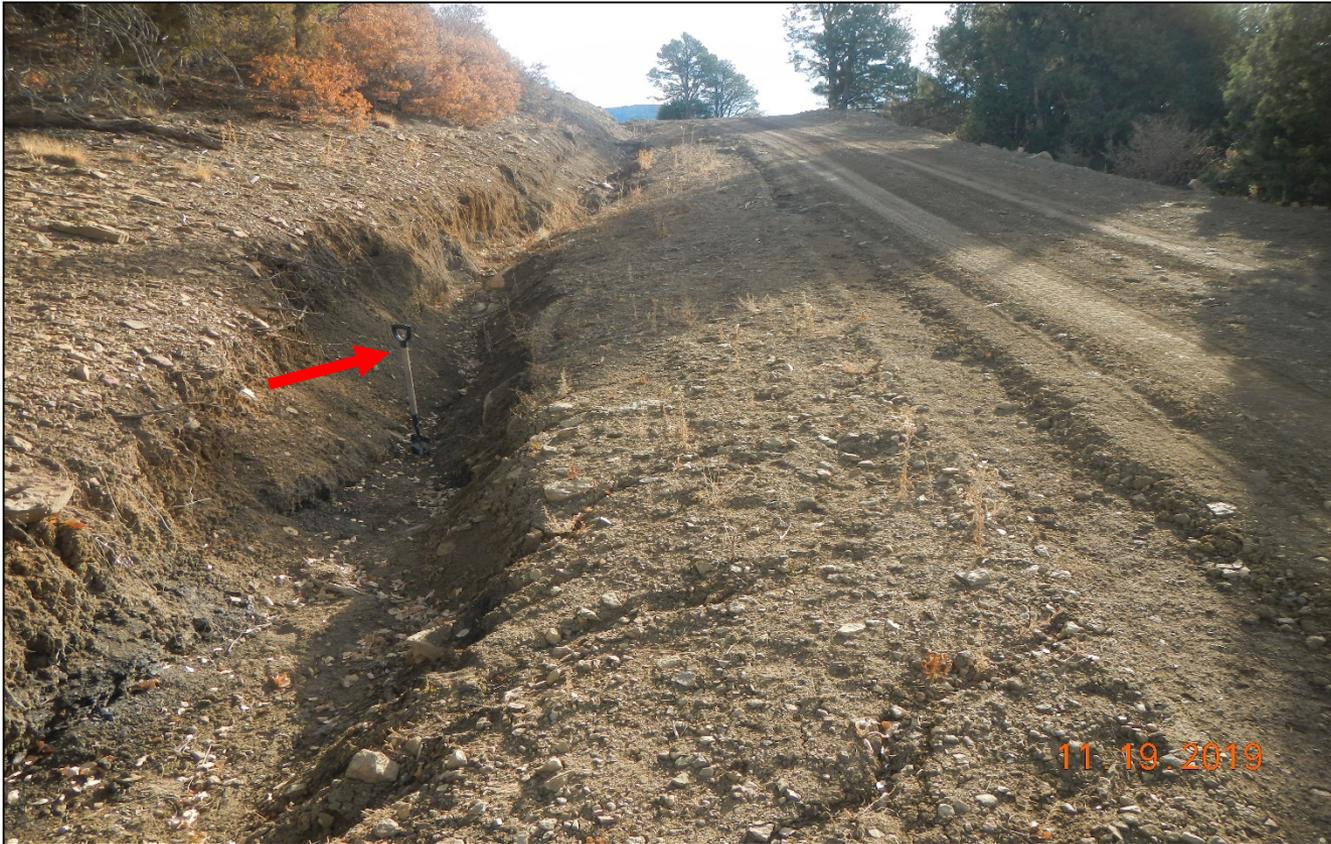
Photo 3. There is a deep erosion channel that has developed along the access road which has not been repaired. Arrow points to 3.5 ft. shovel to show depth of erosion gully. Lat/Long:37.07439,-104.50754

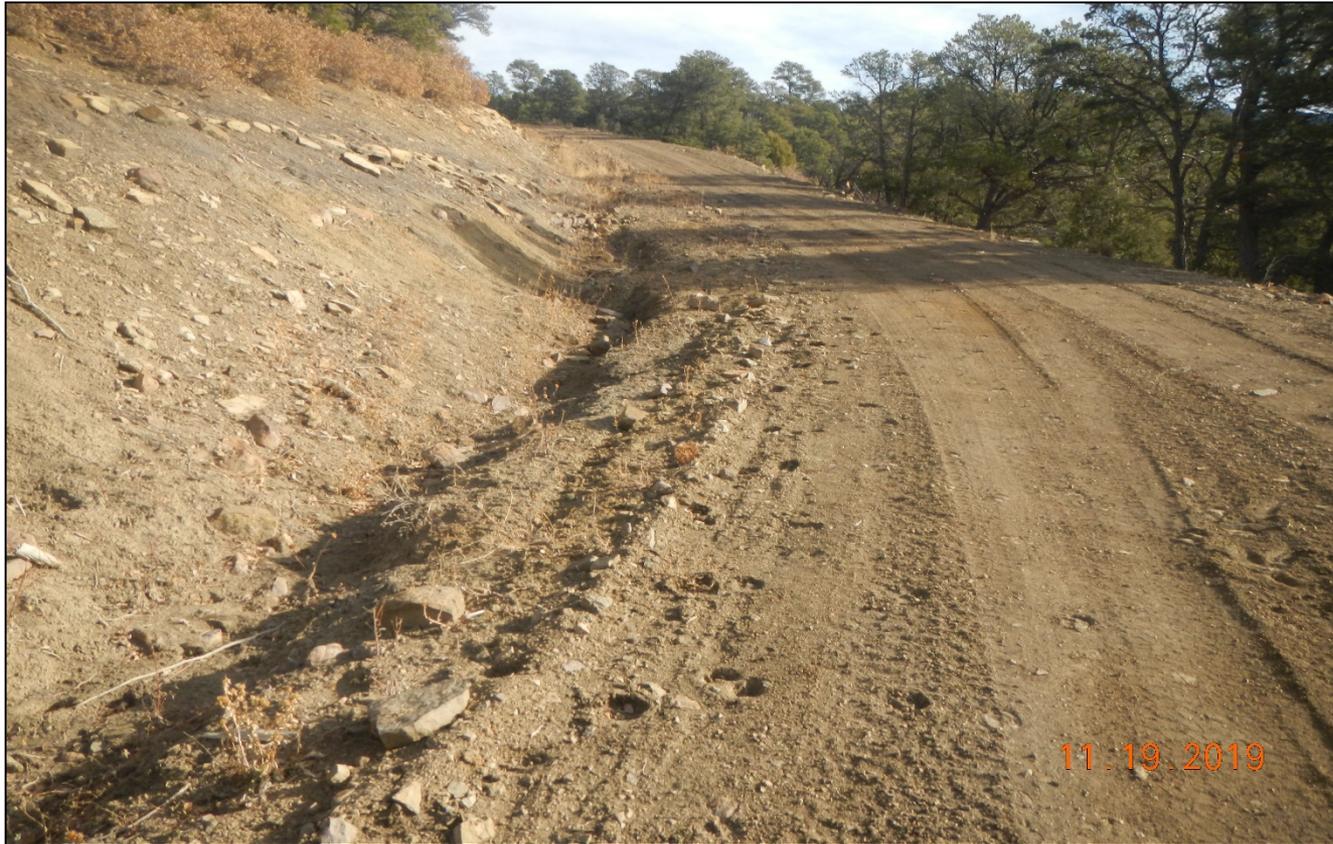
Photo 4. Facing northeast along the access road. The pre-existing road was widened during operations. The side of the road is not stabilized and there is insufficient BMP's to prevent erosion.

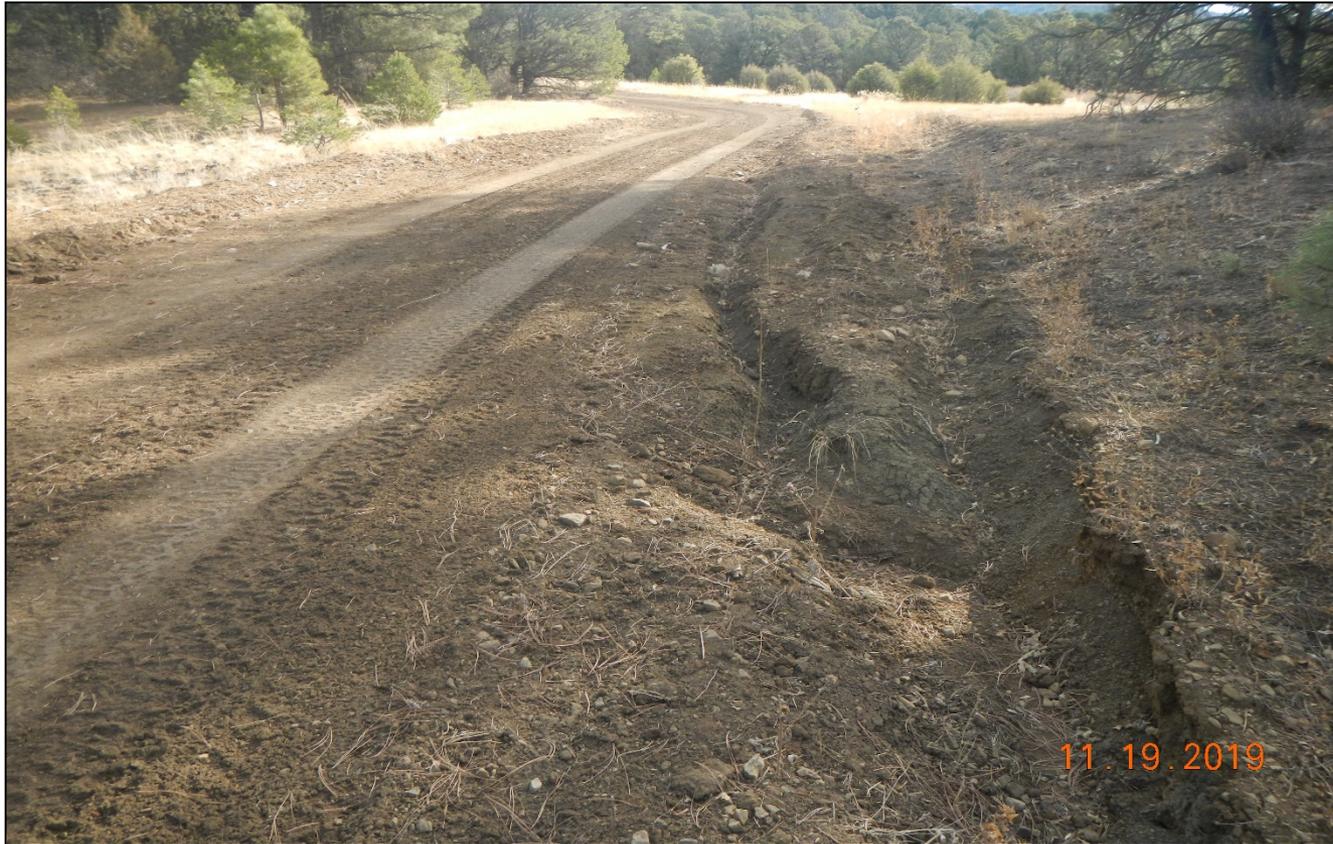
Photo 5. There is erosion issues along the road which must be repaired. . The side of the road is not stabilized and there is insufficient BMP's to prevent erosion.
Lat/Long:37.07560,-104.50457

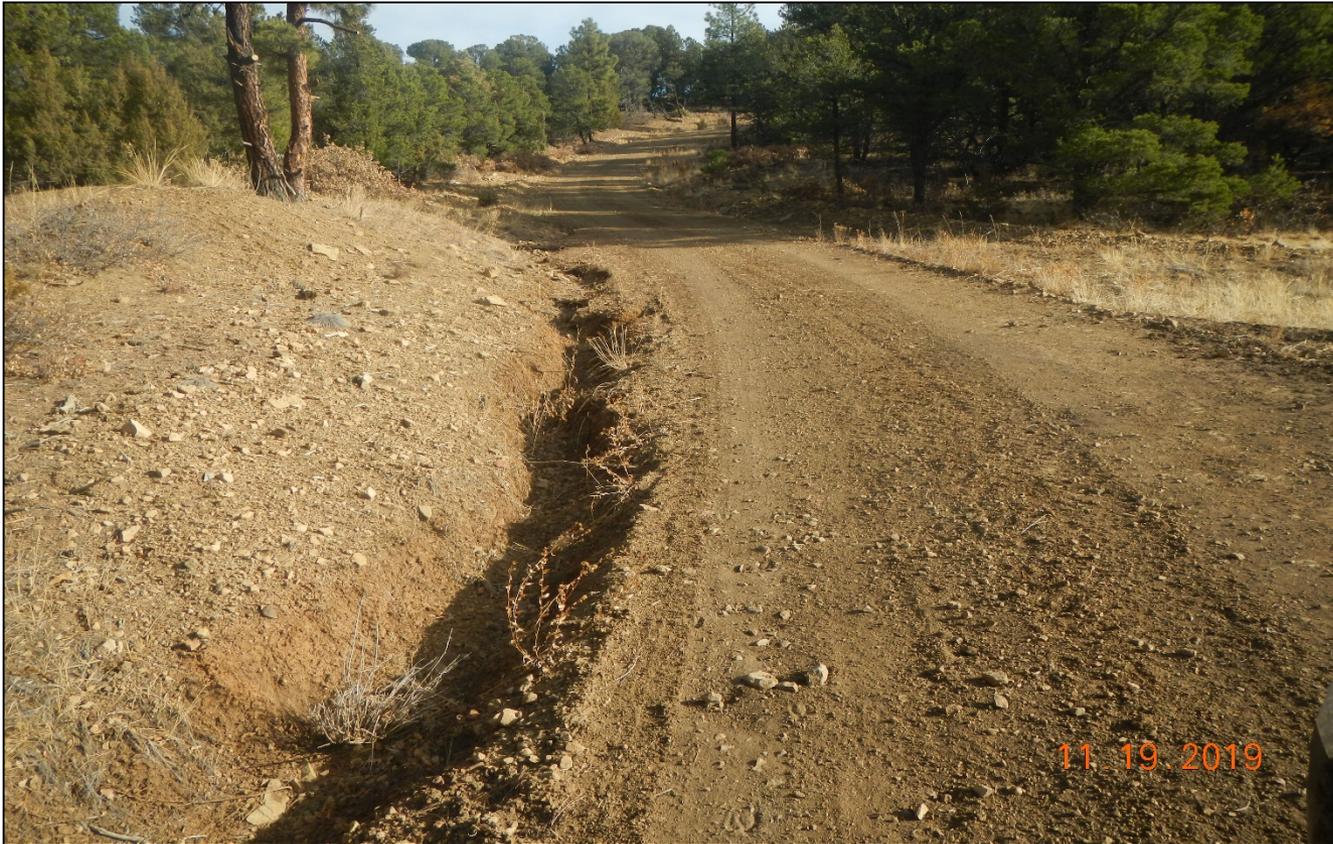
Photo 6. There is erosion issues along the road which must be repaired. . The side of the road is not stabilized and there is insufficient BMP's to prevent erosion.
Lat/Long:37.07560,-104.50379

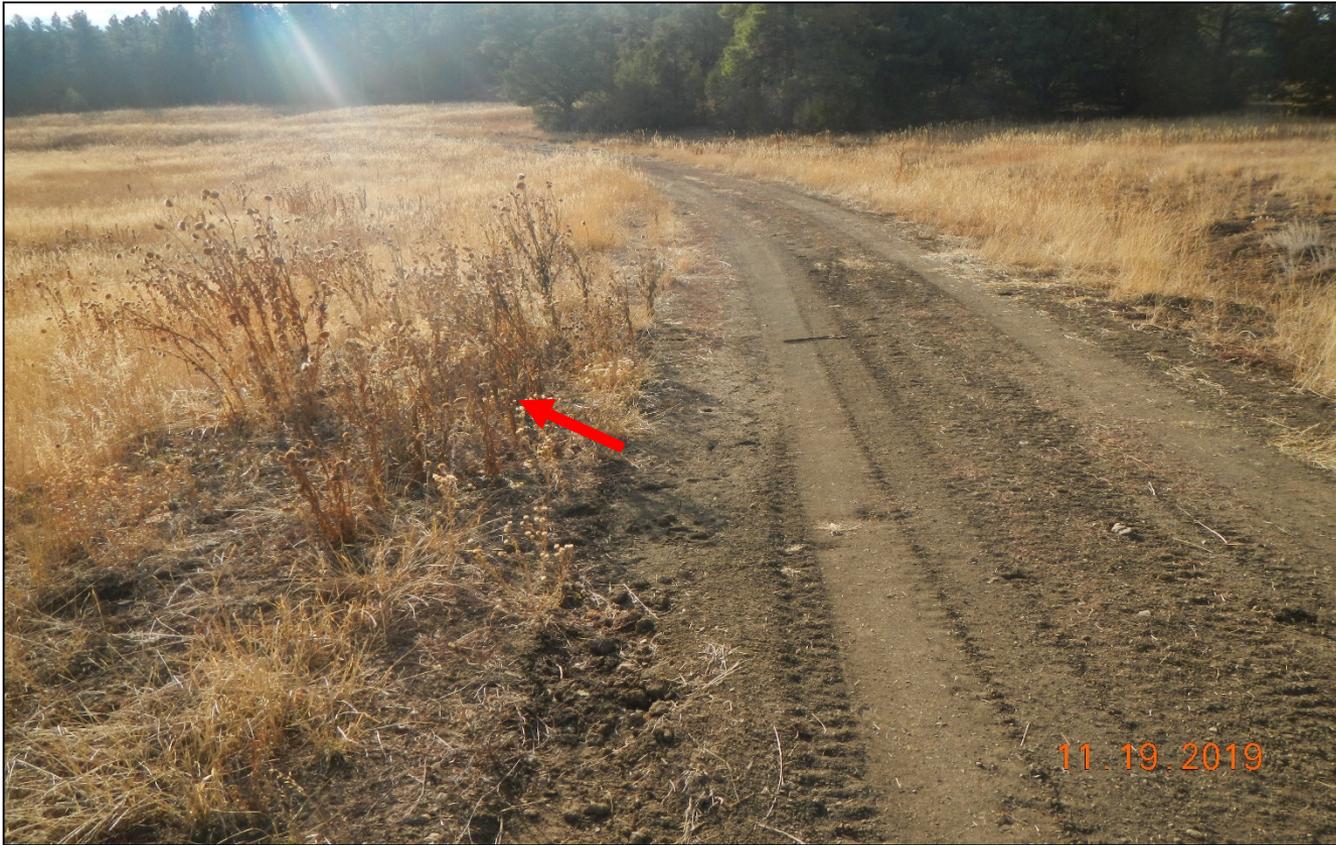
Photo 7. There are numerous noxious weeds along the access road. (Musk thistle)
Noxious weed control was not performed since previous inspection.

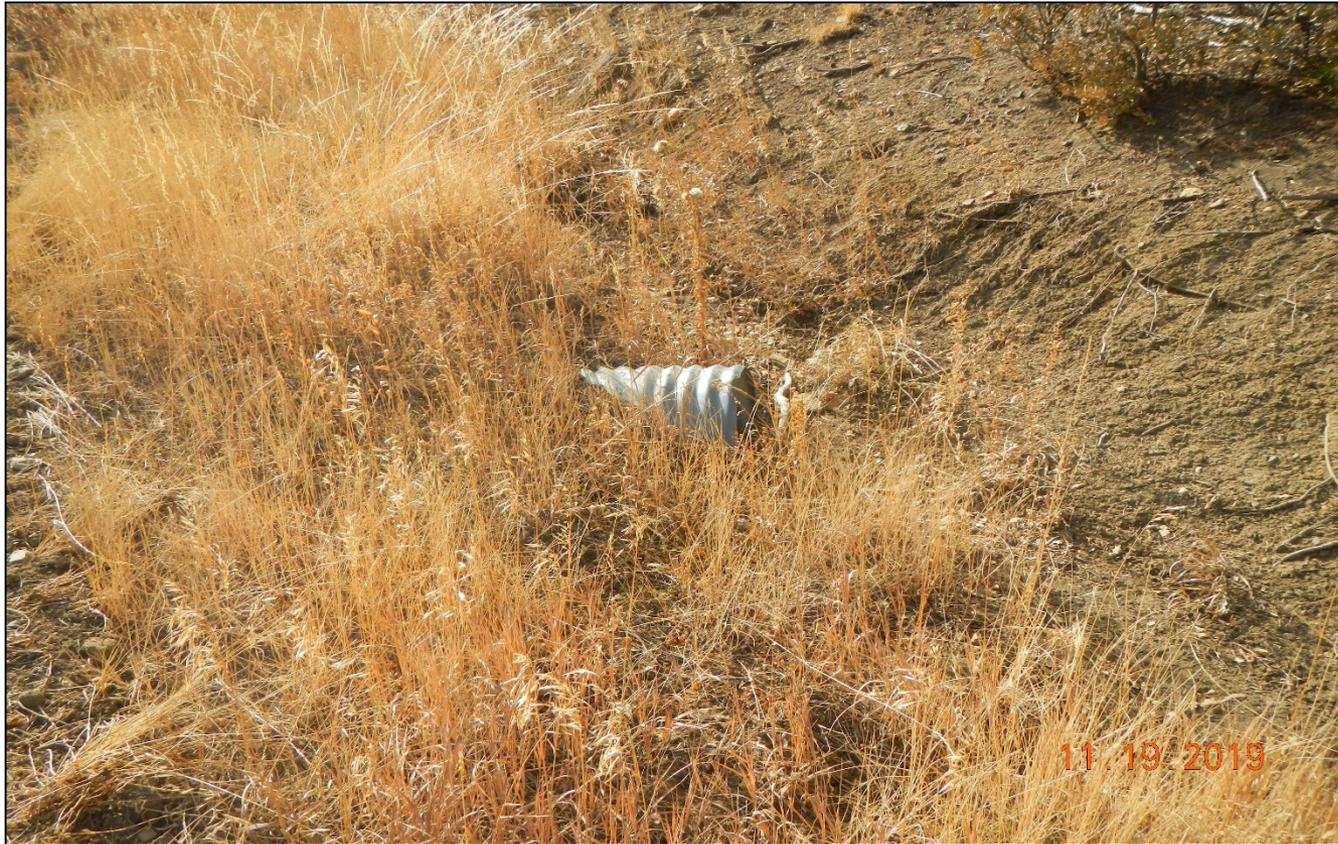
Photo 8. A culvert along the road has filled in with sediment and is not maintained.

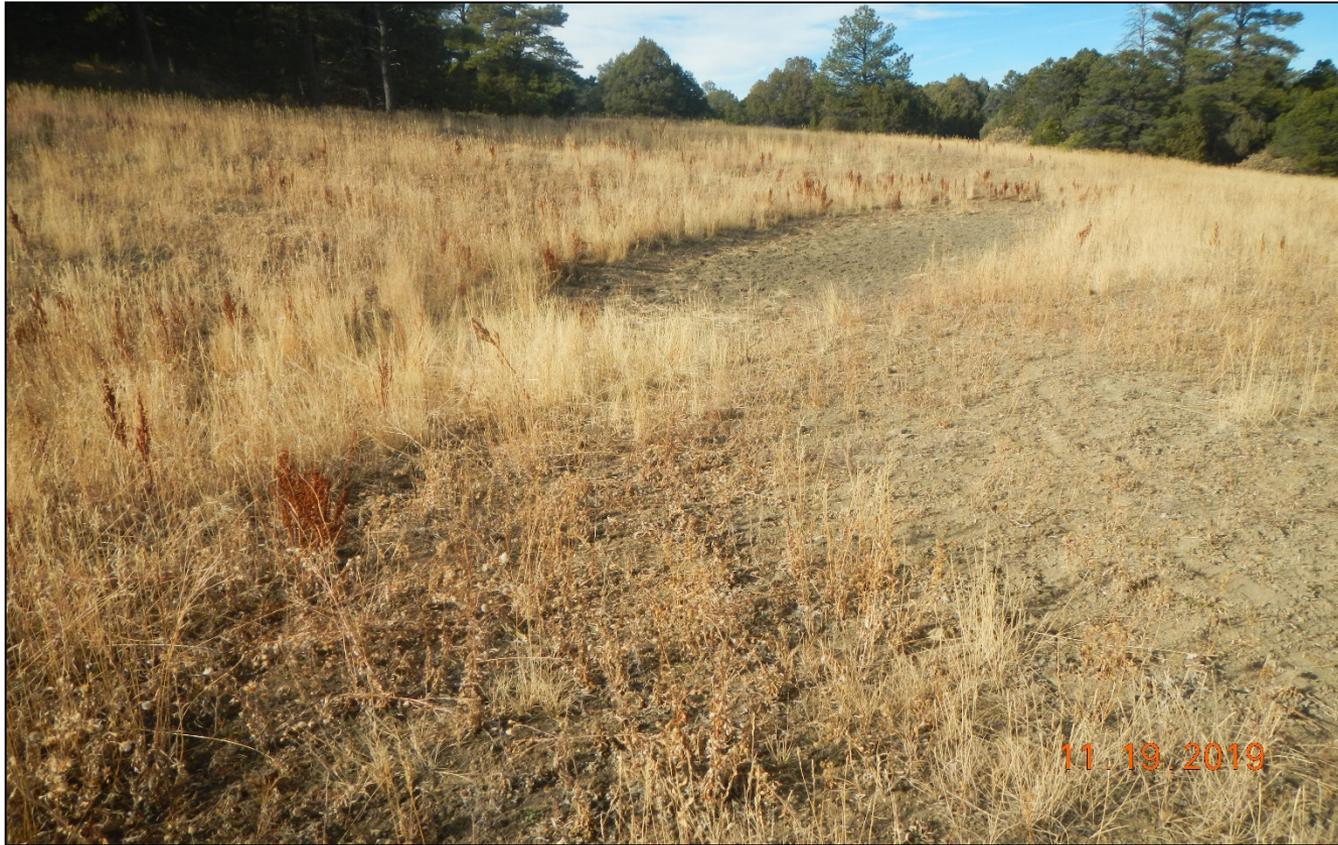
Photo 10. Facing southeast toward the location. A dry shallow pit remains at the location.

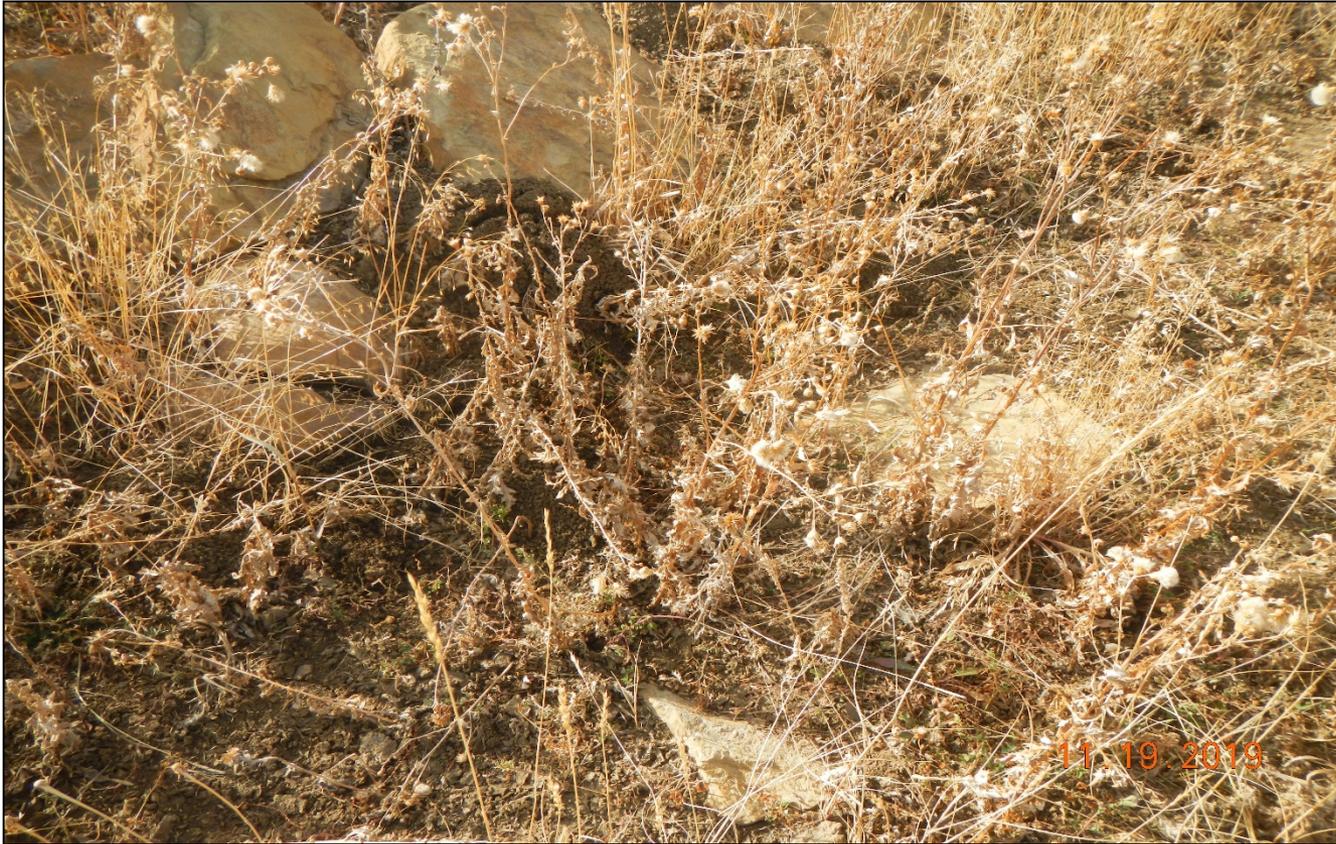
Photo 11. There are noxious weeds present at the site. (Canada thistle, Musk thistle) Noxious weed control was not performed since previous inspection.
