# Inspection Photos

API: 05-071-07969

Operator: PRESCO INC

Inspection Date: 11/19/2019

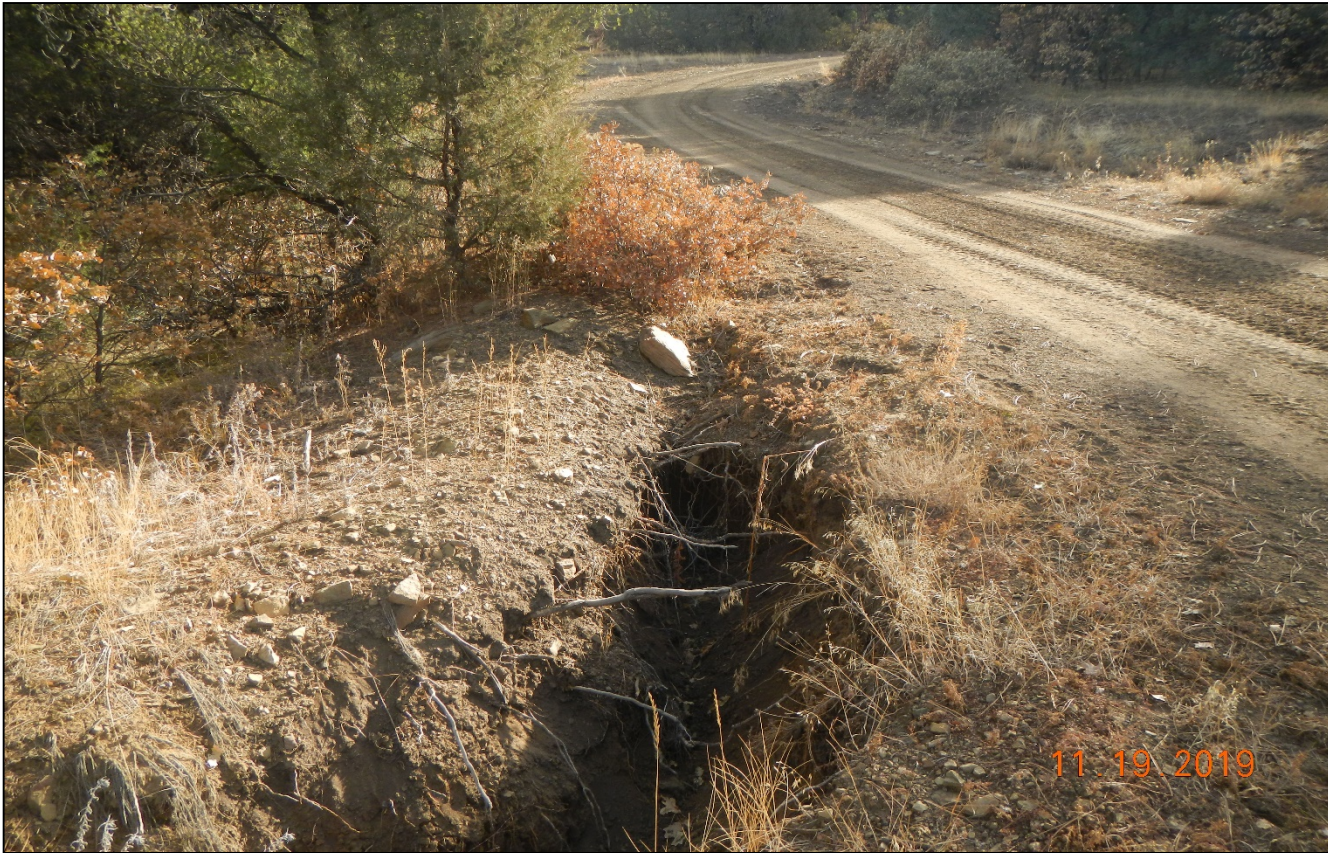
**Photo 1.** There is an erosion channel head cut that has developed along the main access road at Lat/Long:37.07589,-104.50931.

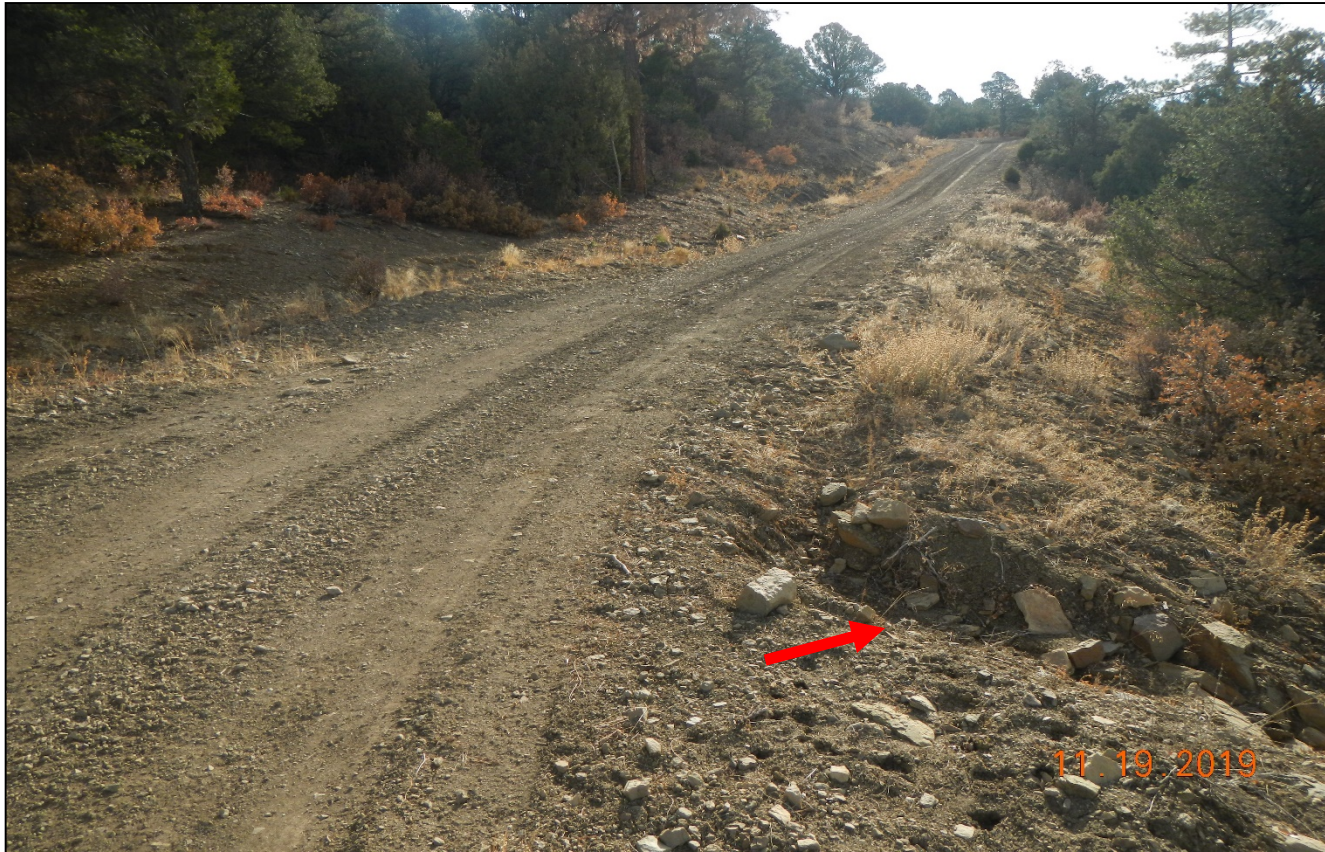
**Photo 2.** Facing southeast along the main access road. The preexisting road was widened during operations. There is erosion along the side of the road.

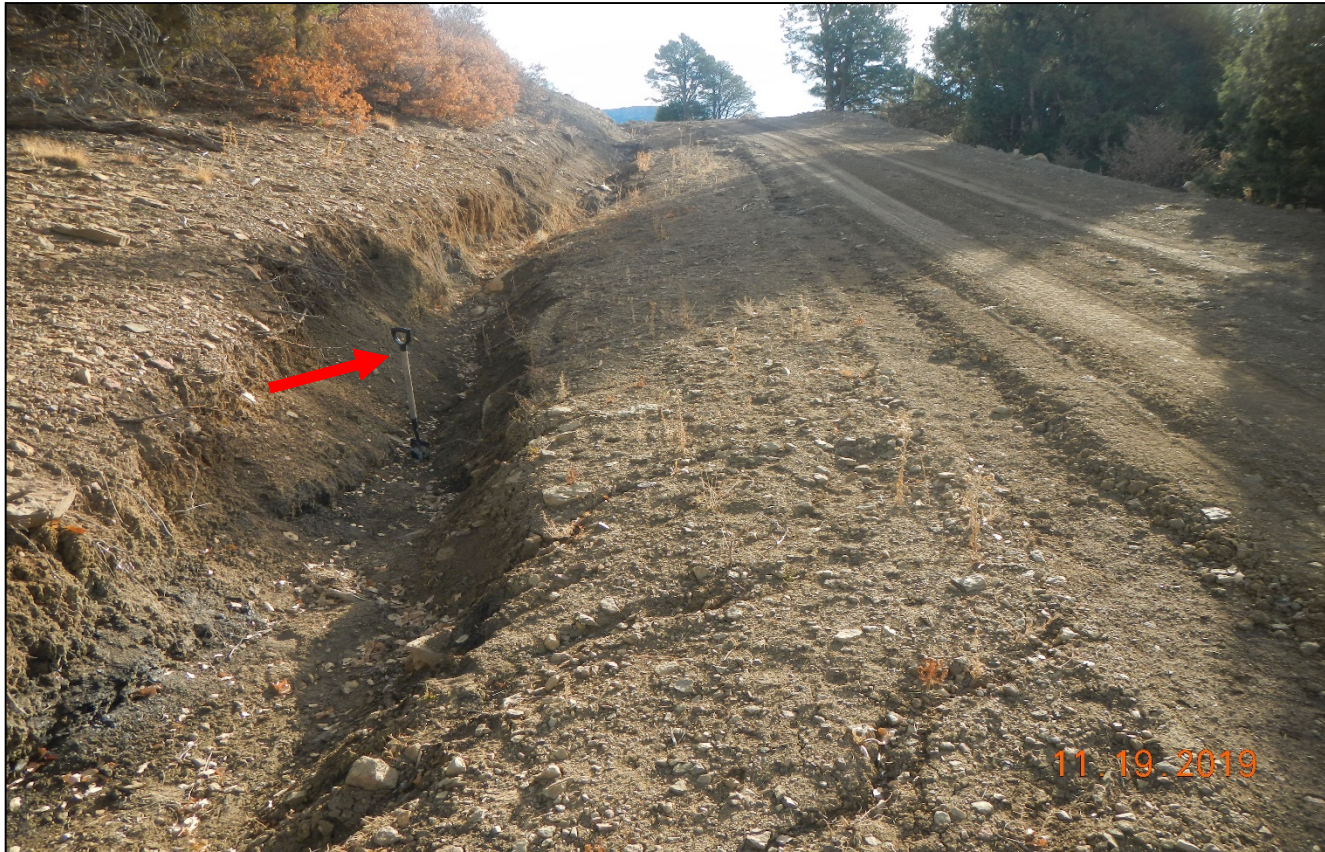
**Photo 3.** There is a deep erosion channel that has developed along the road which has not been repaired. Arrow points to 3.5 ft. shovel to show depth of erosion gully. Lat/Long:37.07439,-104.50754

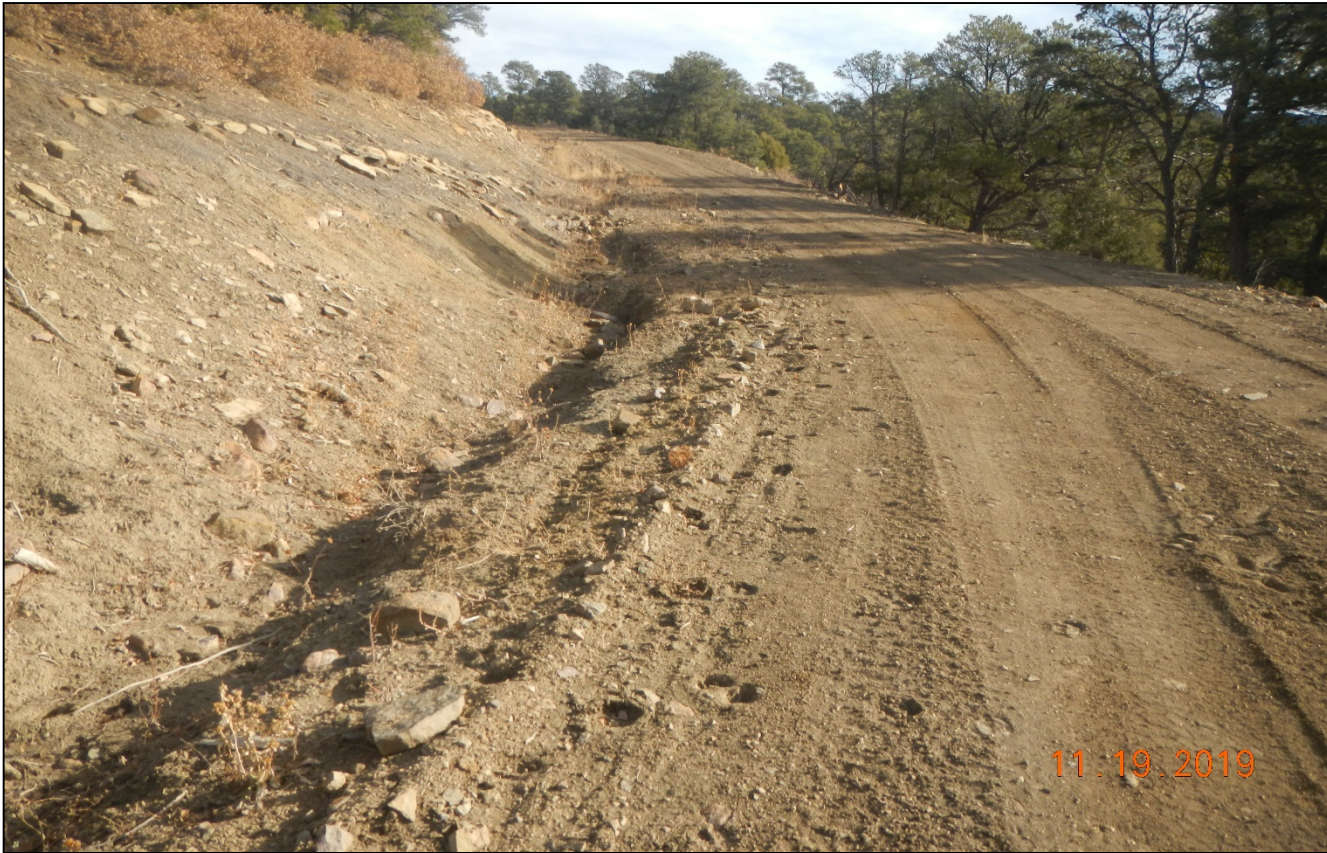
**Photo 4.** Facing northeast along the main access road. The pre-existing road was widened during operations. The side of the road is not stabilized and there is insufficient BMP's to prevent erosion.

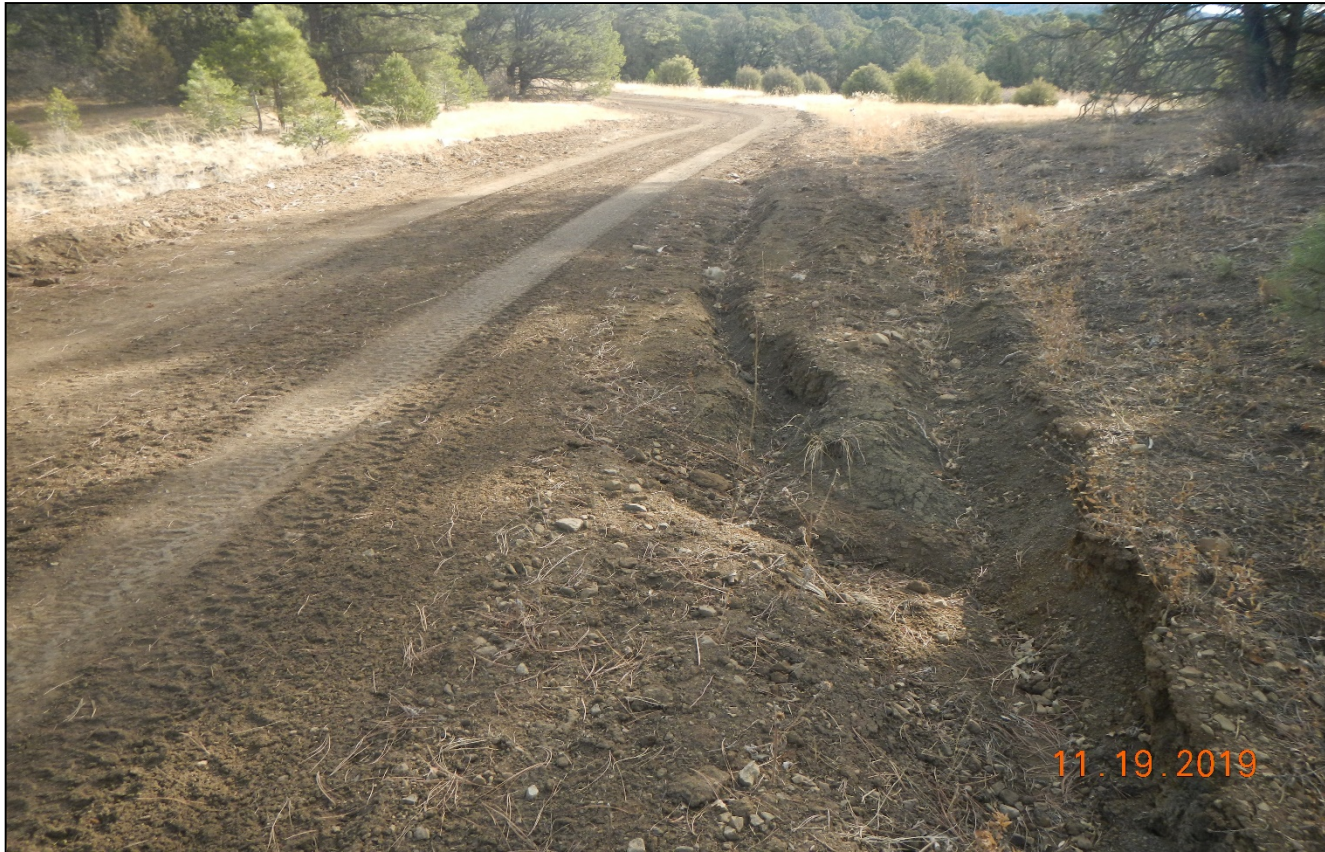
**Photo 5.** There is erosion issues along the road which must be repaired. . The side of the road is not stabilized and there is insufficient BMP's to prevent erosion.  
Lat/Long:37.07560,-104.50457

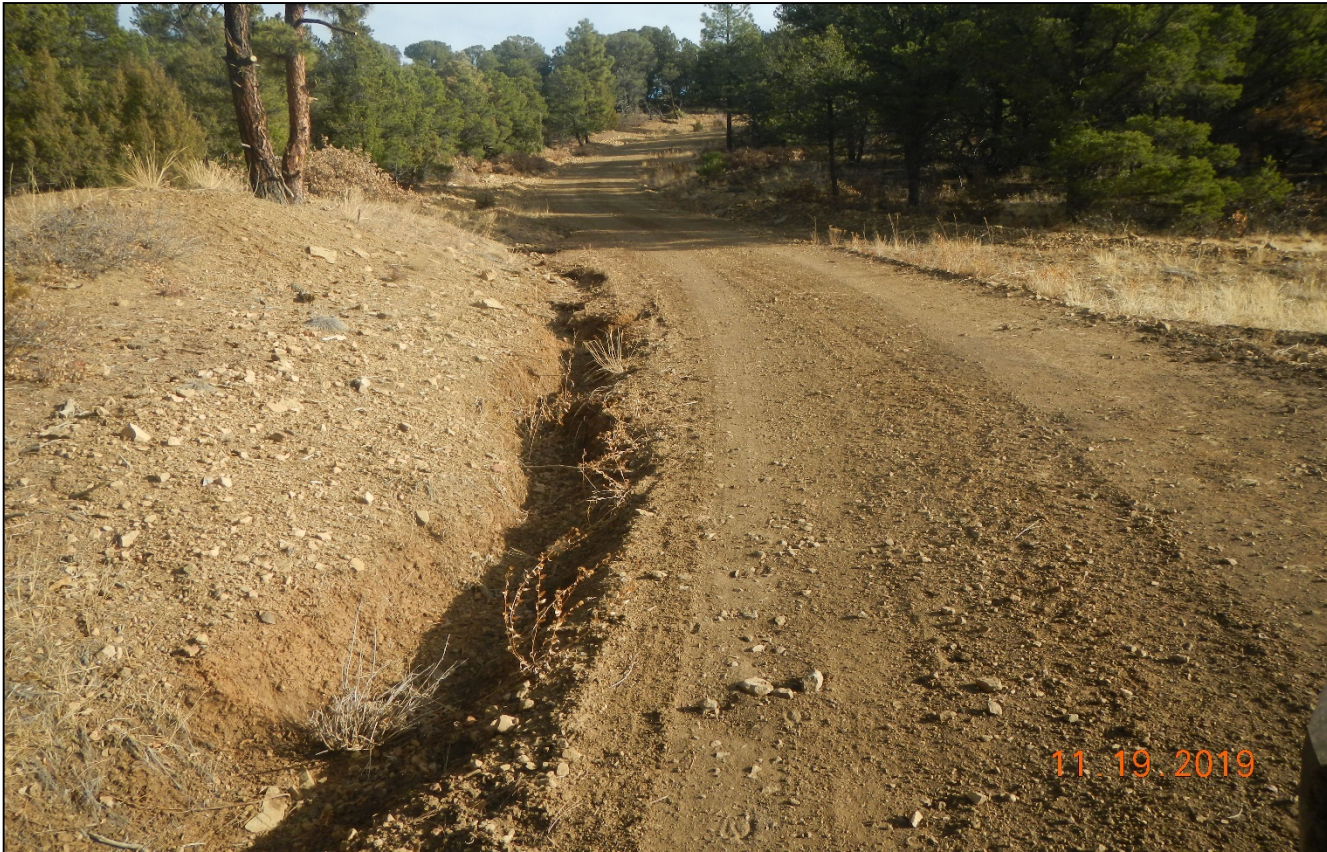
**Photo 6.** There is erosion issues along the road which must be repaired. . The side of the road is not stabilized and there is insufficient BMP's to prevent erosion.  
Lat/Long:37.07560,-104.50379

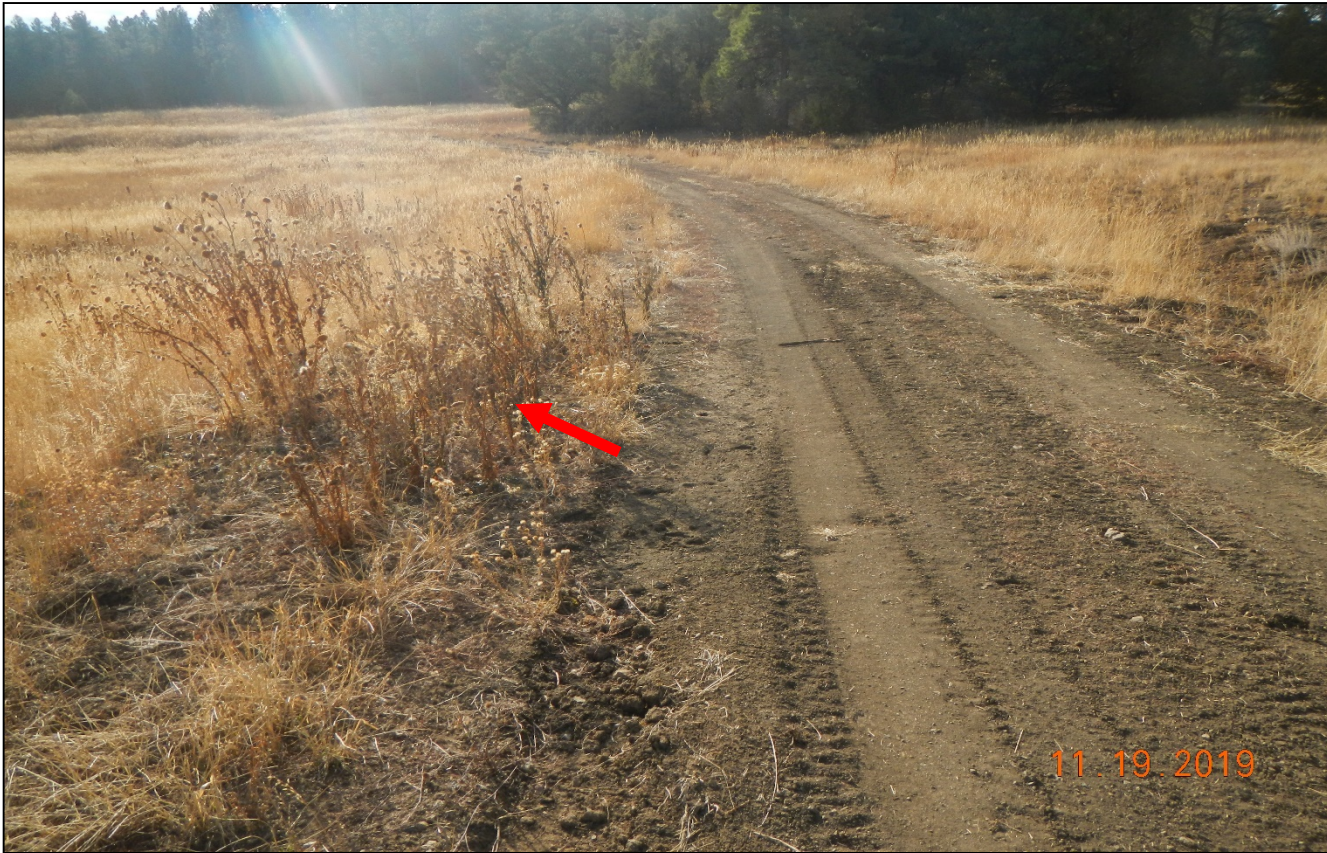
**Photo 7.** There are numerous noxious weeds along the access road. (Musk thistle)  
Noxious weed control was not performed since previous inspection.

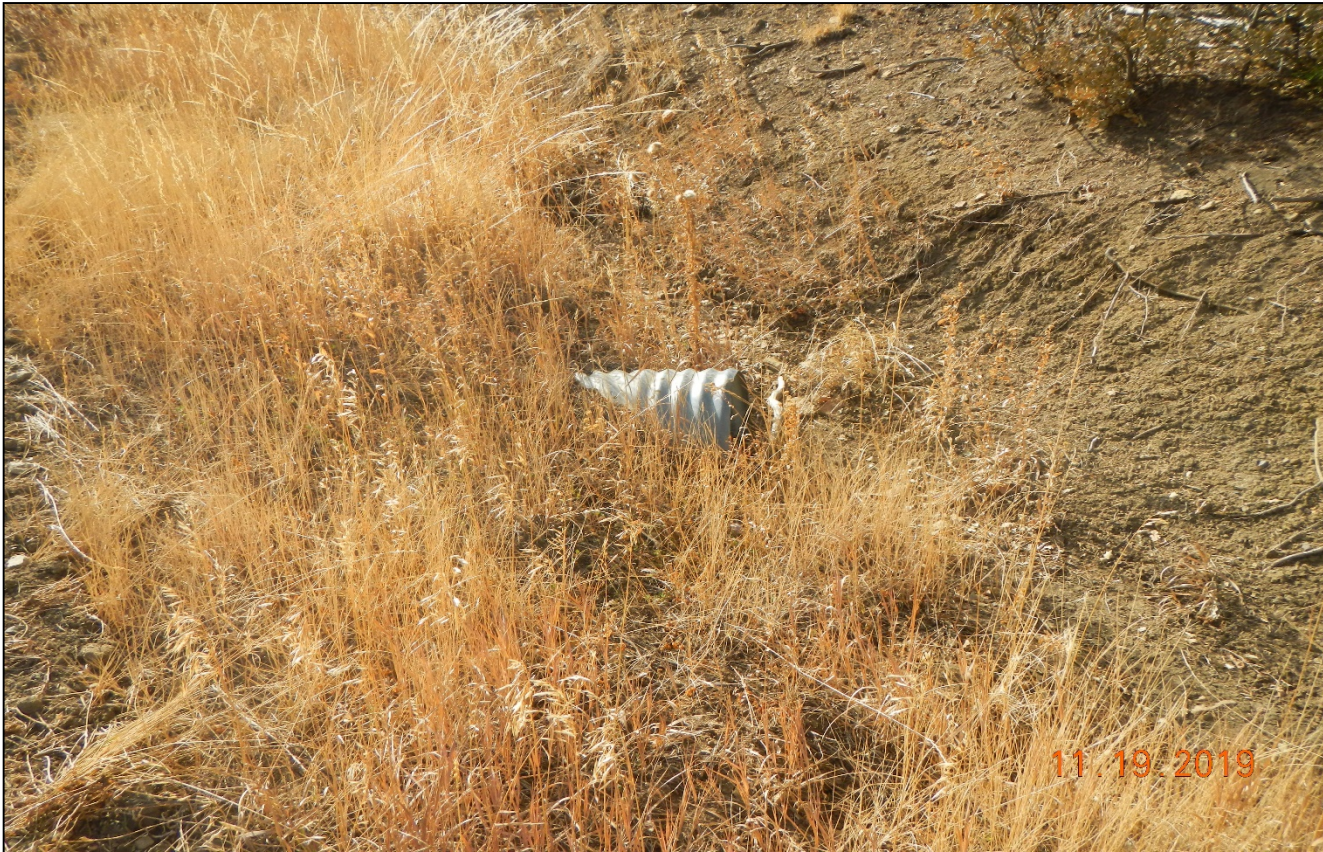
**Photo 8.** A culvert along the road has filled in with sediment and is not maintained.

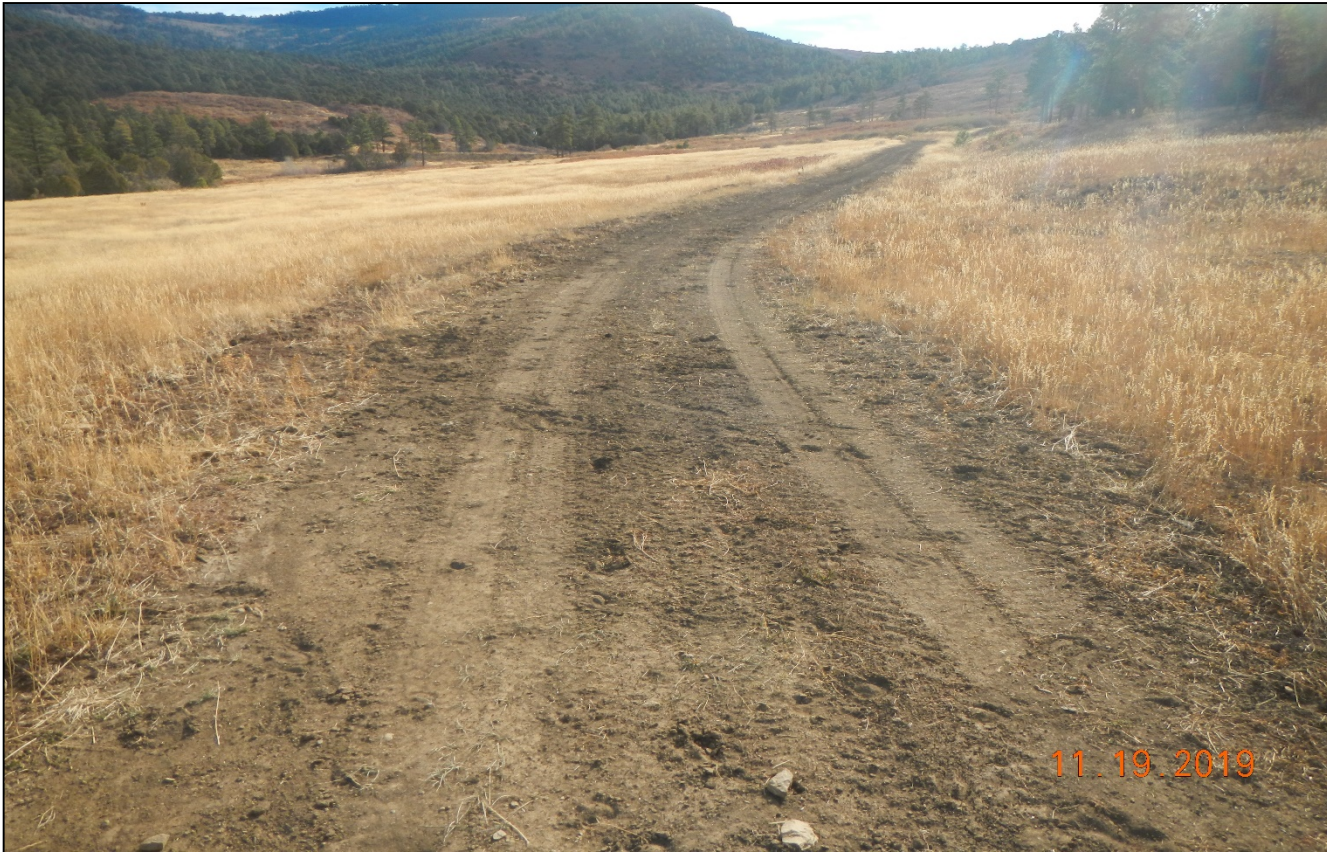
**Photo 9.** Facing southeast along the access road to the location.

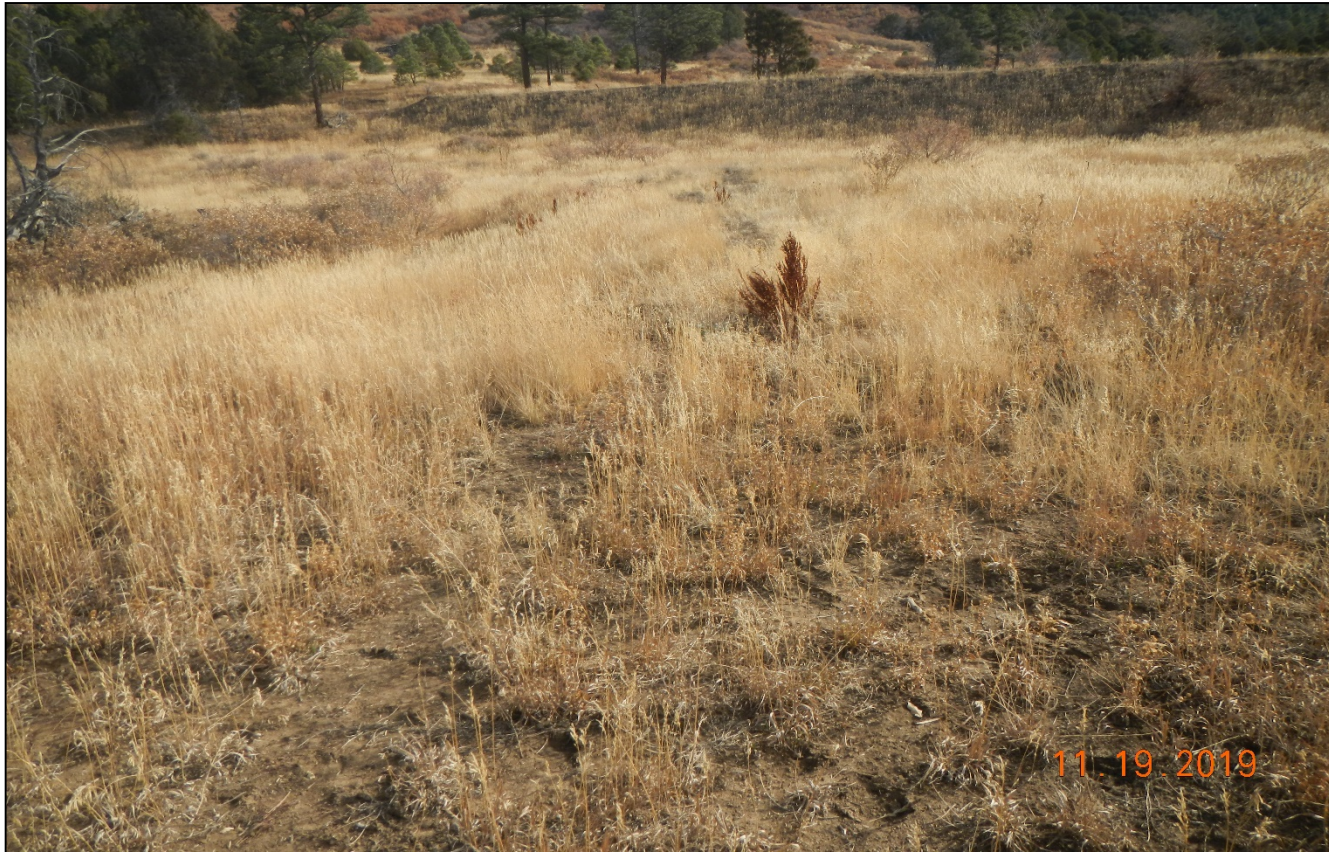
**Photo 10.** Facing northeast along the reclaimed portion of the access road.

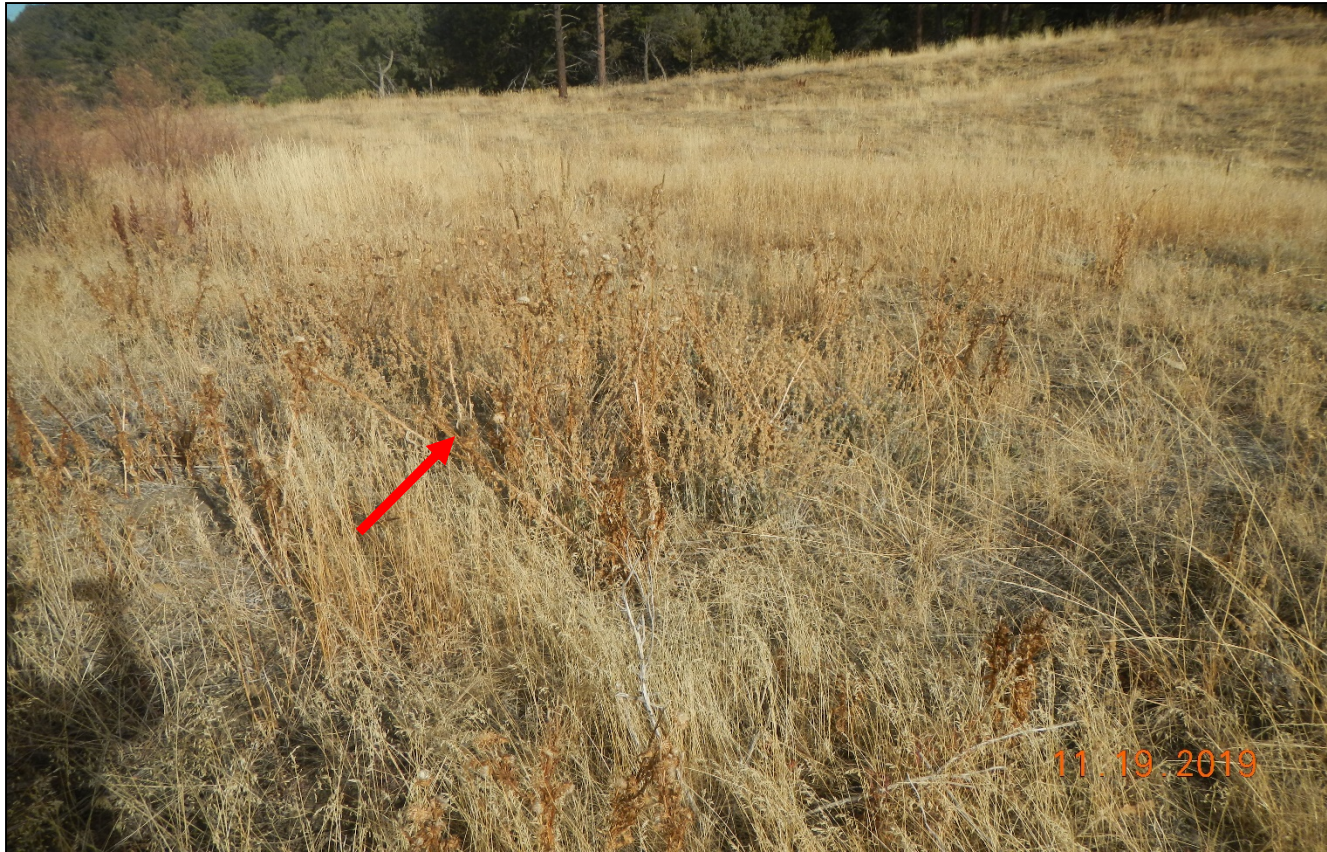
**Photo 11.** Facing northwest toward the location. There are numerous noxious weeds at the location (Musk thistle). Noxious weed control has not been performed.

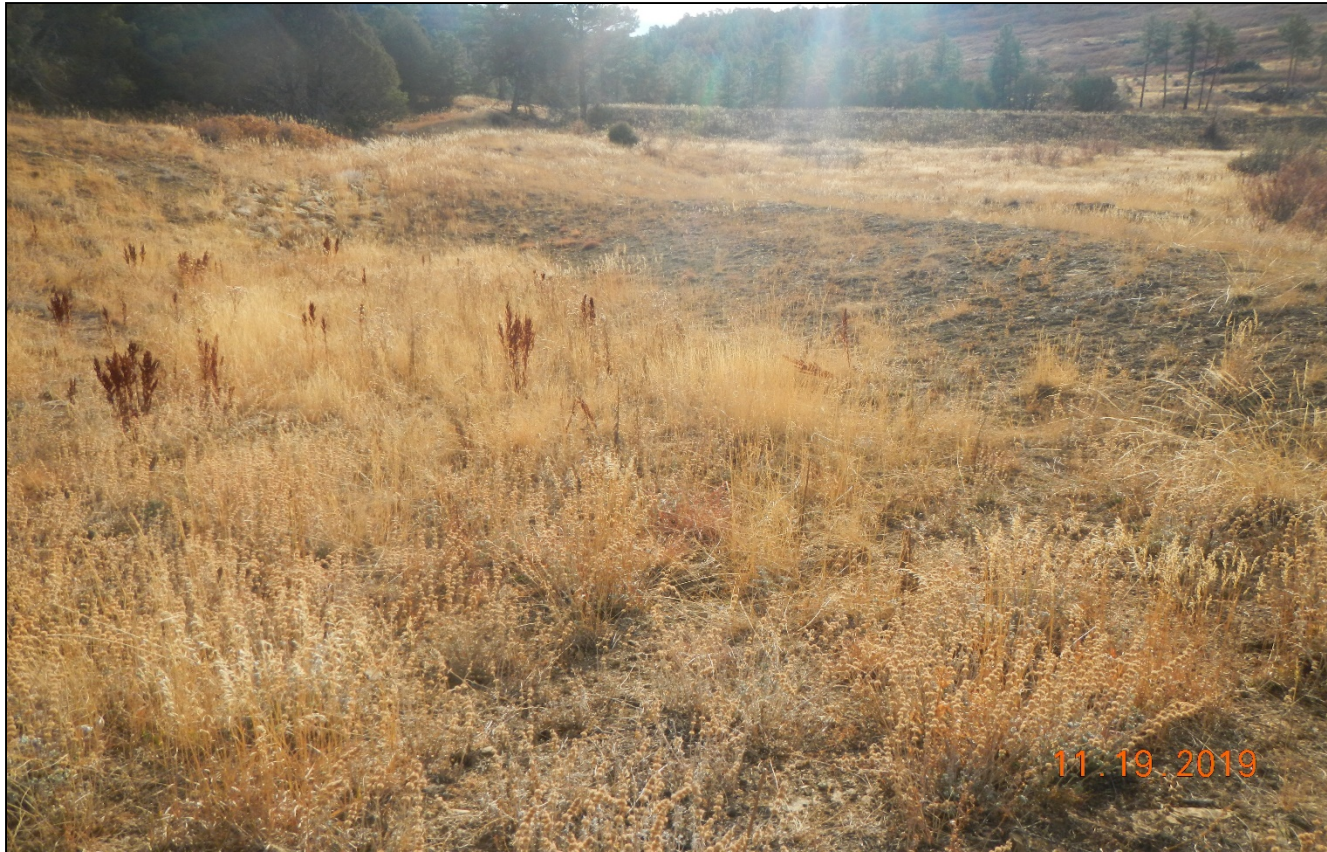
**Photo 12.** Facing east toward the location. A shallow pit remains at the location.
