# Inspection Photos

11/07/2019

Operator: DIAMOND OIL & GAS INC - 10067

Location ID: 322500

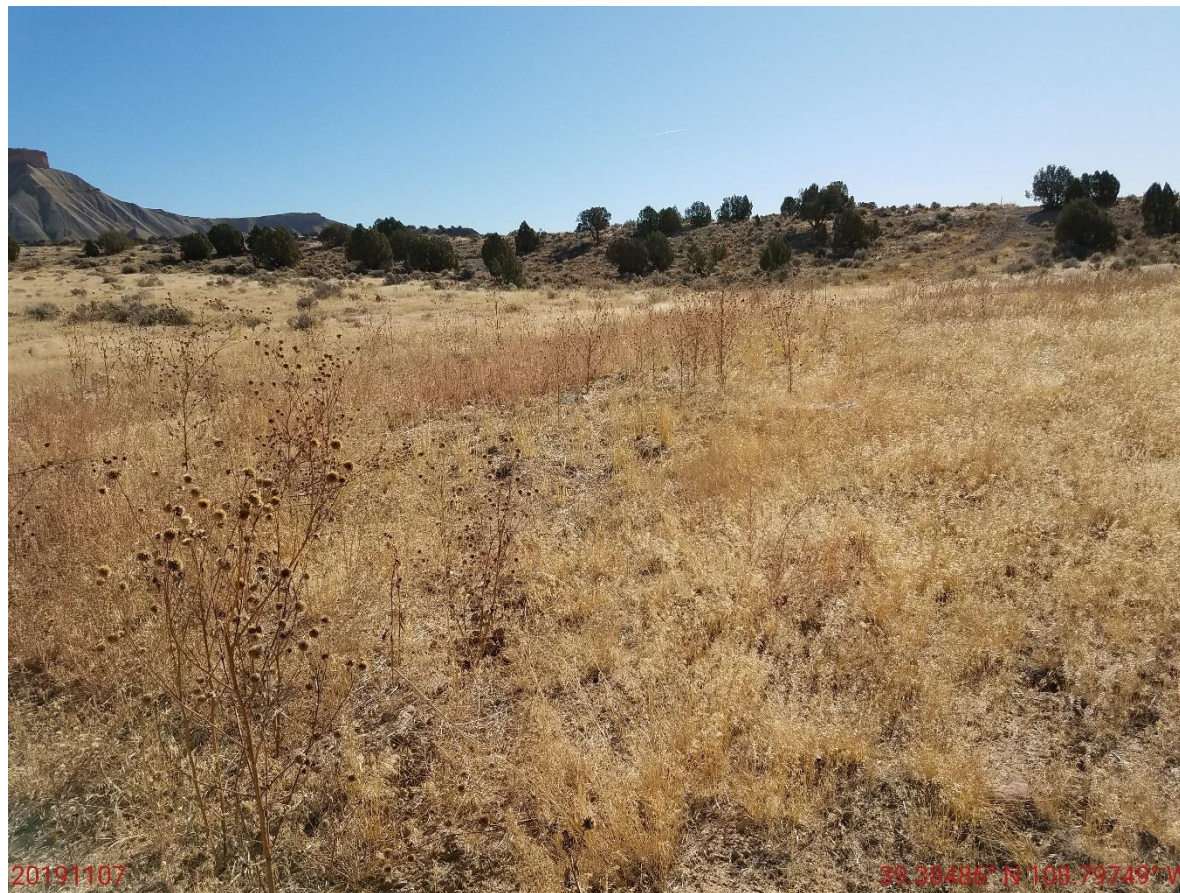
**Photo 1:** Photo taken from the west end of the location, facing southeast. Photos 1-3 provide an overview of the location and reclamation in process from southeast, east to northeast. Location predominantly annual vegetation, though desirable perennial vegetative establishment evident.

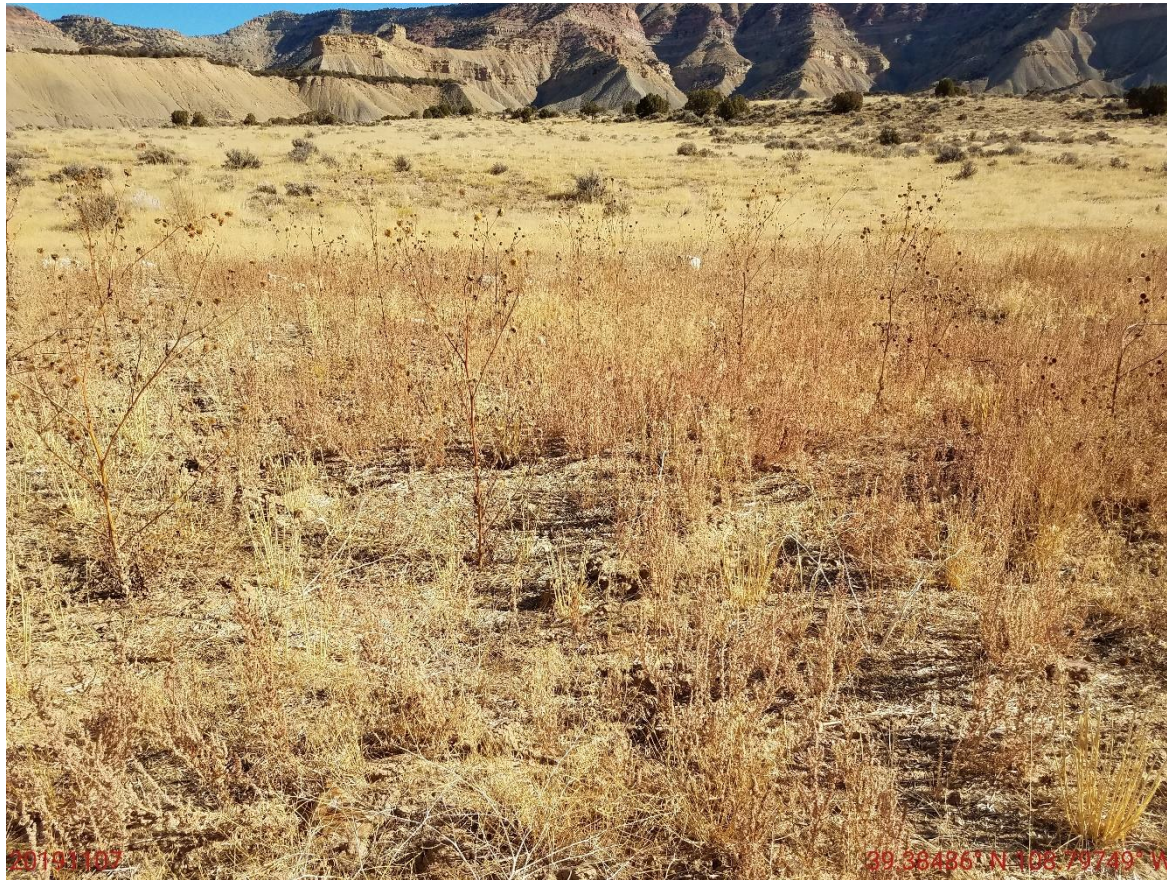
**Photo 2:** See comments under photo 1.

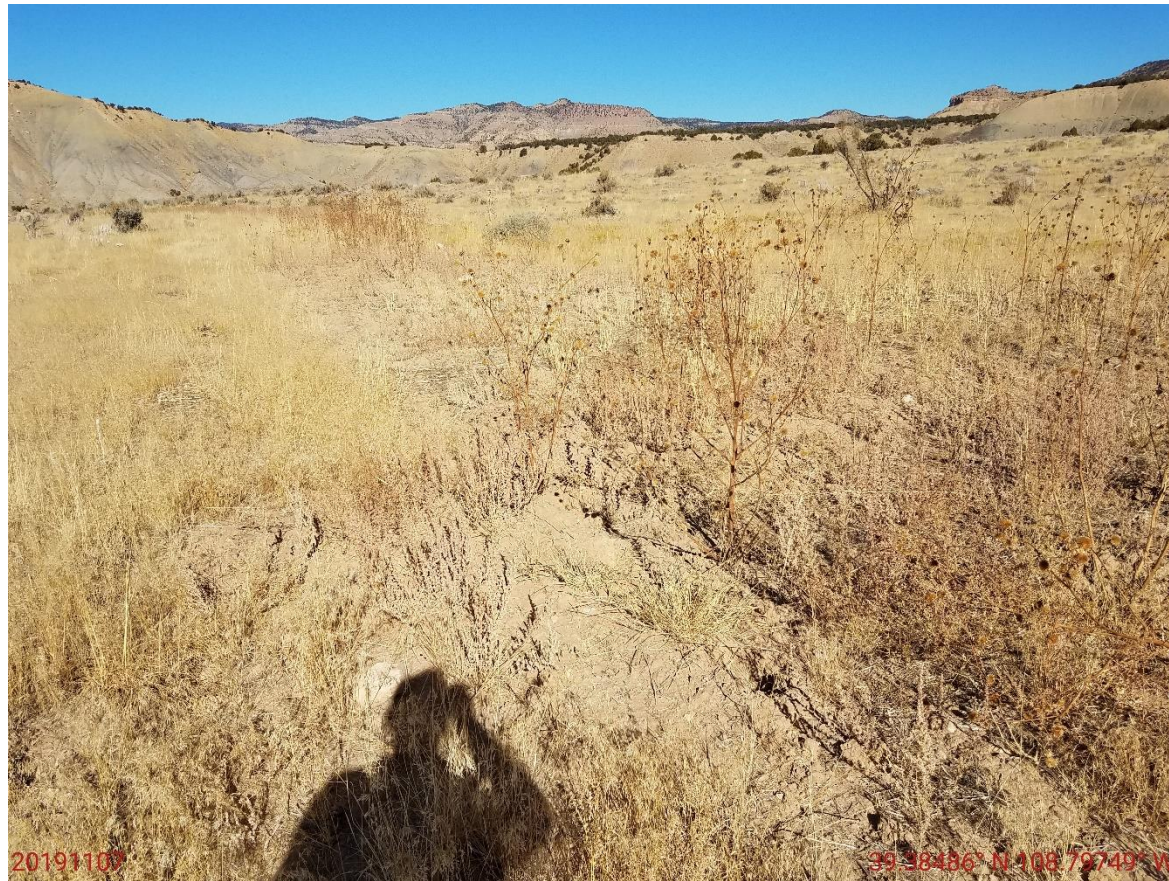
**Photo 3:** See comments under photo 1.

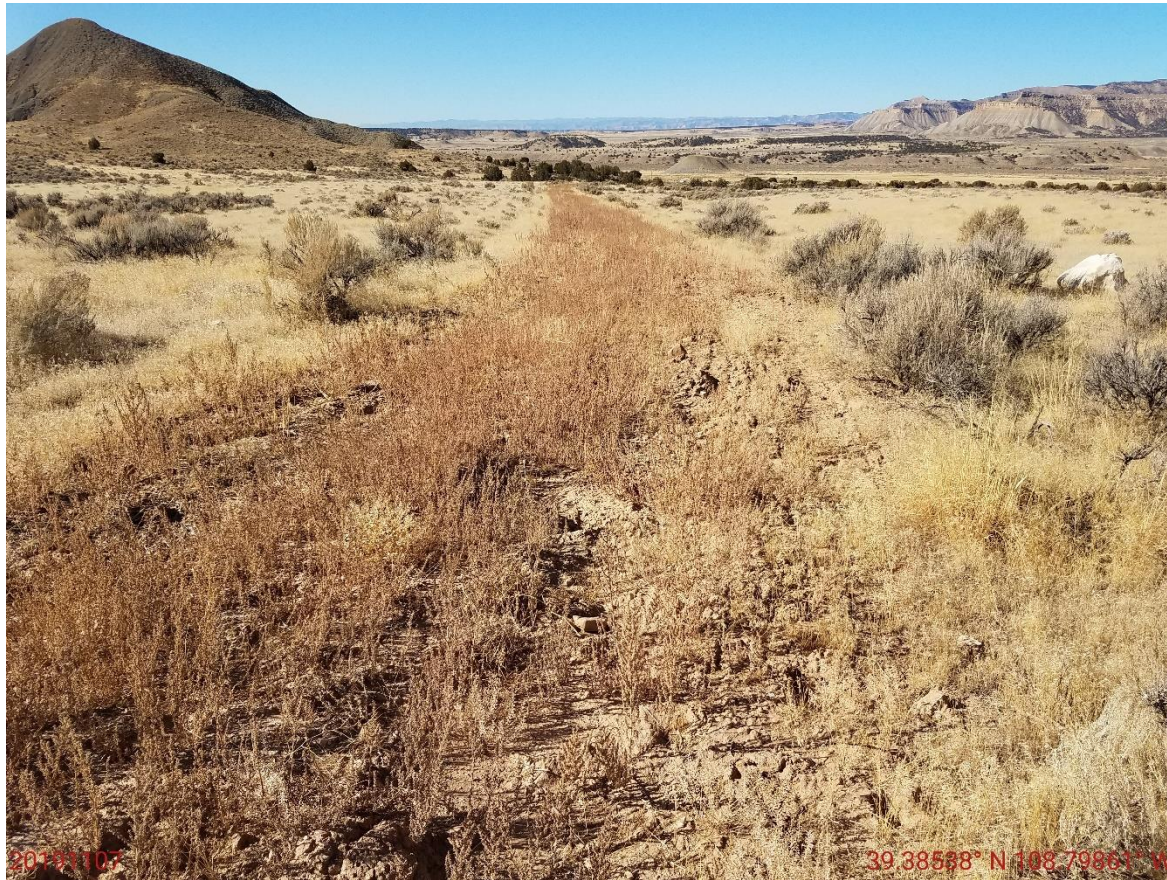
**Photo 4:** Photo taken from the access road, facing west. Vegetation on access road predominantly undesirable weedy plant species. Additional monitoring of reclamation on access road advised to determine if reclamation is progressing towards COGCC 1000 series standards.

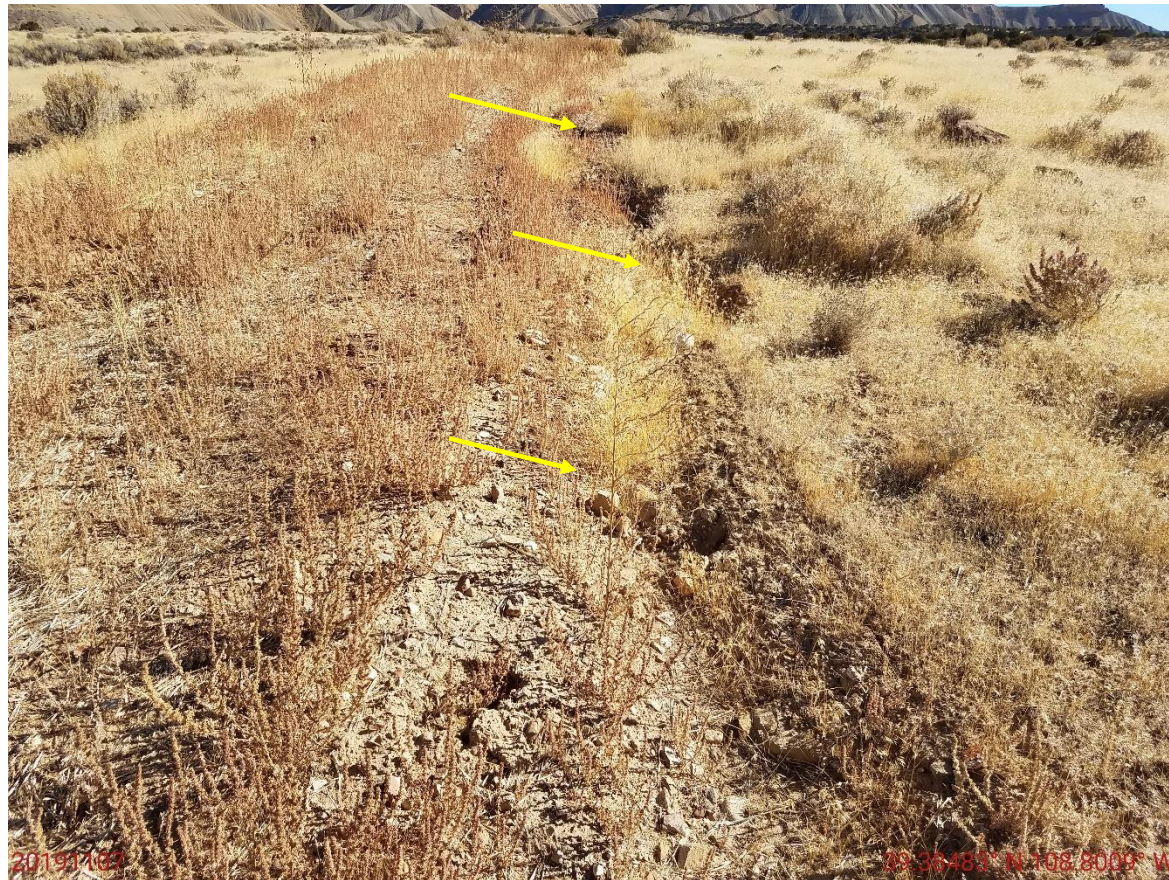
**Photo 5:** Photo taken from the access road, facing east. Photo shows areas of the access road where stormwater erosion degradation is becoming evident. Installation of additional BMPs is advised.

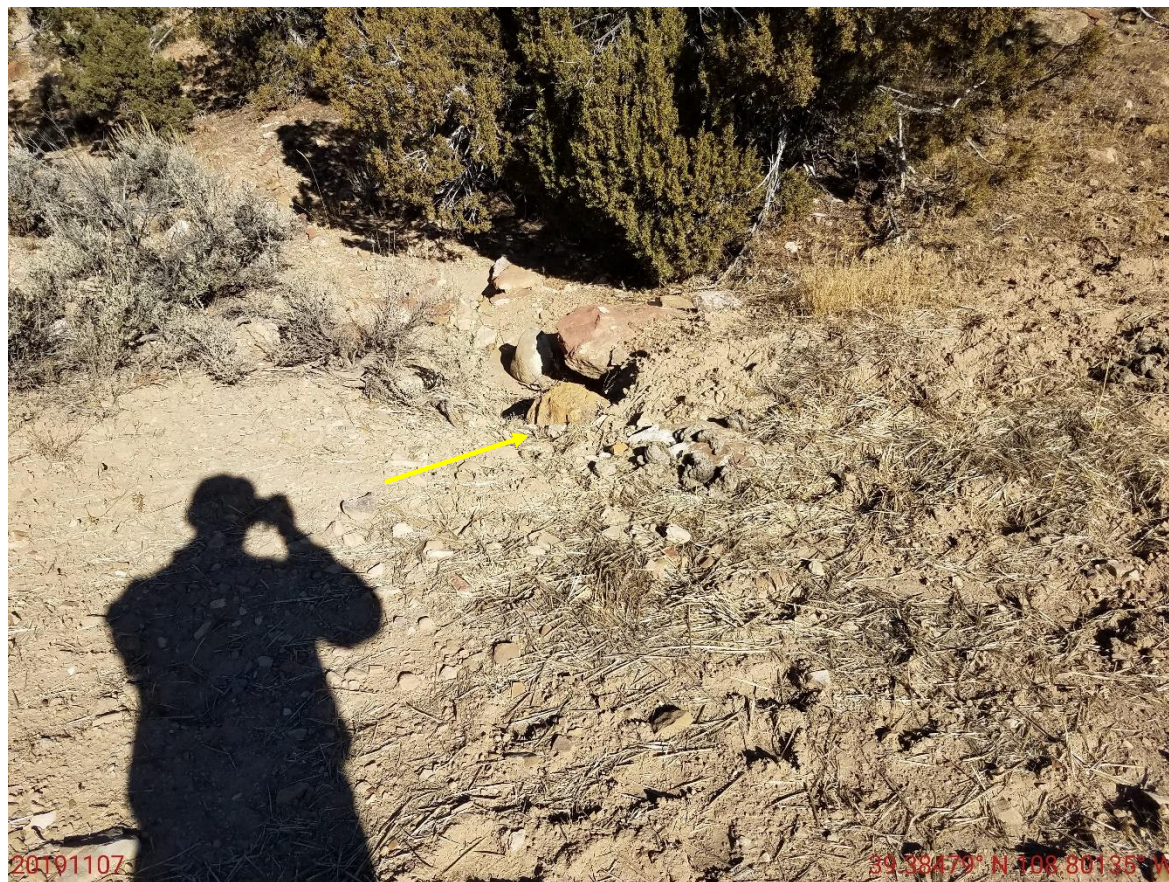
**Photo 6:** Photo taken from the access road, facing north. Photo shows a low point in the access road where stormwater discharges into a drainage. Currently no BMPs appear to be in place to stabilize and protect drainage from stormwater runoff concentrated on access road. Head-cut and a gully will likely develop. Installation of additional BMPs is advised.

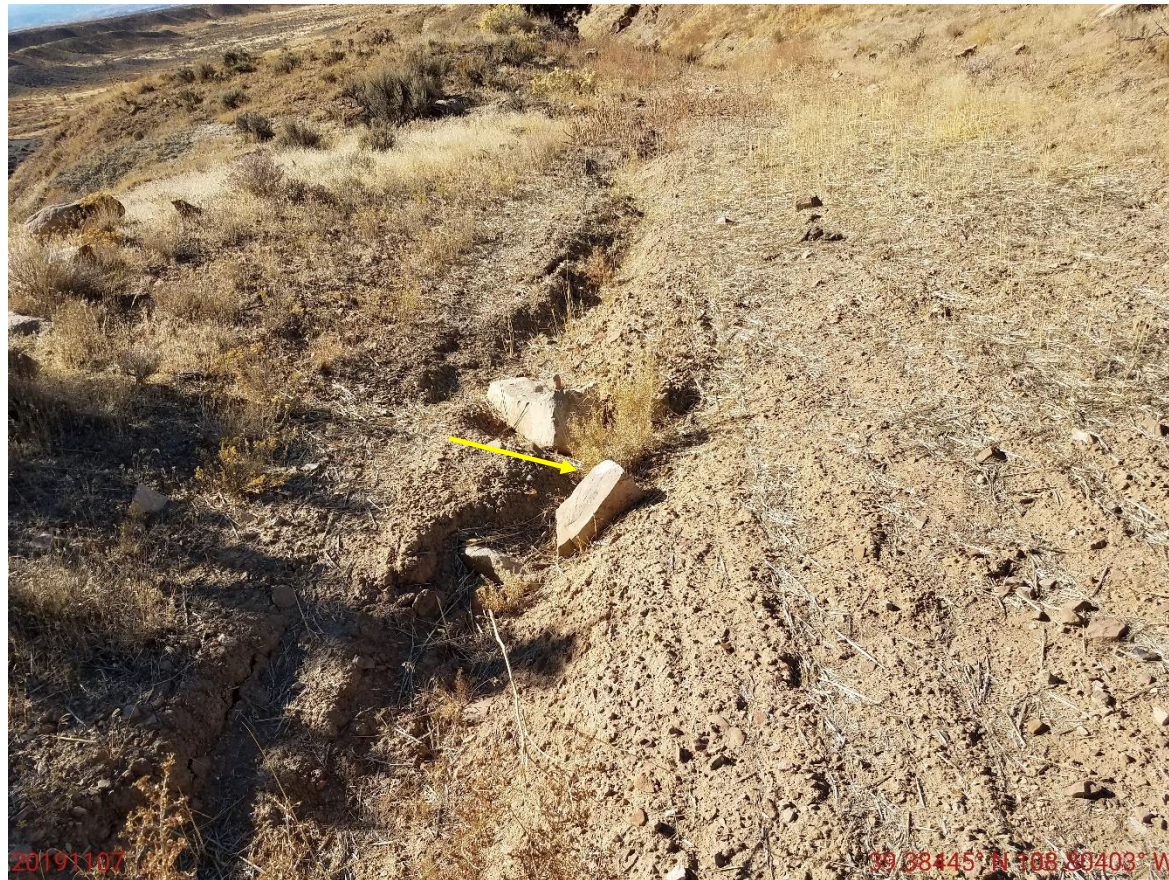
**Photo 7:** Photo taken from the access road, facing west. Photo shows areas of the access road where stormwater erosion degradation is becoming evident. Installation of additional BMPs is advised.

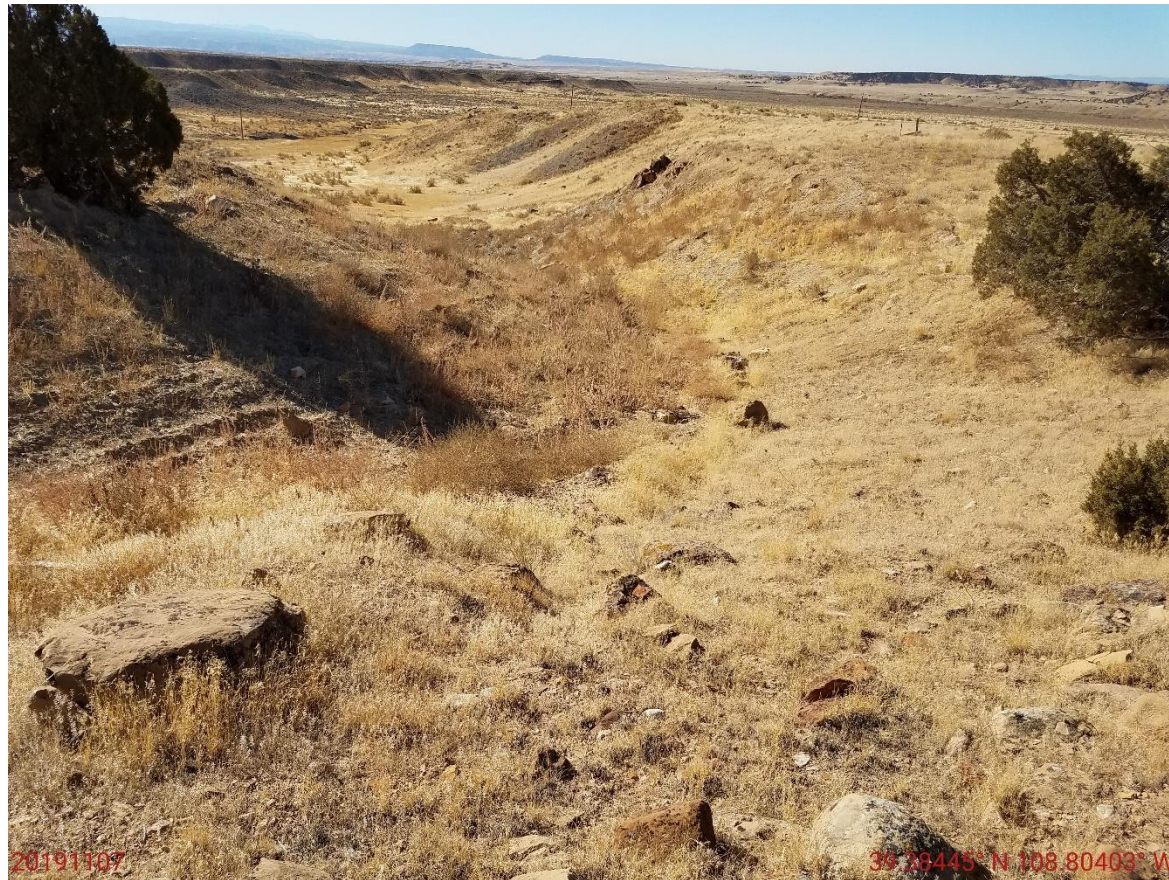
**Photo 8:** Photo taken from the access road, facing north. Photo shows vegetation over the reclamation area.
