Inspection Photos  
Operator: Logos Operating  
Location/API #: 067-06249  
Date: 11-12-2019

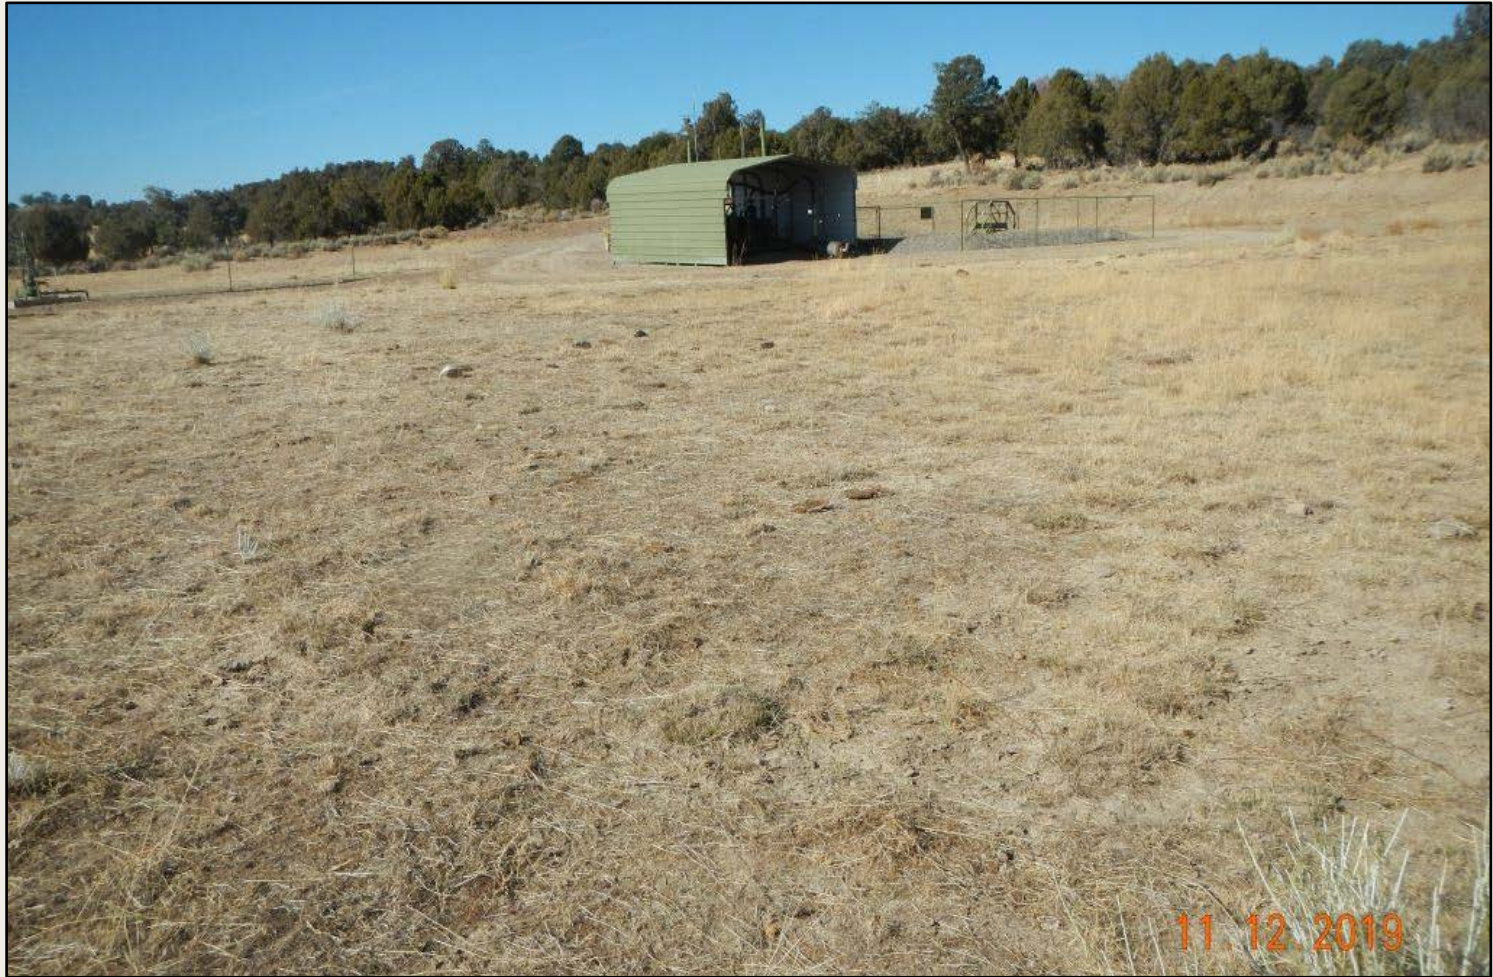
Photo 1. View of the project area from the southeastern corner facing center.

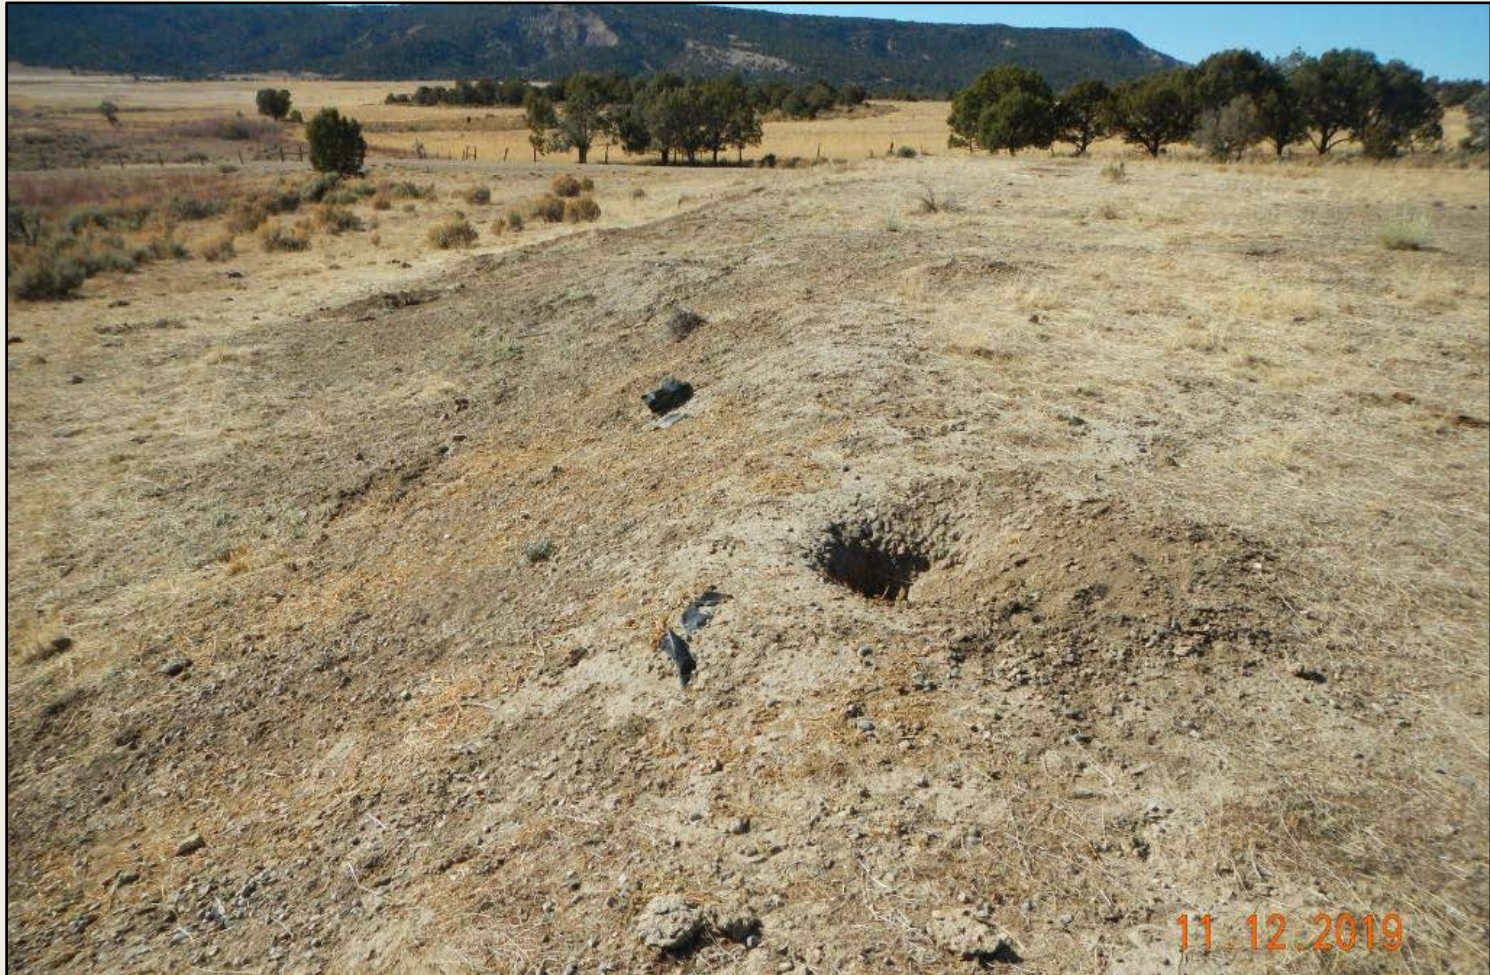
Photo 2. View of the southern fill slope from the southeastern corner facing westward. Little desirable vegetative cover observed on the slope. Brown surface vegetation on slope appears to be field bindweed.

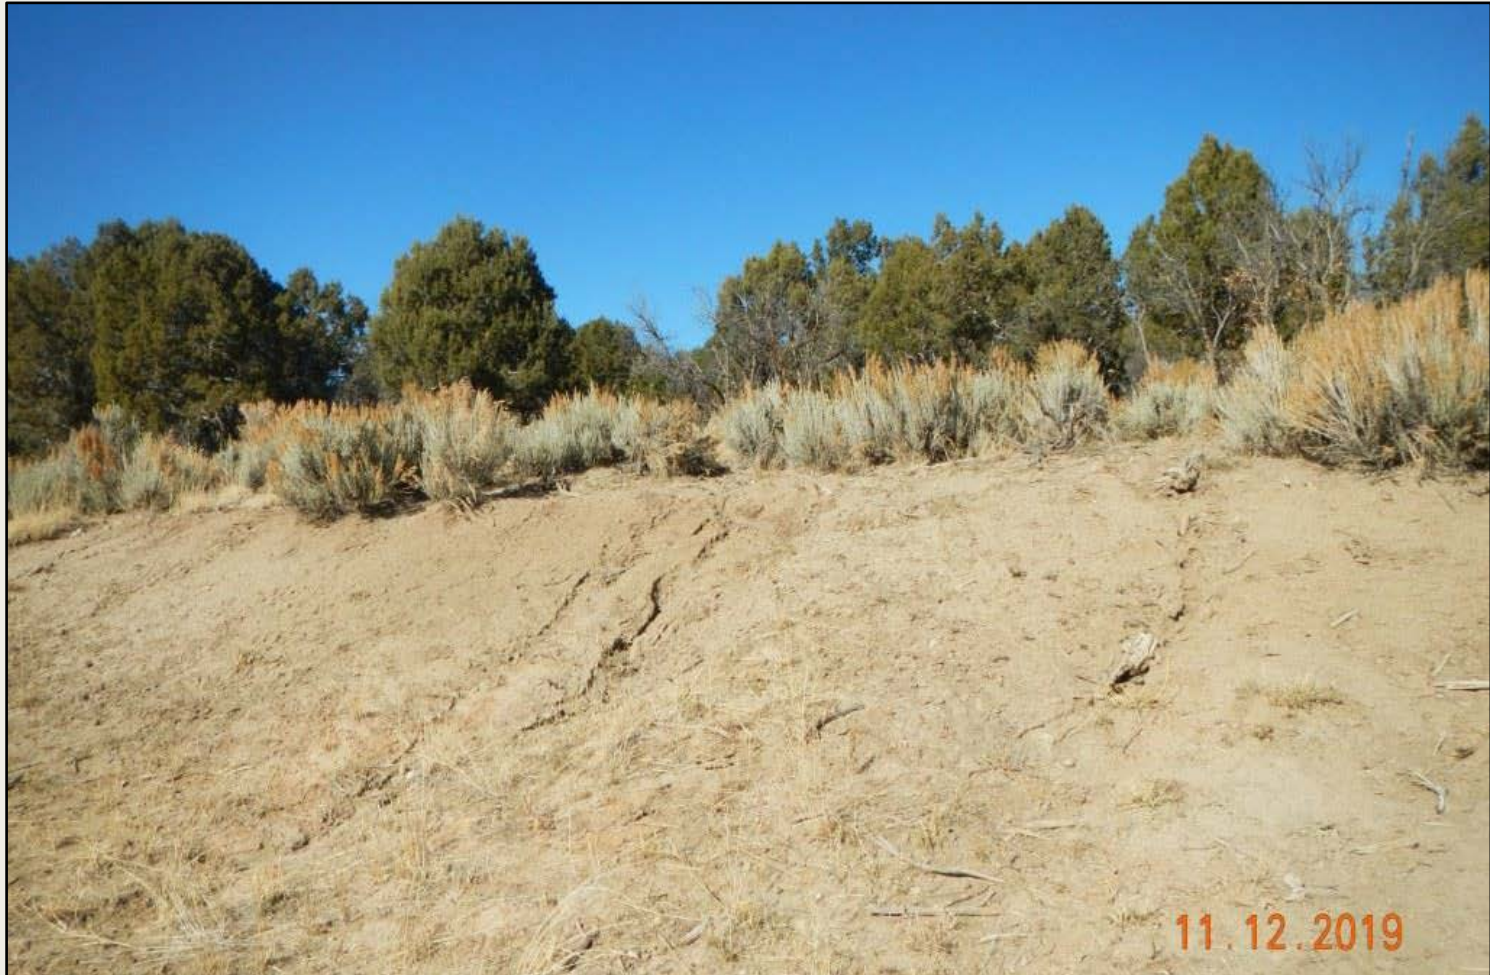
Photo 3. View of erosional rilling on well pad cut-slopes, need to be stabilized.

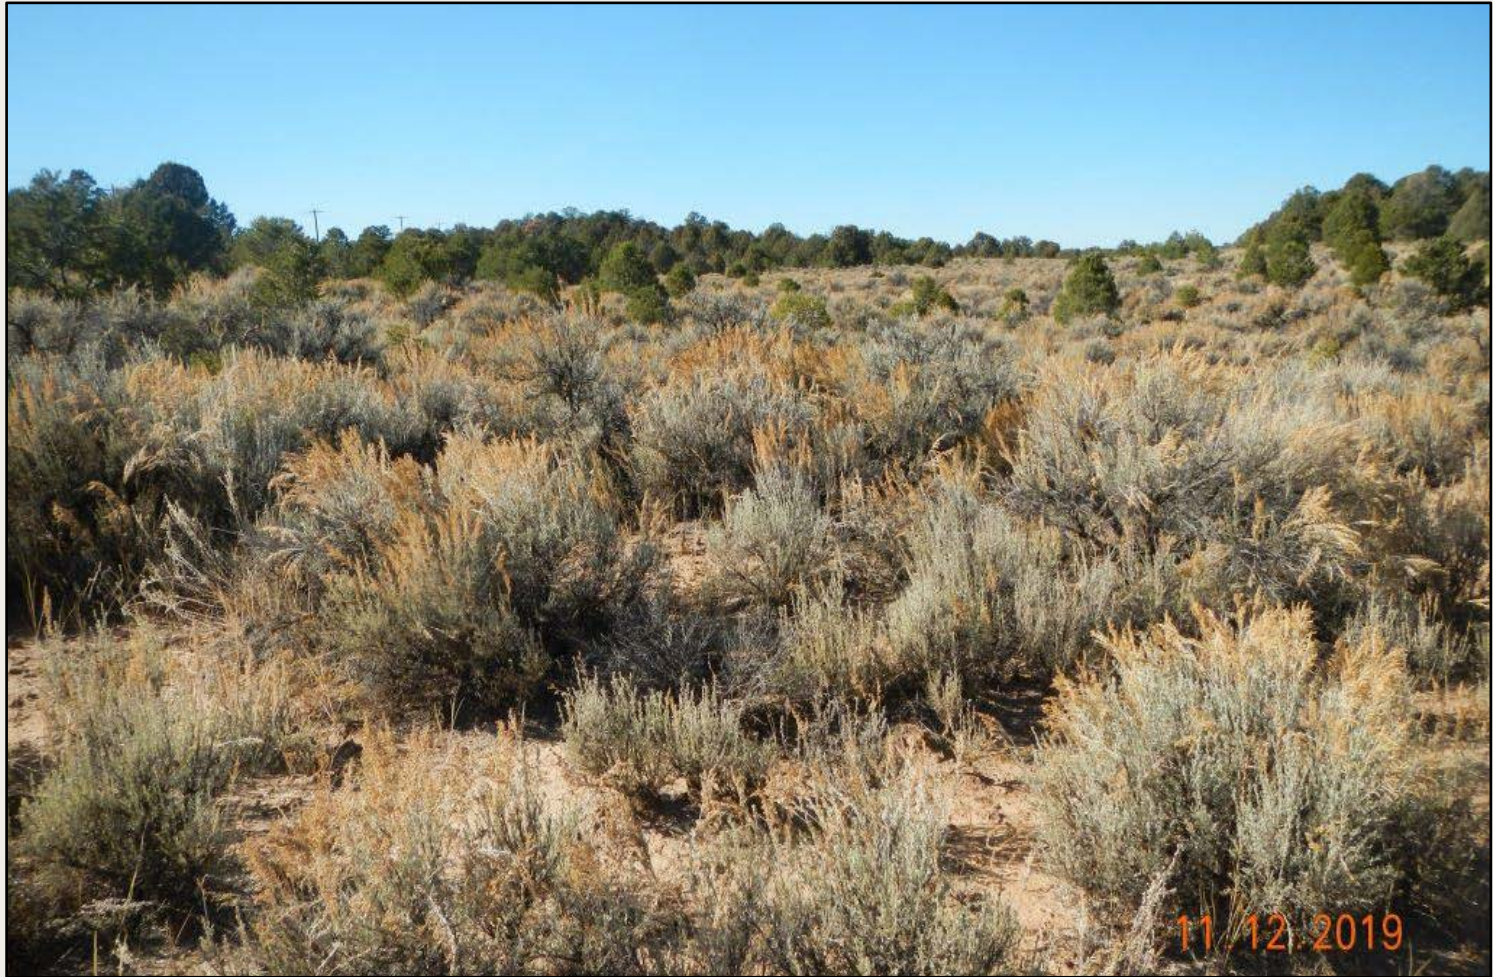
Photo 4. View of reference area comprised of sagebrush and pinyon juniper woodland.
