# Construction and Stormwater Inspection

November 19, 2019

Operator: EDGE ENERGY II LLC- #10671

Inspection Photos  
Location Name: Deporter /29-A Pad  
Location ID: 456286

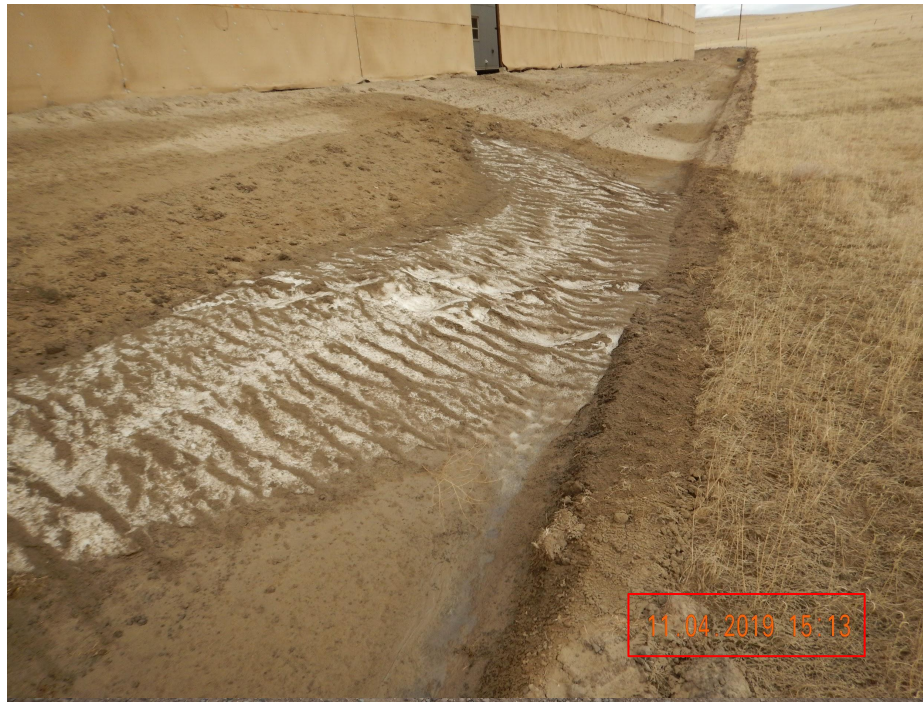
**Photo 1.** Photo taken from the southern perimeter of location on 11/4/2019, facing East. Photo illustrates sediment accumulation within the shallow ditch BMP. Also, Operator shall stabilized the unconsolidated fill material along the southern location as this is susceptible to wind and water erosion.

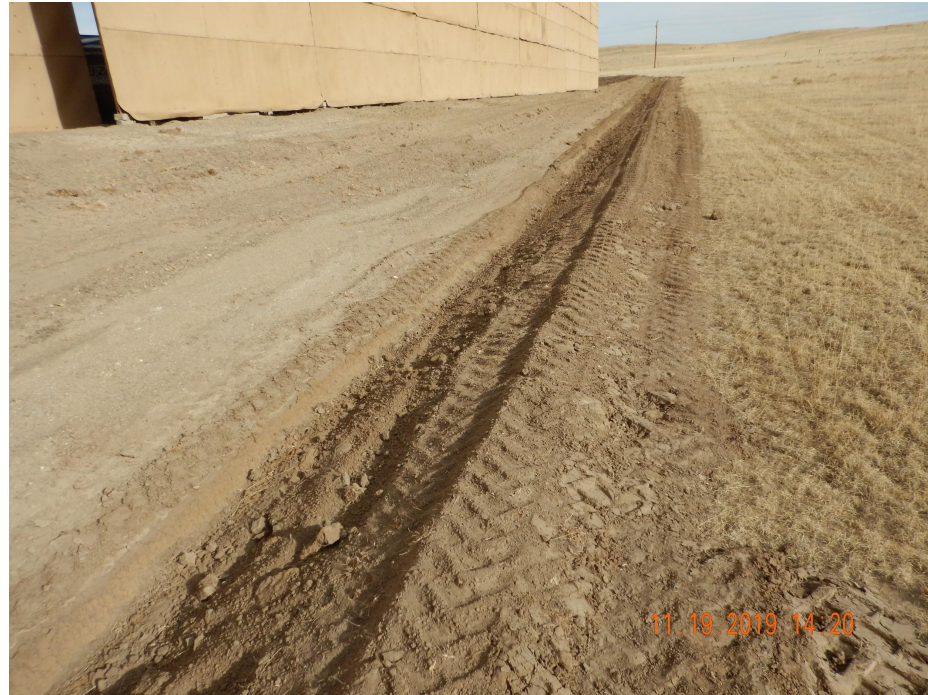
**Photo 2.** Photo taken from the southern perimeter of location on 11/19/2019, facing East. Photo illustrates Operator increased the depth of the ditch and built a berm BMP. Also, Operator shall stabilized the unconsolidated fill material along the southern location as this is susceptible to wind and water erosion.

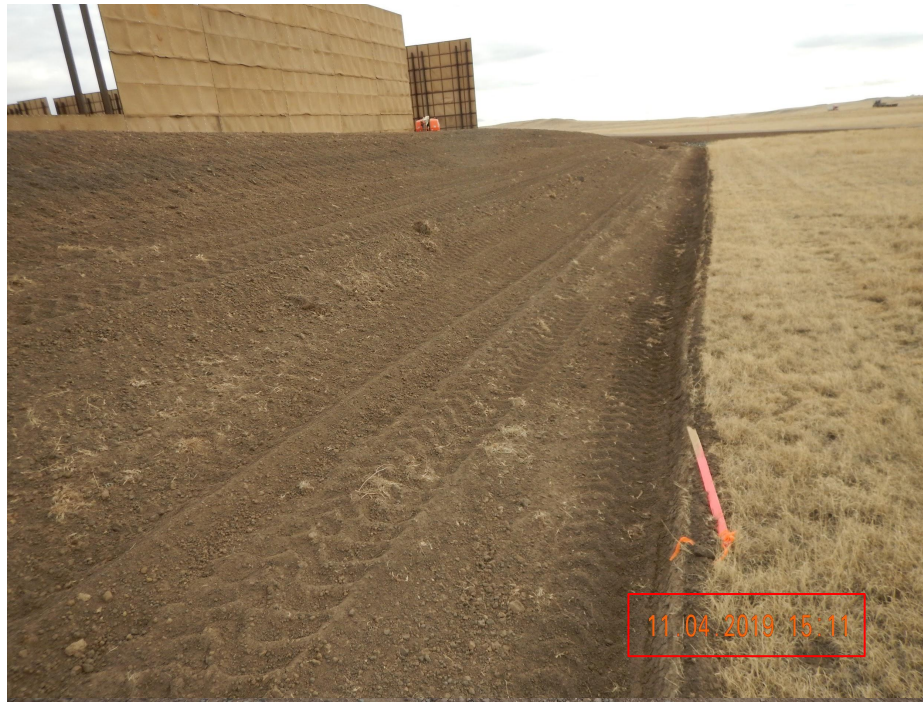
**Photo 3.** Photo taken from the western perimeter of location on 11/4/2019, facing South. Photo illustrates a shallow ditch BMP along the western location. This ditch BMP would not be considered installed to a sufficient depth.

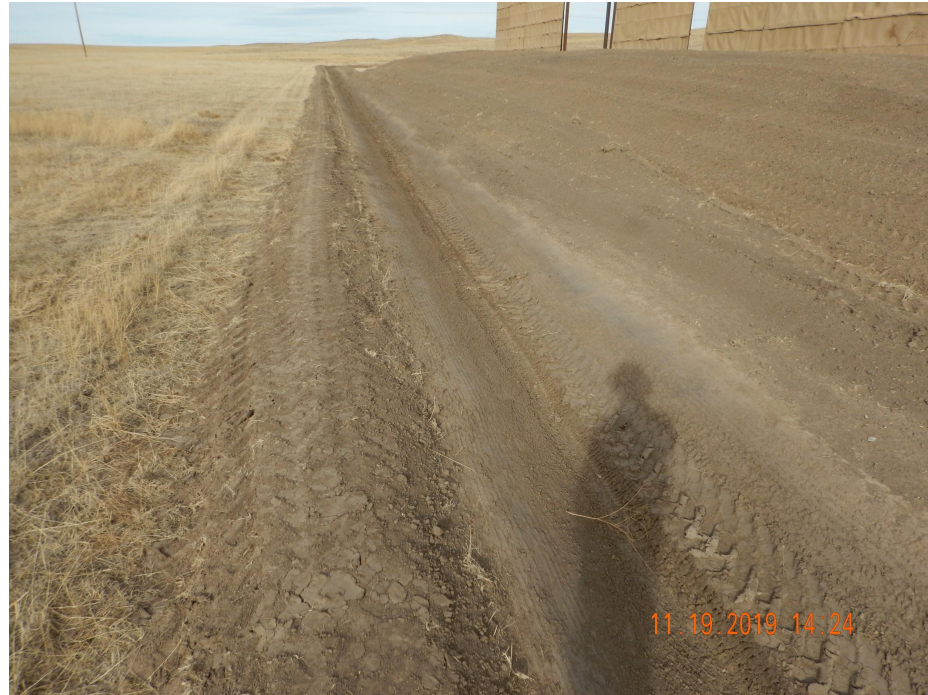
**Photo 4.** Photo taken from the western perimeter of location on 11/19/2019, facing North. Photo illustrates Operator increased the depth of the ditch and built a berm BMP.

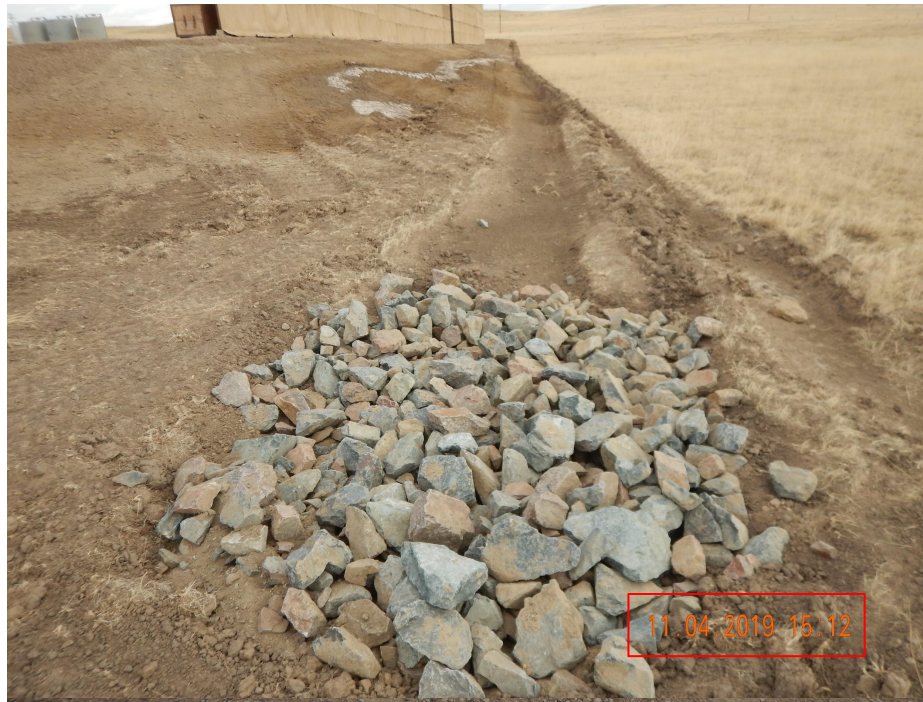
**Photo 5.** Photo taken from the southwestern perimeter of location on 11/4/2019, facing East. Photo illustrates what the Operator considered a sediment trap. Operator indicated that the depth below the riprap was ~24”.

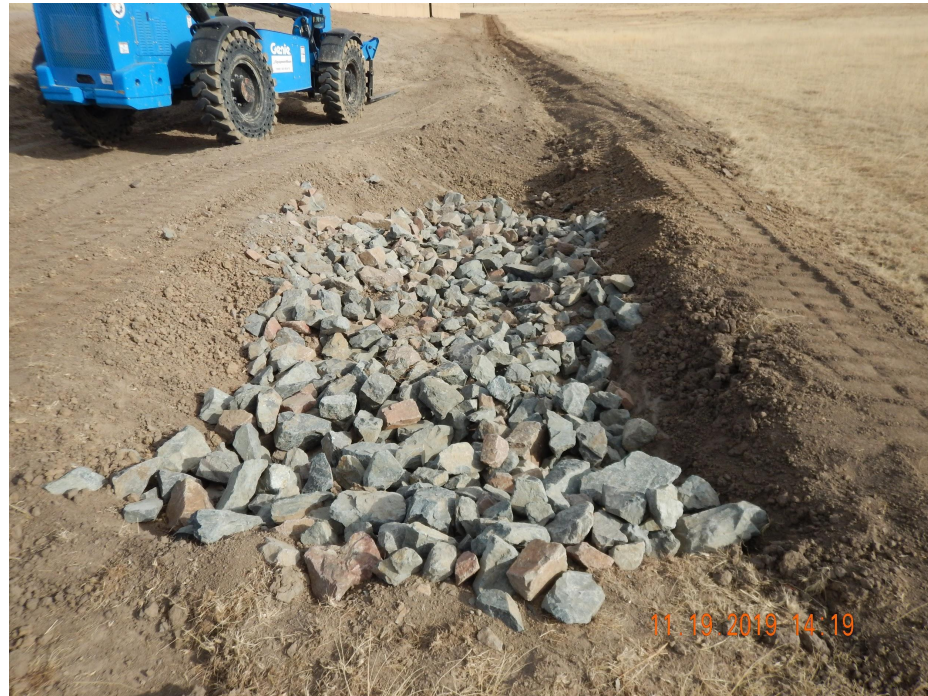
**Photo 6.** Photo taken from the southwestern perimeter of location on 11/19/2019, facing East. Photo illustrates Operator increased the depth and size of the sediment trap.
