Inspection Photos
Location Name: Waste Management #2L-441
Location ID: 432119

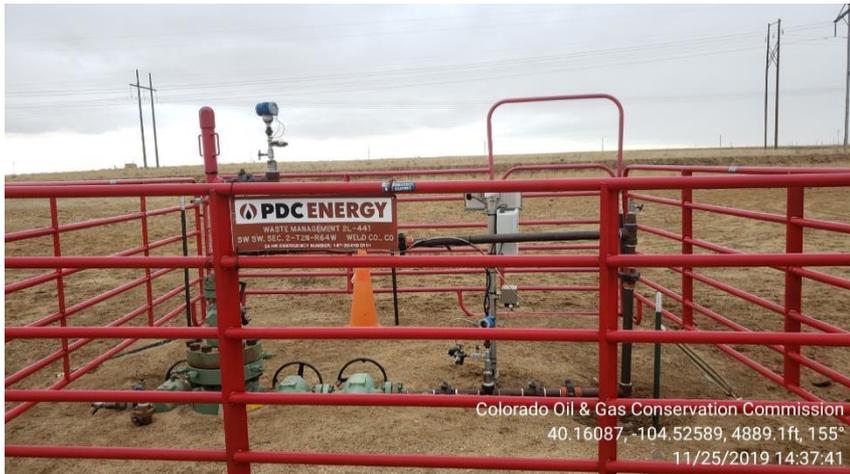
Photo 1 WH sign

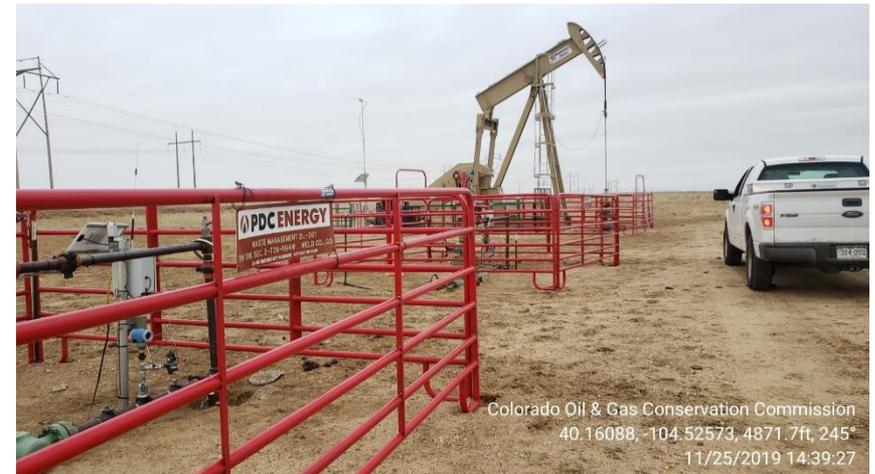
Photo 2 wellsite

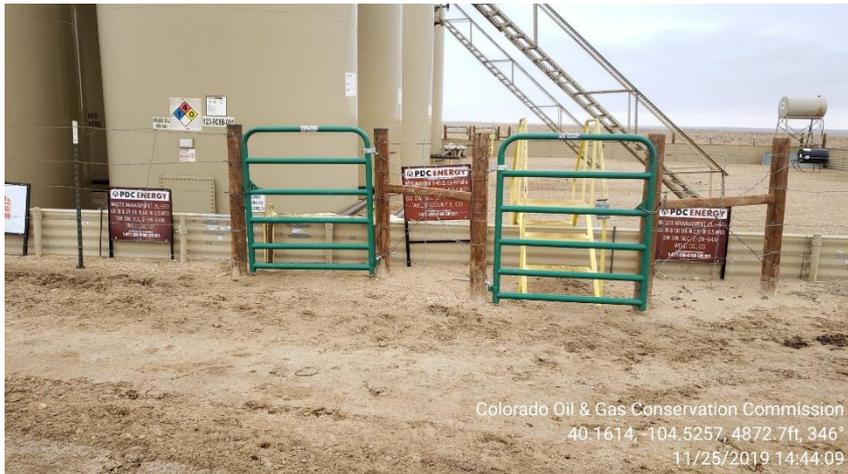
Photo 3 TB signs

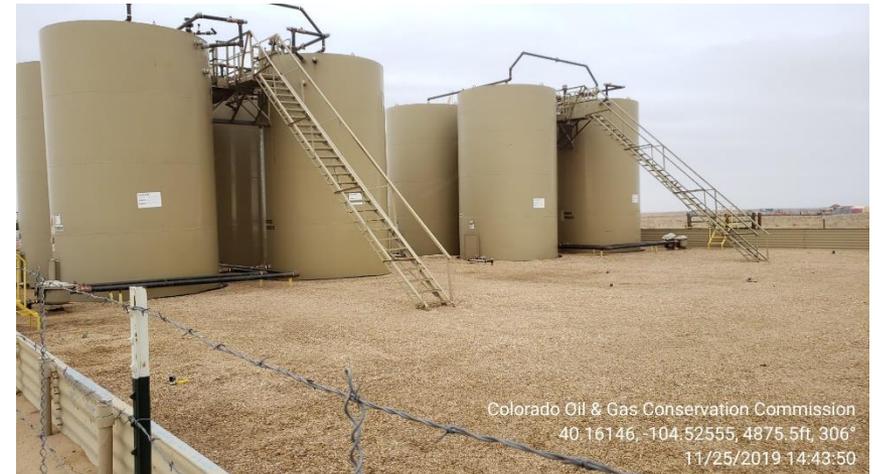
Photo 4 TB

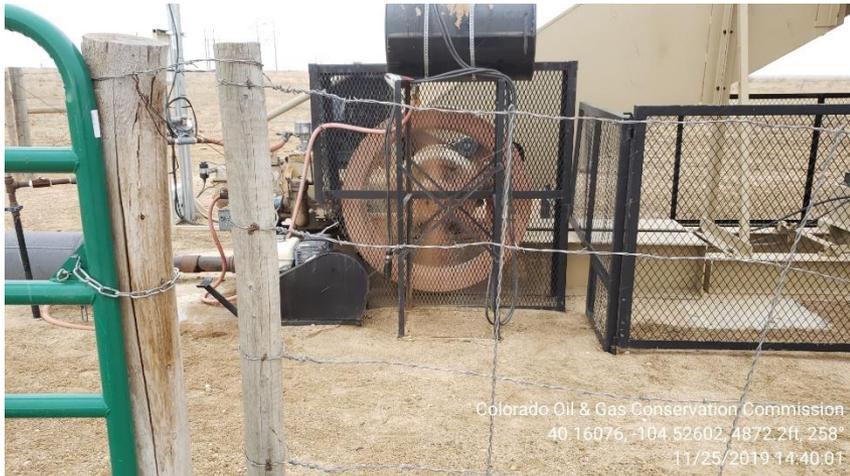
Photo 5 no containment under aux. tank

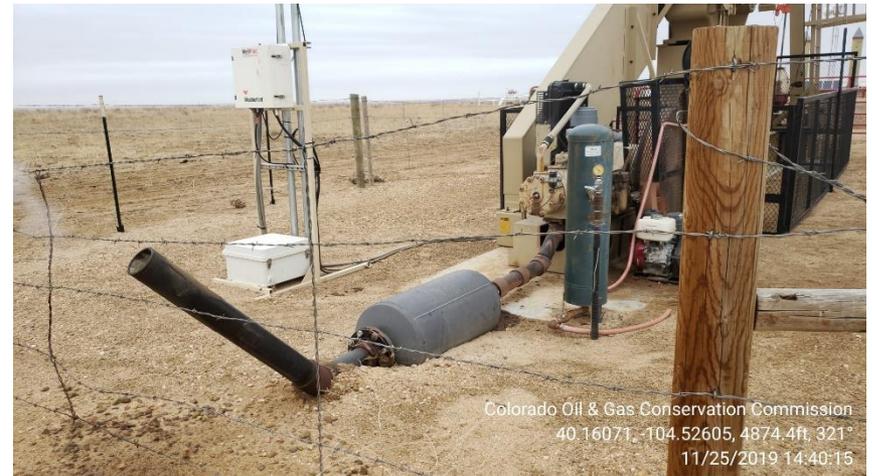
Photo 6 stained soil removed exhaust has been rerouted

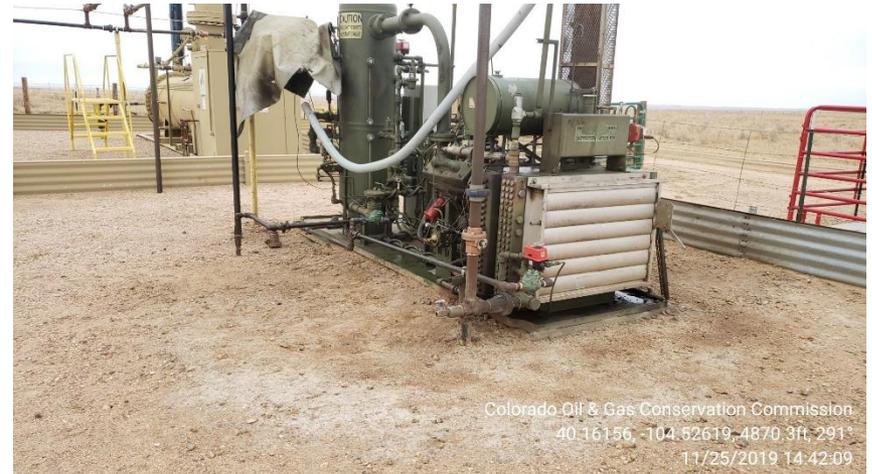
Photo 8 stained soil removed mech. Issue appears to have been addressed

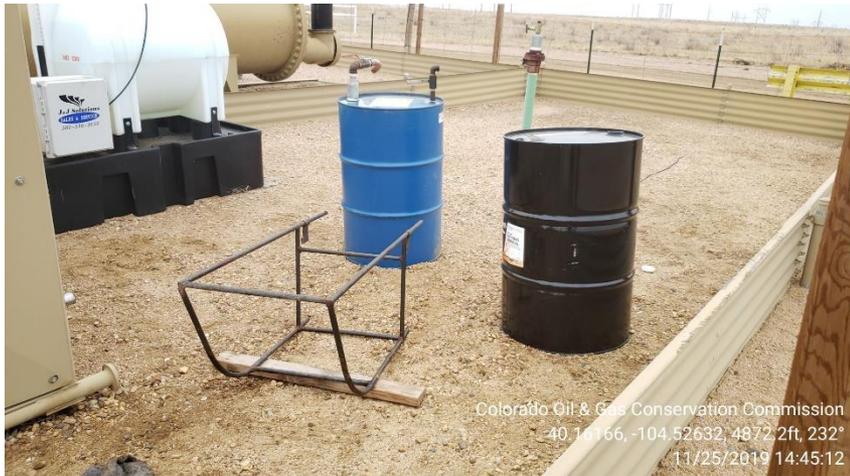
Photo 9 unused drums no containment

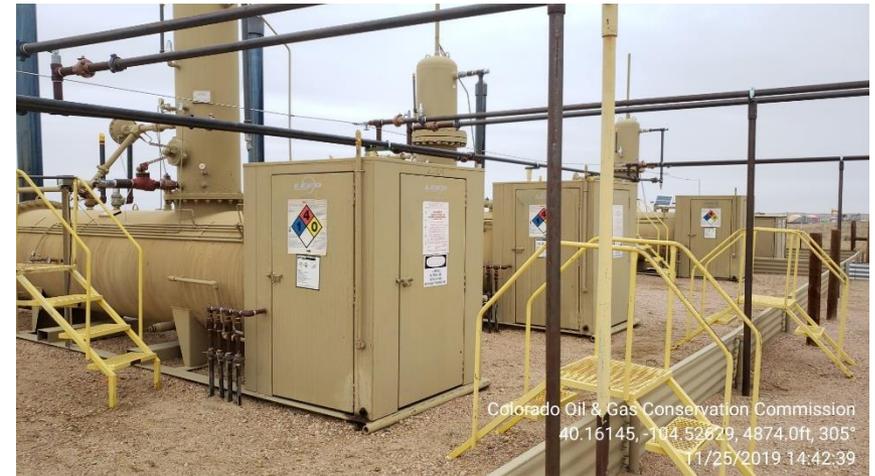
Photo 10 heated horiz.sep.

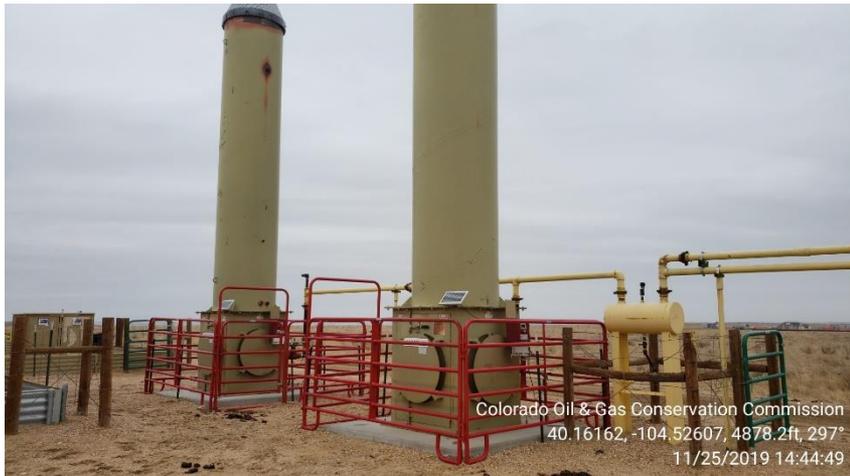
Photo 11 ECDs

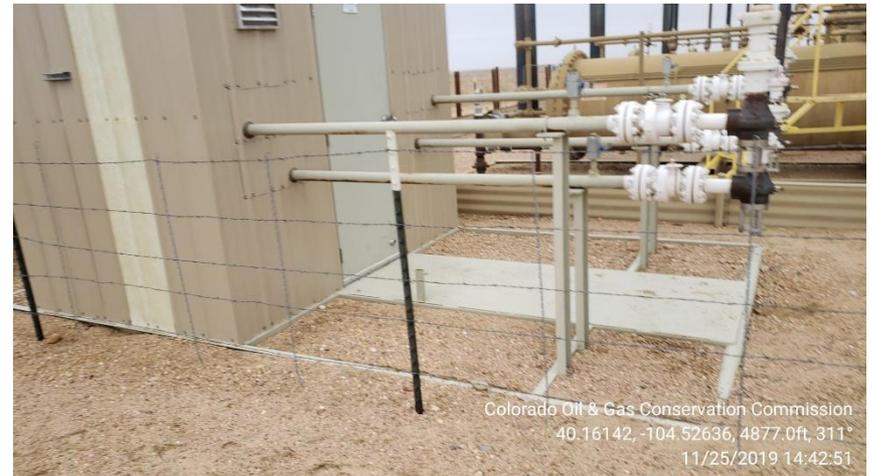
Photo 12 Gas meter run
