Inspection Photos

Location Name: COUNTRYMAN 24-31

API#: 05-071-09404

INSP. #: 695101824

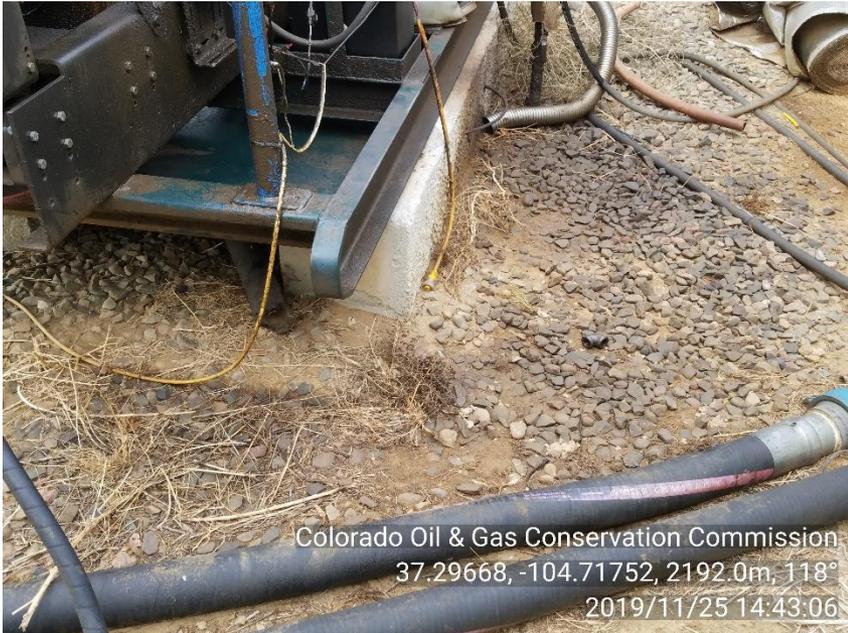
PHOTO 3: AREA OF IMPACTED SOIL NEAR PRIME MOVER (ENGINE SKID) MOTOR ON ENGINE SKID HAS OIL LEAKS IN NUMEROUS PLACES. Remove and dispose impacted material in approved manner, service and maintain equipment and self inspect to prevent recurrence of conditions per 1002.f(2) and 907. Increase frequency of maintenance and self inspection schedule of equipment to prevent impacting surface materials and mixing of wastes with precipitation. Rule 907 & 1002.f.(2). CA DATE 12-25-19.

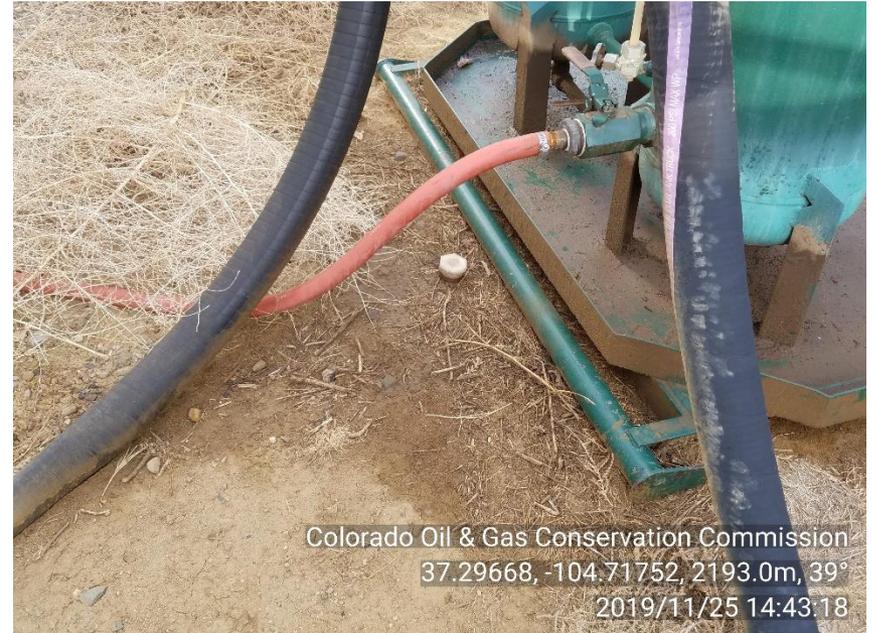
PHOTO 4: ANOTHER AREA OF IMPACTED SOIL AROUND COMPRESSOR. SAME CA AS PHOTO 3.

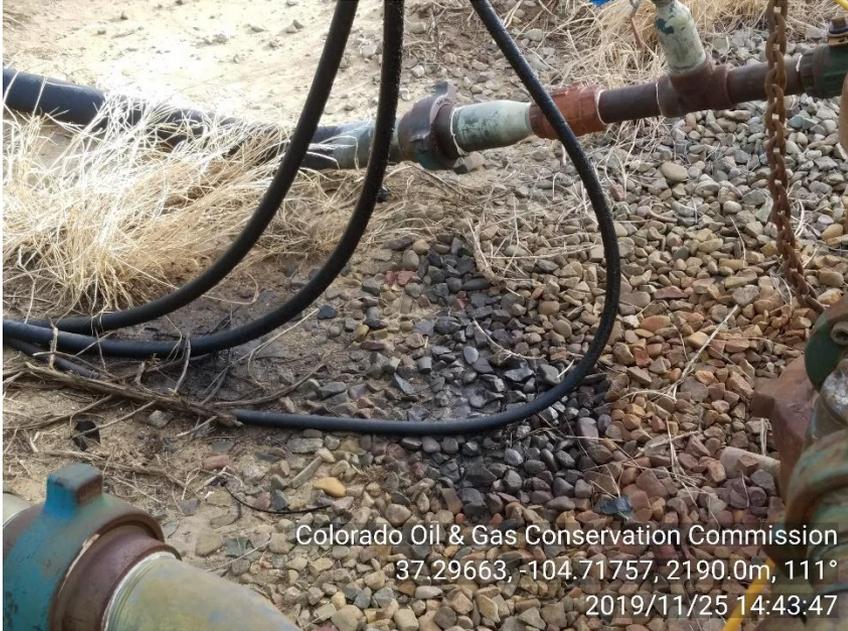
PHOTO 5: ANOTHER AREA OF IMPACTED SOIL AROUND WELLHEAD. SAME CA AS PHOTO 3.

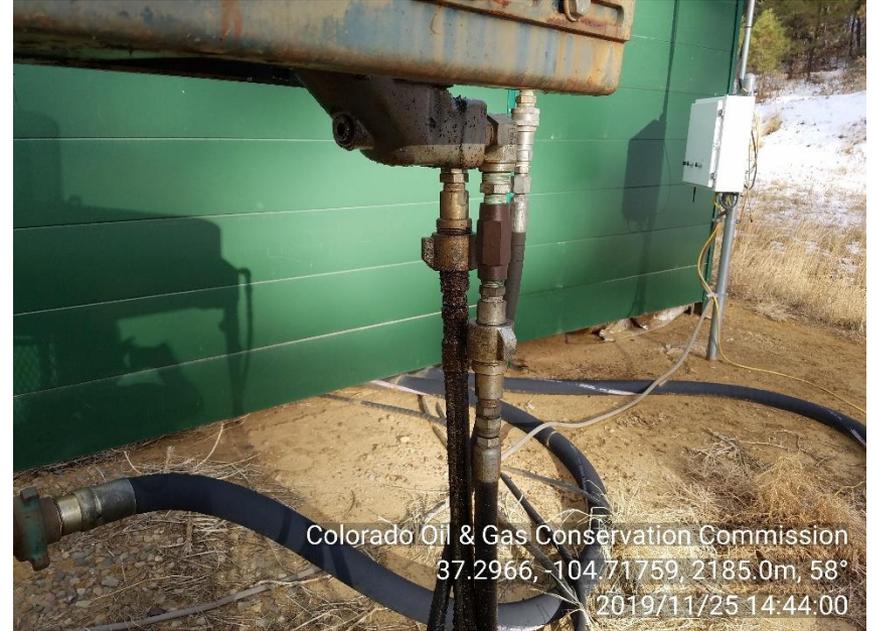
PHOTO 6: MECHANICAL CONDITION. HYDRAULIC HOSE LEAKING AT CONNECTIONS. Increase frequency of maintenance and self inspection schedule of equipment to prevent impacting surface materials and mixing of wastes with precipitation. Rule 907 & 1002.f.(2). CA DATE 12-25-19.
