Inspection Photos

API: 05-017-07811

Operator: MCCOY PETROLEUM CORPORATION

Inspection Date: 11/25/2019

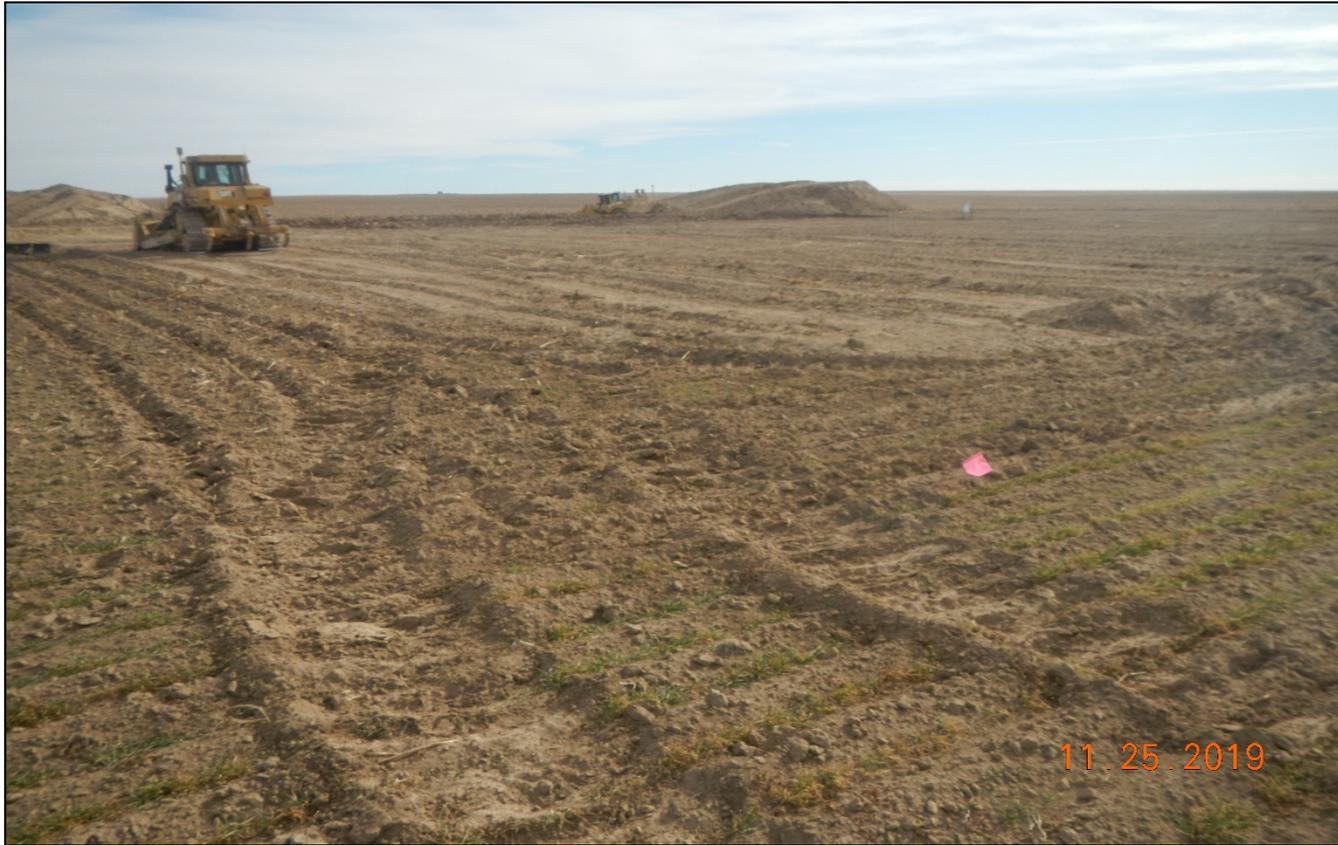
Photo 1. Northwest side of the location facing southeast. The location was in process of construction.

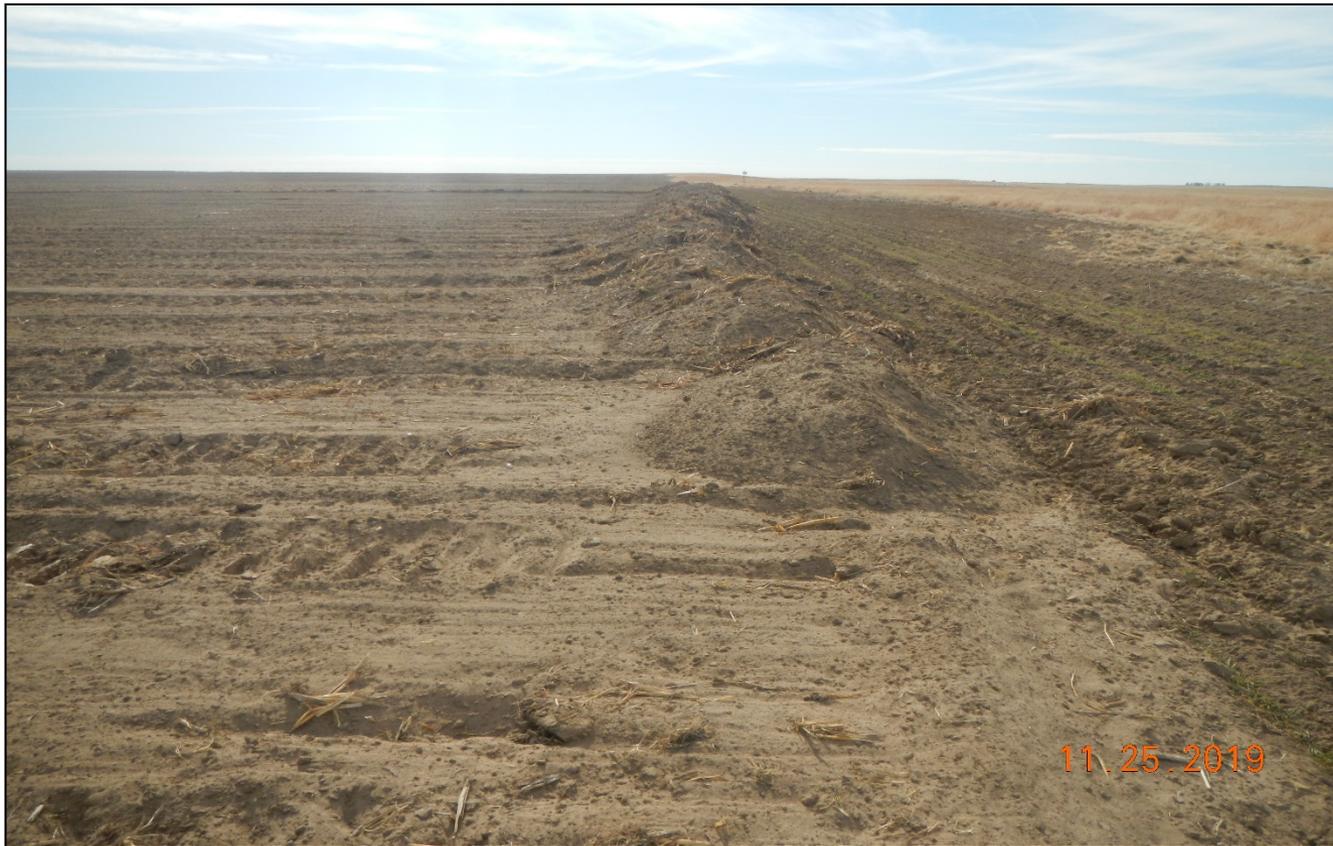
Photo 2. Topsoil was stockpiled at the west side of the location. There did not appear to be enough topsoil salvaged at the time of inspection.

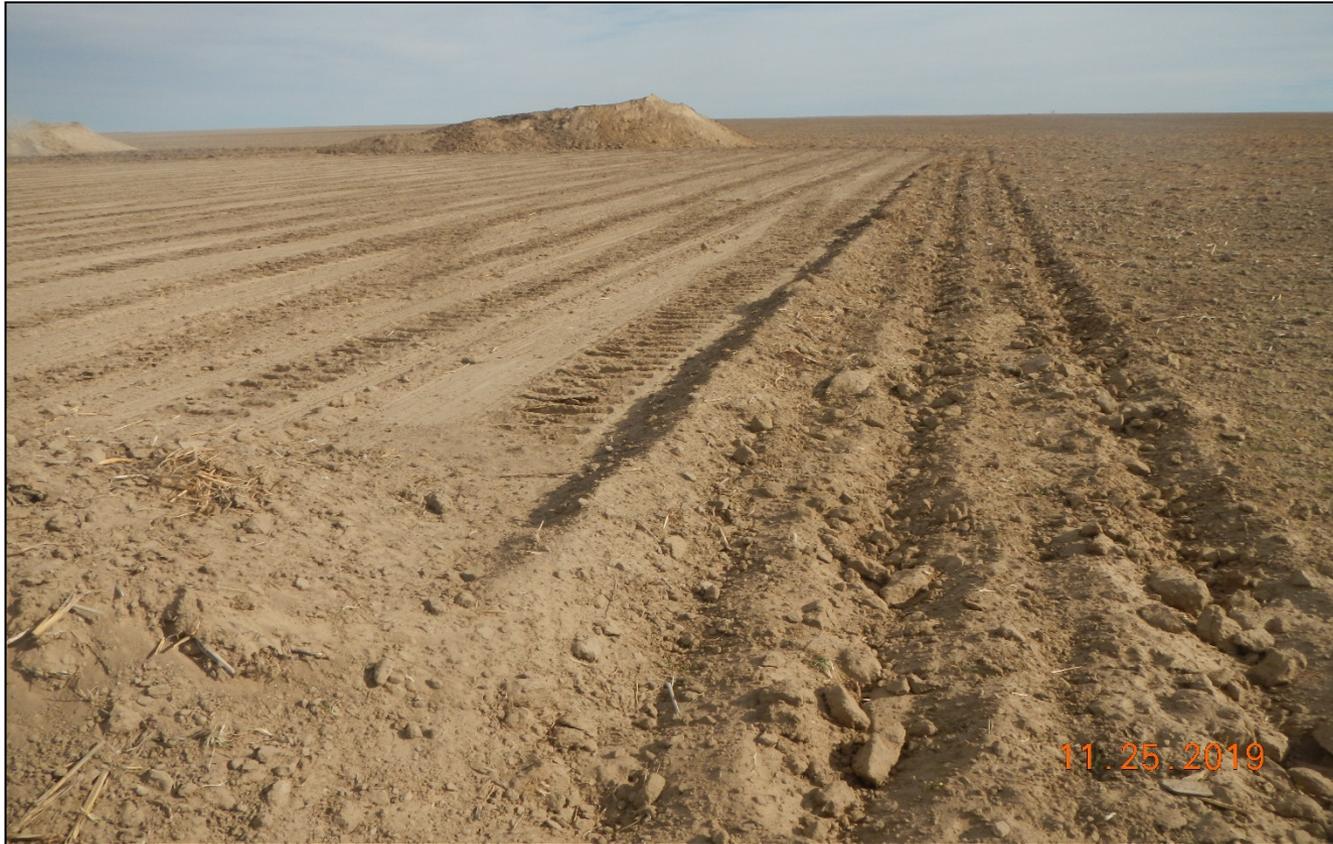
Photo 3. Southwest side of the location facing east. Surface roughening around the perimeter however this practice should be performed in conjunction with other BMP's.

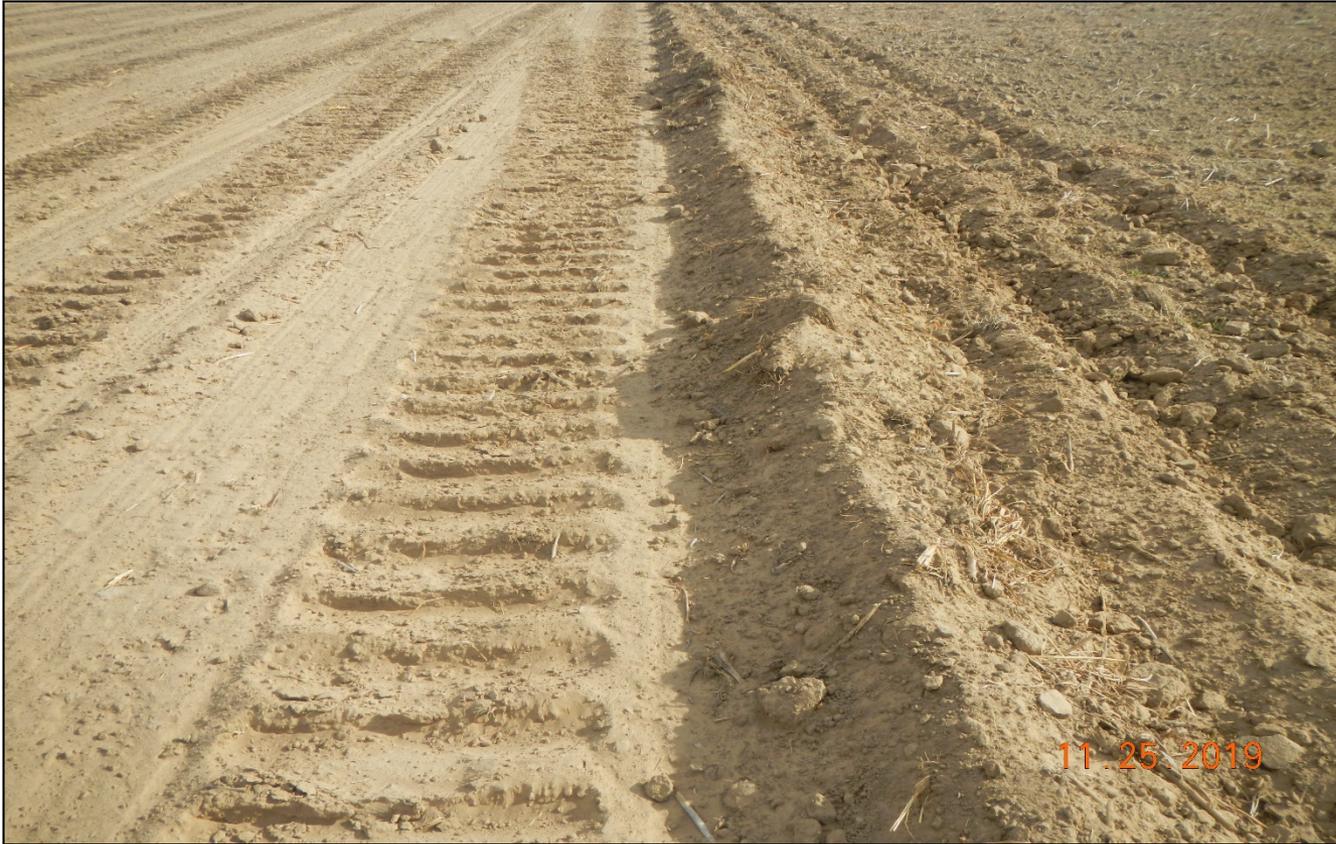
Photo 4. Facing east along the southern edge of the location which show topsoil salvaged was approximately 6 inches on this side of the pad and even less on the northern side of the pad.

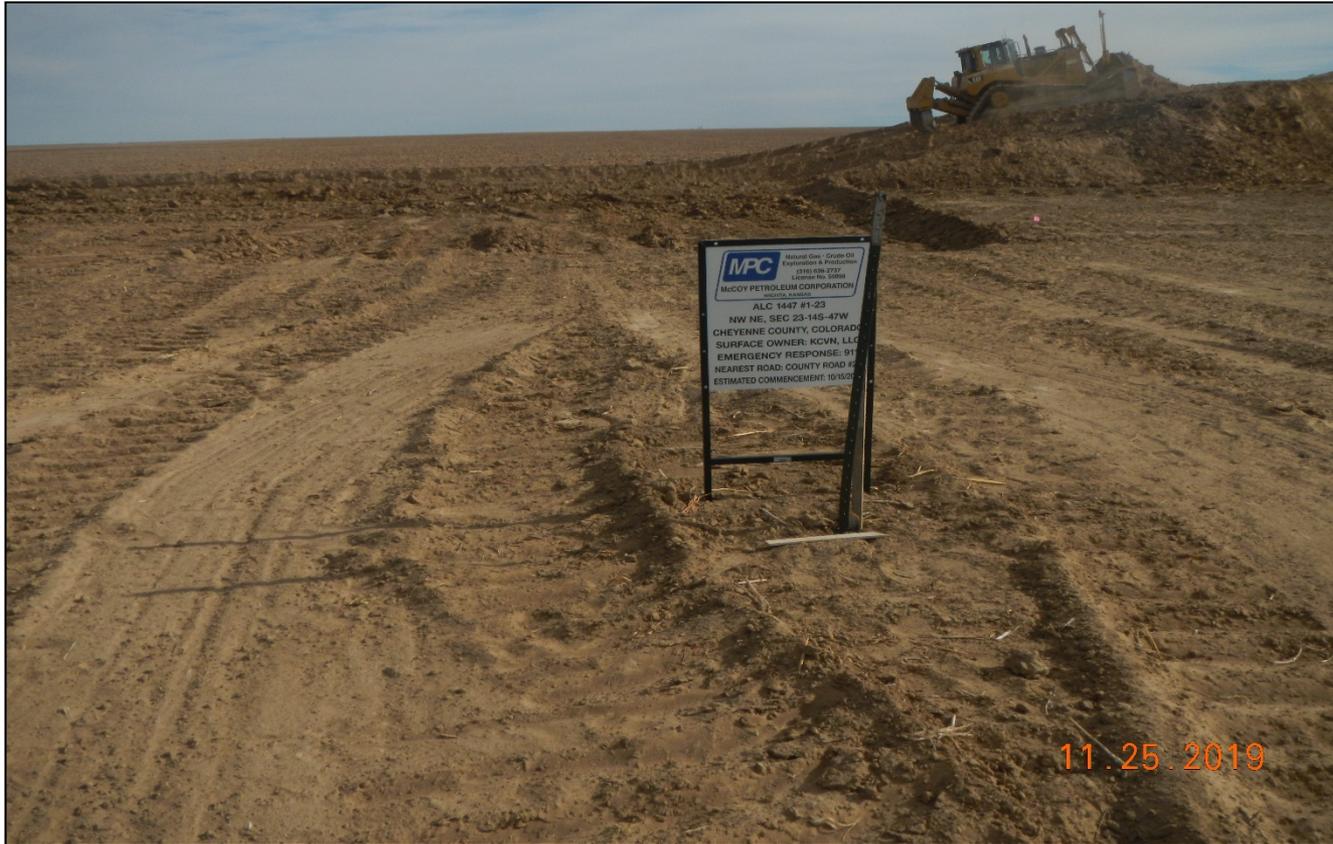
Photo 5. Location sign was posted at the center of the location.

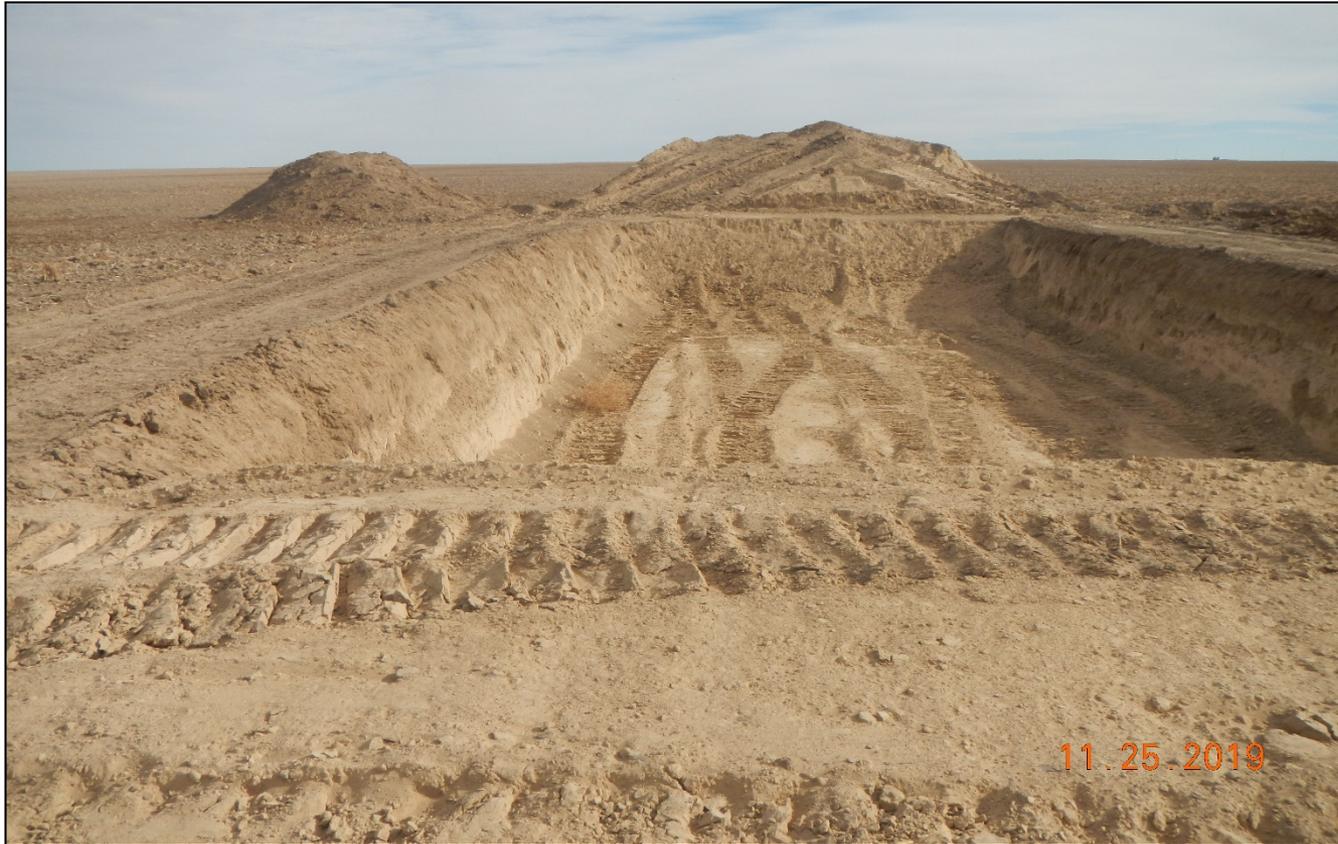
Photo 6. The drilling pit had been excavated and topsoil was salvaged and stored in upper left of the photo.

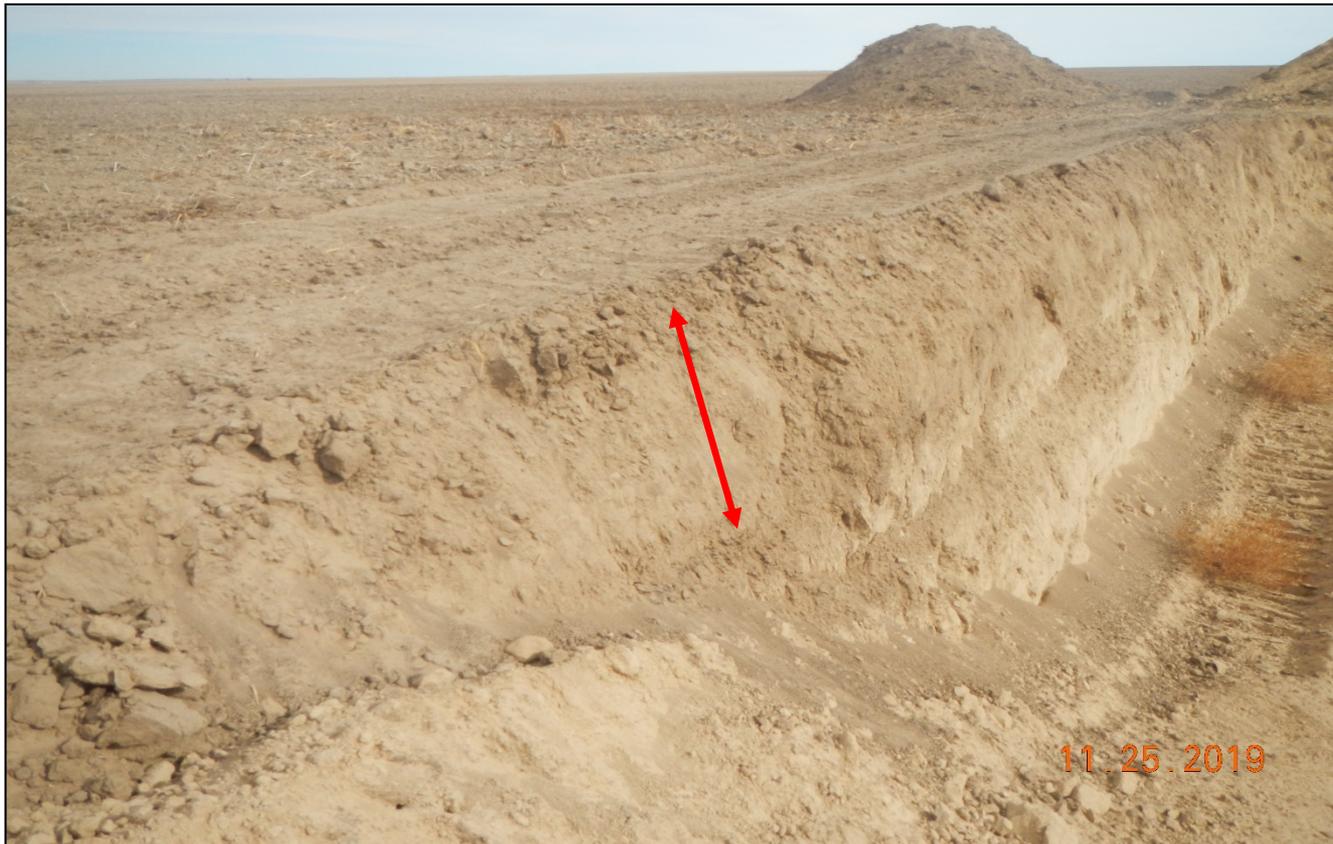
Photo 7. Excavated pit shows topsoil horizon.
