Inspection Photos

API: 05-017-07255

Operator: KUENZLER & FLORA RESERVE COMPANY

Inspection Date: 11/25/2019

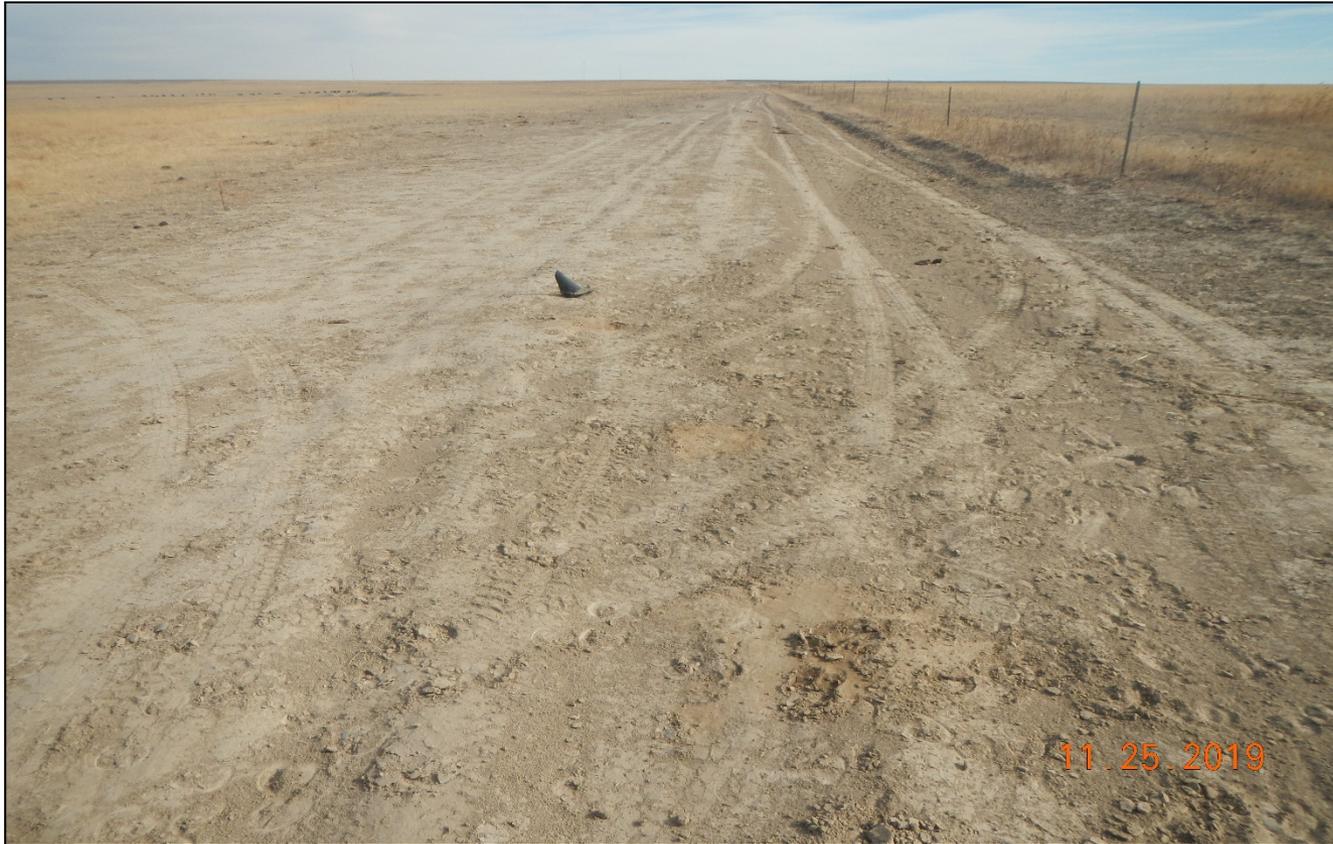
Photo 1. Facing east along the access road to the location. The road has been widened and disturbed during drilling operations. Disturbance outside of the road must be reclaimed.

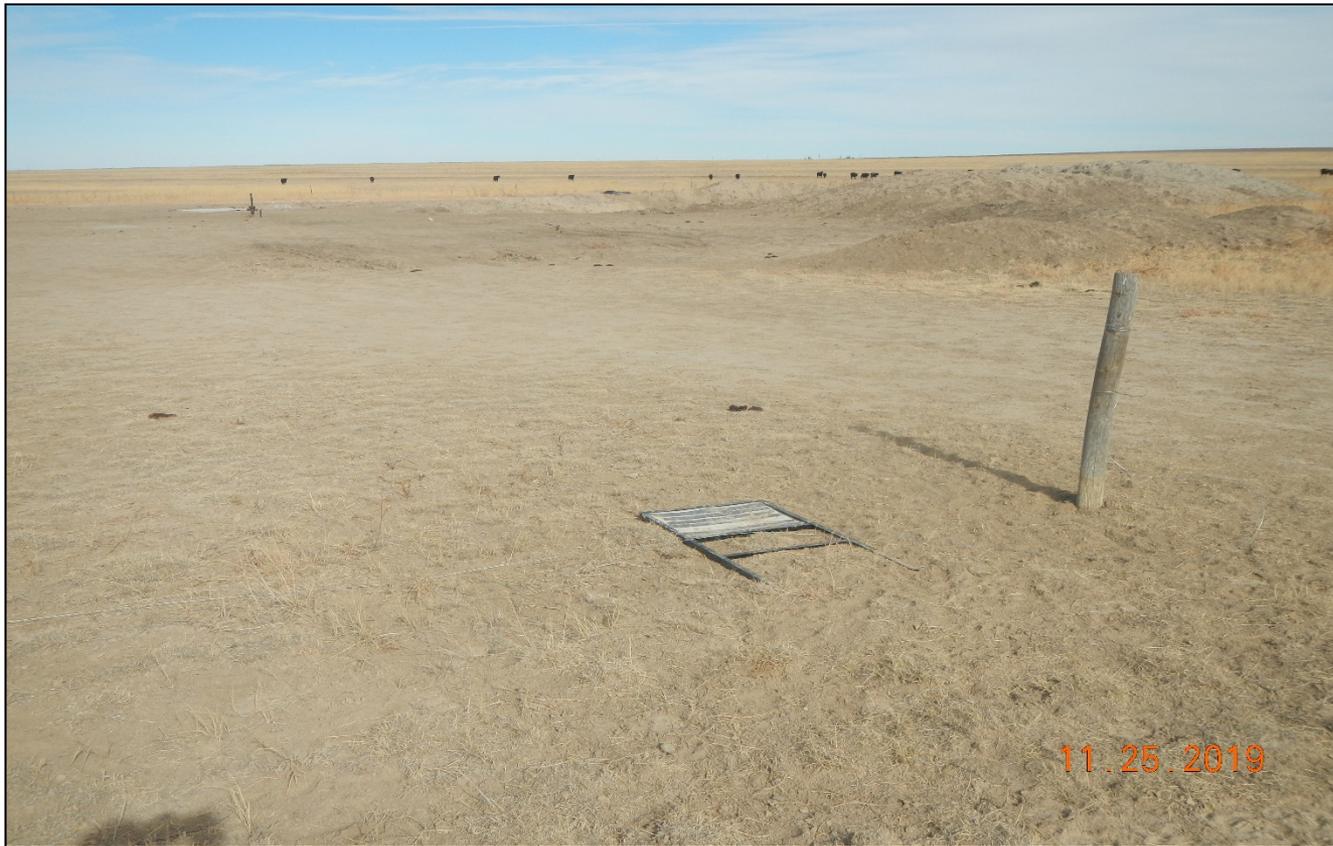
Photo 2. Facing northeast toward the location. The location sign has fallen over and is not properly installed.

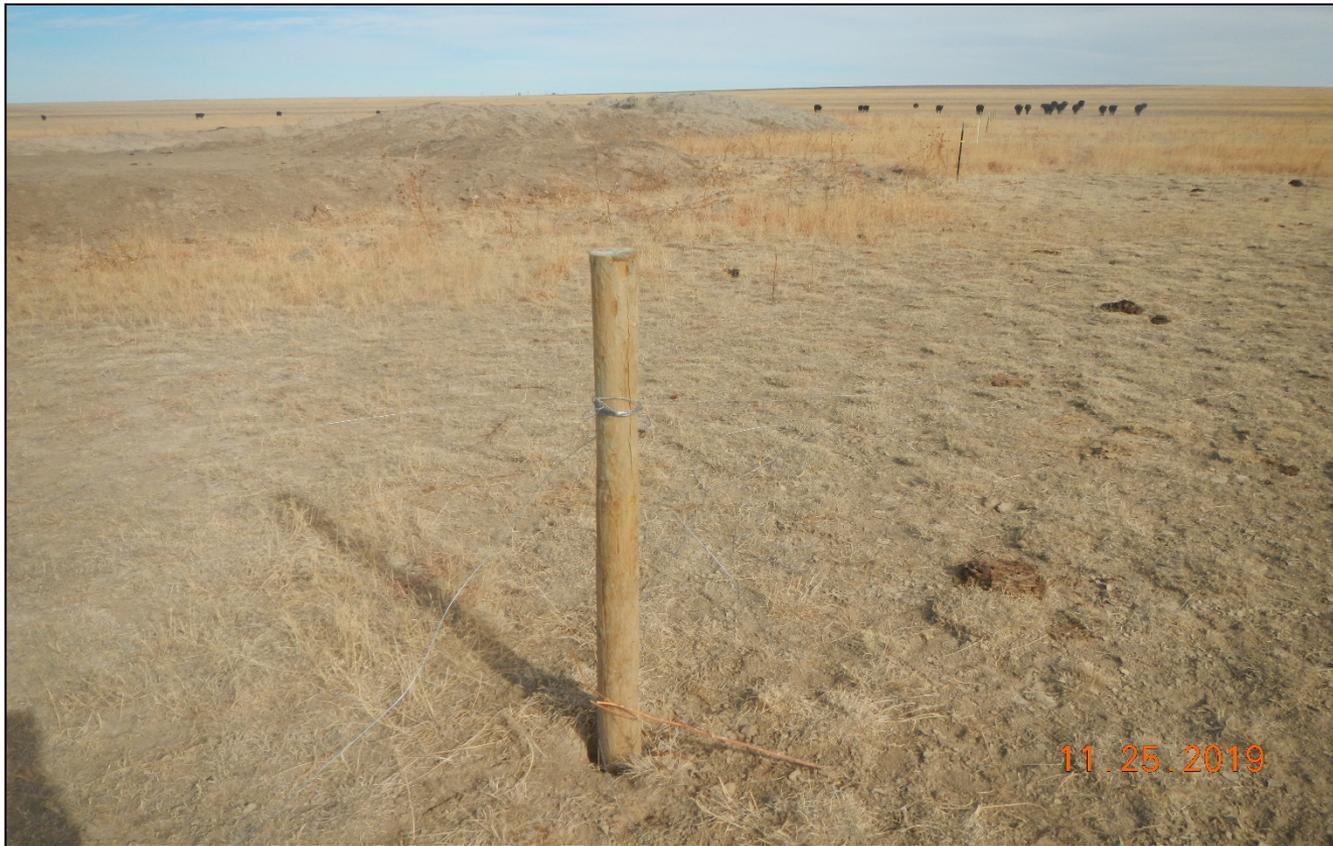
Photo 3. The electric fence around the location is in disrepair and wire is strung along the ground.

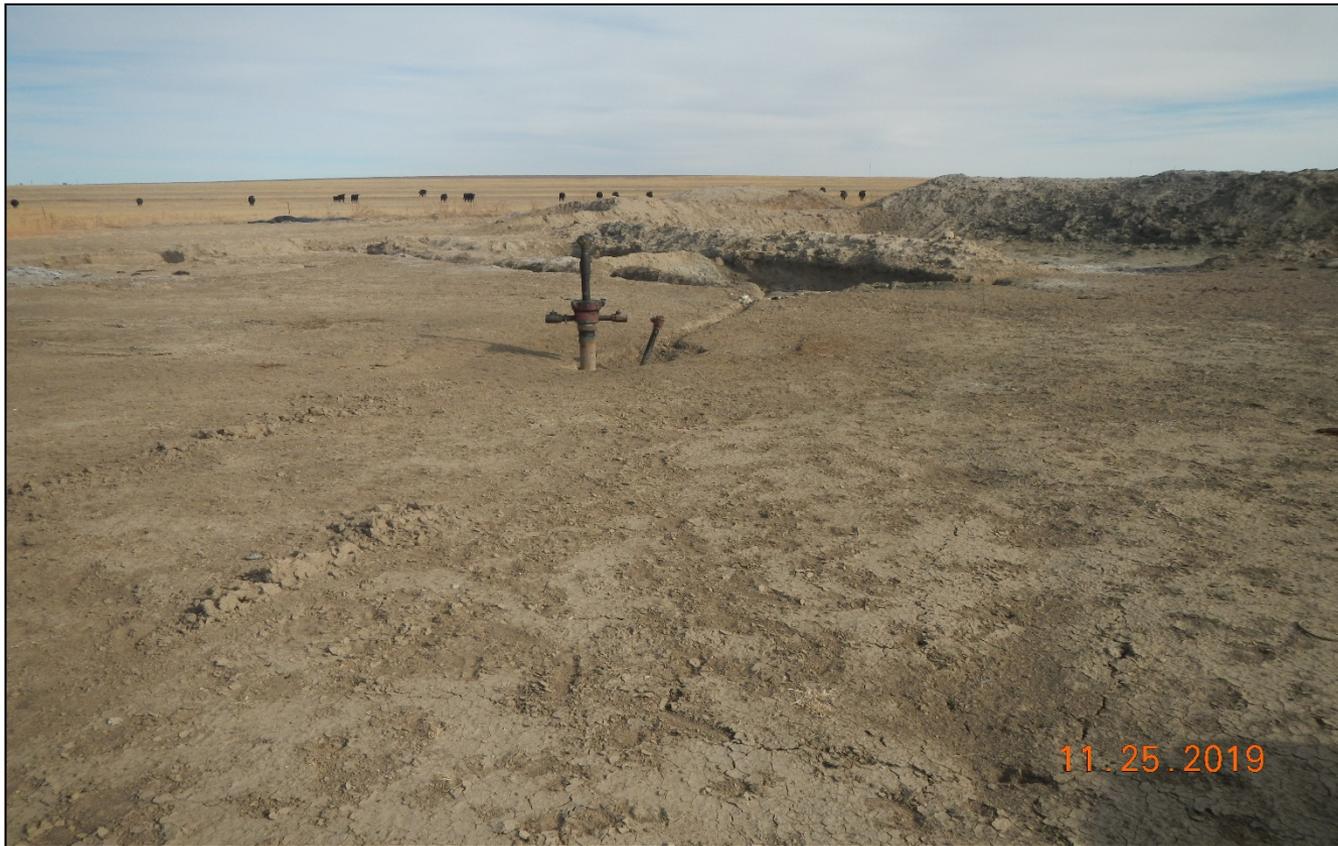
Photo 4. Facing toward the wellhead.

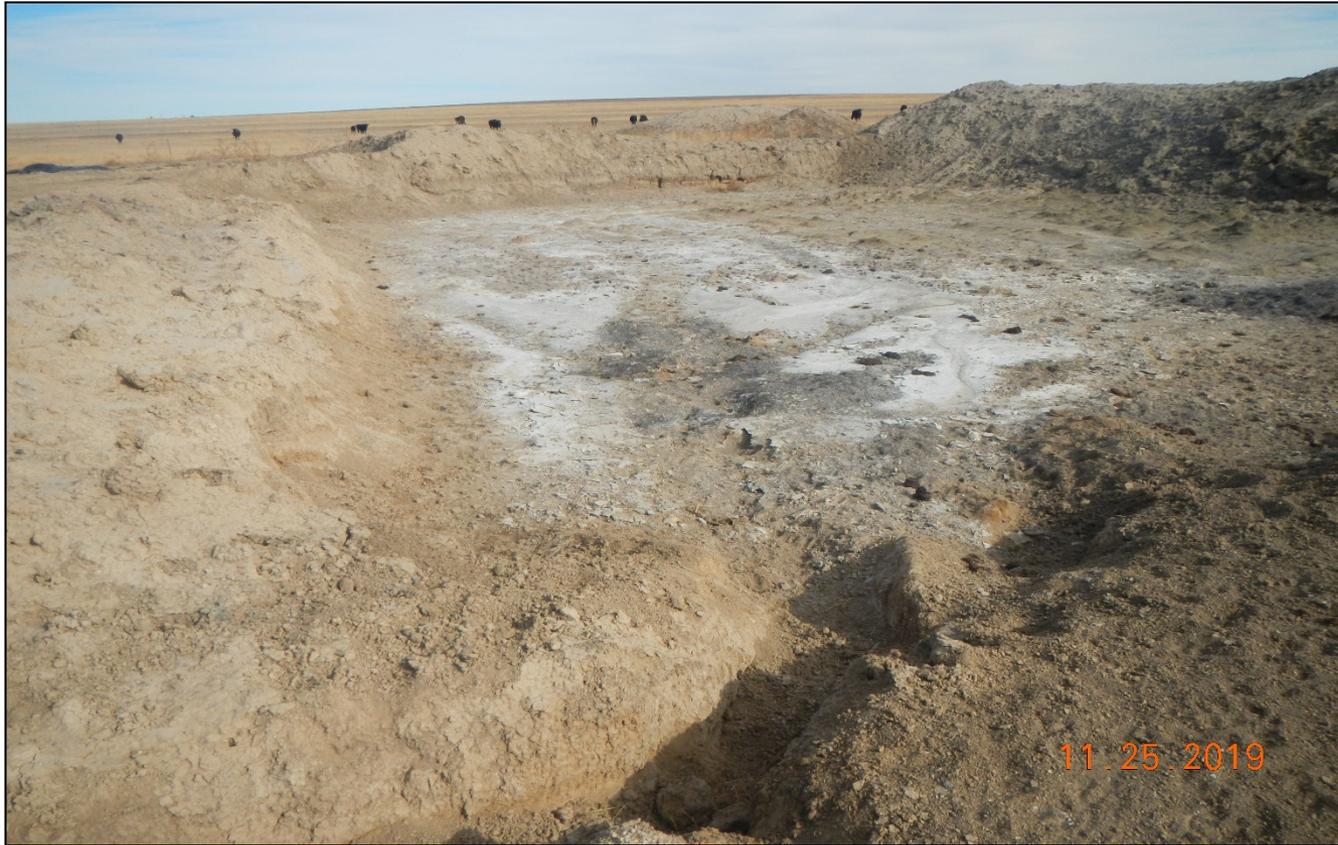
Photo 5. Drilling pit remains open and drilling materials present.

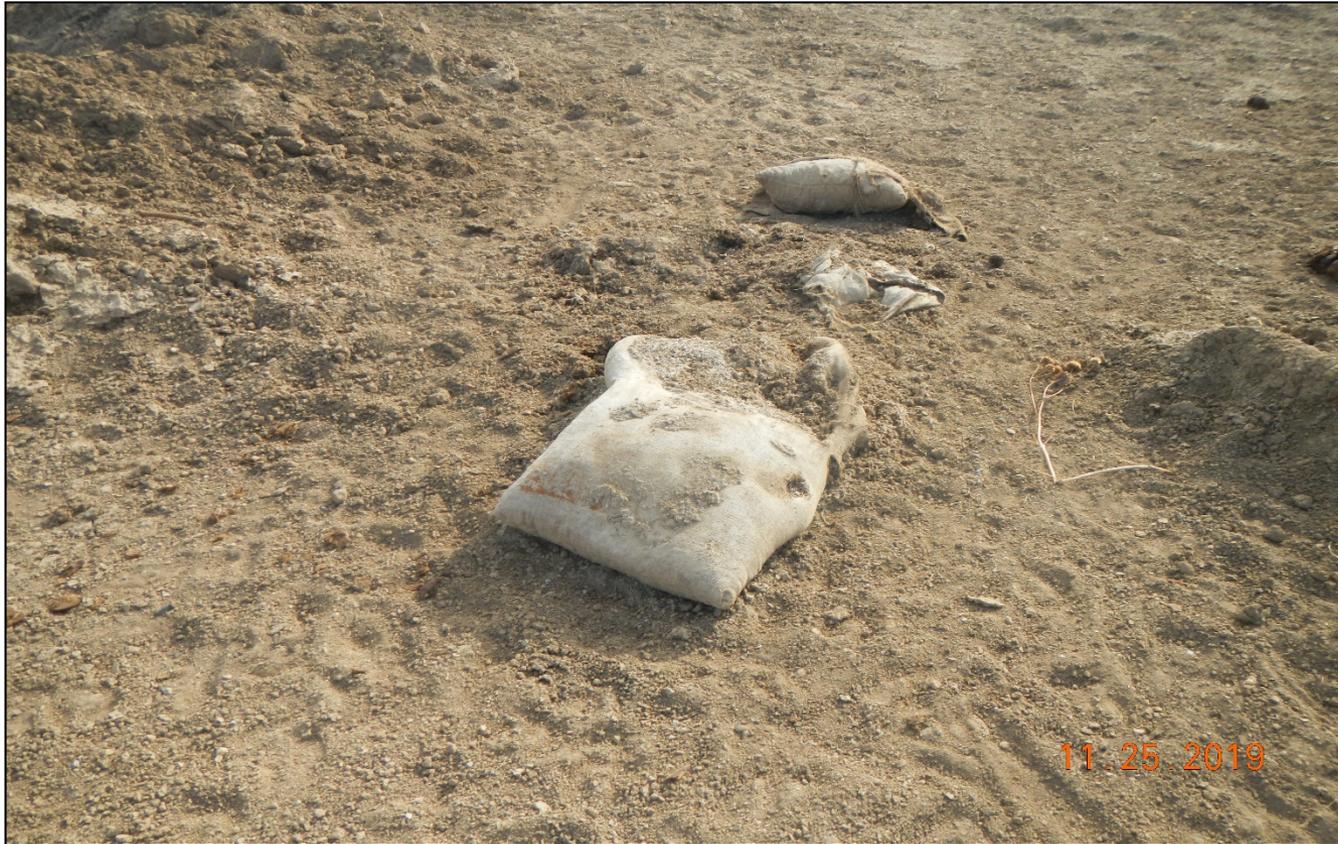
Photo 6. The is a torn bag of unknown contents which is spilled on the ground.

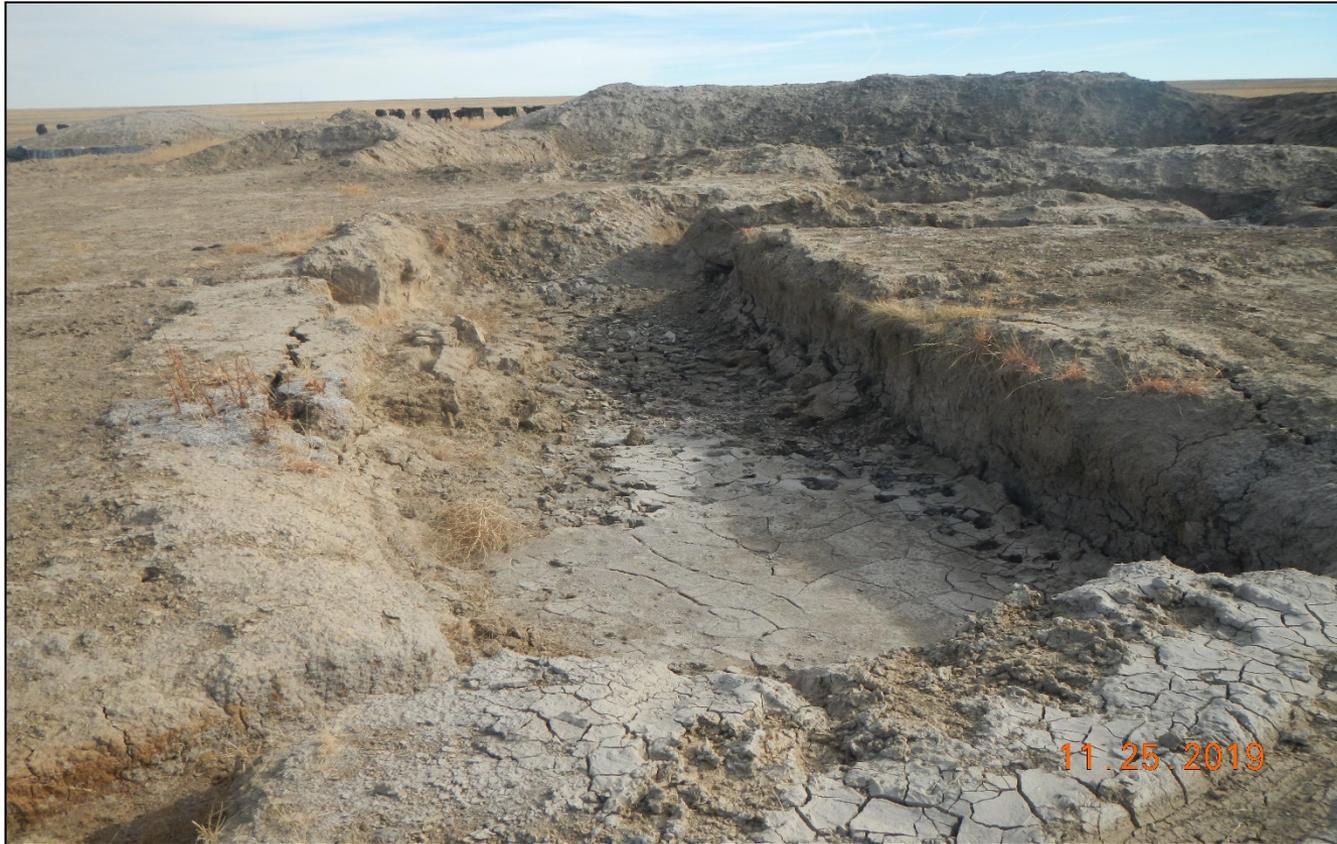
Photo 7. Excavated pit remain open at the location. There are signs that cattle have been entering the pits.

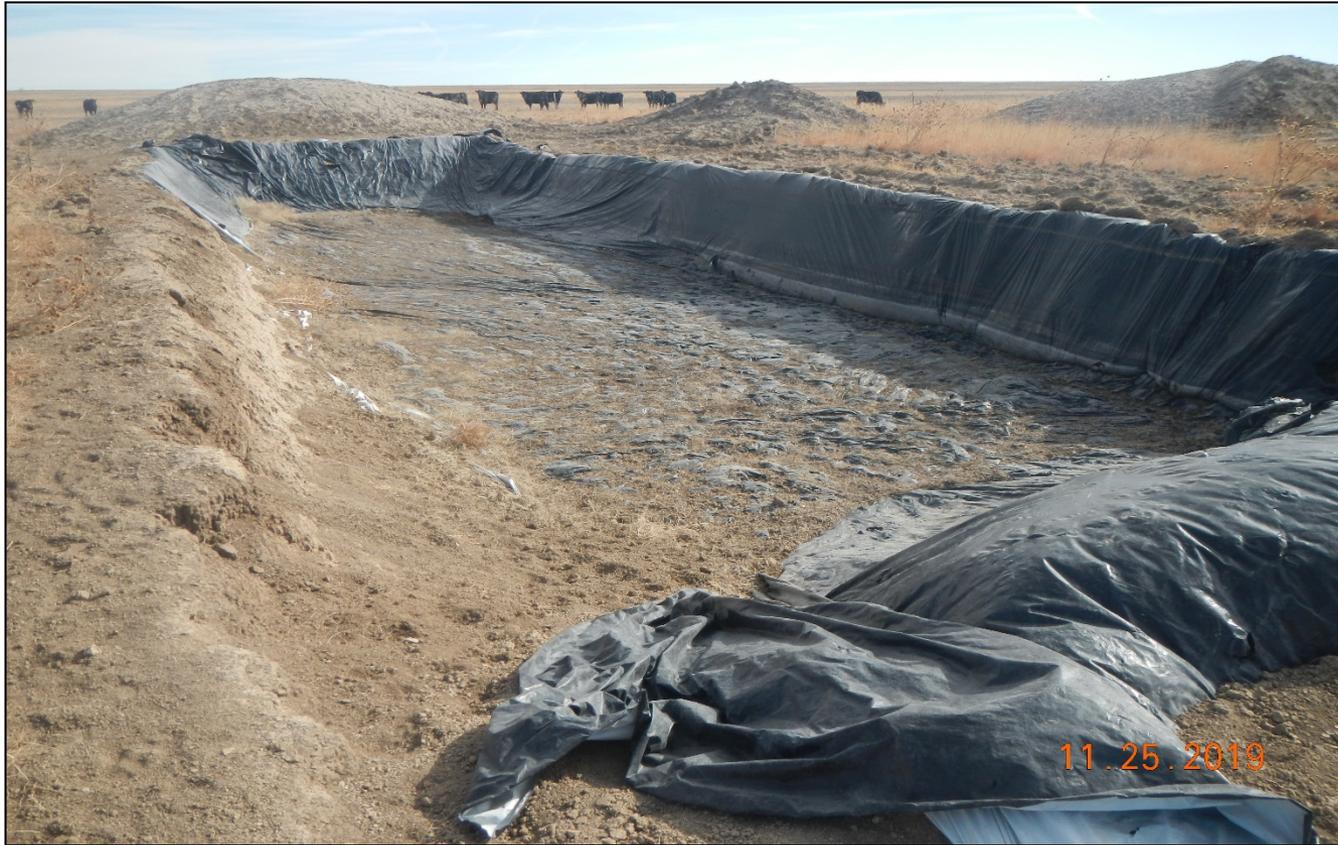
Photo 8. The lined pit remains open. The liner is torn and in disrepair.

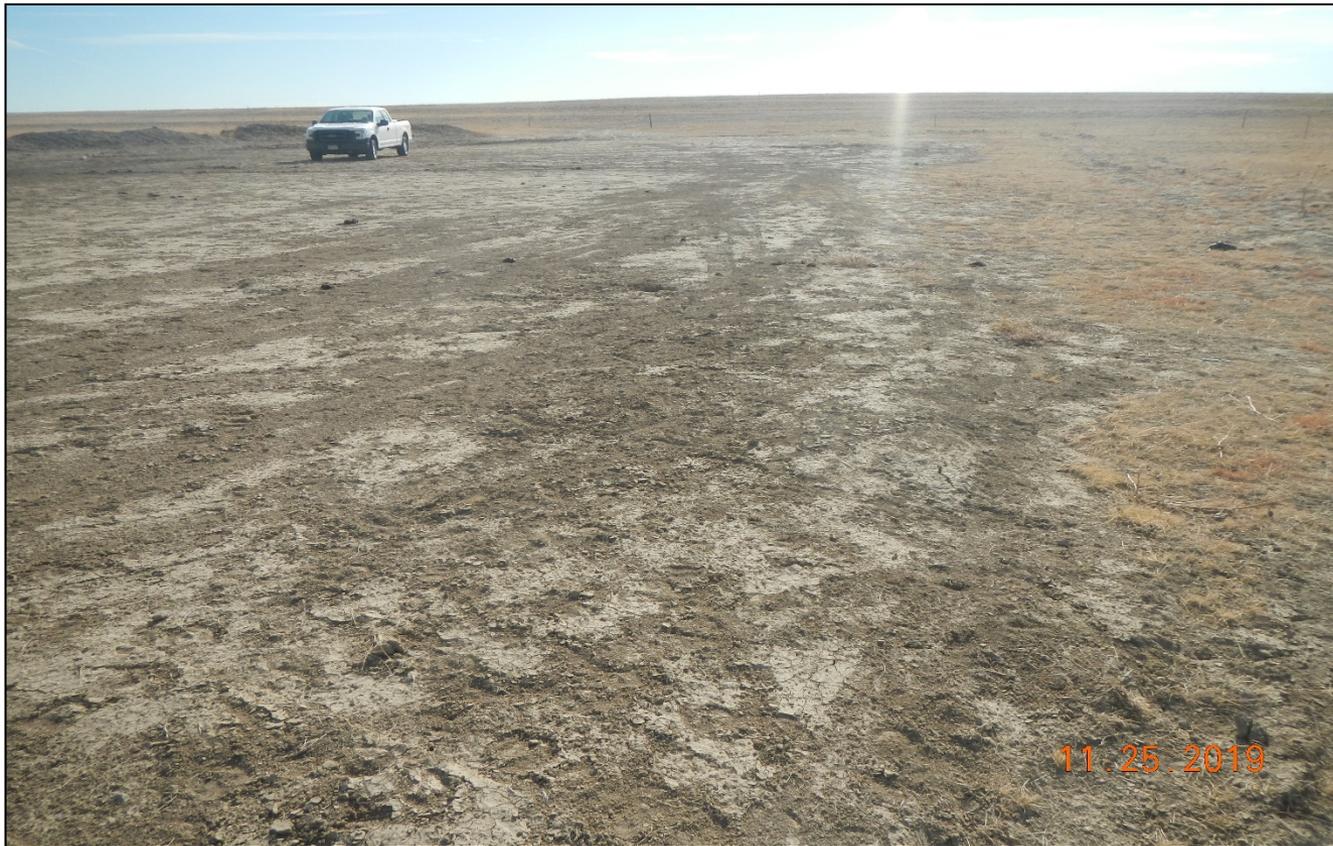
Photo 9. Facing south at the location. Top soil was not properly salvaged from the location.

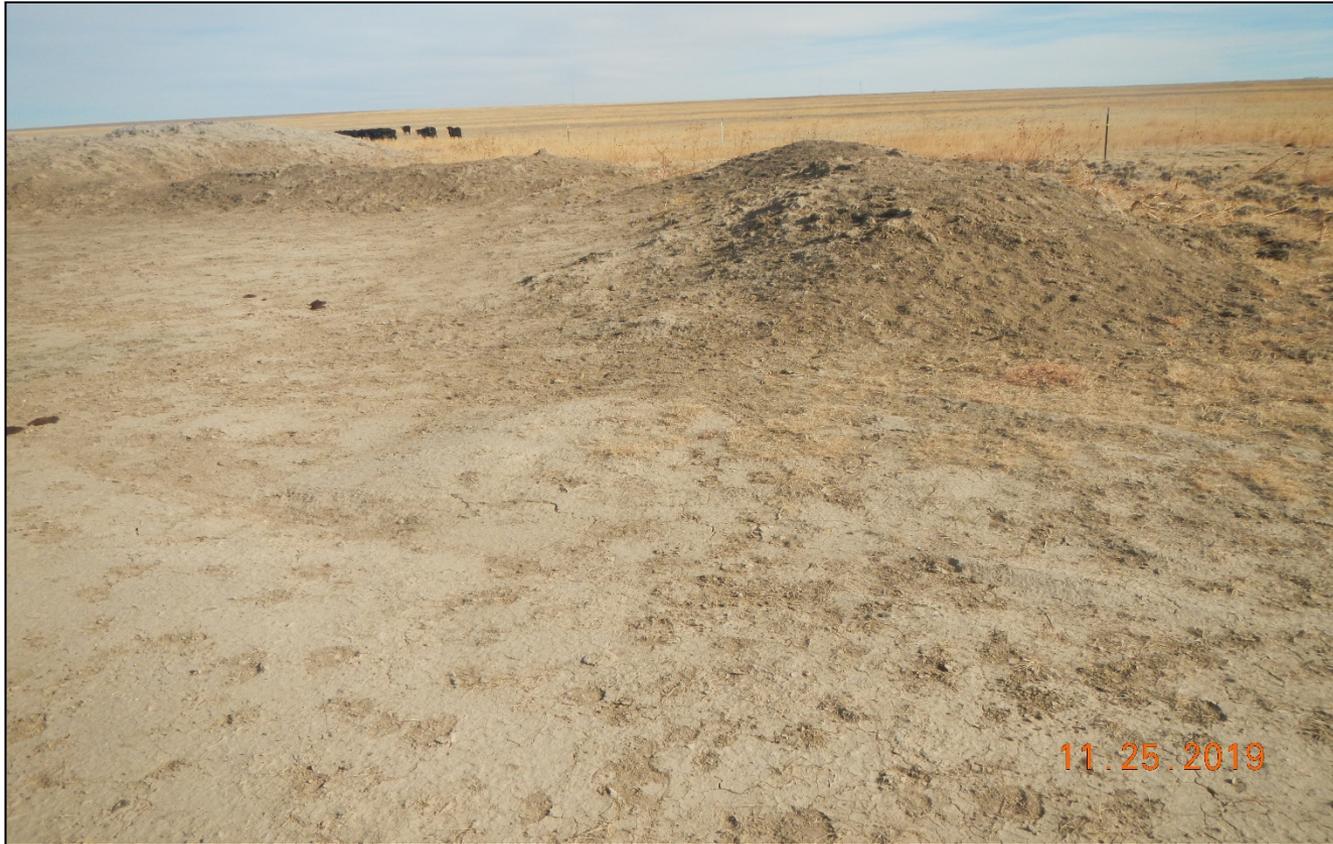
Photo 10. There are minimal topsoil salvage piles at the southeast side of the location which are not protected.
