Inspection Photos

API: 05-017-07809

Operator: MCCOY PETROLEUM CORPORATION

Inspection Date: 11/25/2019

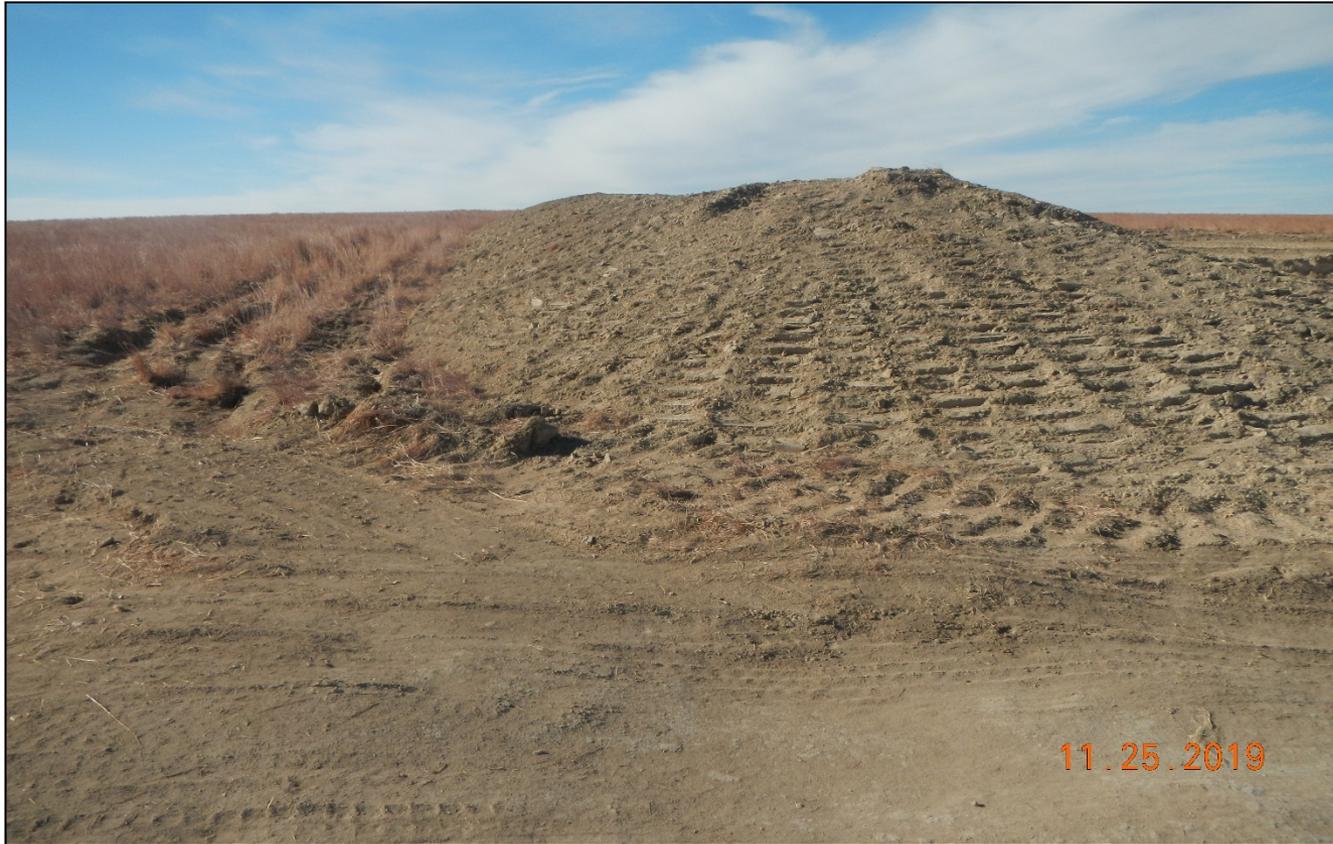
Photo 2. Topsoil is salvaged and stored at the south side of the location. Topsoil is tracked for temporary stabilization. Topsoil will need to be seeded and stabilized if reclamation is not performed soon.

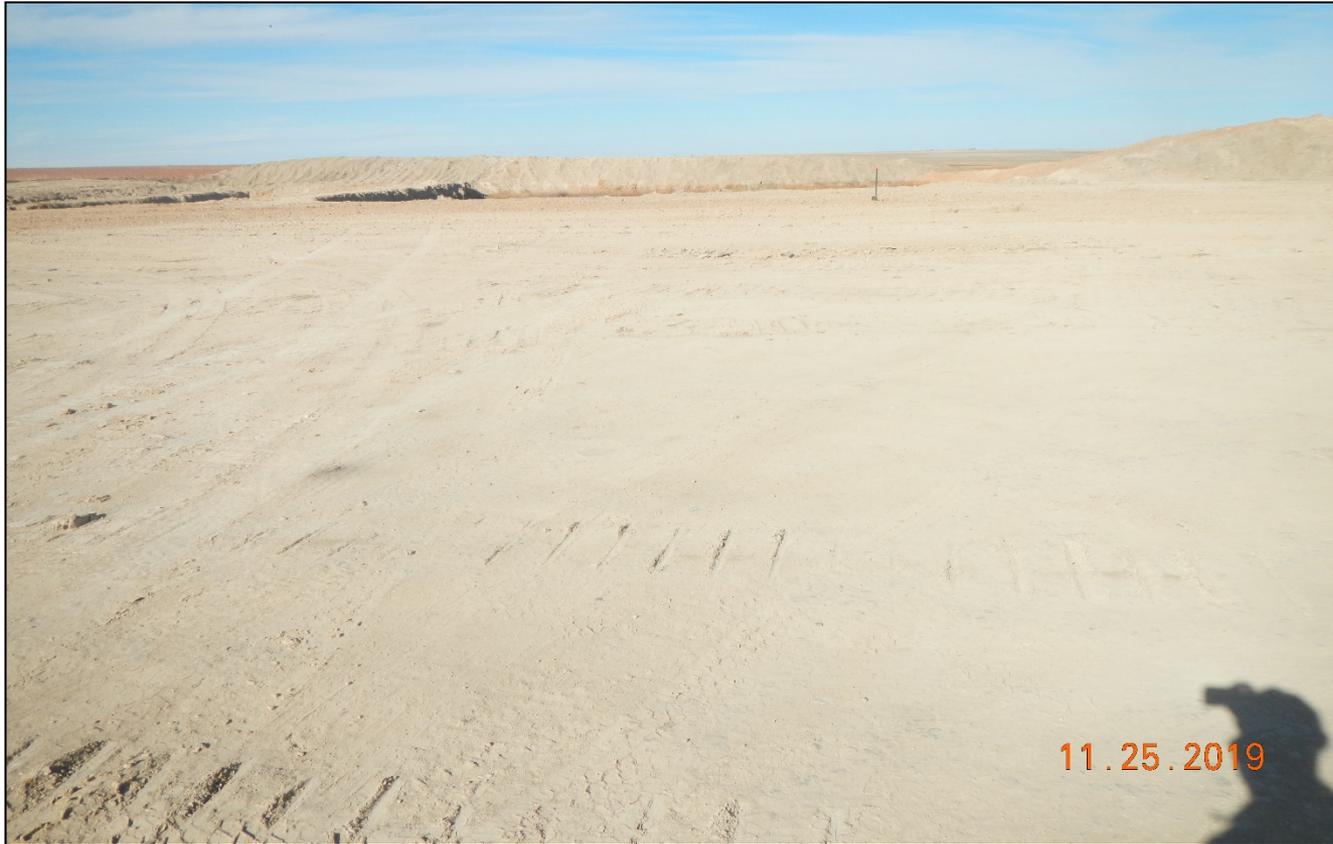
Photo 3. Facing north toward the location.

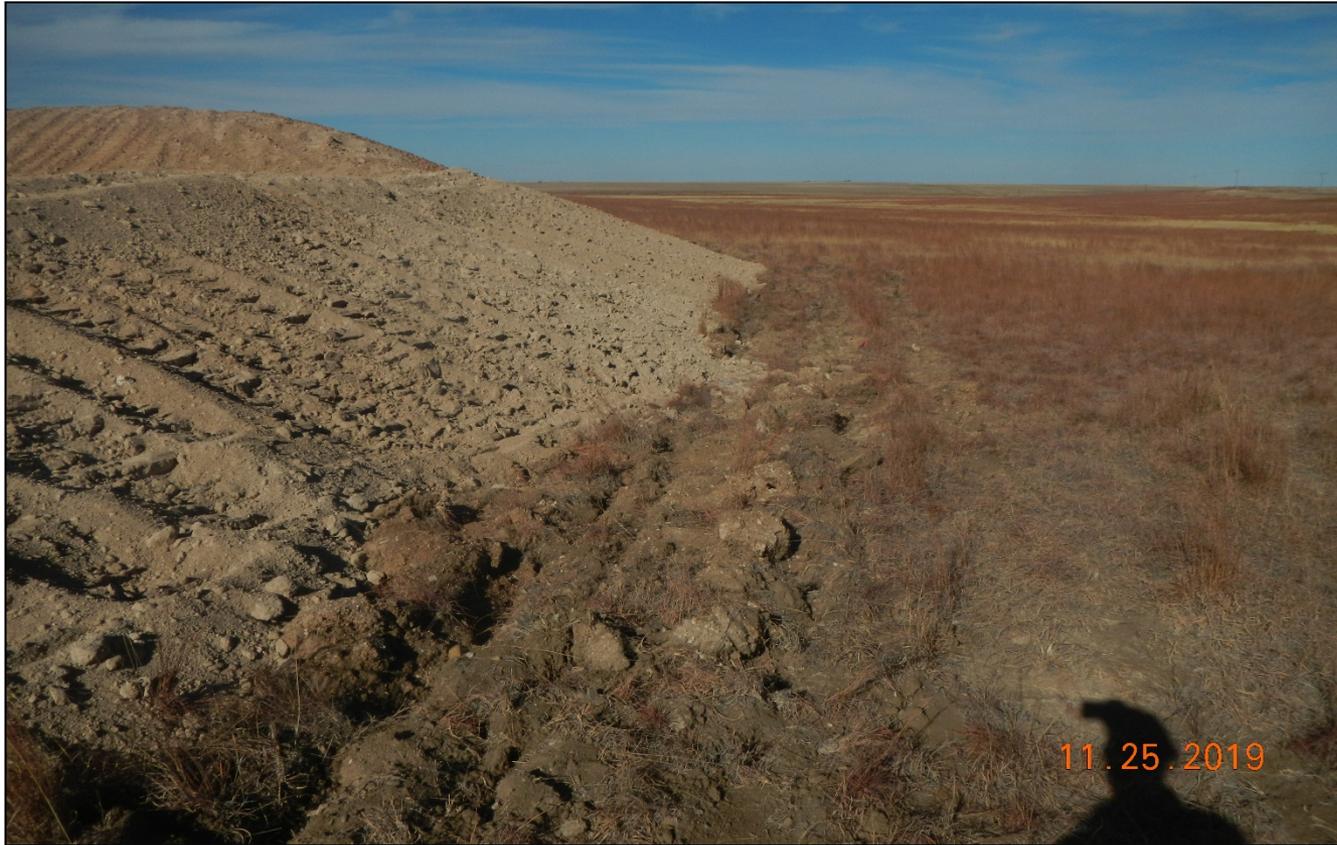
Photo 4. Facing north along the east side of the location. The side of the pad was tracked in however, soils are loose and susceptible to erosion. Surface roughening was performed around the perimeter but is inadequate to control erosion.

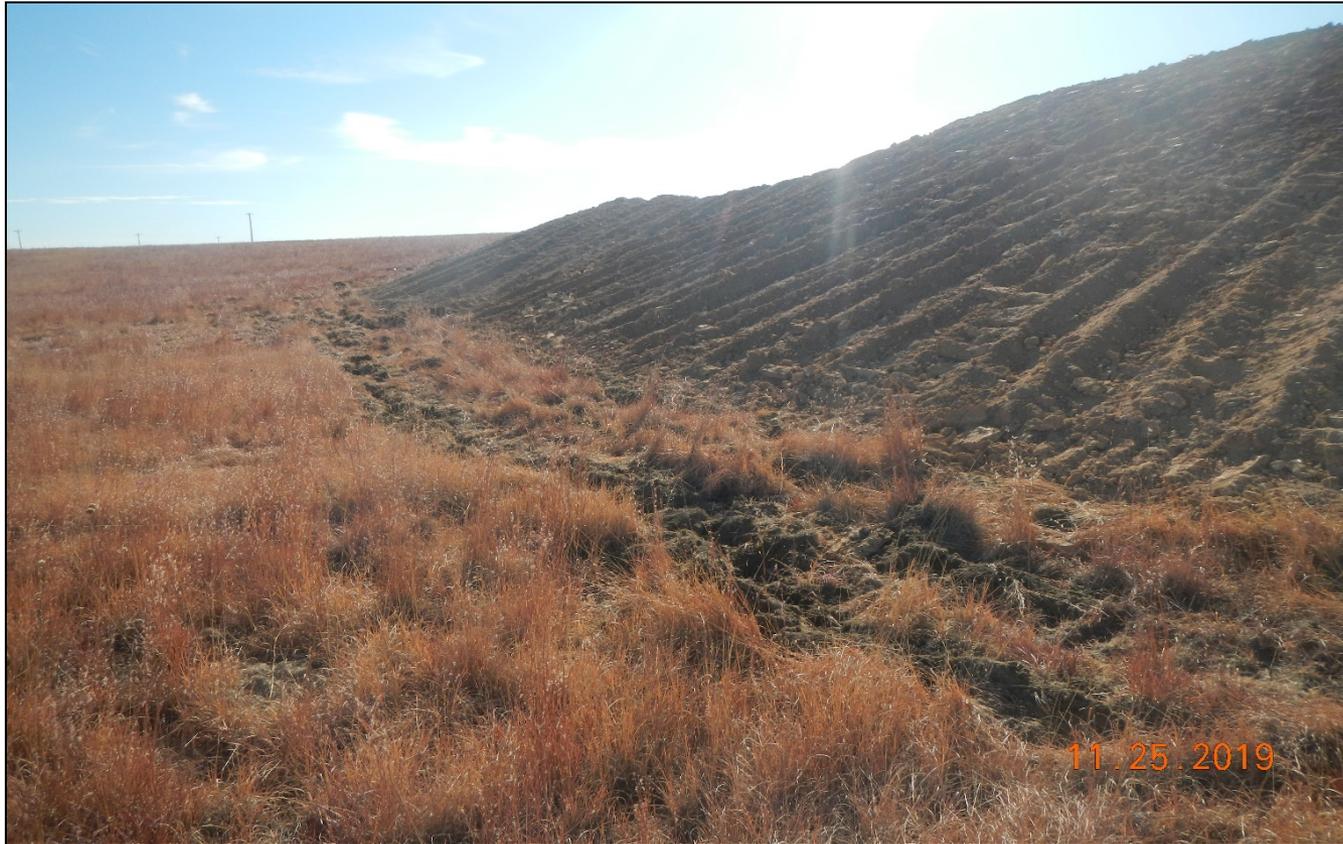
Photo 5. Facing south at the east side of the location. The side of the pad was tracked in however, soils are loose and susceptible to erosion. Surface roughening was performed around the perimeter but is inadequate to control erosion.

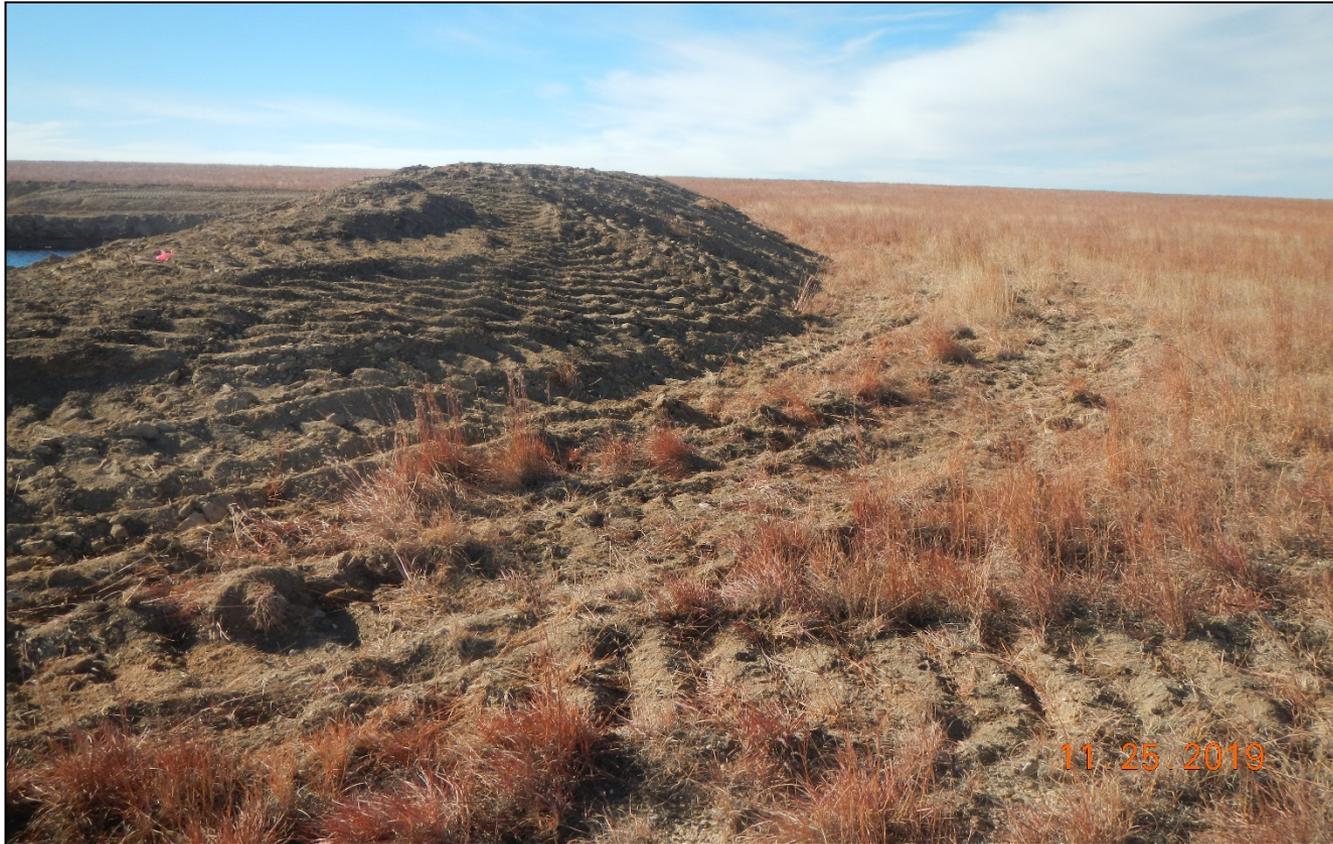
Photo 6. Facing west at the north side of the location. Topsoil appears to be salvaged and stored at this area.

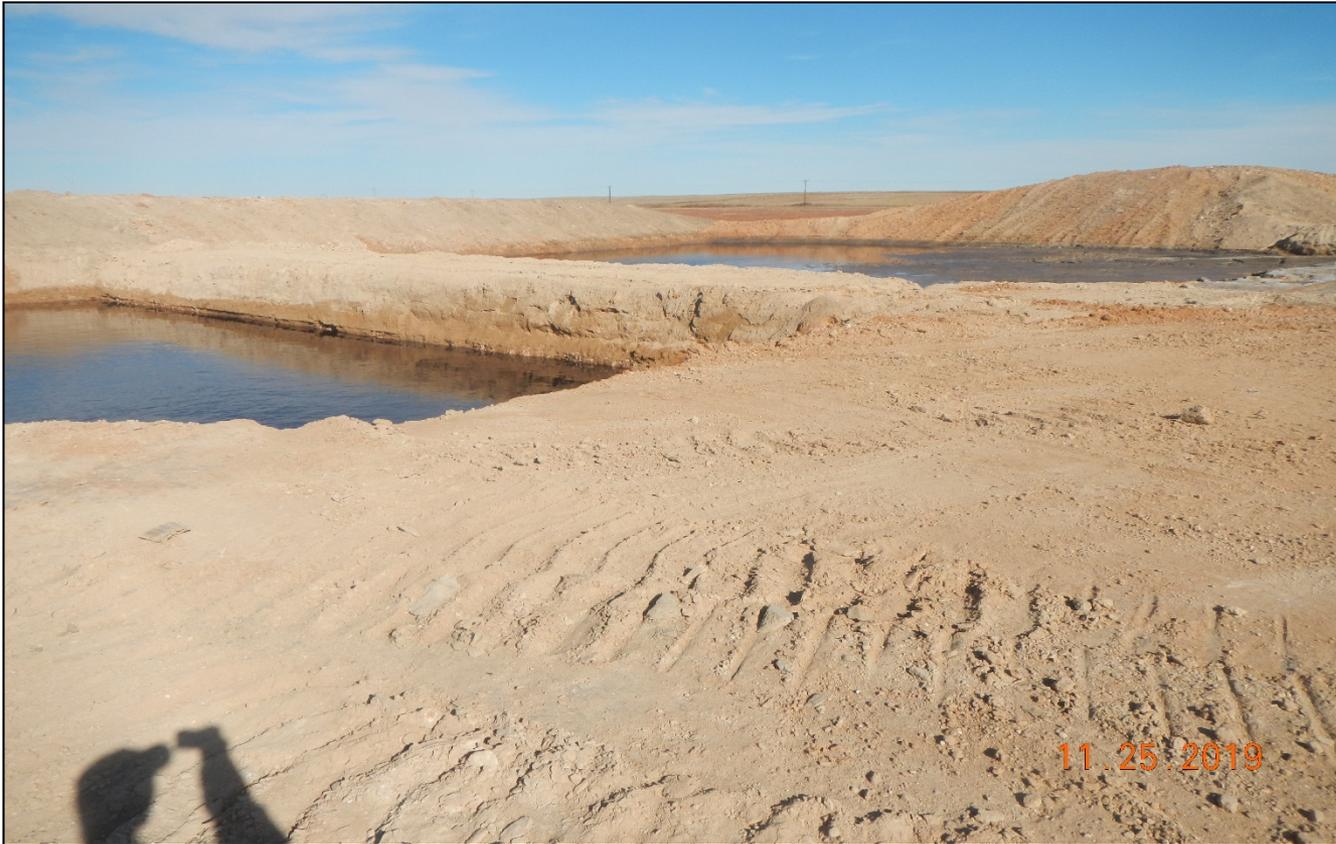
Photo 7. Facing northeast toward the drilling pits. Drilling material and fluid are present in the pits.
