Inspection Photos

API: 05-025-06020

Operator: CRAZY 8 ENERGY LLC

Inspection Date: 11/25/2019

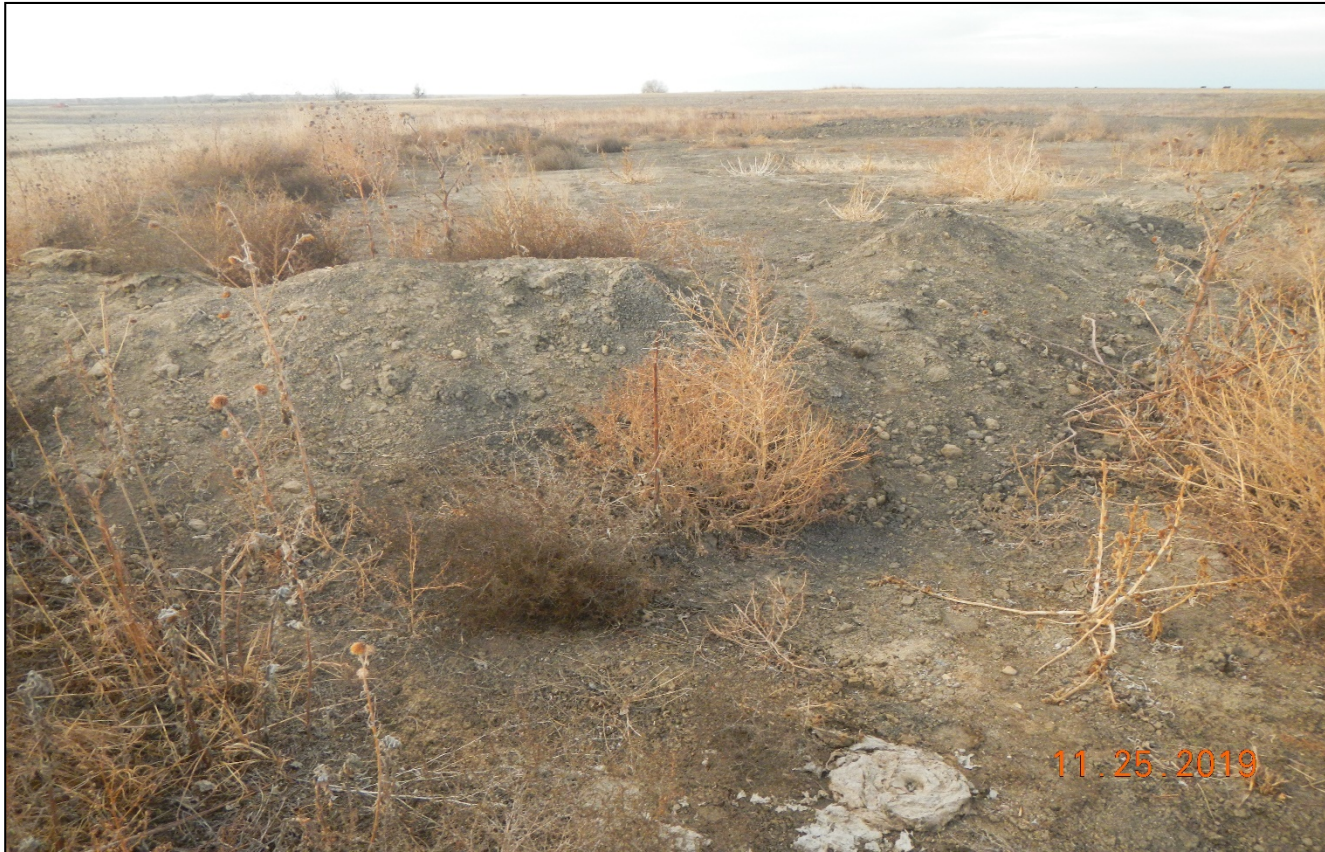
Photo 1. Facing northwest toward the location. The location has not been recontoured. Soil piles and ditches remain.

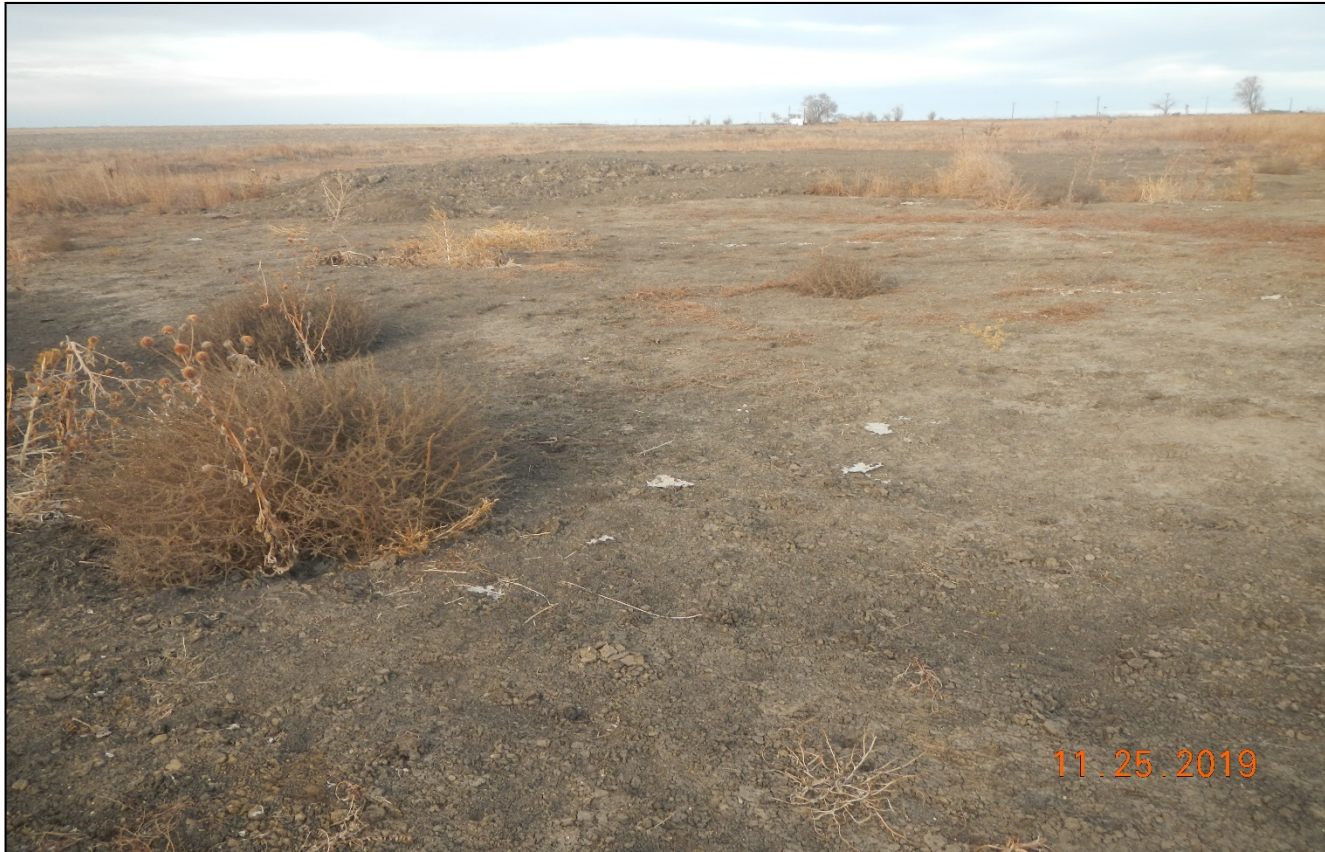
Photo 2. Facing north toward the location. The location has not been reclaimed. There are weeds and bare soil throughout the site.

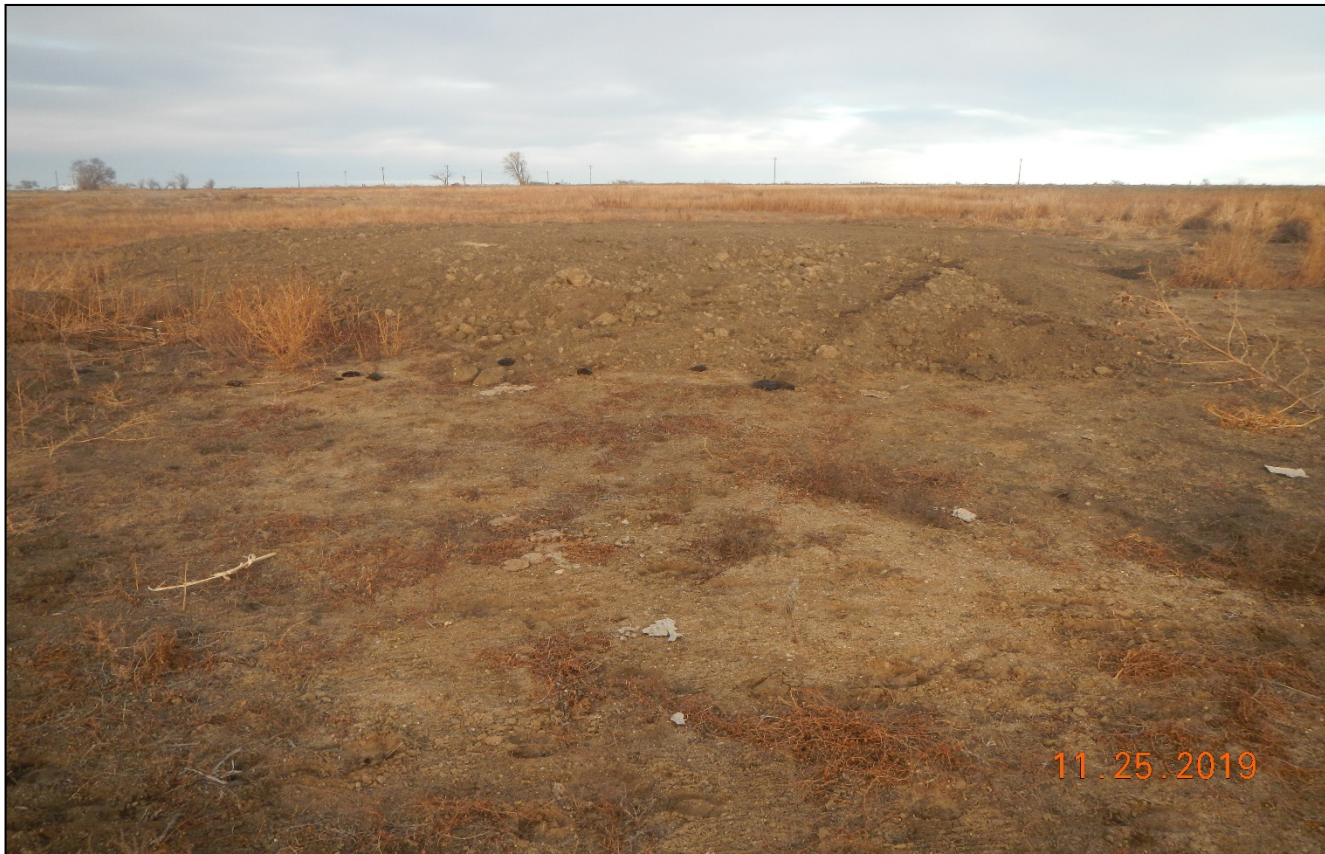
Photo 3. The pit area has been closed and backfilled however, soils have not been leveled and reclaimed.

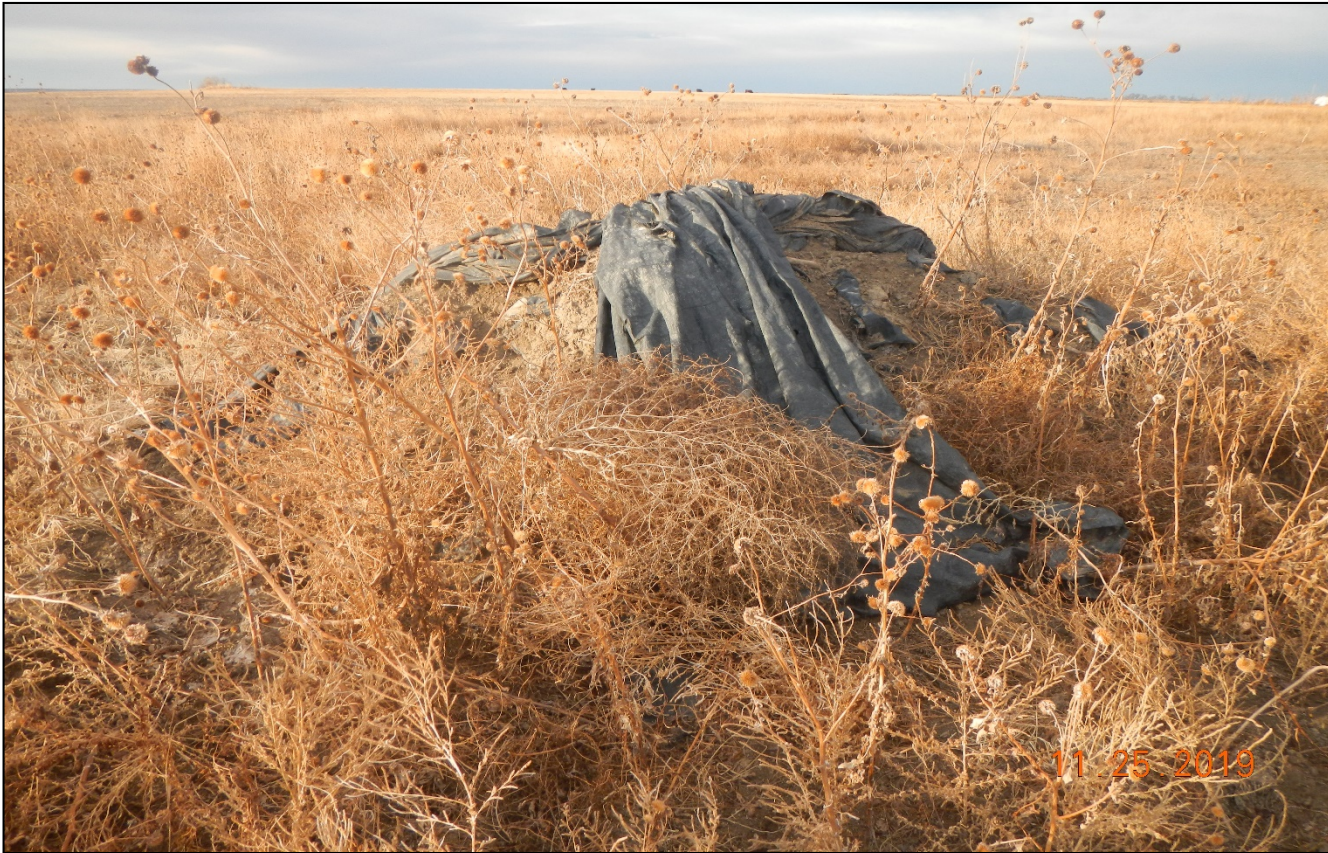
Photo 4. There is a pile of pit liner debris that remains at the east side of the location.

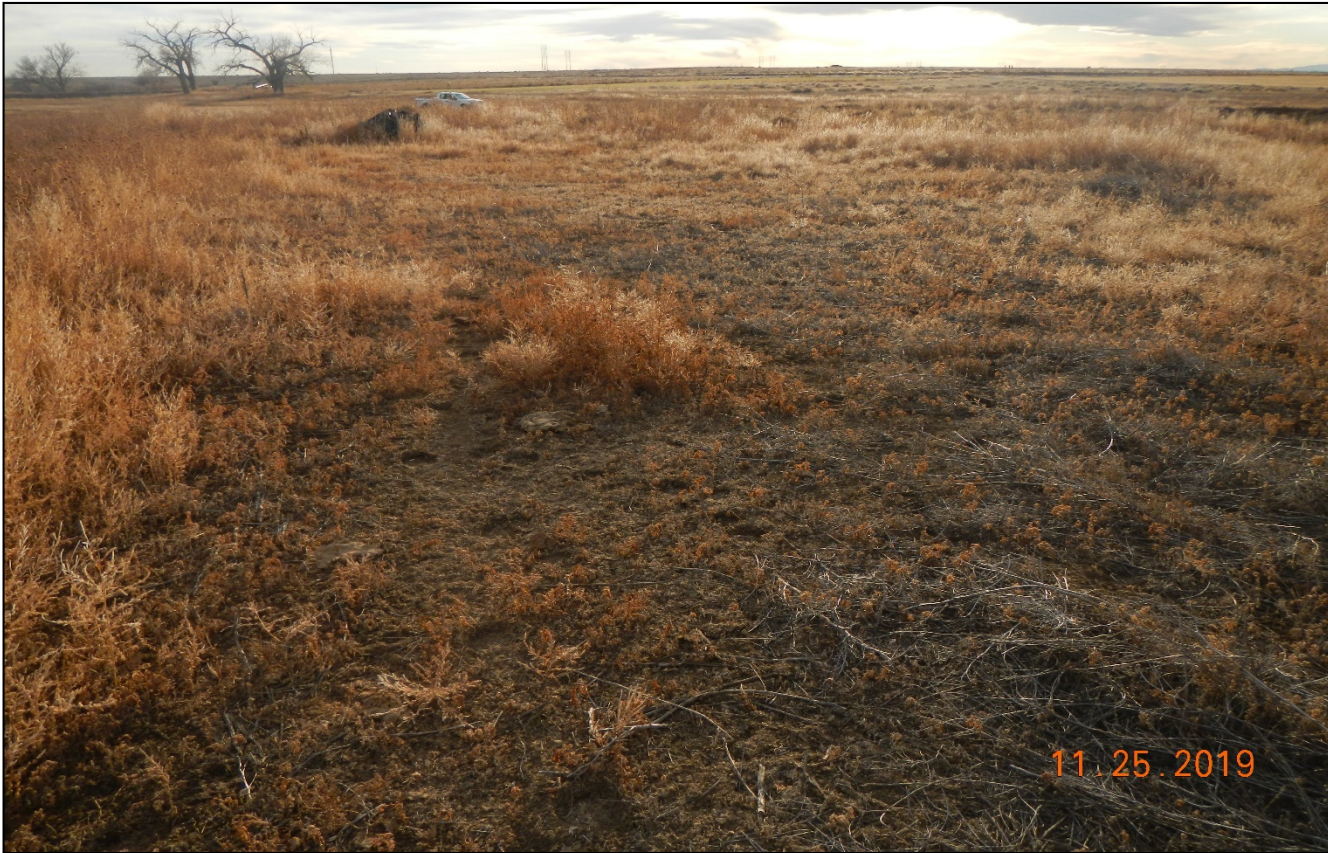
Photo 5. Facing south toward the location. There is undesirable weeds (*Kochia* sp.) throughout the location.

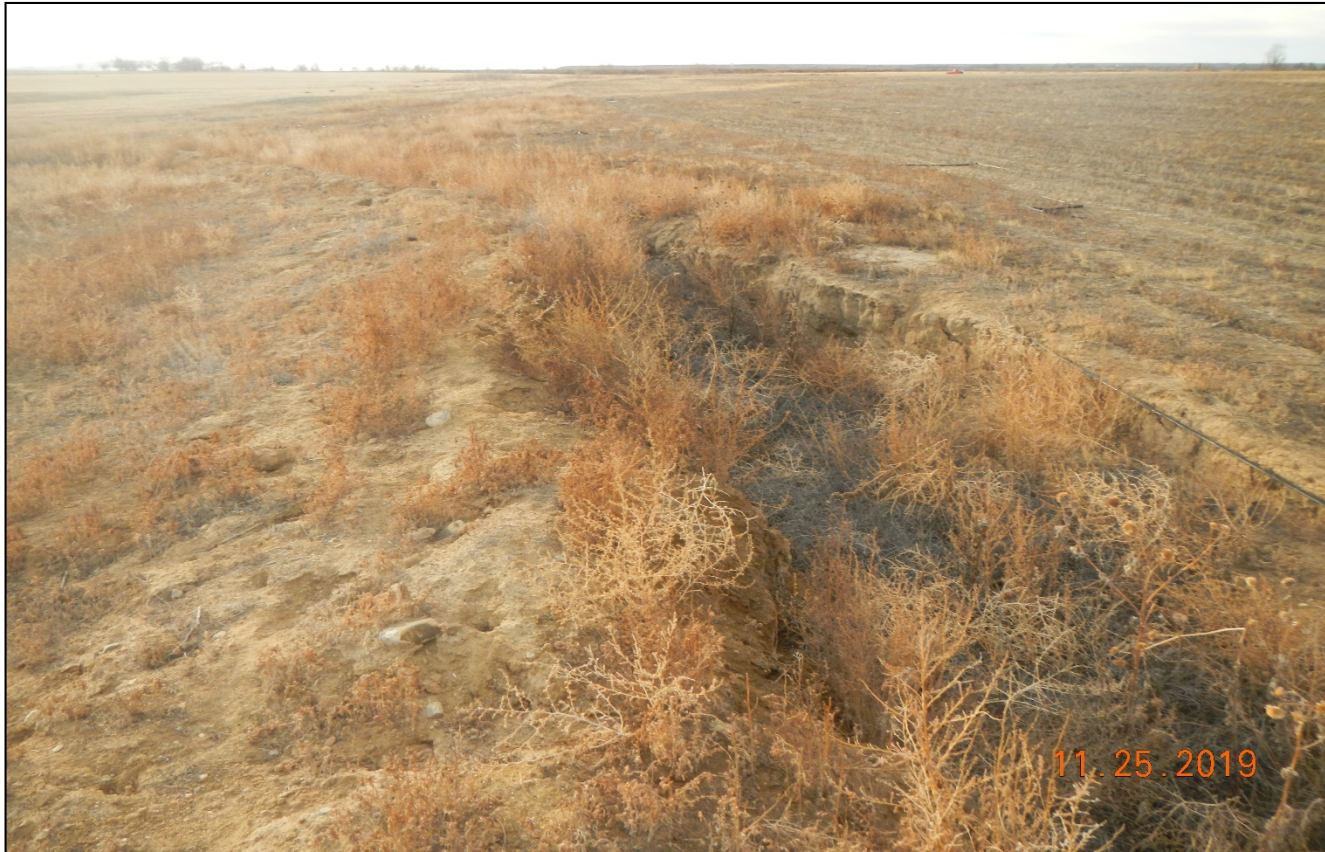
Photo 6. The diversion ditches around and through the location have not been backfilled and reclaimed. There are erosion issues along the ditches.

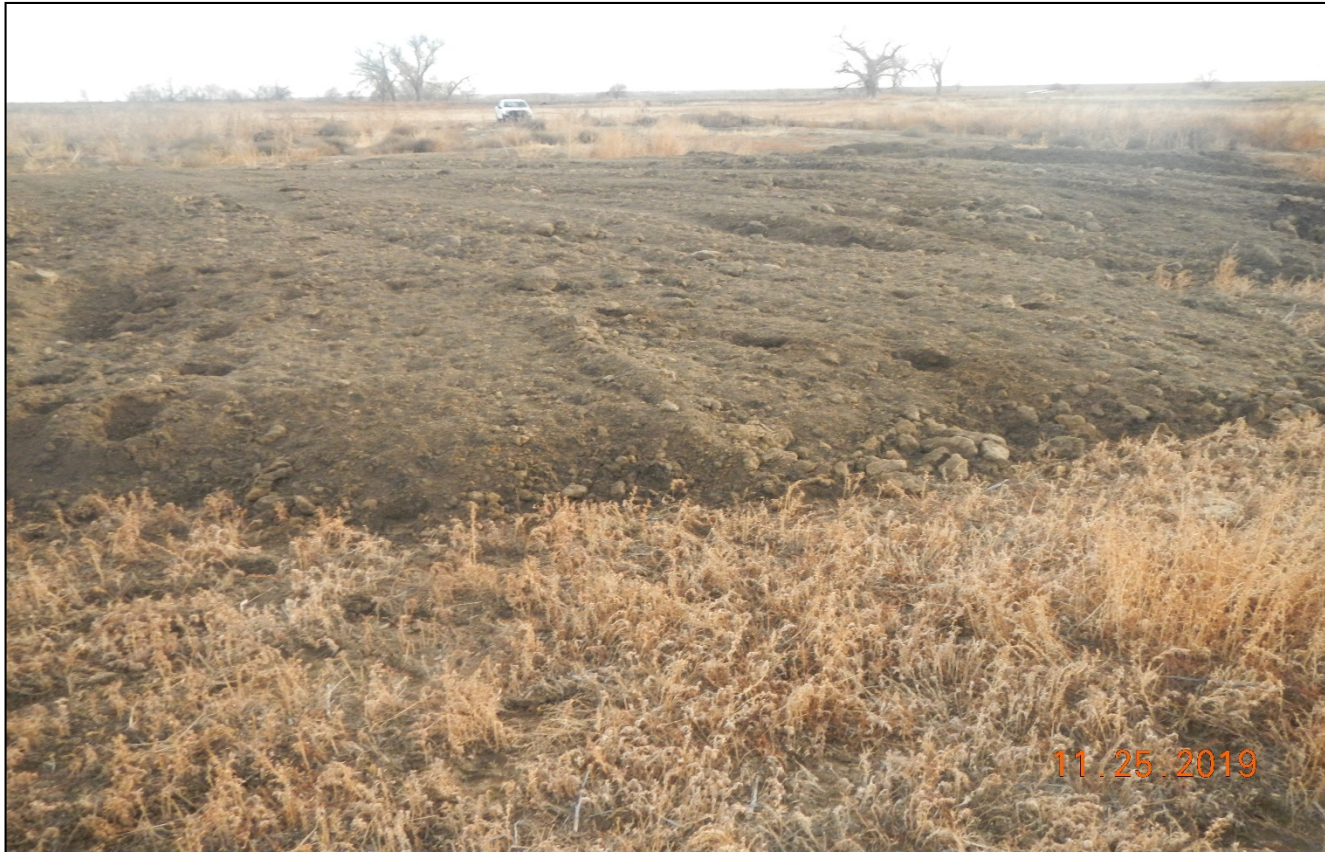
Photo 7. Facing southeast toward the pit area. The pit area has been closed and backfilled however, soils have not been leveled and reclaimed.

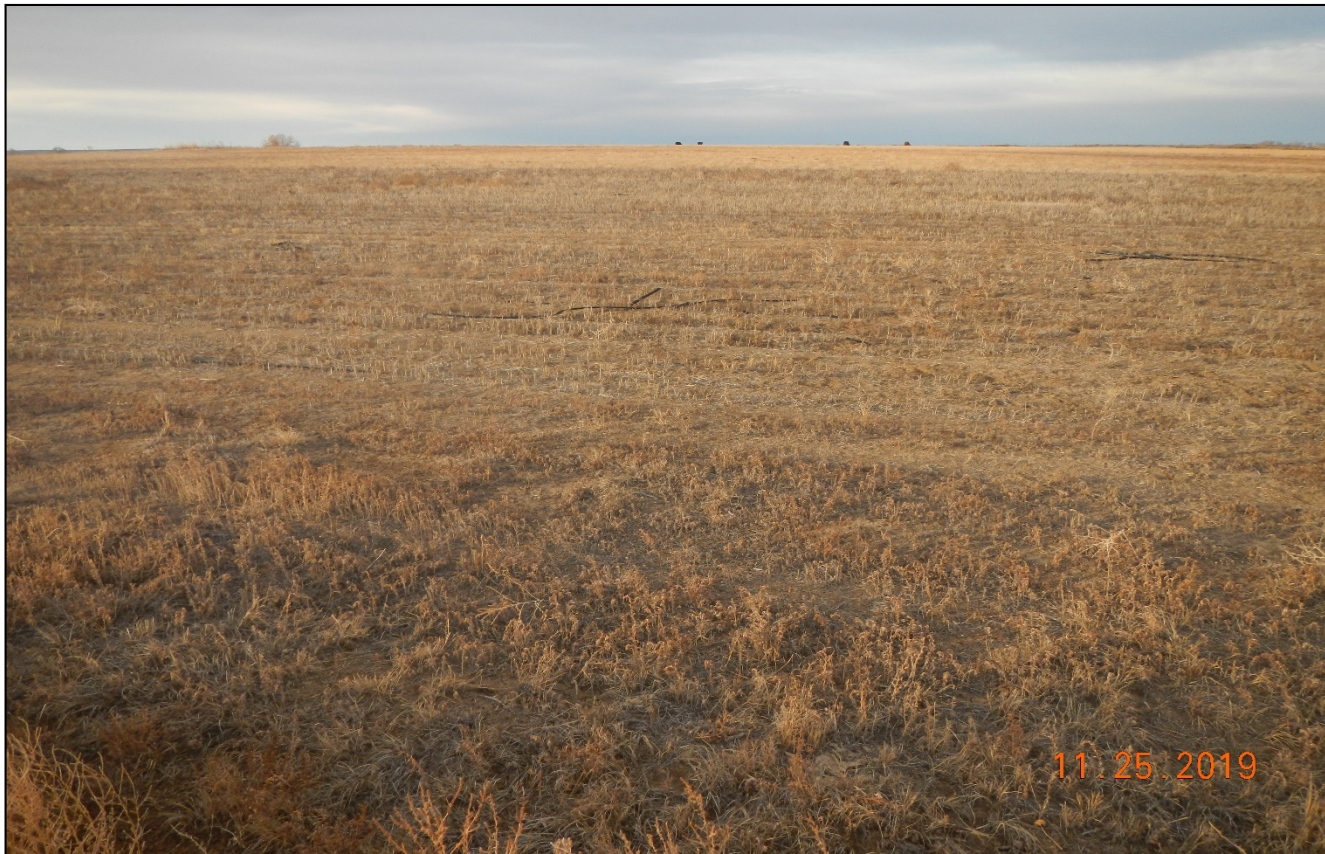
Photo 8. Facing north toward outside of the location the land use is cropland.

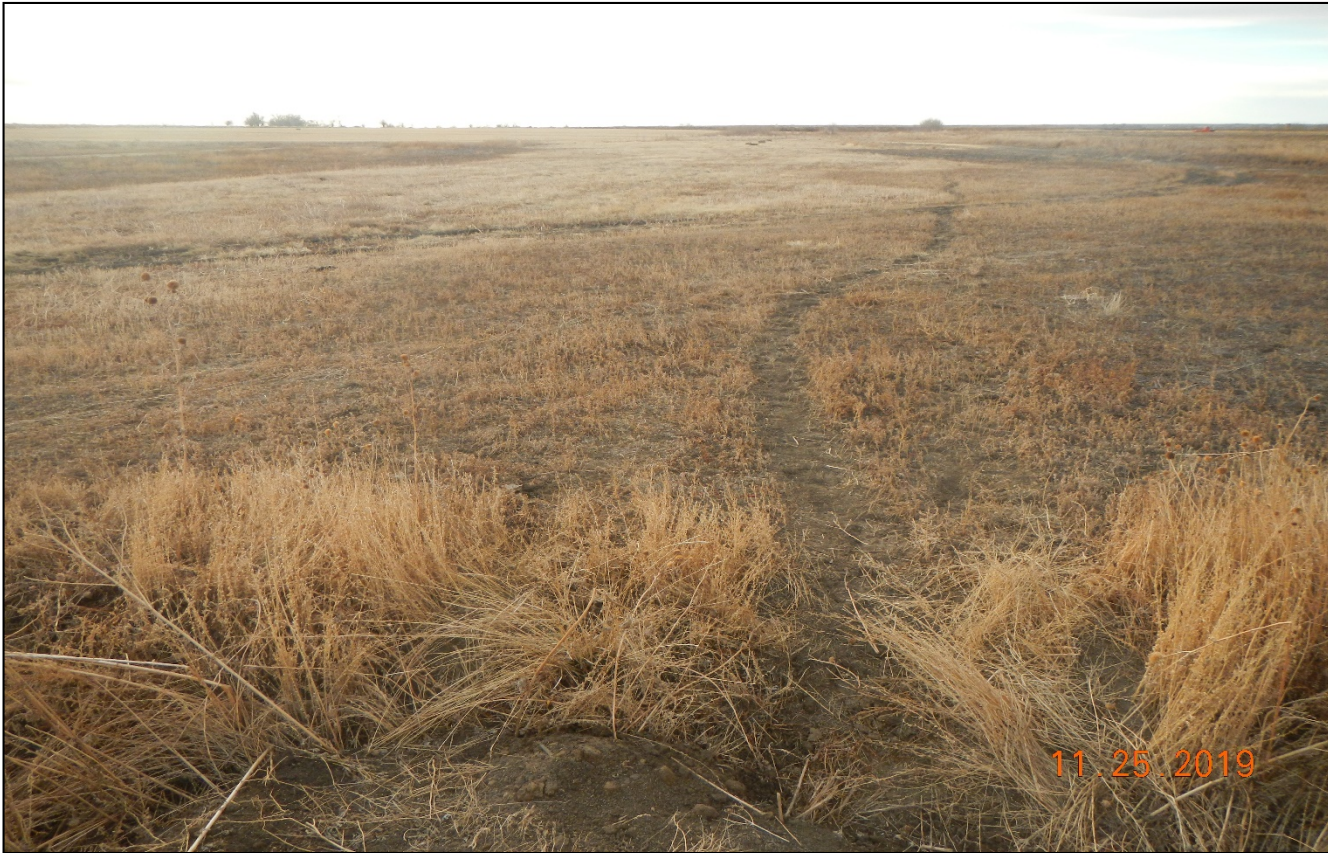
Photo 9. Facing west toward outside of the location the land use is cropland.

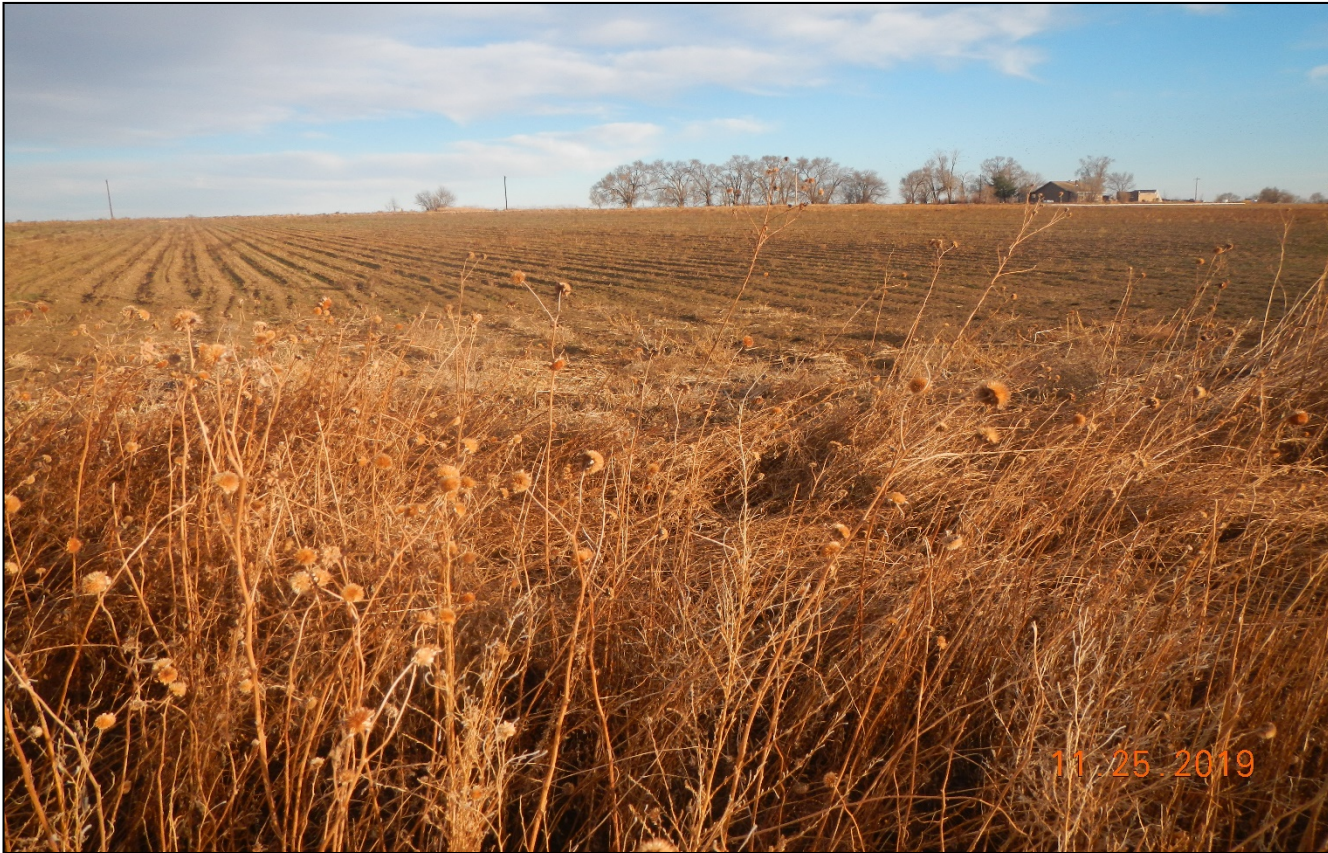
Photo 10. Facing east toward outside of the location the land use is cropland.
