Inspection Photos

API: 05-061-06293

Operator: CHEMCO INC

Inspection Date: 11/25/2019

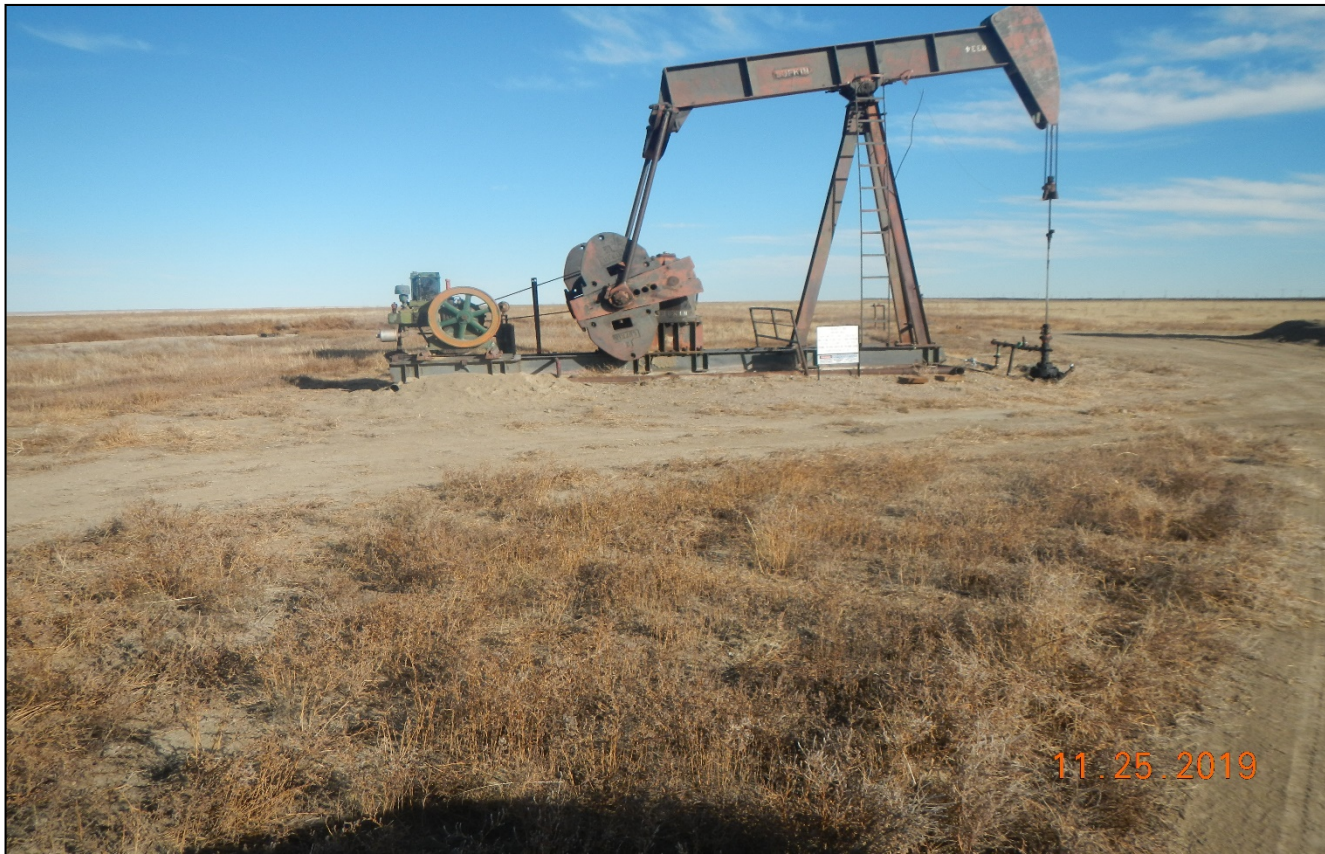
Photo 1. Facing southwest toward the pumpjack.

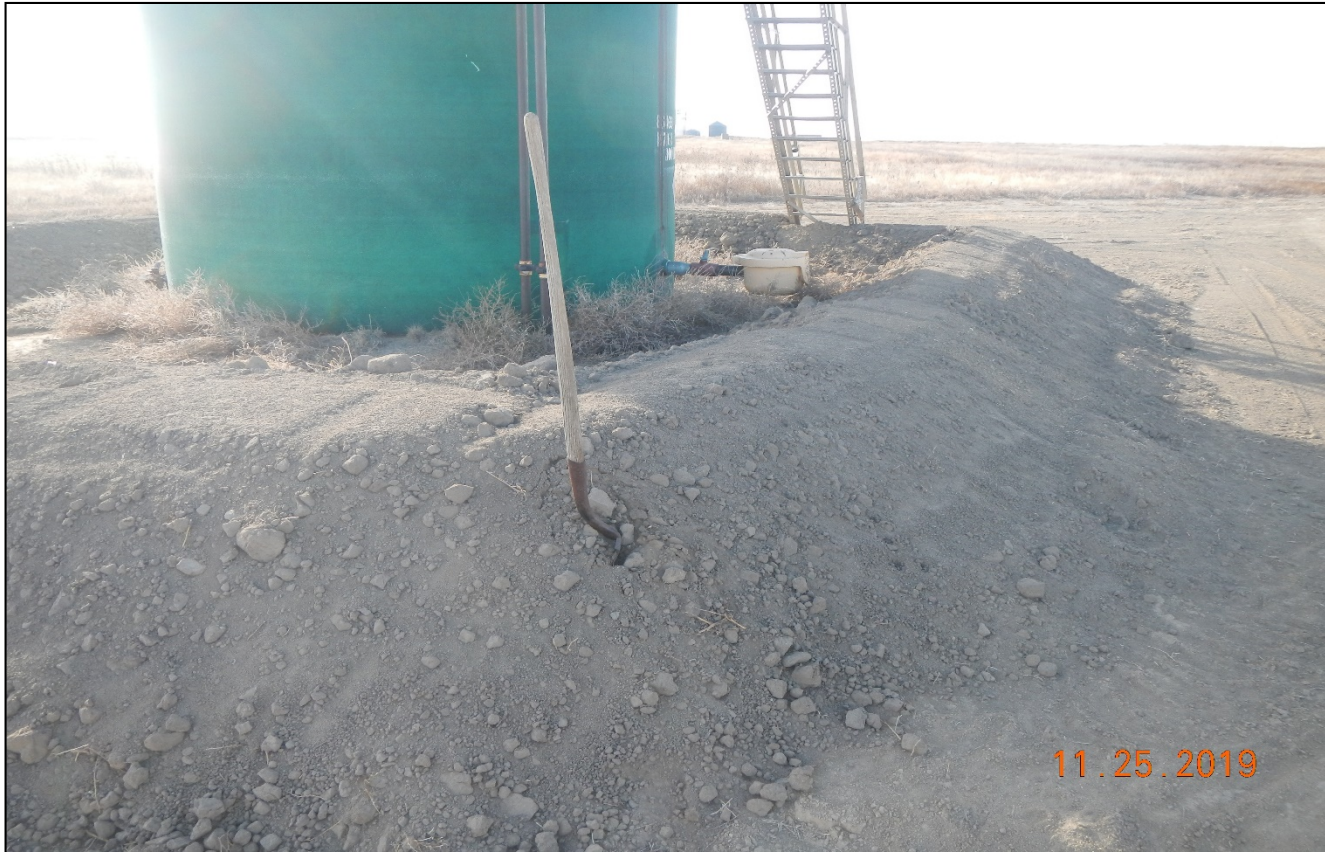
Photo 2. The berm around the tank has been built up however, soils are loose and not compacted.

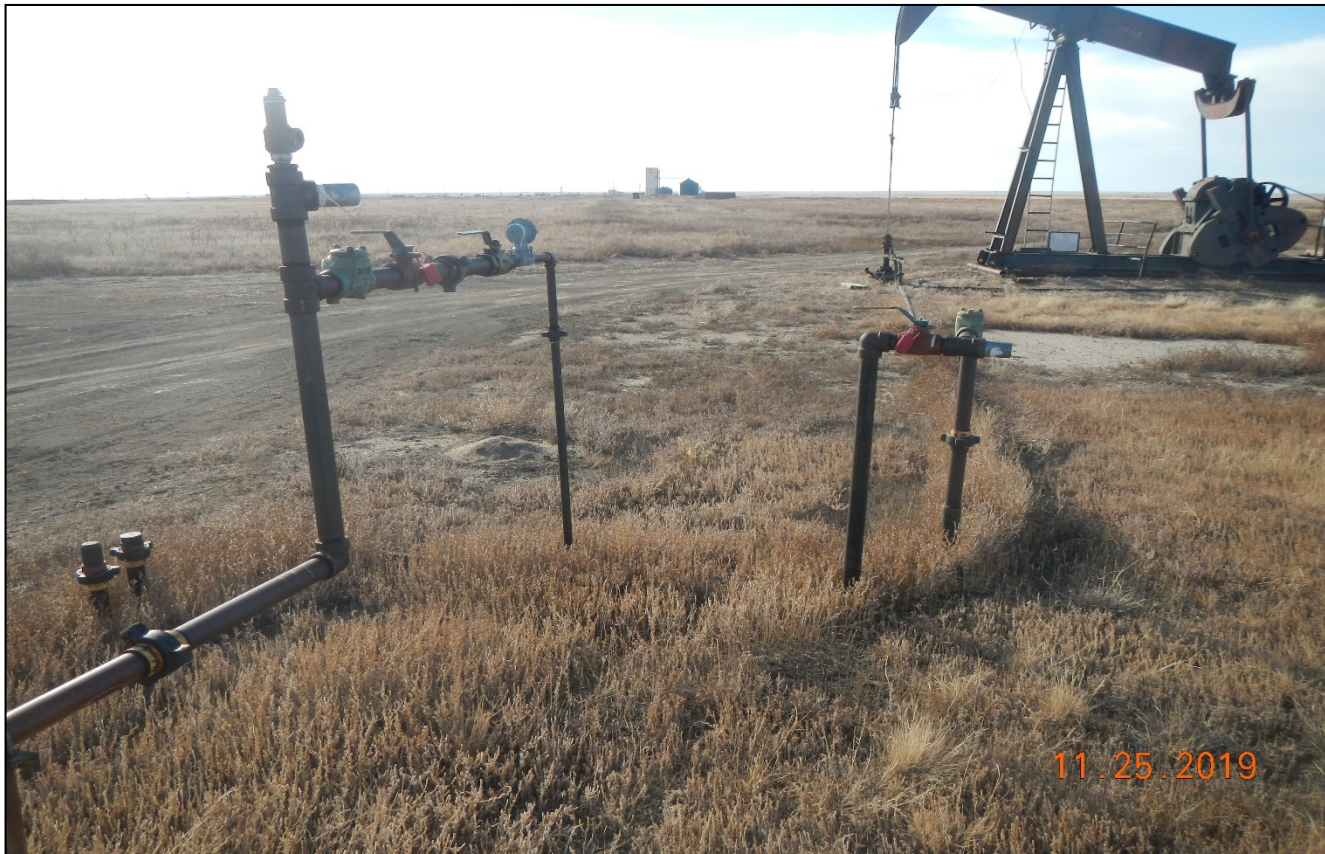
Photo 3. The pipe risers at the location have been LO/TO.

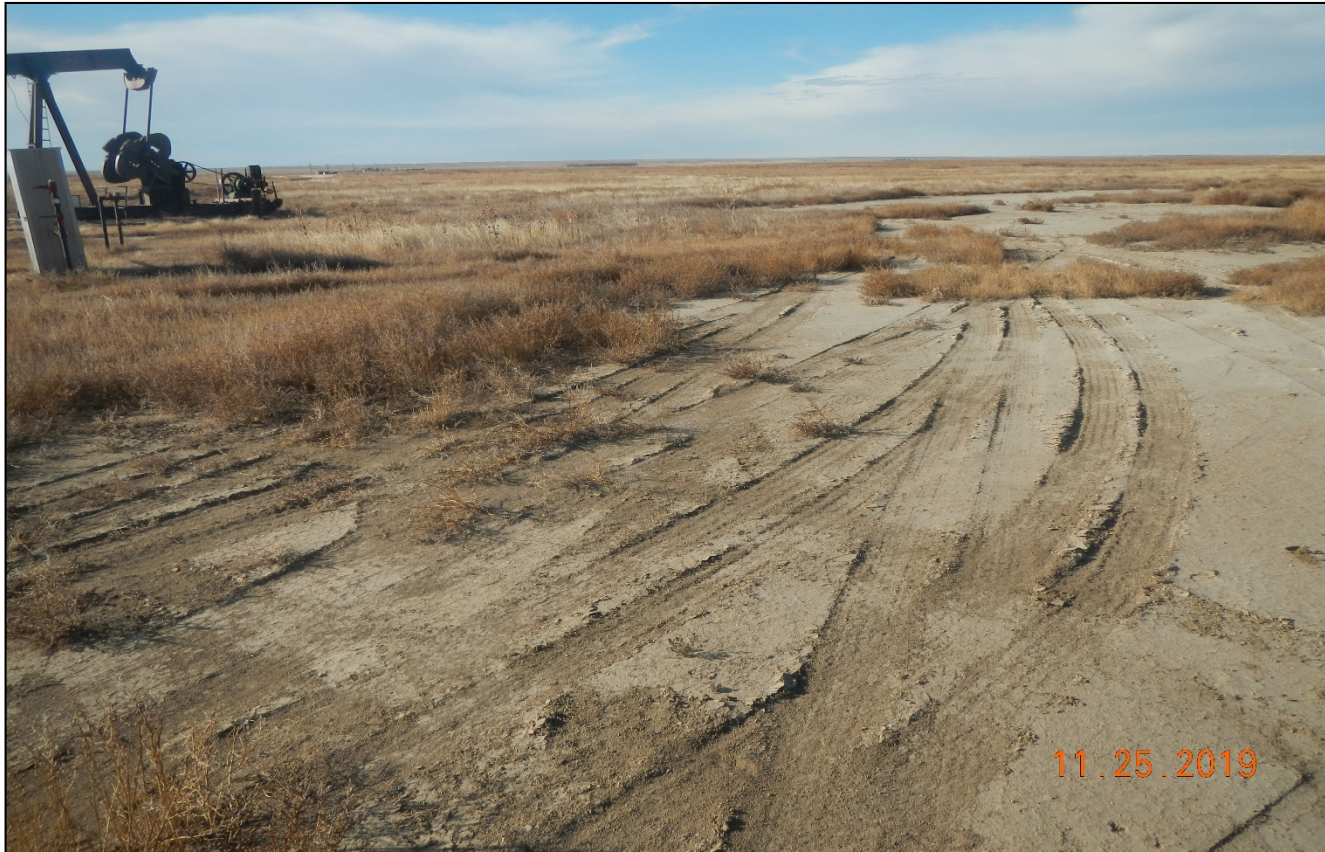
Photo 4. Facing northwest toward the wellhead. The area northeast of the well is bare of vegetation and appears to be a result of a spill.

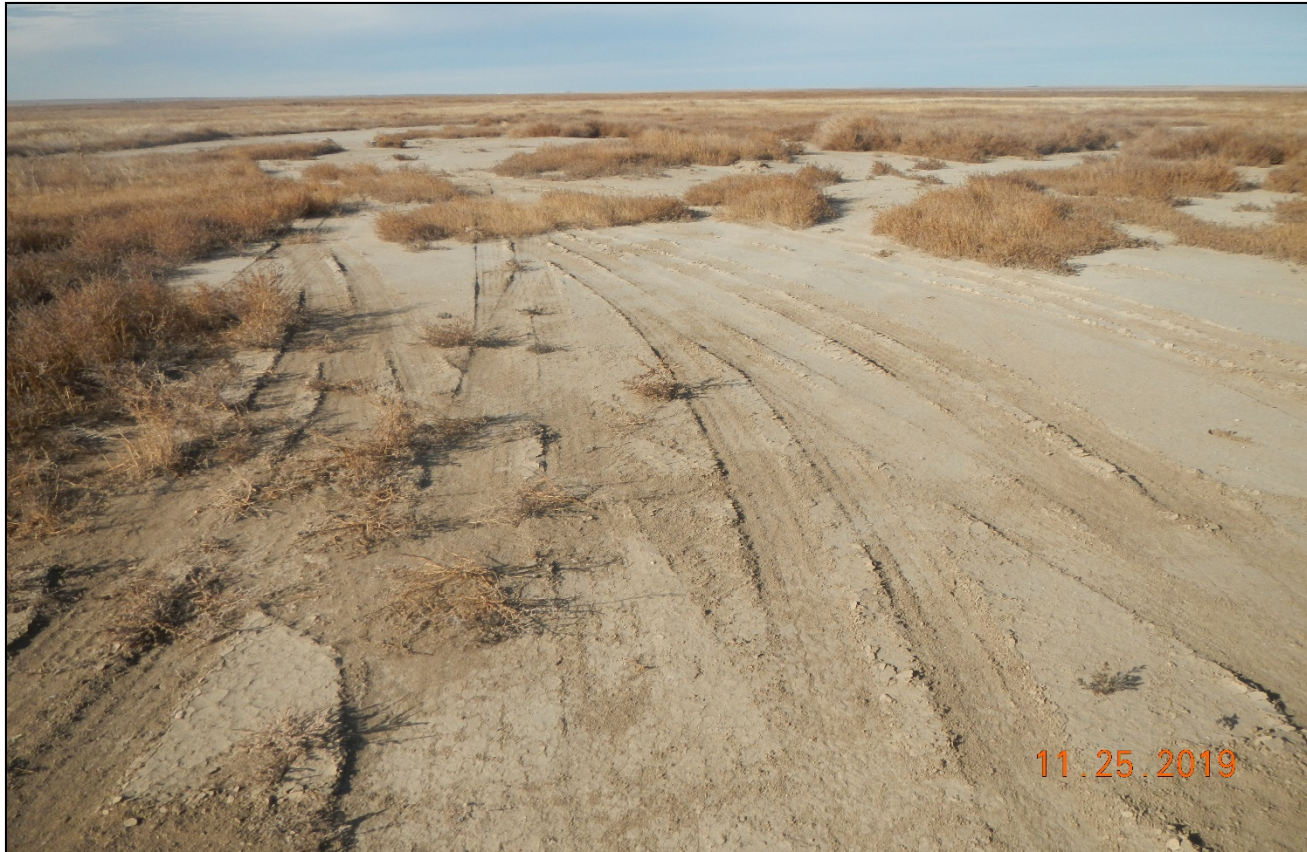
Photo 5. Facing north at the location which appears to have been impacted by a spill.

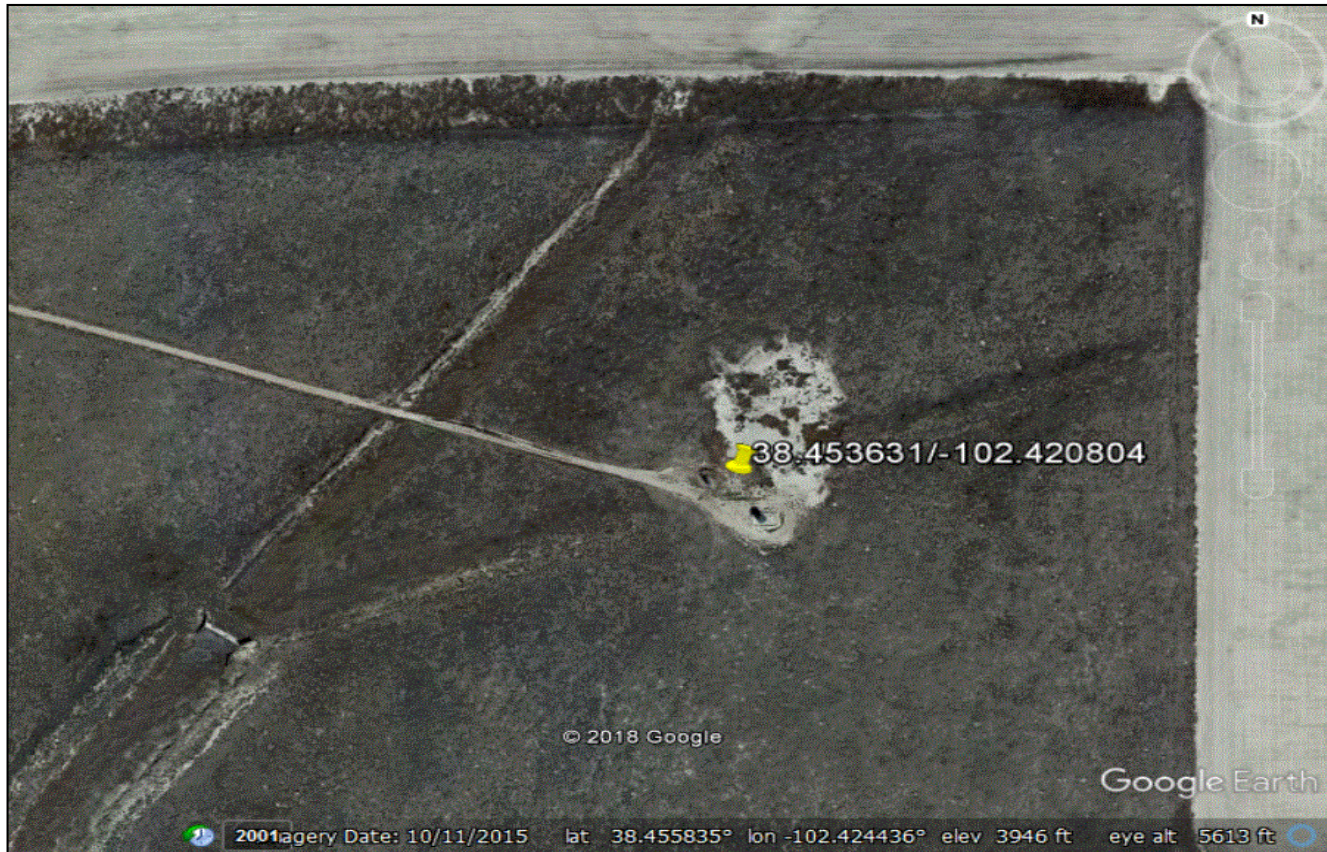
Photo 6. View of aerial image shows area north of the location bare of vegetation which may be the result of a former spill.
