**Inspection Photos**  
**Location Name: Morrison #9-1**  
**Location ID: 320512**

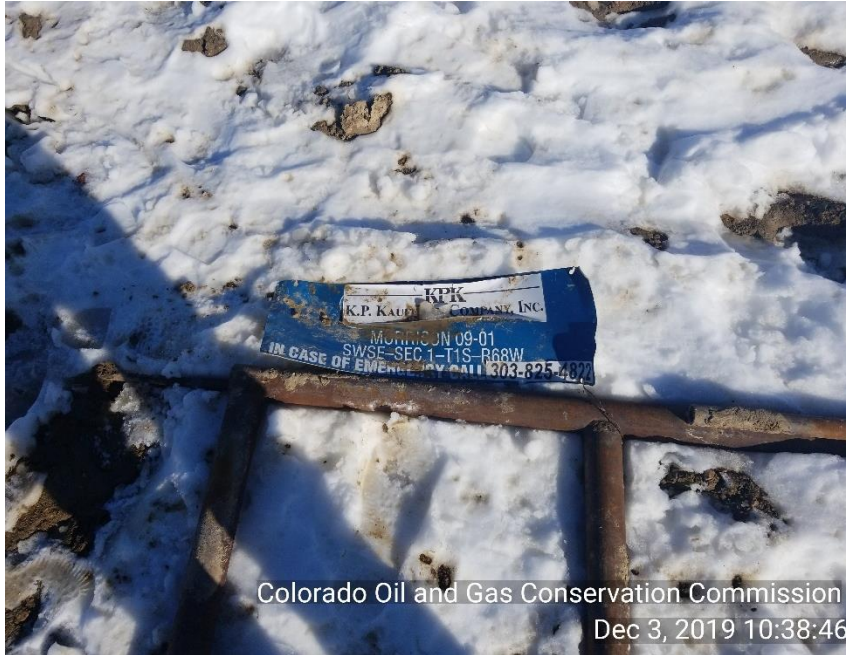
**Photo 1 WH sign is on site but in disrepair**

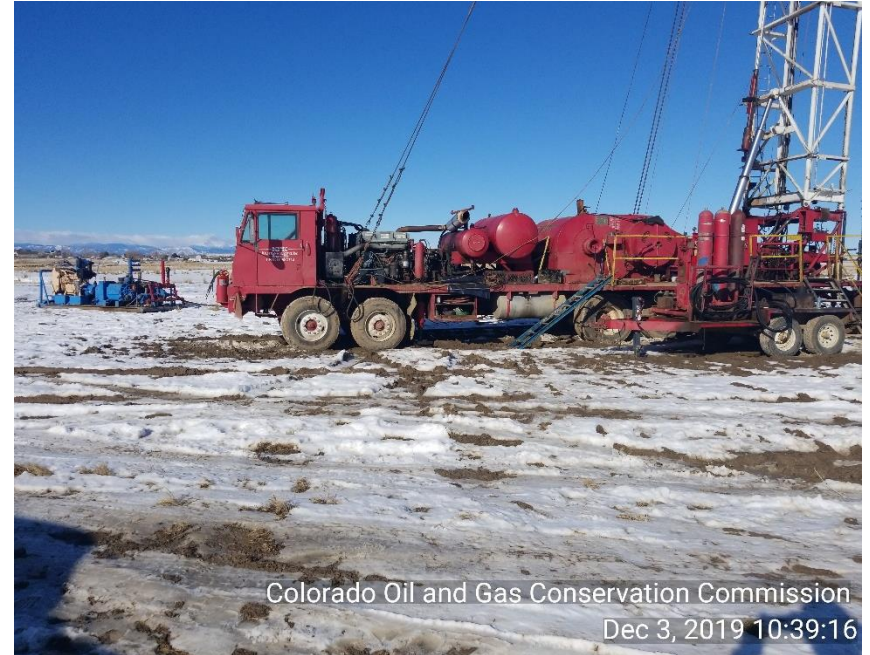
**Photo 2 KPK rig not on secondary containment**

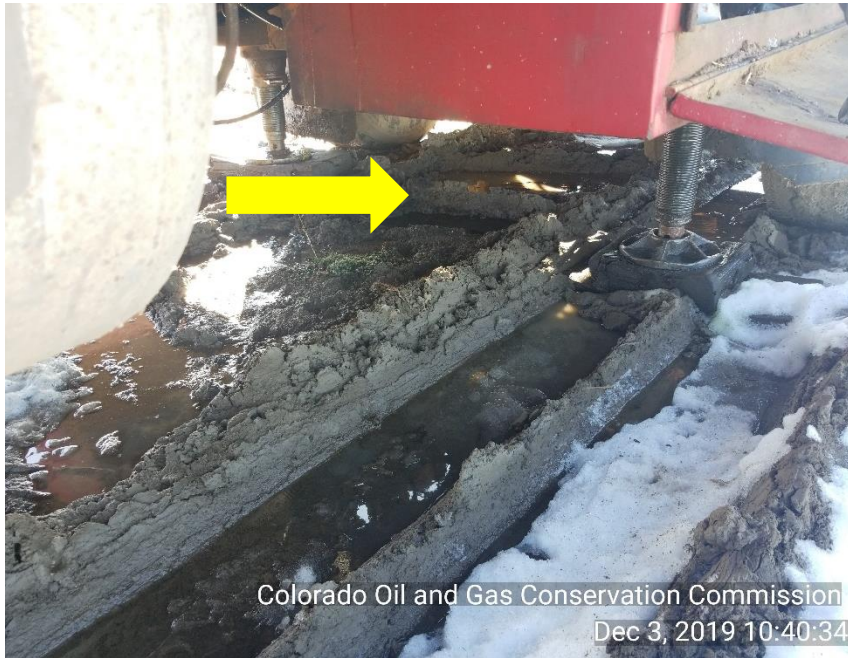
**Photo 3 no secondary containment under rig, oil is dripping off motor and collecting on water and mud.**

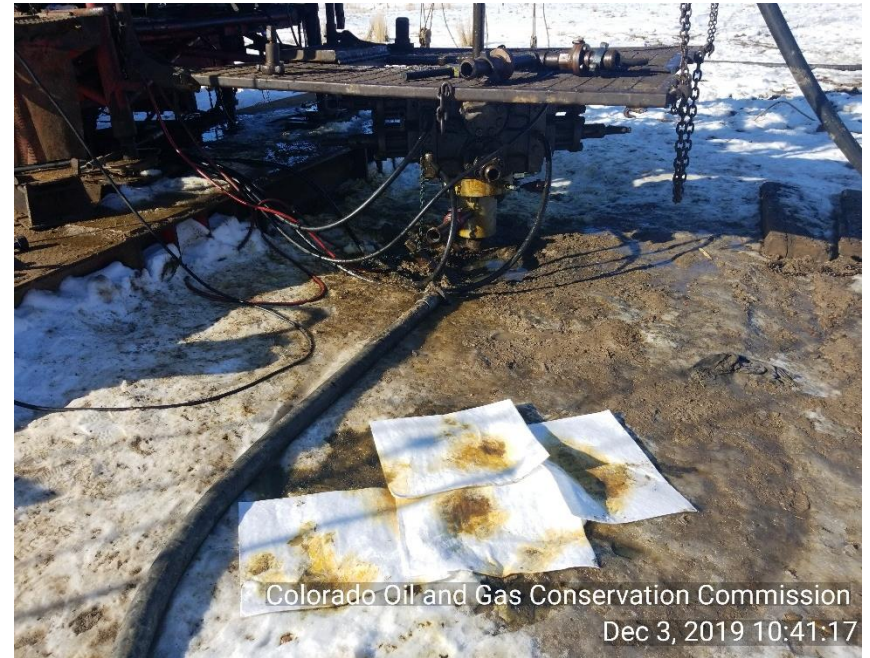
**Photo 4 stained soil around well head.**
