Inspection Photos
Operator: Enduring Resources
Location/API #: 067-07769
Date: 11-14-2019

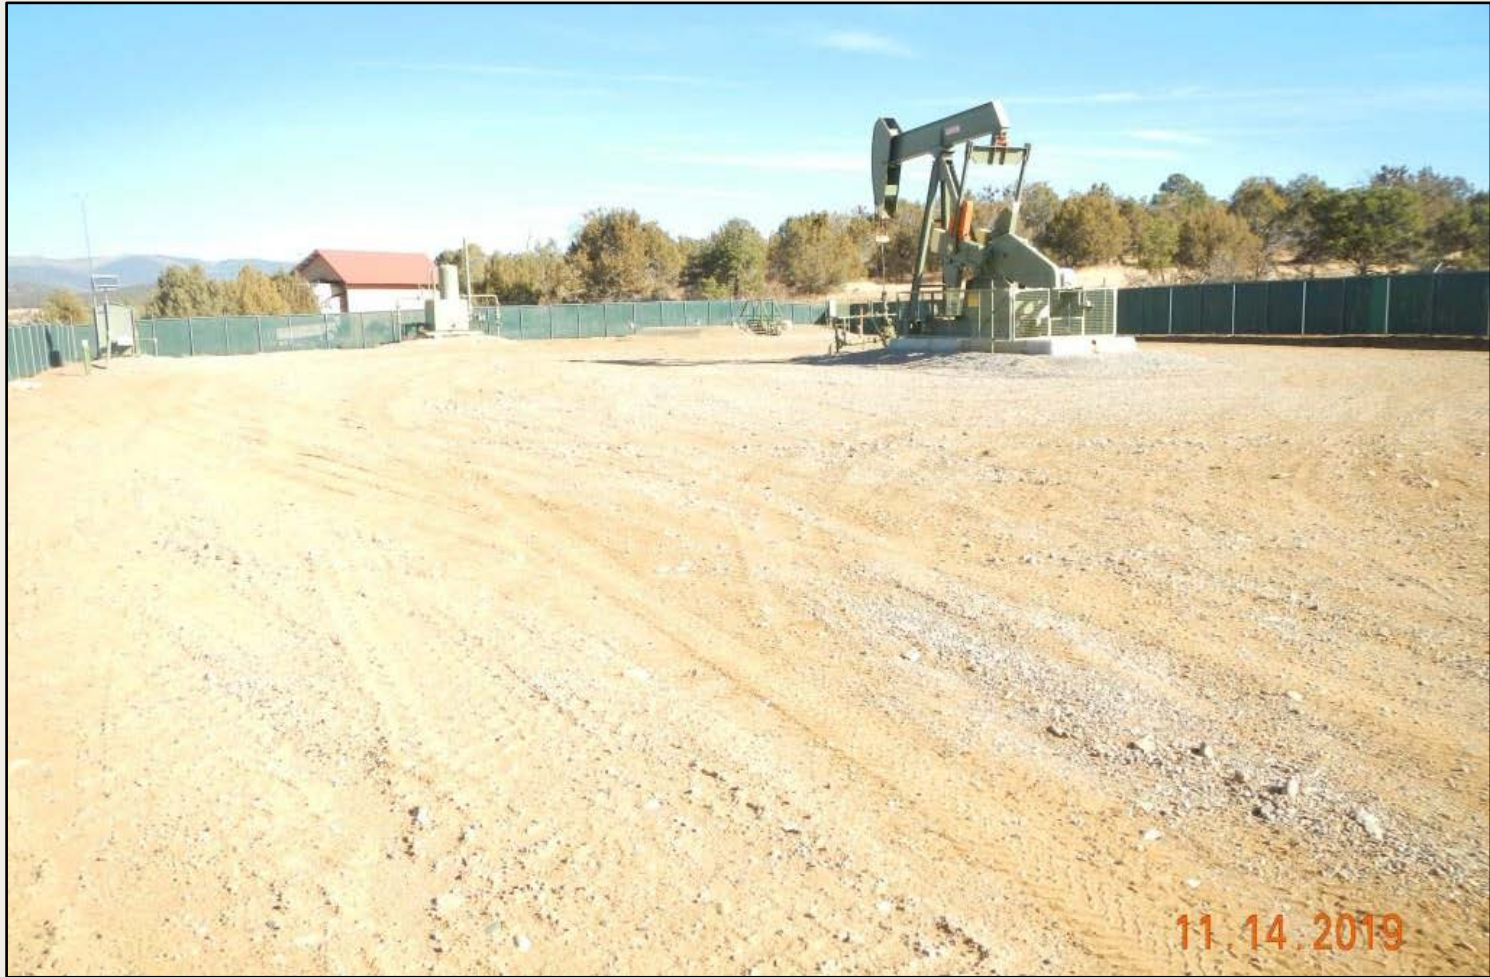
Photo 1. View of the project area from the well pad entrance facing center.

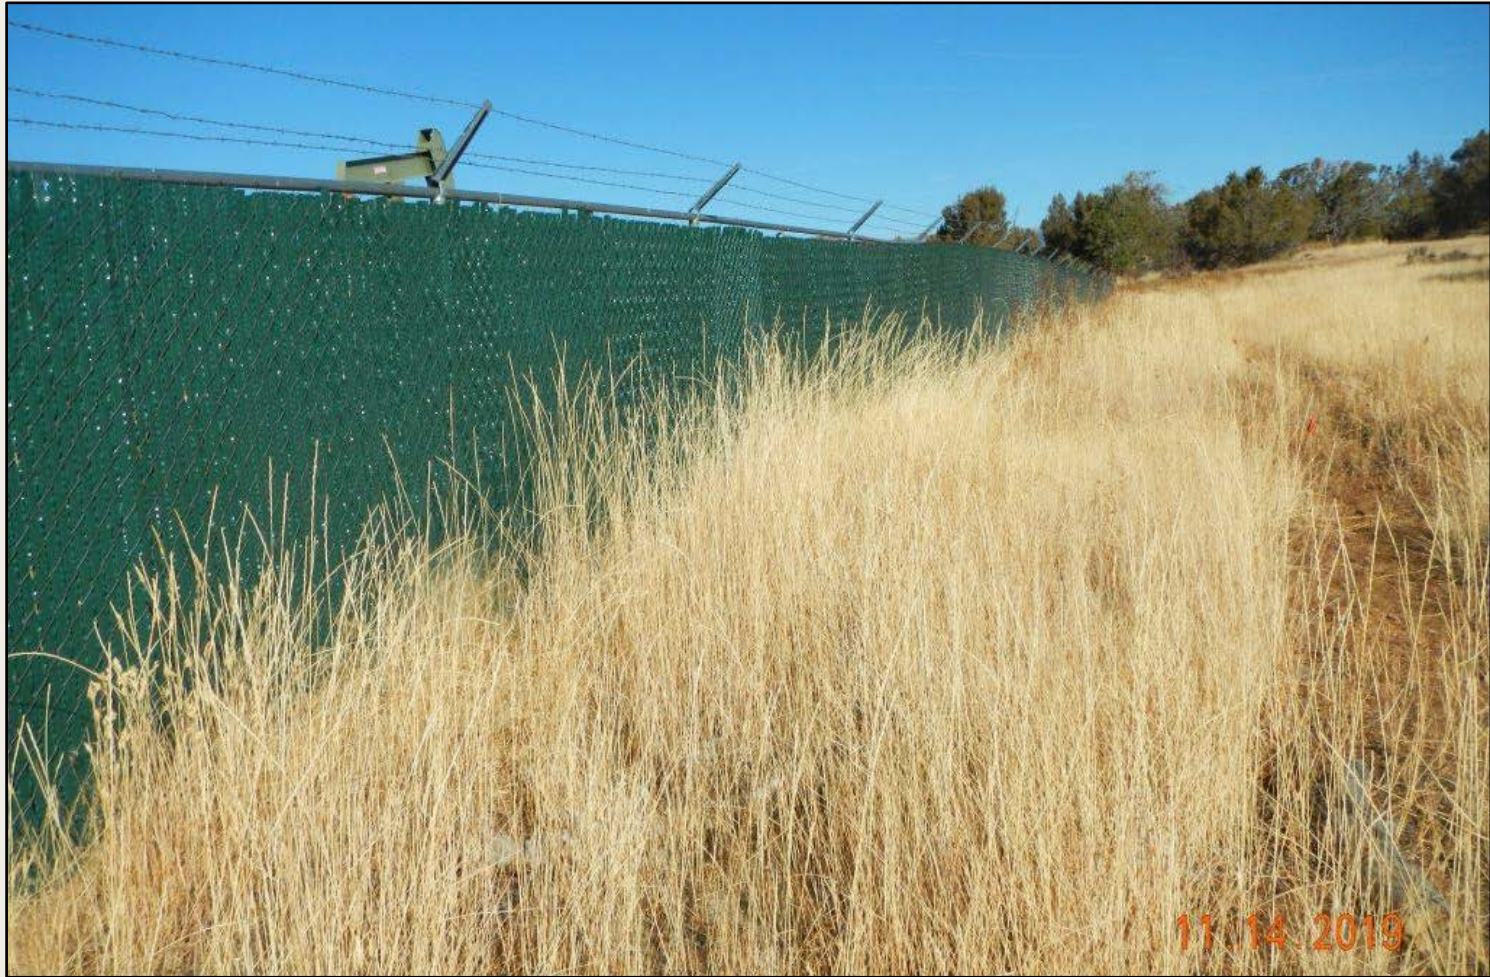
Photo 2. View of the eastern project area from the southeastern corner facing northward. Revegetation is progressing with intermediate wheatgrass, smooth brome, and crested wheatgrass.

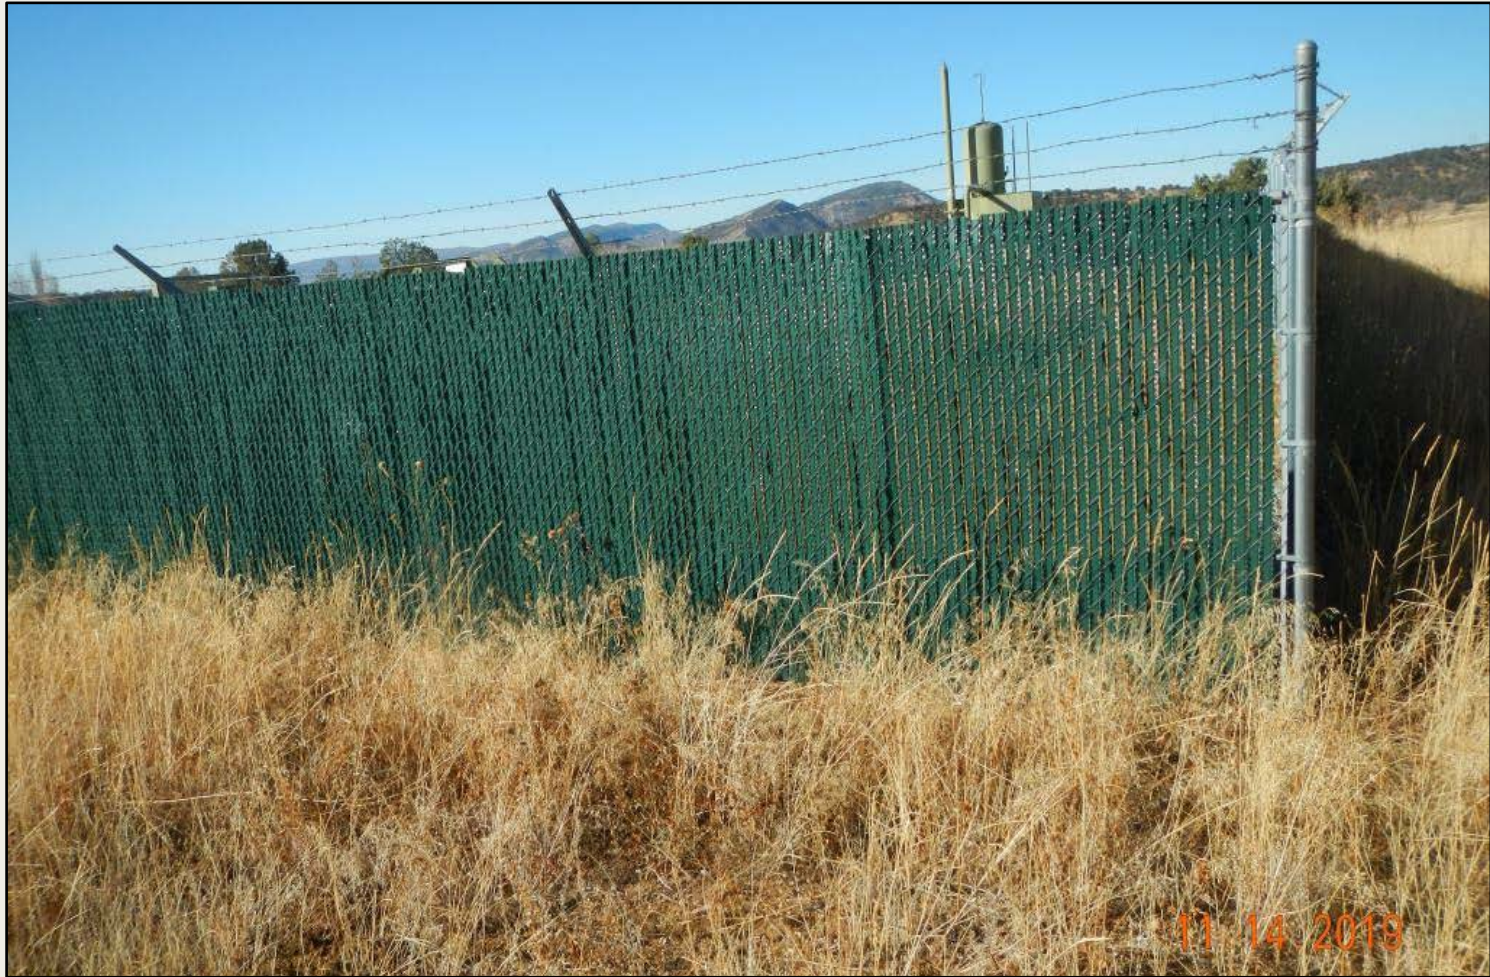
Photo 3. View of the northern project area from the northeastern corner facing westward. Revegetation is progressing as described above.

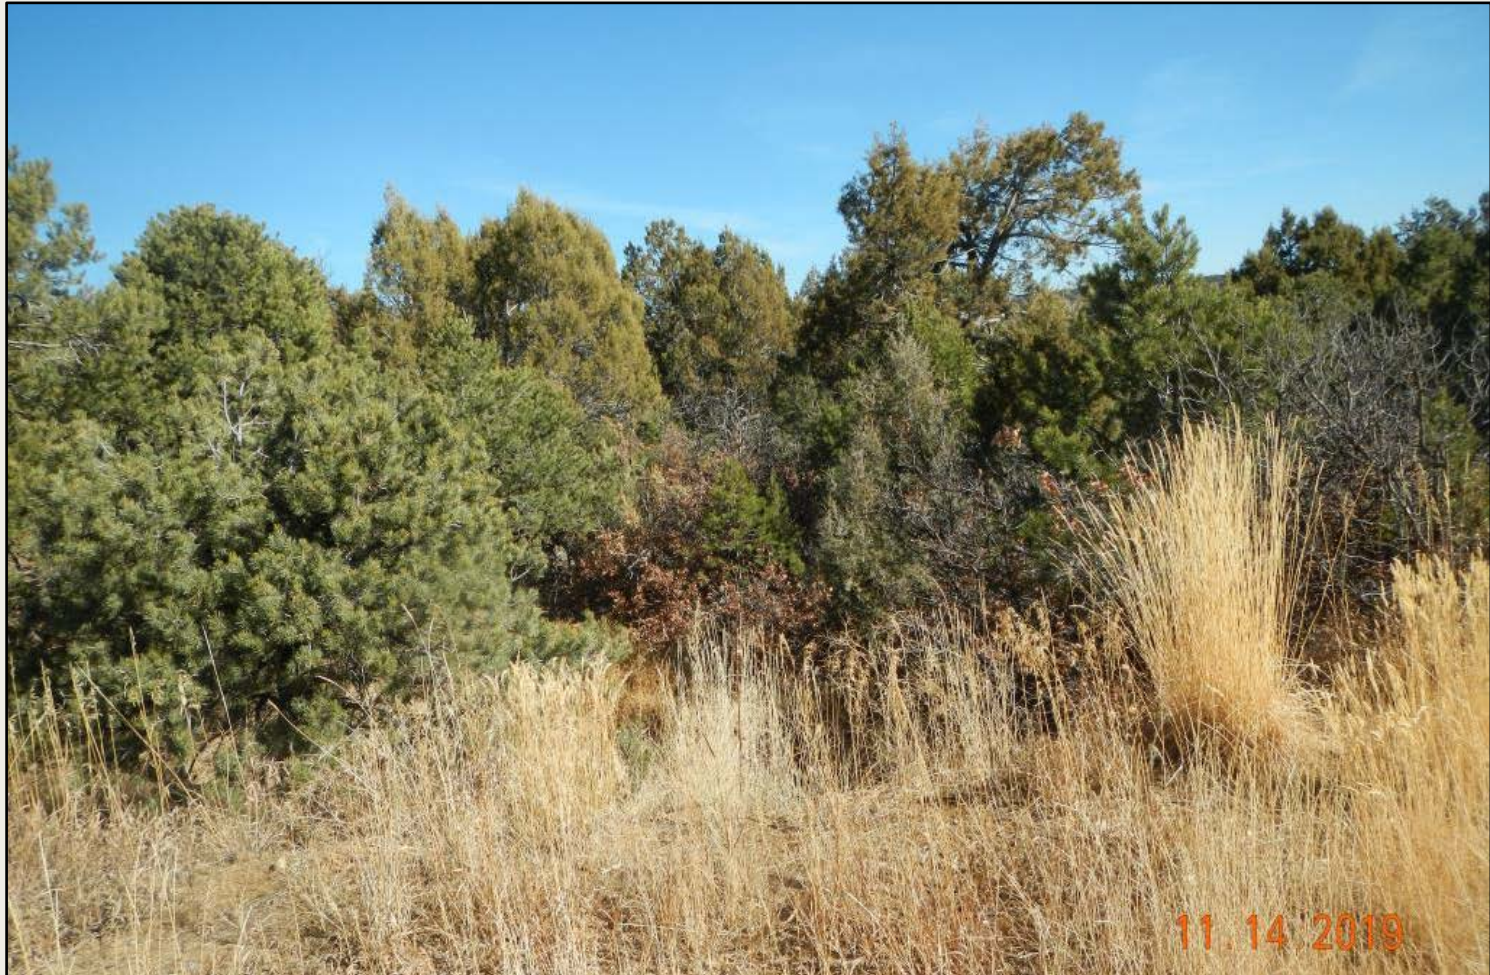
Photo 4. View of reference area, comprised of sagebrush and pinyon juniper woodland, with grasses planted in openings.
