Inspection Photos
Operator: Enduring Resources
Location/API #: 067-08667
Date: 11-14-2019

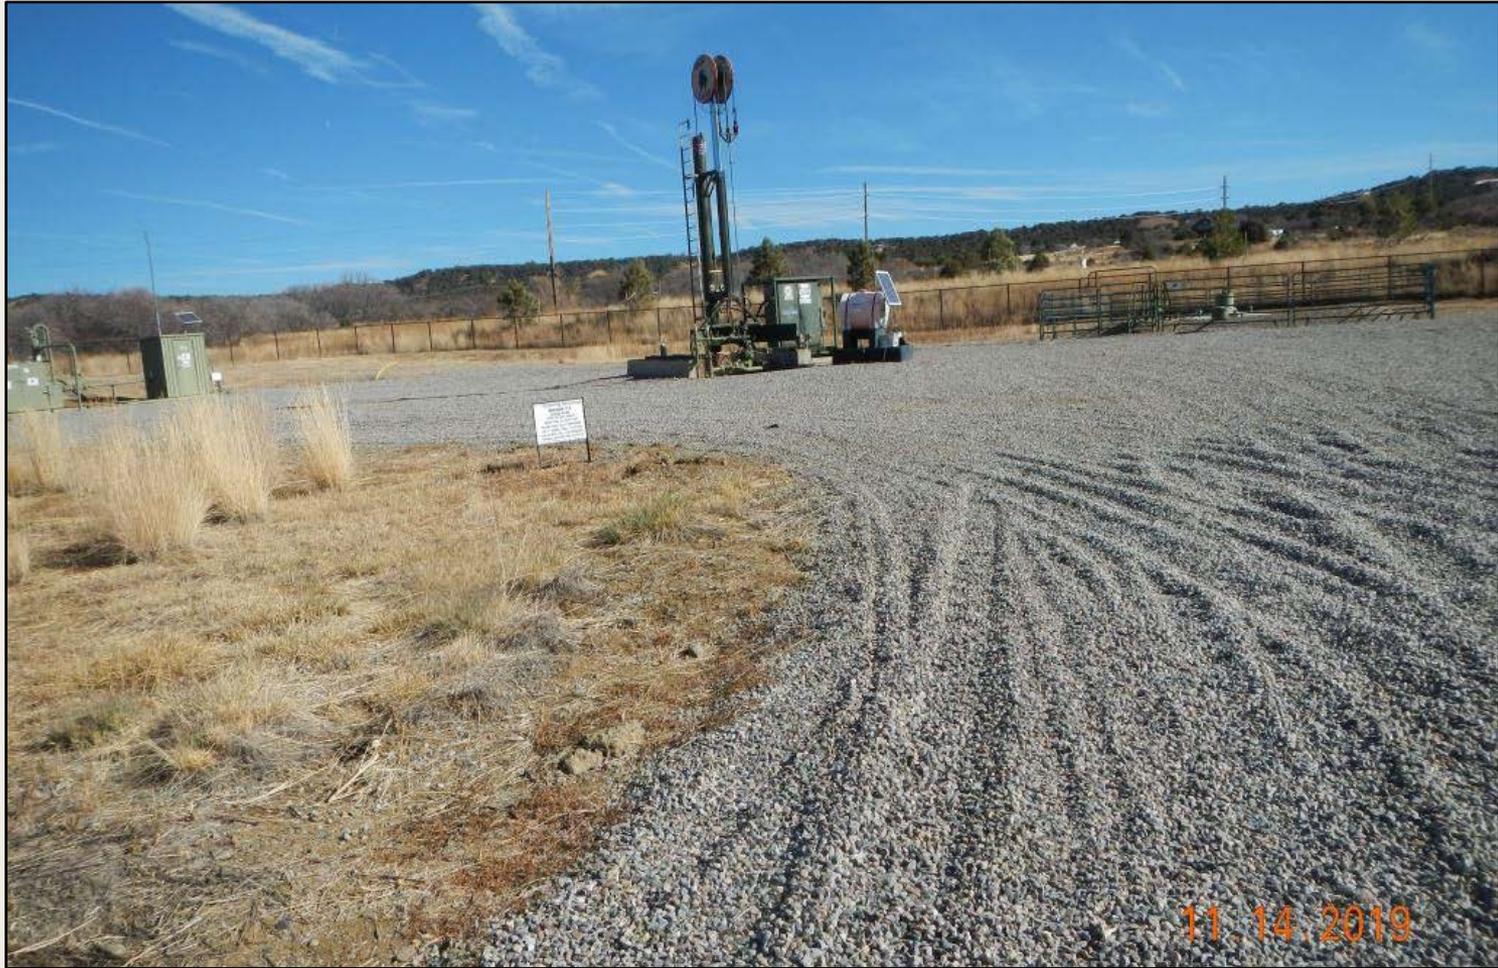
Photo 1. View of the project area from the well pad entrance facing center.

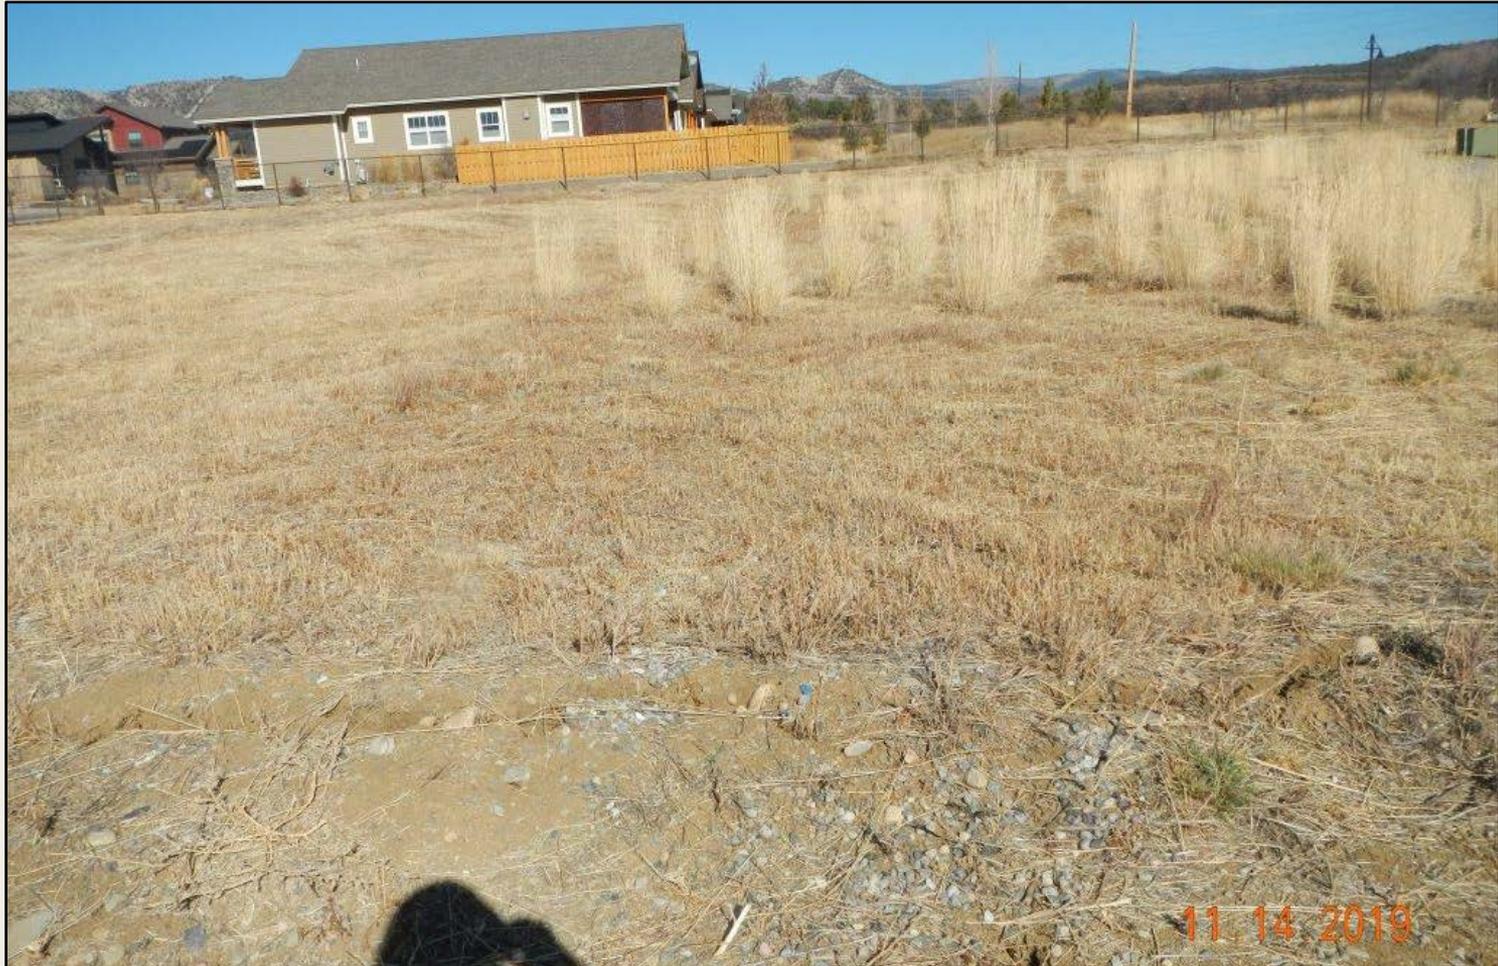
Photo 2. View of the northwestern project area from the access entrance facing northward. Revegetation is progressing with intermediate wheatgrass, smooth brome, and crested wheatgrass. Location is partially surrounded by residential development. Most of the vegetation is mowed.

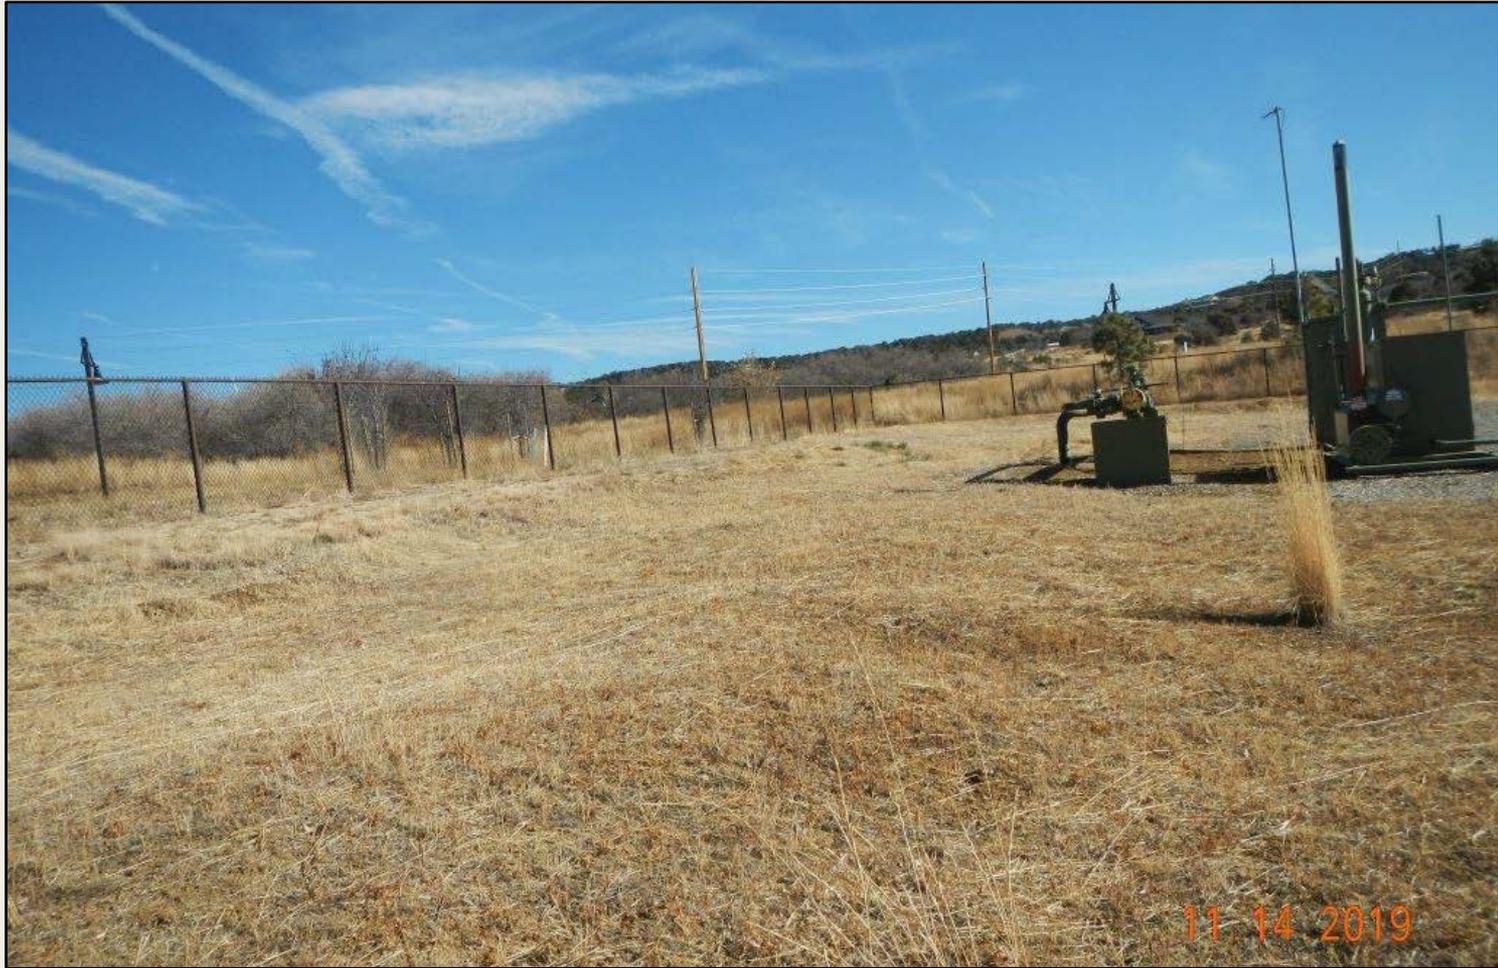
Photo 3. View of the northern project area from the northwestern corner facing eastward. Revegetation is progressing as described above.

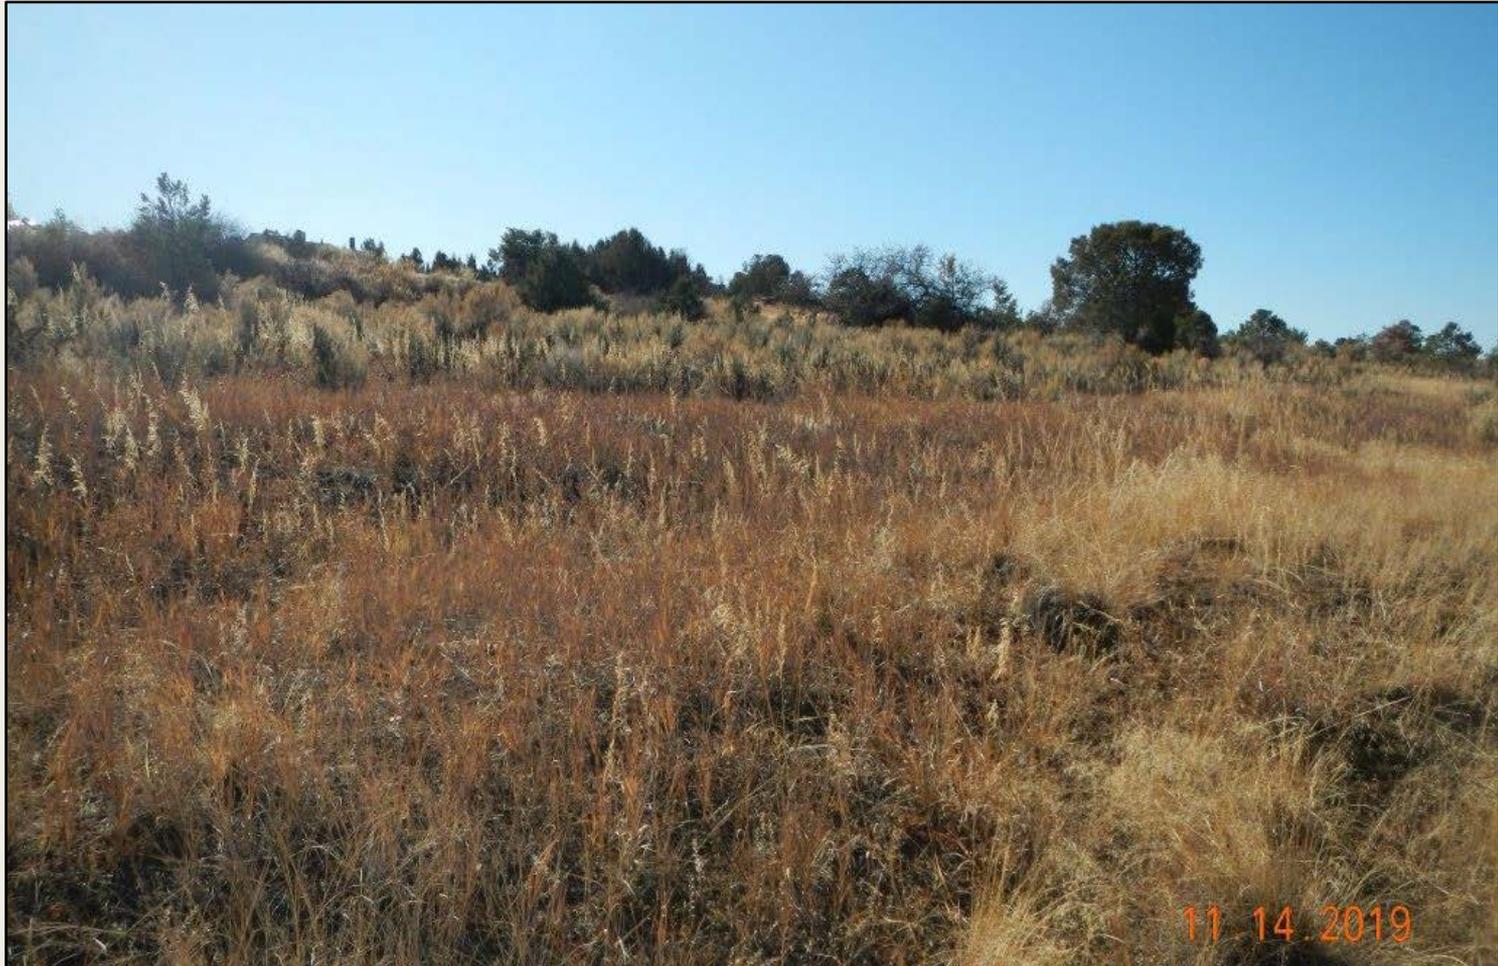
Photo 4. View of reference area, comprised of sagebrush shrubland, with grasses planted in openings.
