Inspection Photos

Operator: Enduring Resources
Location/API #: 067-07468
Date: 11-14-2019

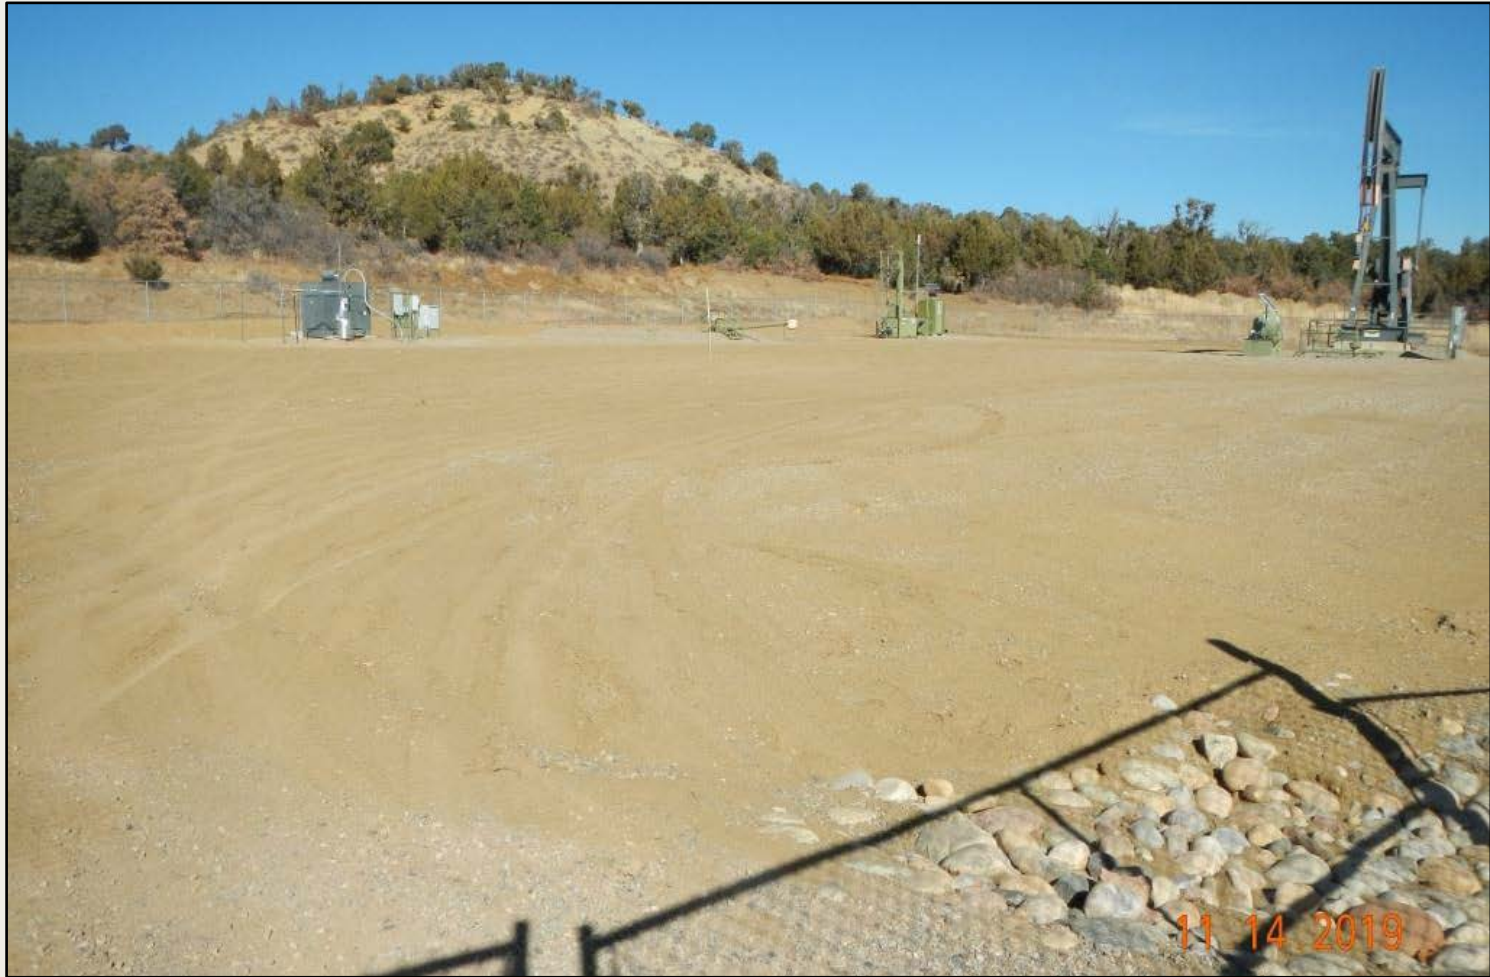
Photo 1. View of the project area from the well pad entrance facing center.

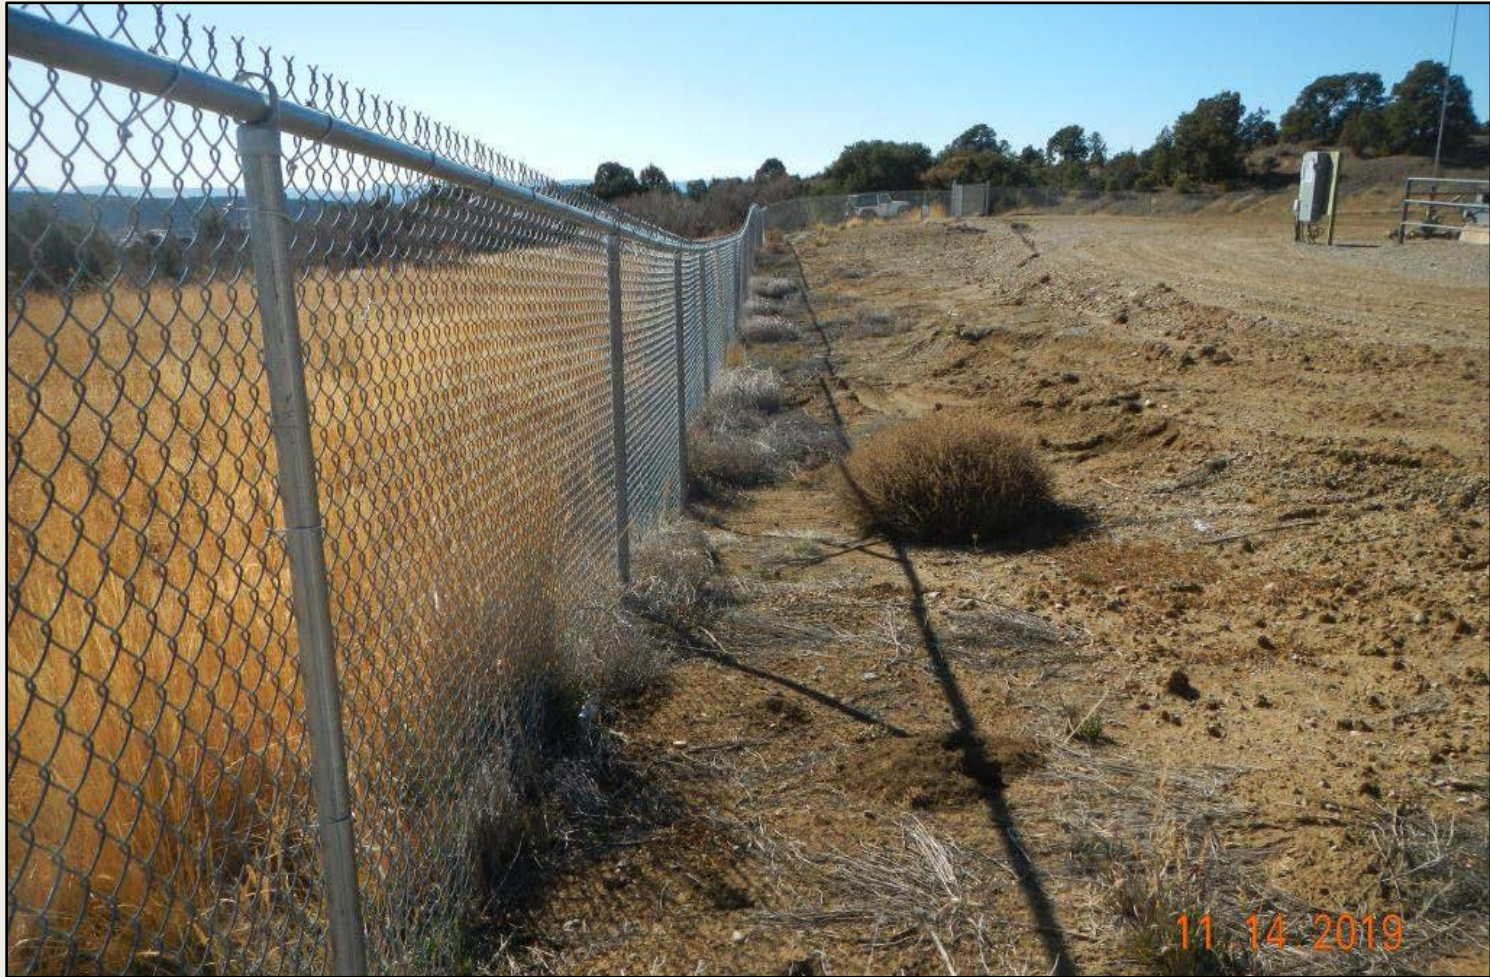
Photo 2. View of the eastern project area, within the fenced working area. Stormwater flows from the well pad are eroding the area off of the road surface, which is not vegetated with desirable vegetation.

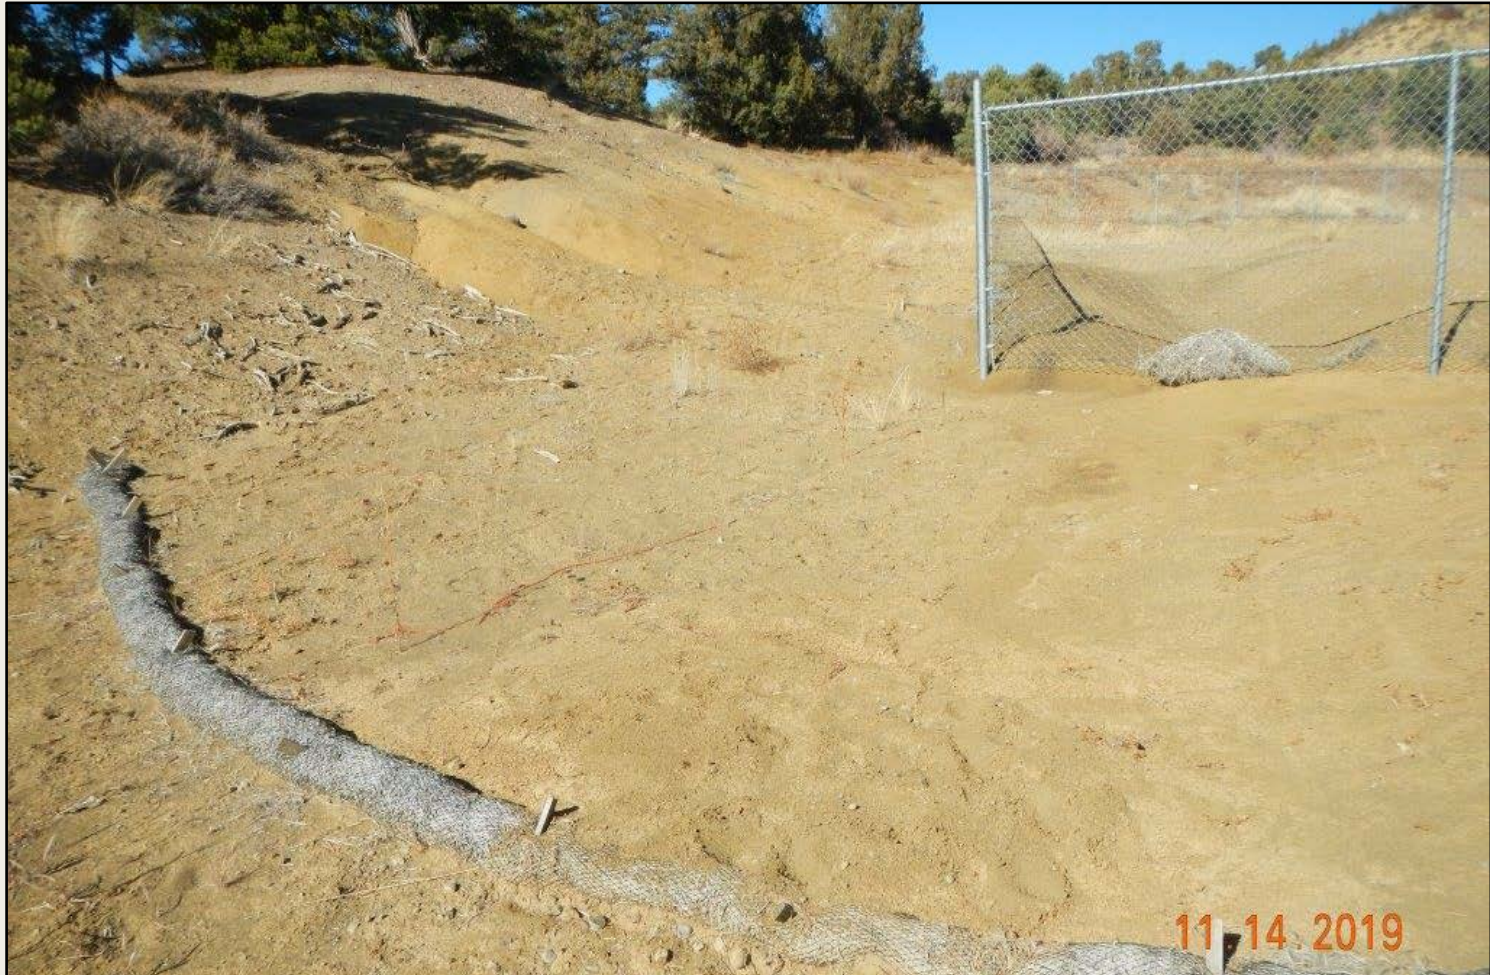
Photo 3. View of area with significant erosion in the southwestern project area. Wattles are full of sediment and are not adequate stormwater controls in this area. Cut slopes are not stabilized and erosional channels are forming on the slopes, and the sediment flows southwest where it discharges from the project area.

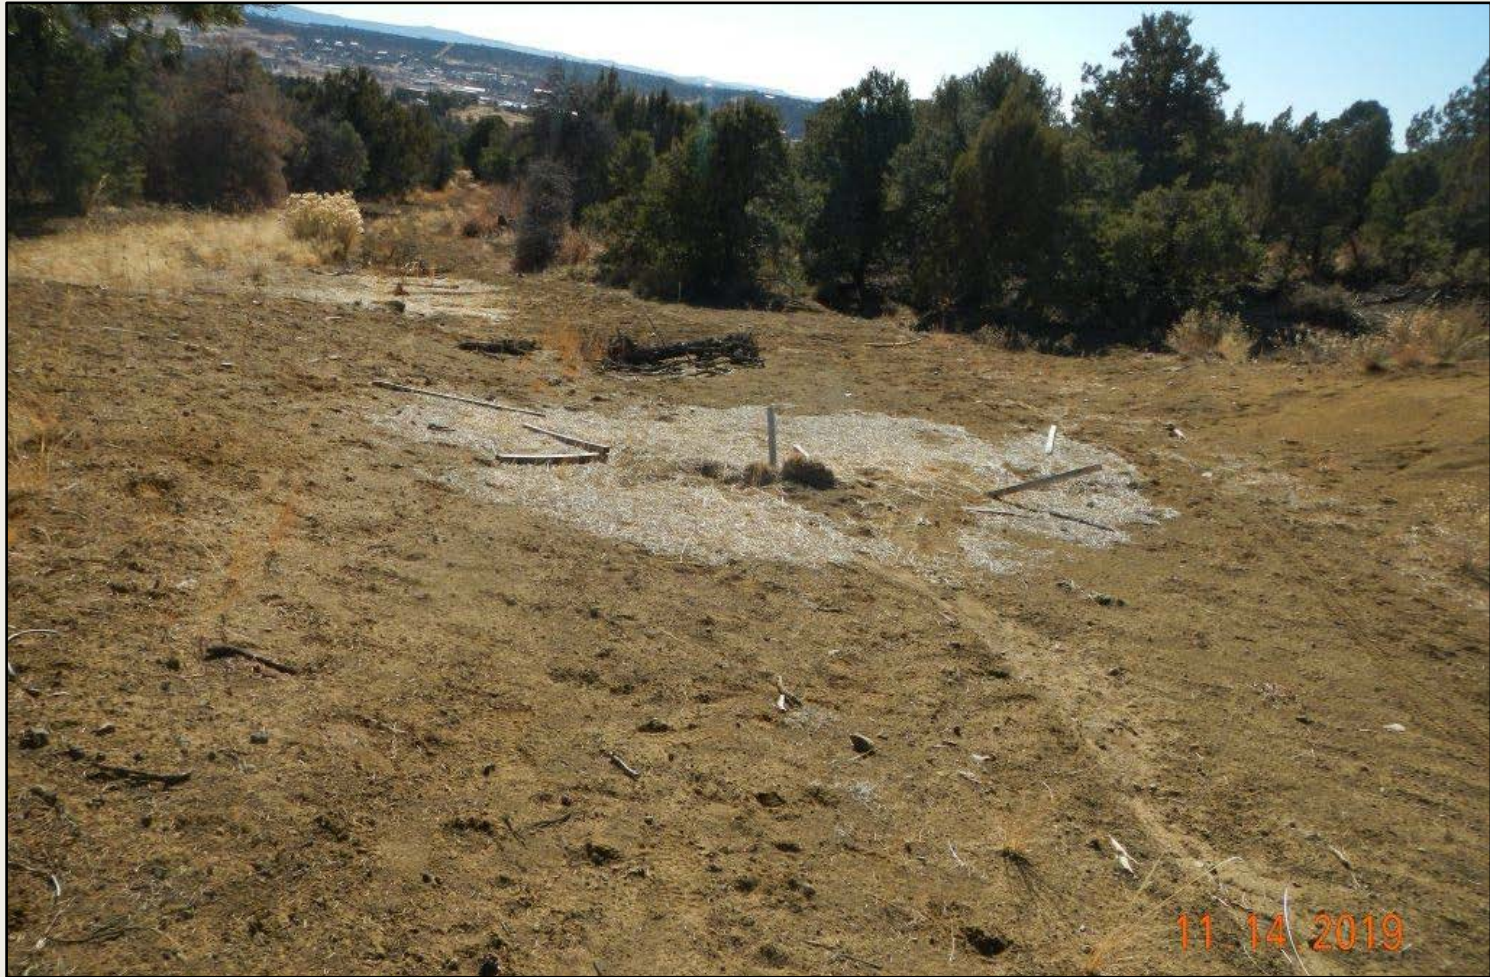
Photo 4. Another view of sedimentation and failed BMPs in the southwestern project area. Area needs stabilization measures and revegetation.

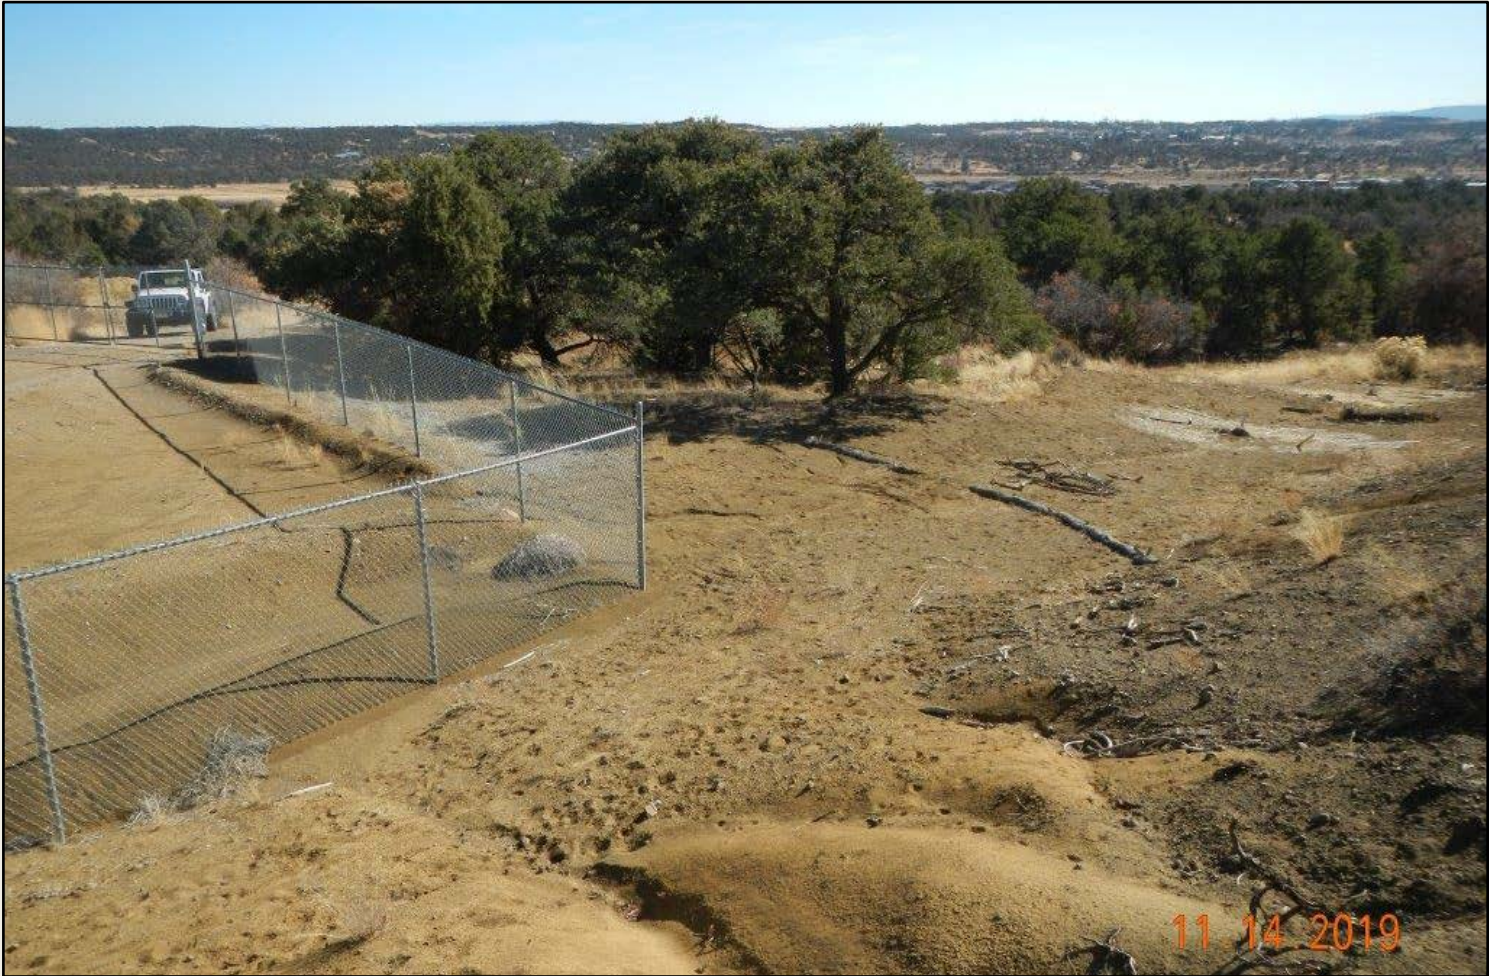
Photo 5. View of erosion and sedimentation in the southwestern project area, facing down-slope from the western cut-slope.

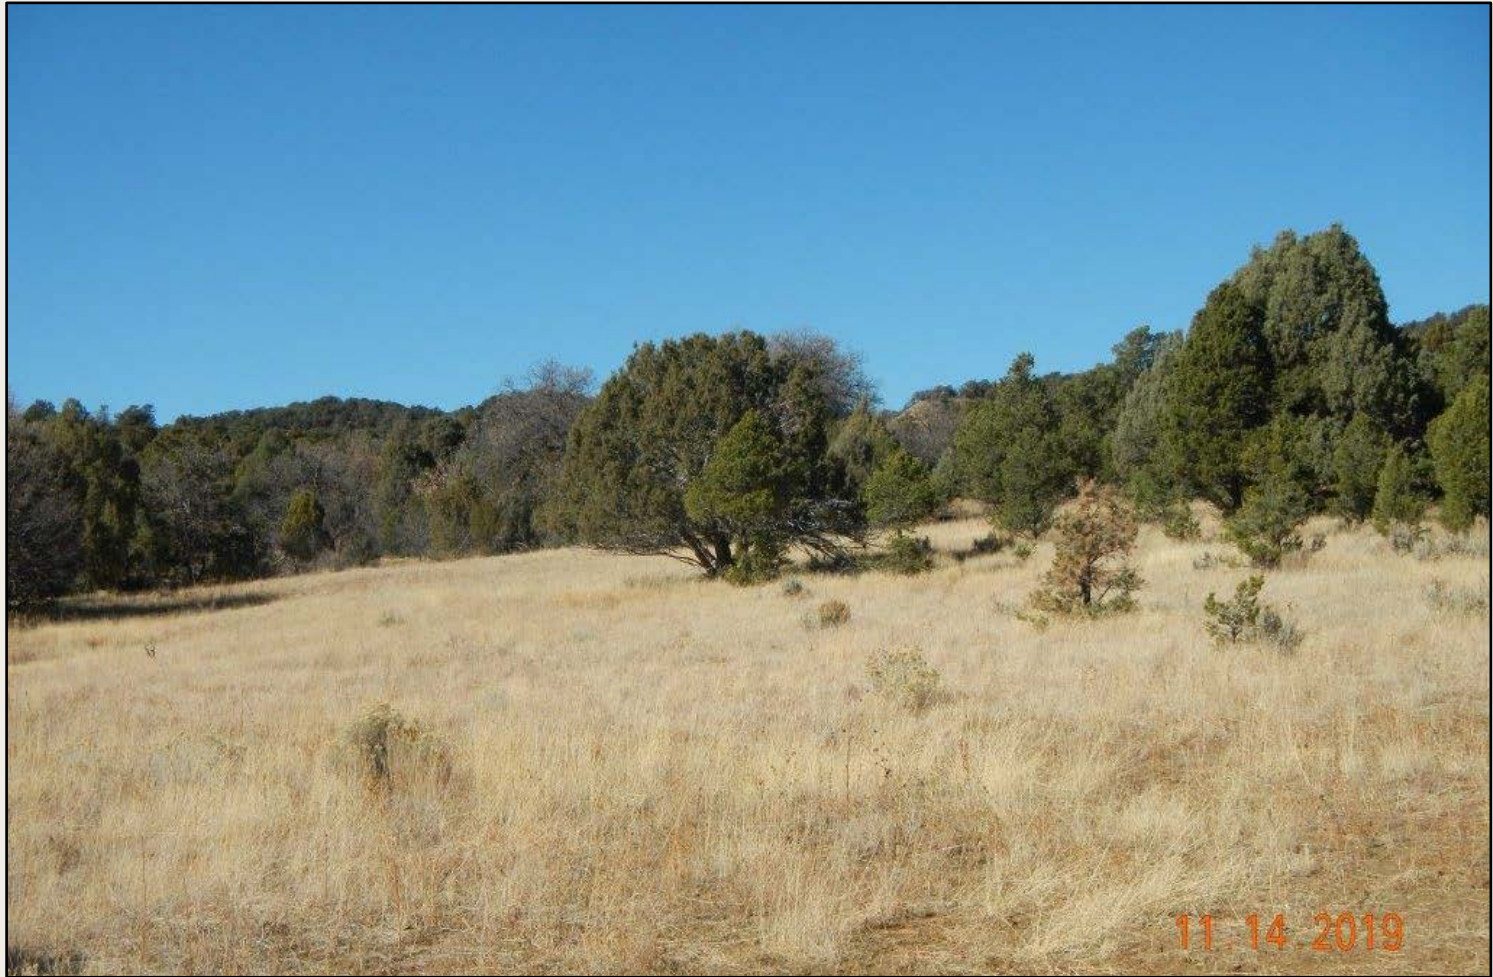
Photo 6. View of reference area, comprised of pinyon juniper woodland with grassy understory in openings.
