# Inspection Photos

Operator: Enduring Resources  
Location/API #: 067-07759  
Date: 11-14-2019

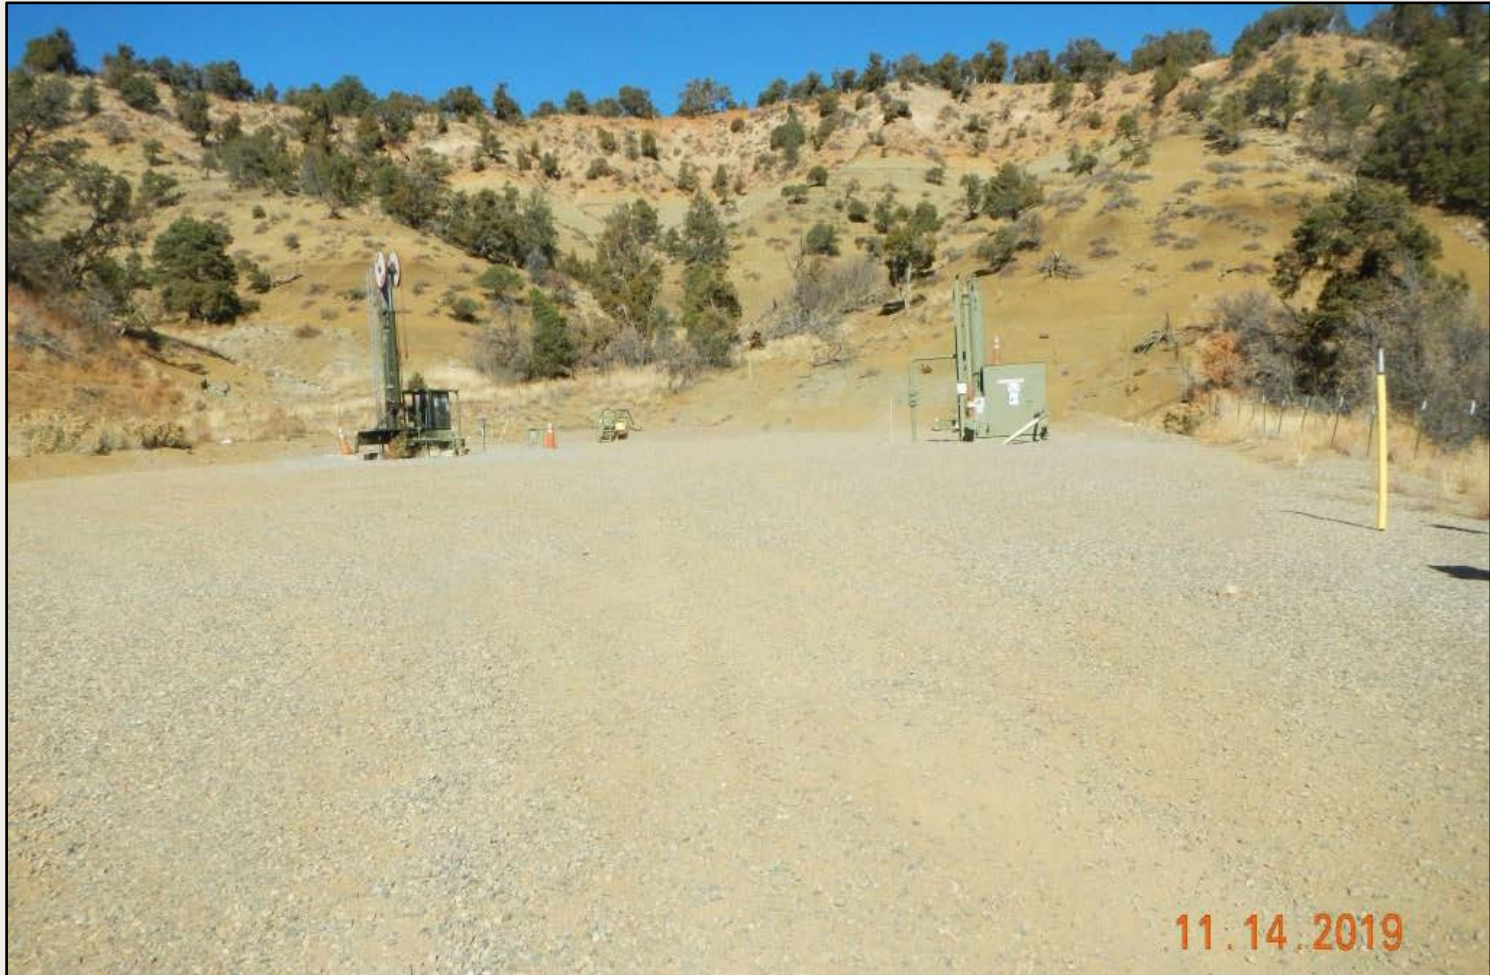
Photo 1. View of the project area from the well pad entrance facing center.

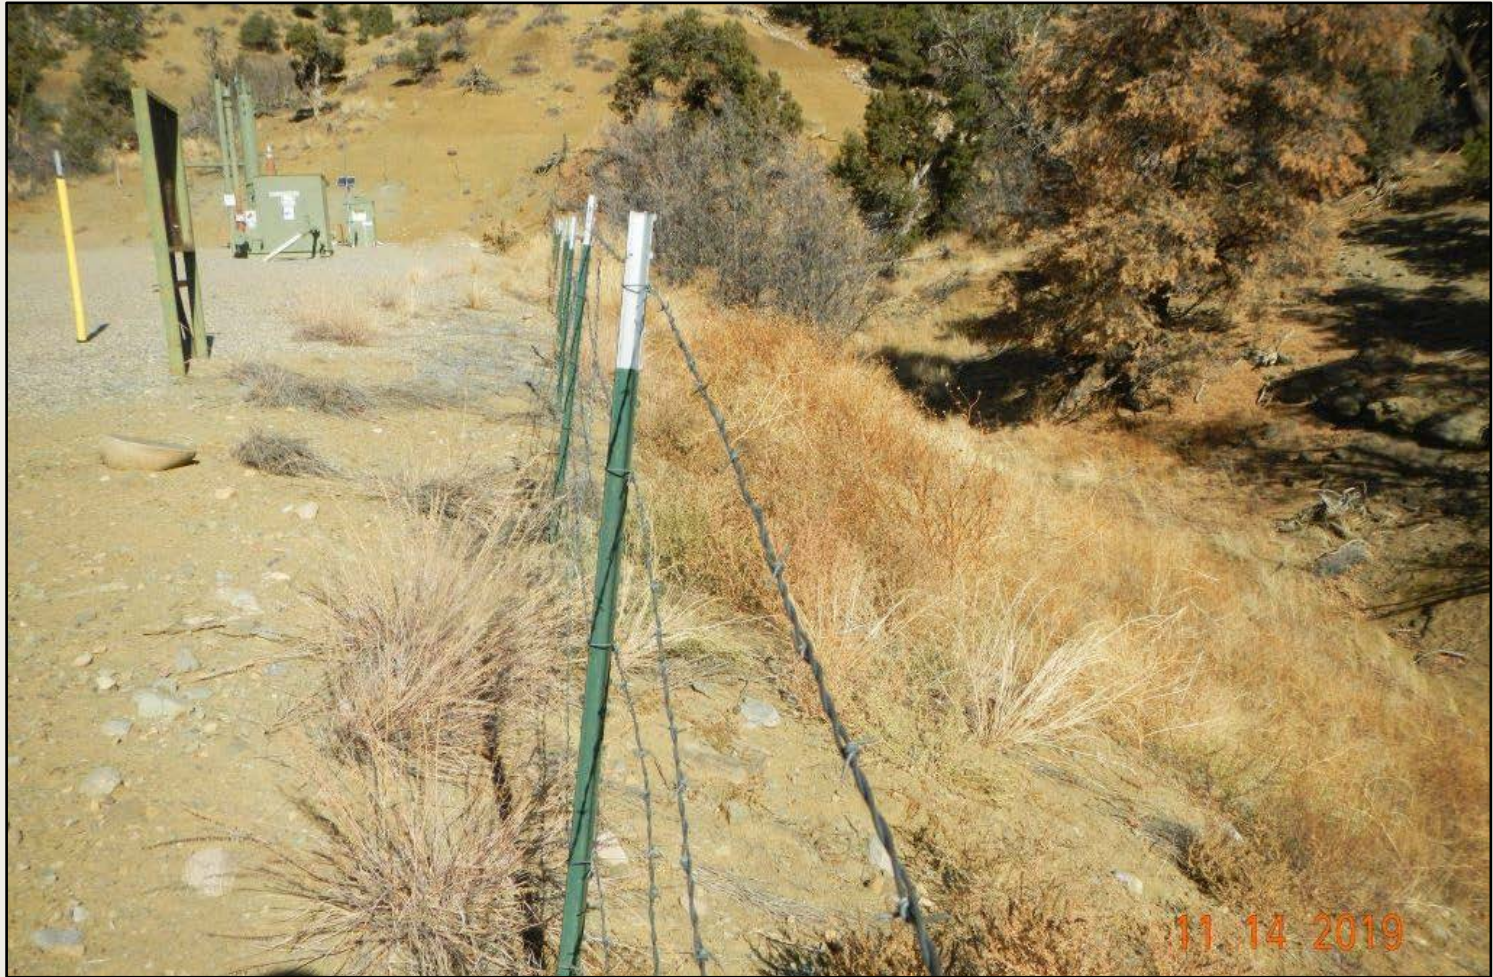
Photo 2. View of the eastern project area from the southeastern edge facing northward. Revegetation is progressing in portions of this slope with sand dropseed and sideoats grama.

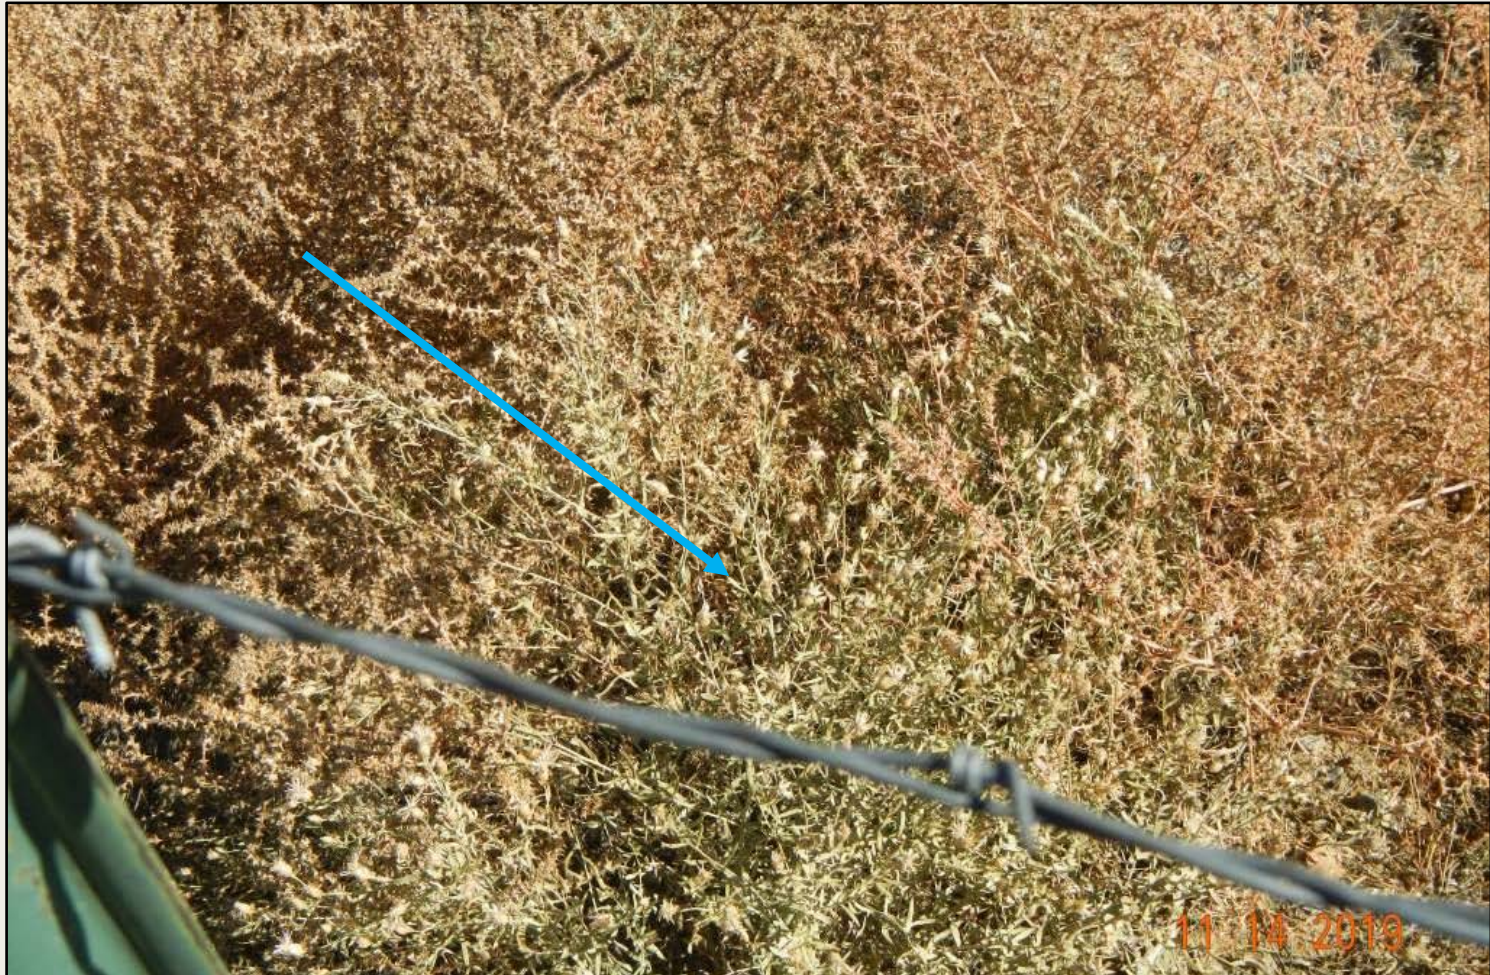
Photo 3. View of Russian knapweed and Russian thistles debris within the eastern project area. Approximately 500 Russian knapweeds observed.

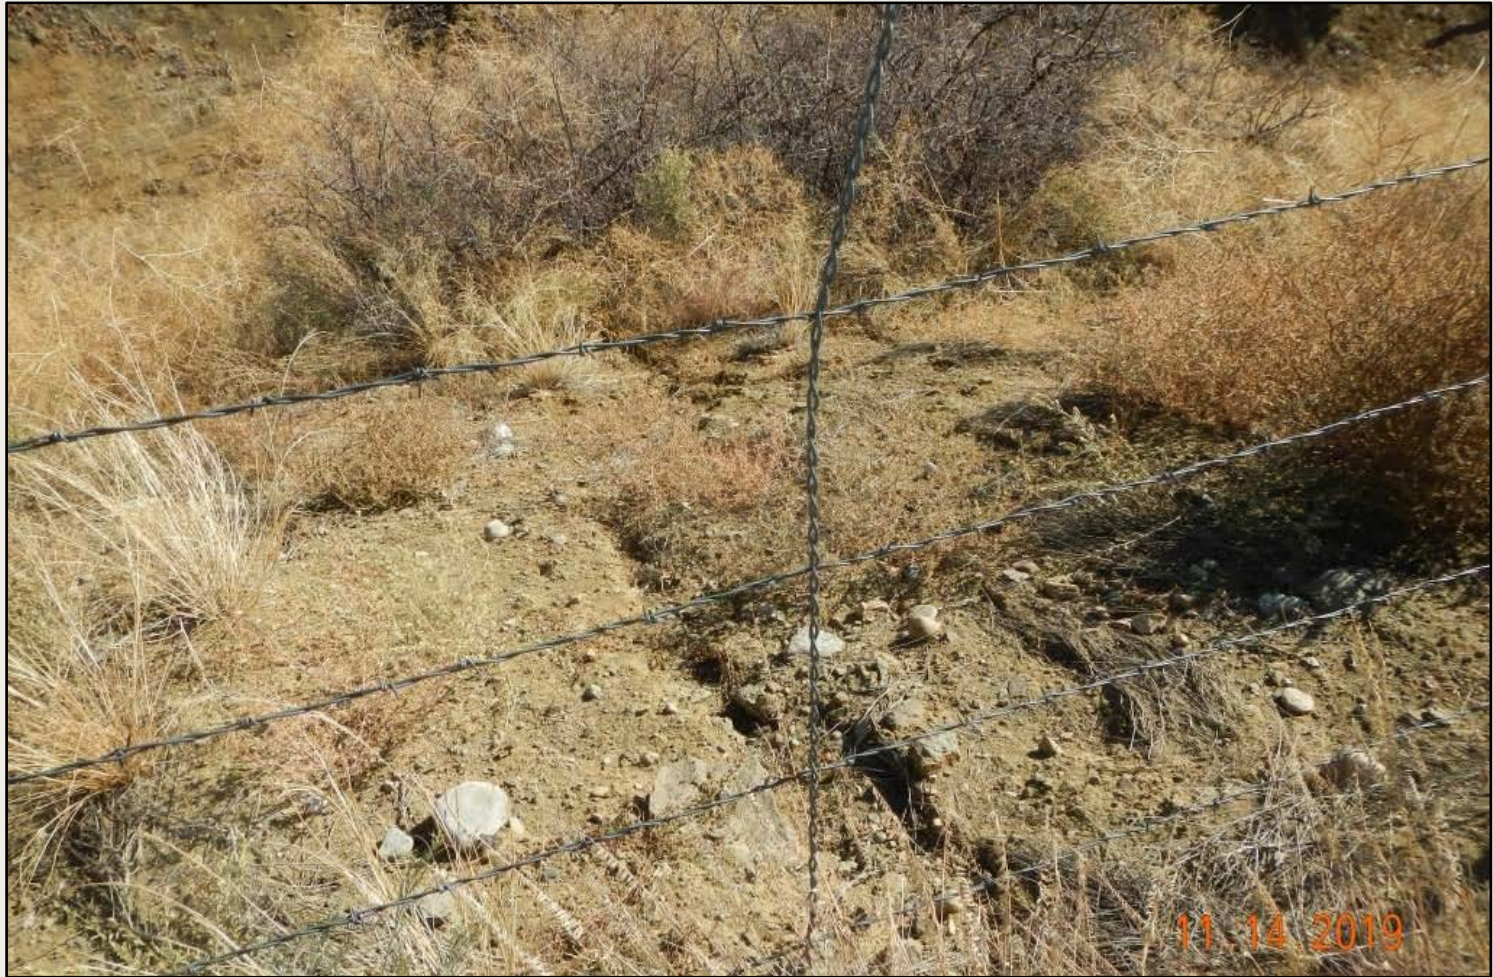
Photo 4. View of erosional rilling within the southeastern project area.

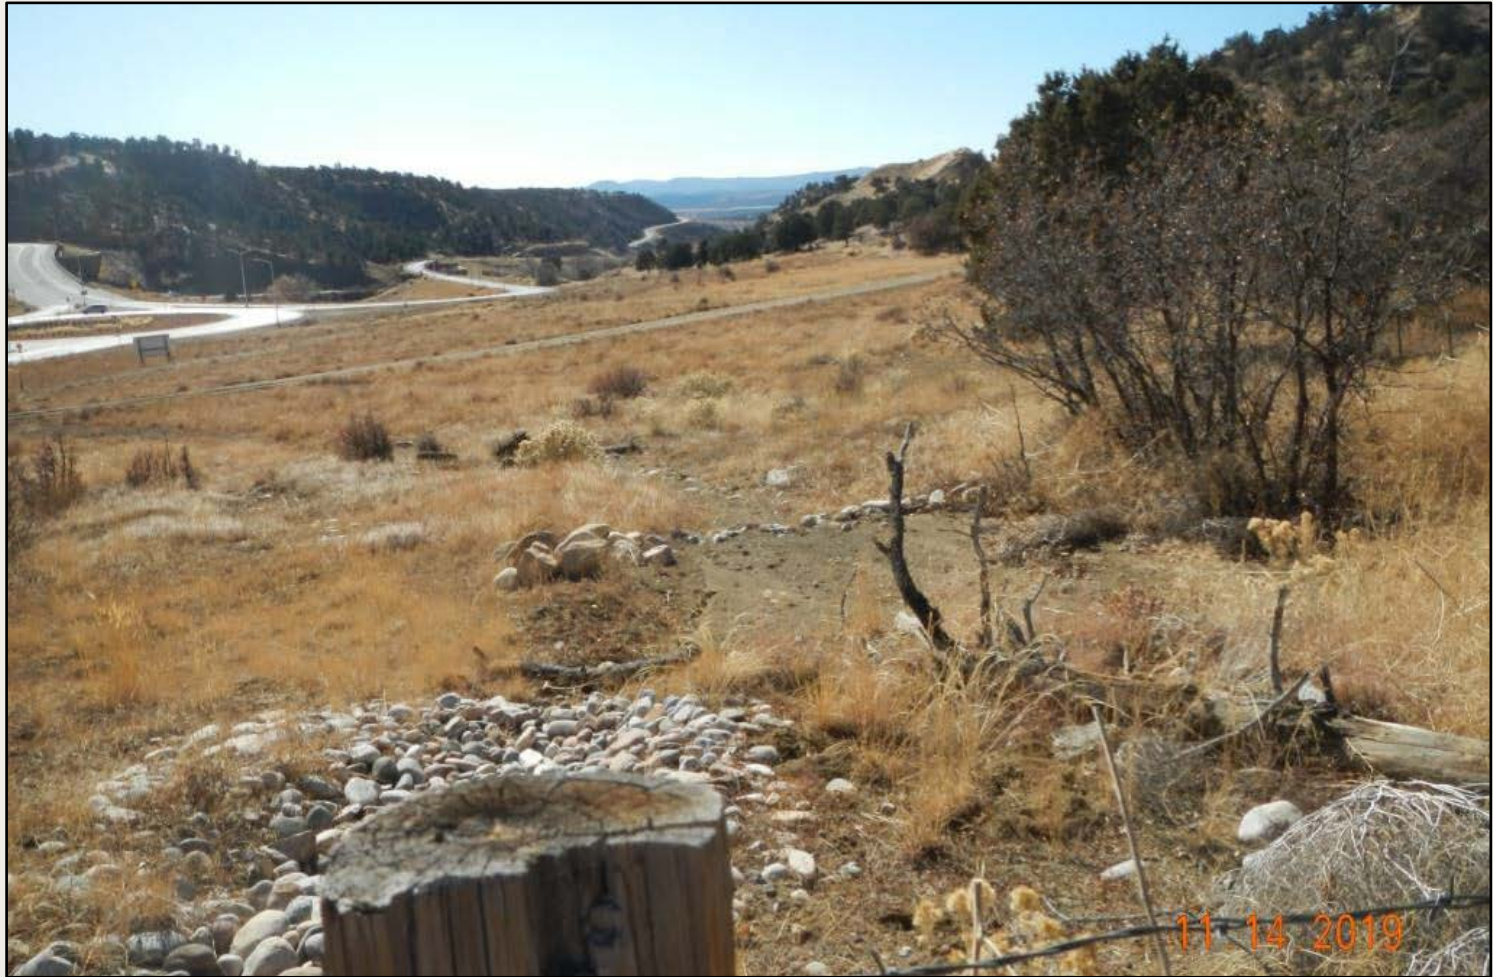
Photo 5. View of area in the southwestern project area where diverted stormwater flows deposit sediment. Stormwater controls are full of sediment and need maintenance.

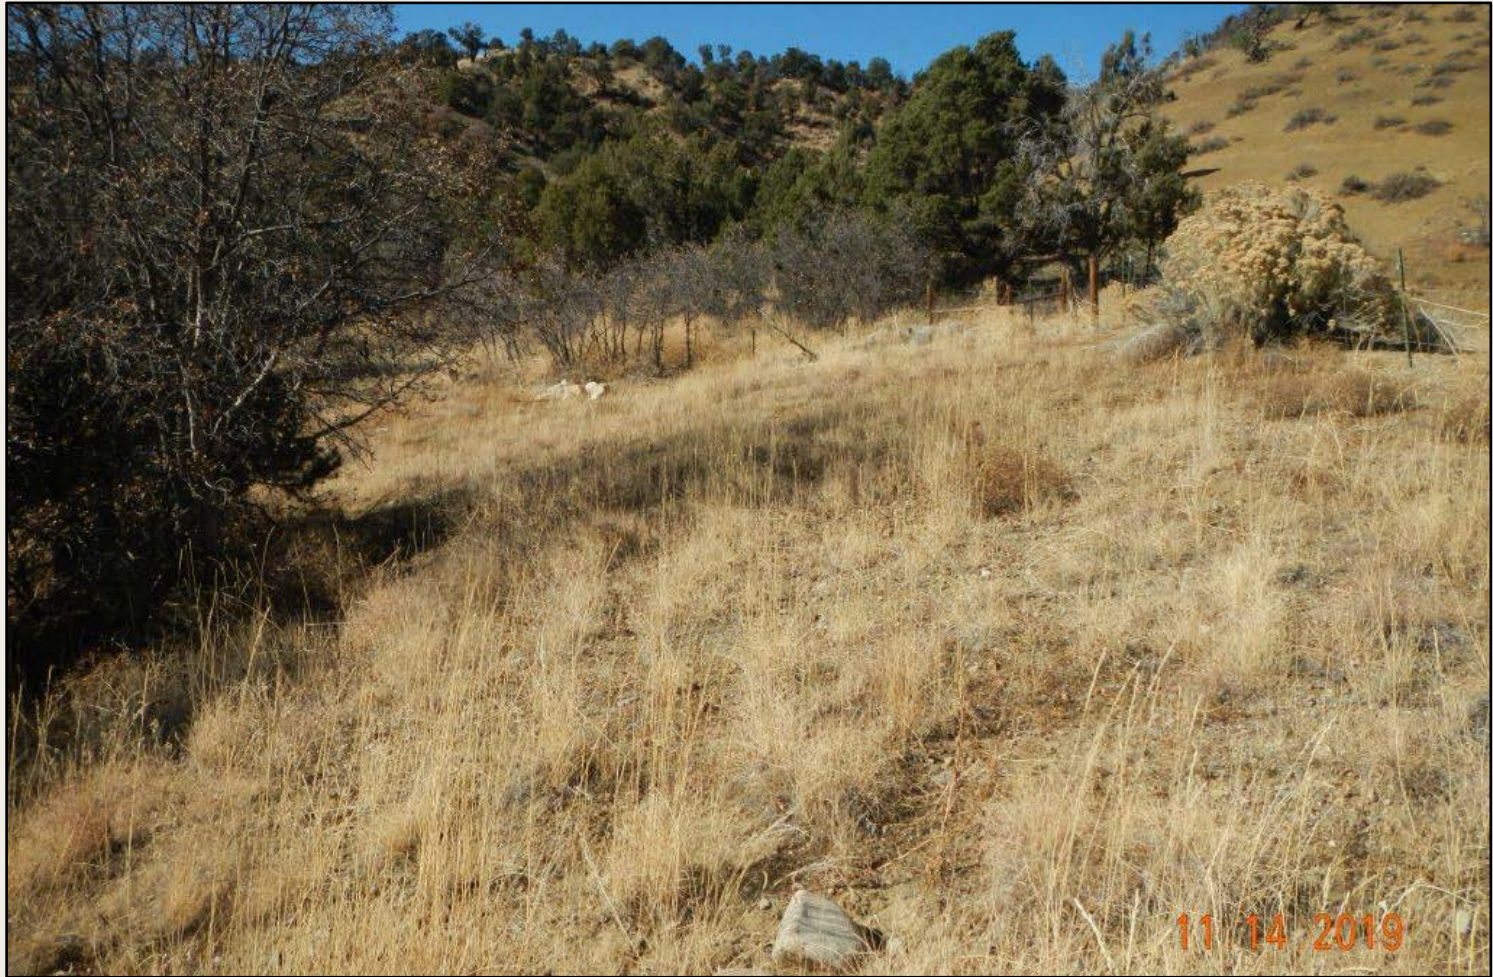
Photo 6. View of the southern project area from the southeastern edge facing westward. Revegetation is progressing here.

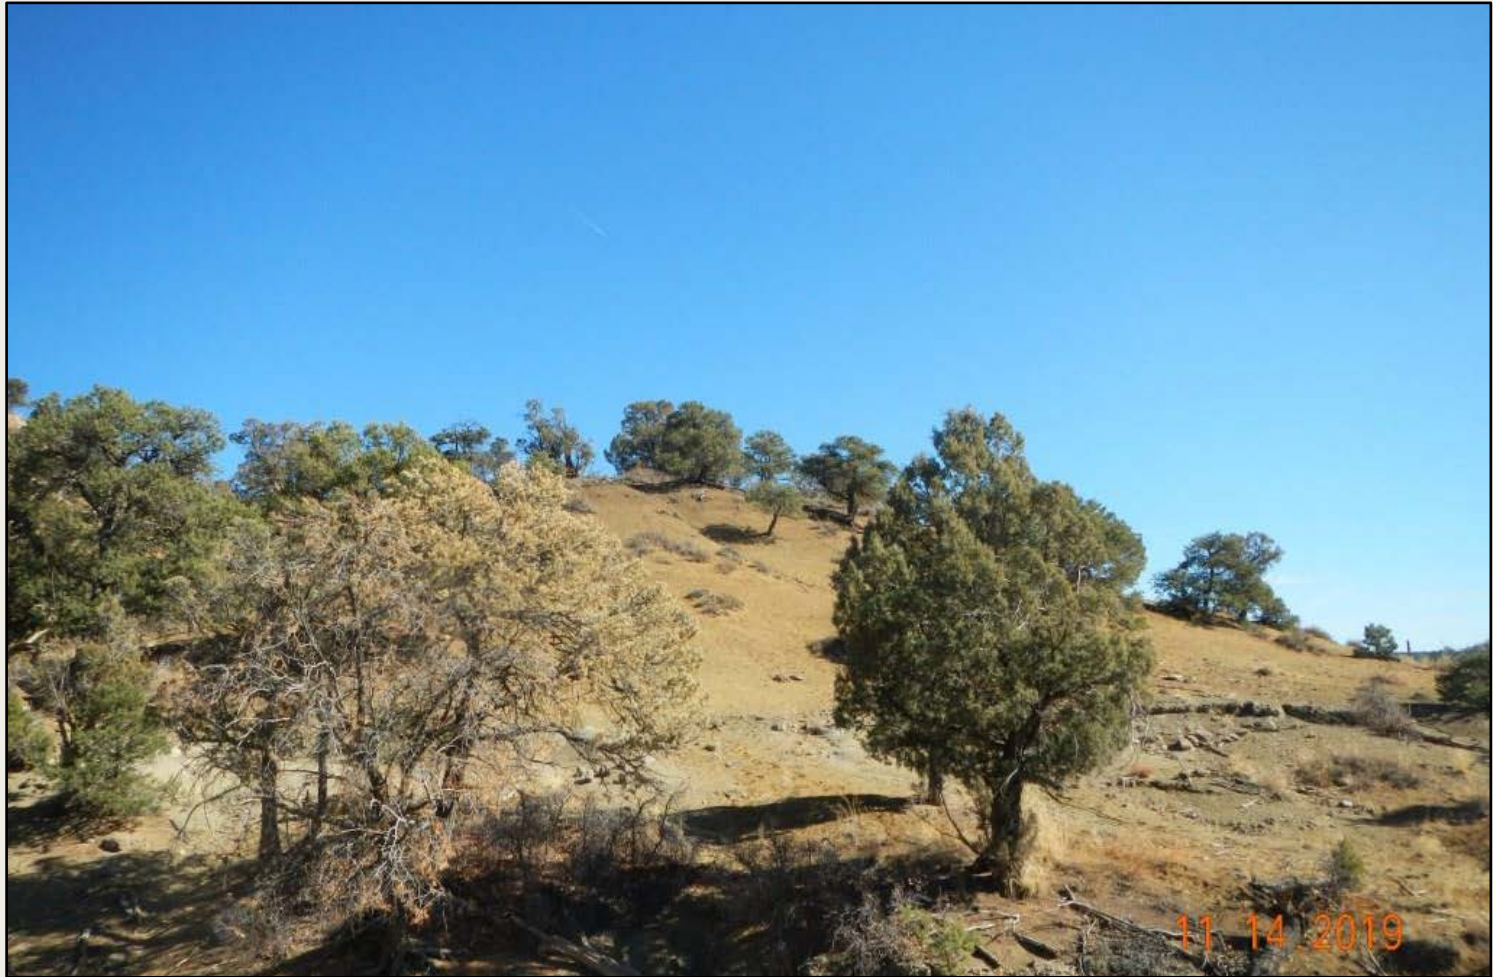
Photo 7. View of reference area, comprised of open pinyon juniper woodland with grasses, sagebrush, and buckbrush.
