Inspection Photos
Operator: Williford Resources
Location/API #: 067-06718
Date: 11-19-2019

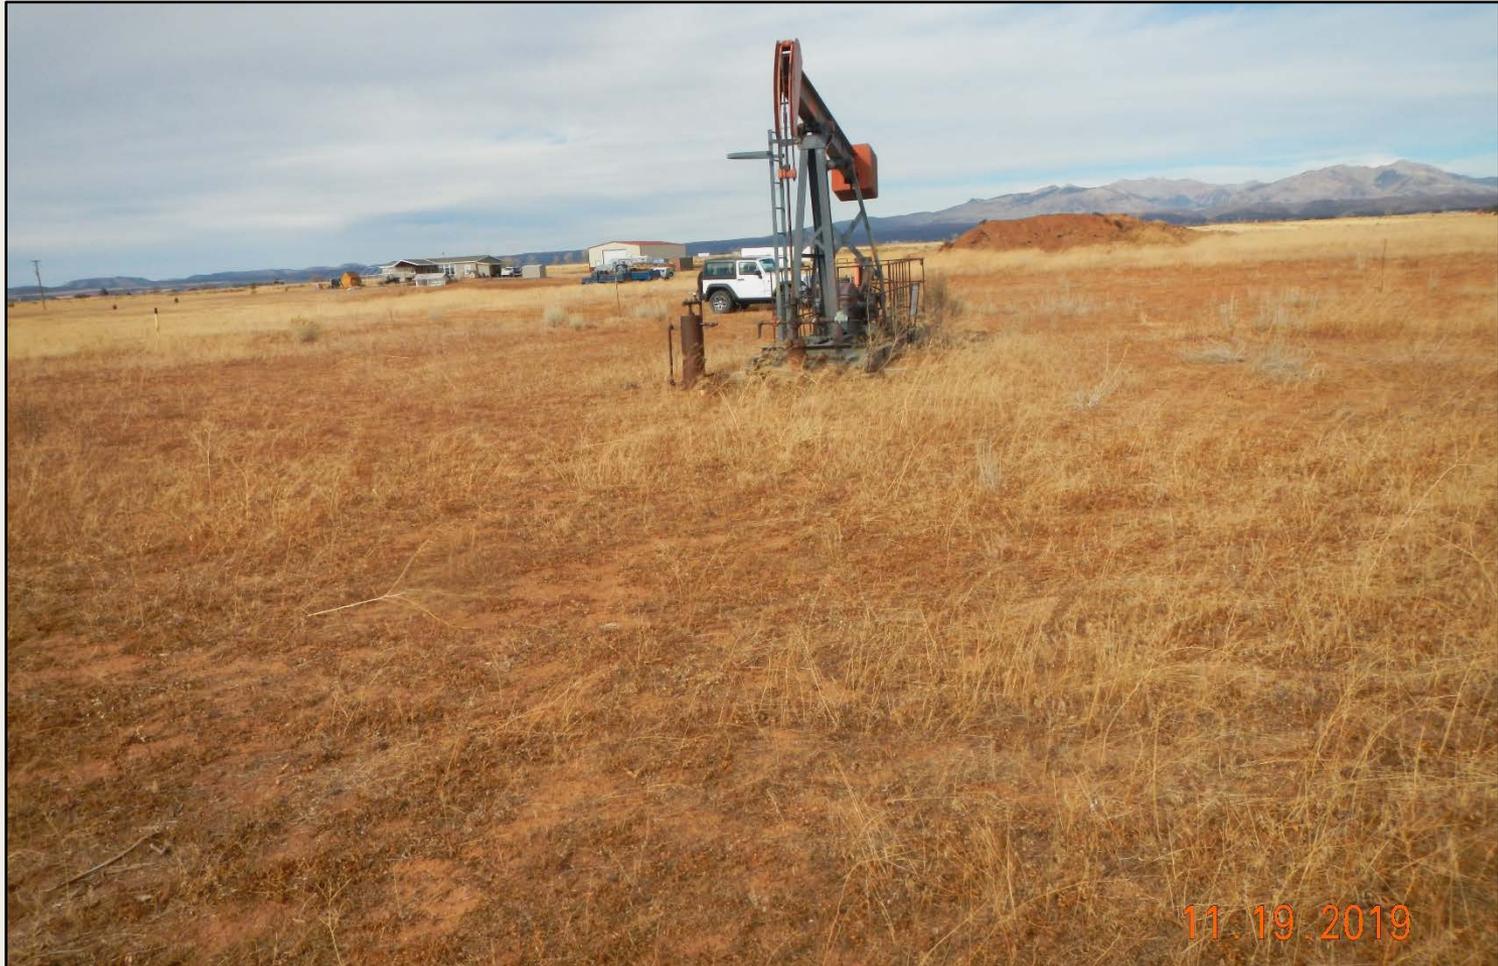
Photo 1. View of the project area from the southeastern corner facing center. Soil pile in background appears to be surface owner excavation.

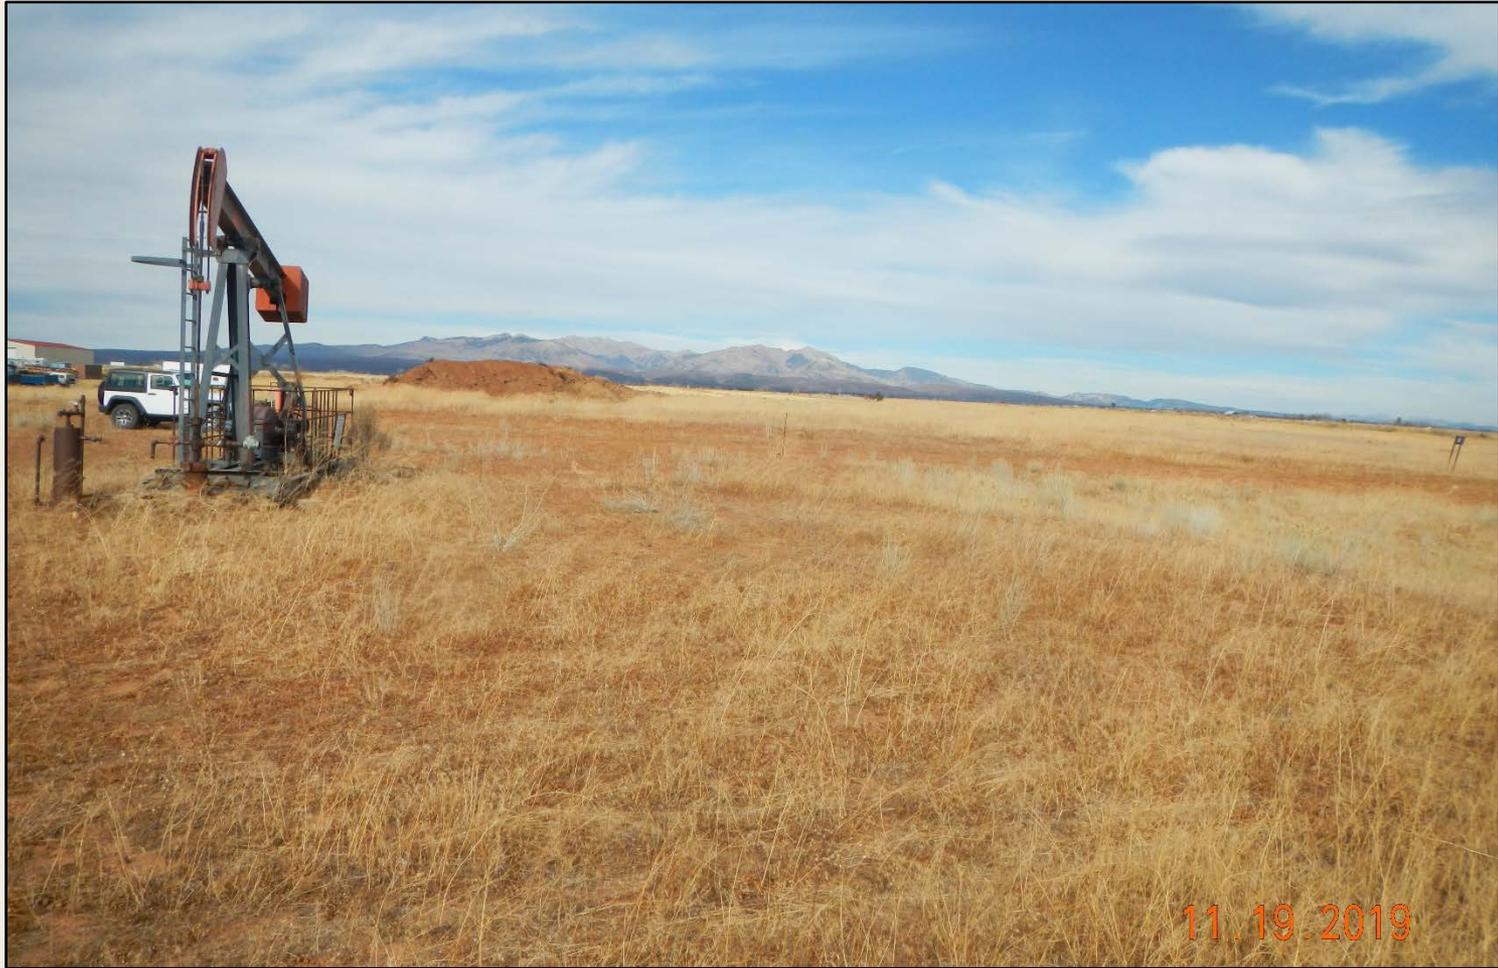
Photo 2. View of the eastern project area from the northeastern corner facing southward. Revegetation is progressing in portions of the project area with mixed wheatgrasses, such as crested wheatgrass and western wheatgrass, as well as annual weeds such as cheatgrass and alyssum.

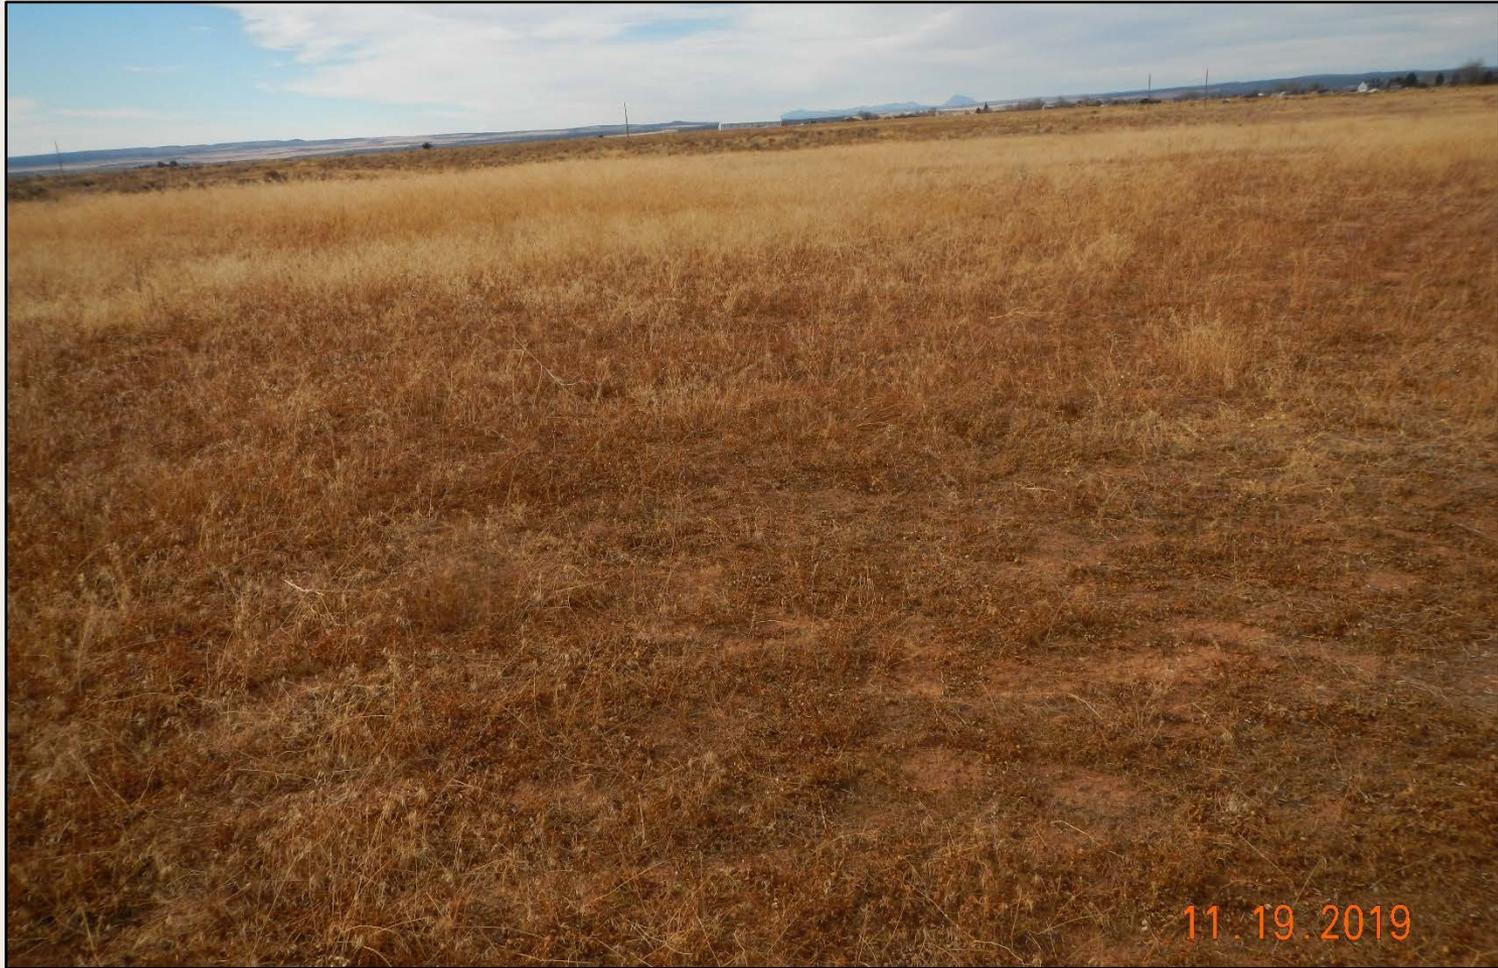
Photo 3. View of reference area, comprised of open grass field.
