# Inspection Photos

API: 05-043-40002

Operator: JAVERNICK OIL

Inspection Date: 12/4/2019

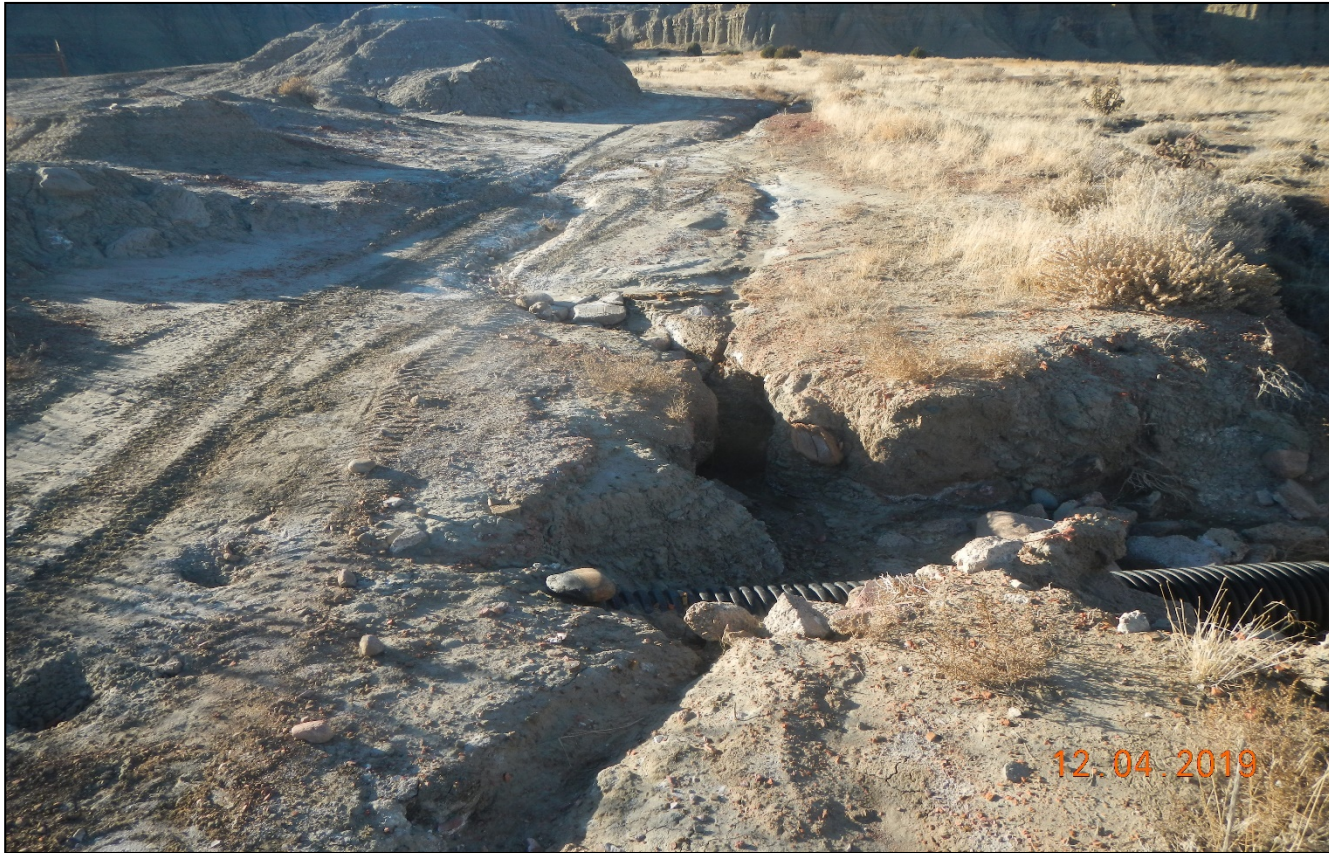
**Photo 1.** Facing west along the access road. There are erosion issues that must be repaired.

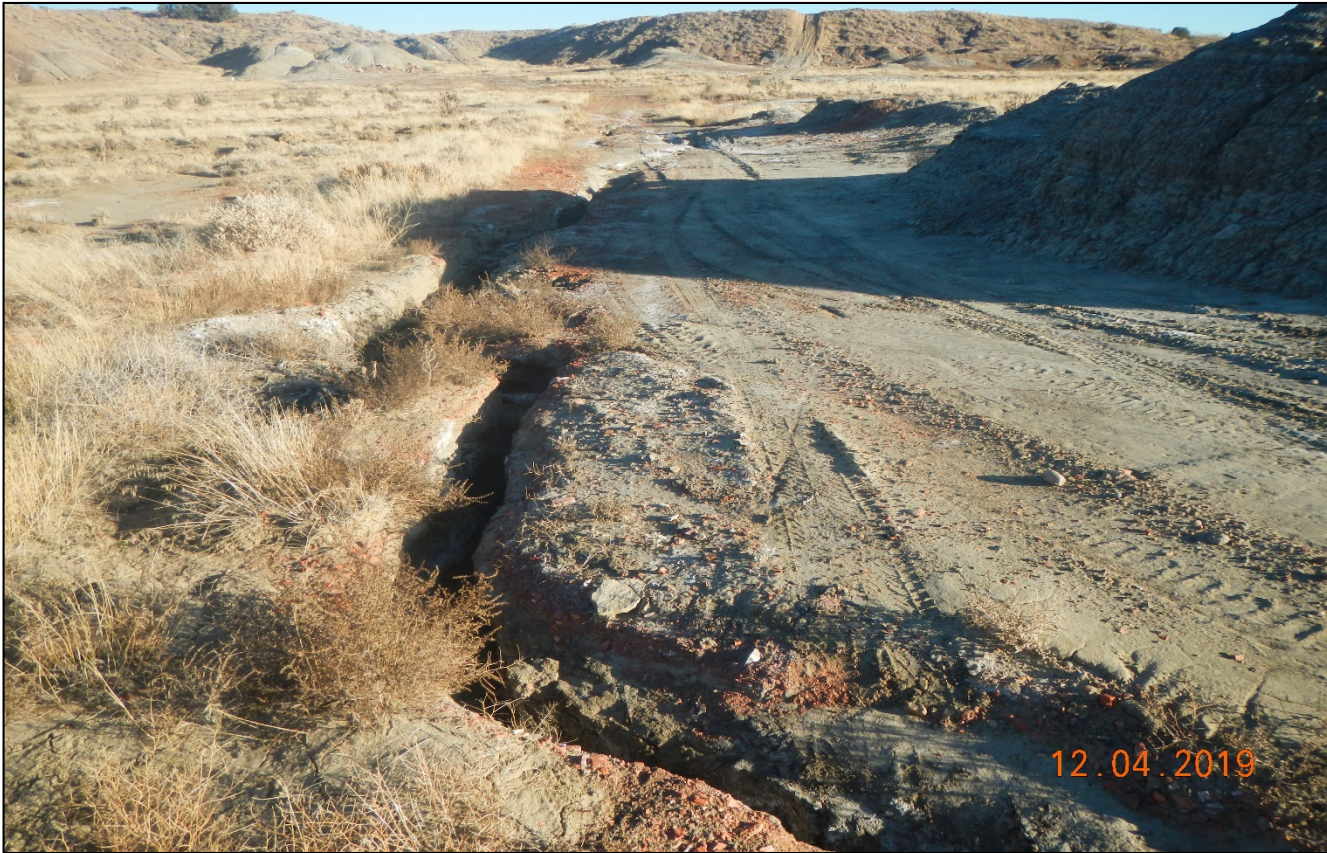
**Photo 2.** Facing back toward the east. There is a deep erosion channel that has degraded the main access road that must be repaired.

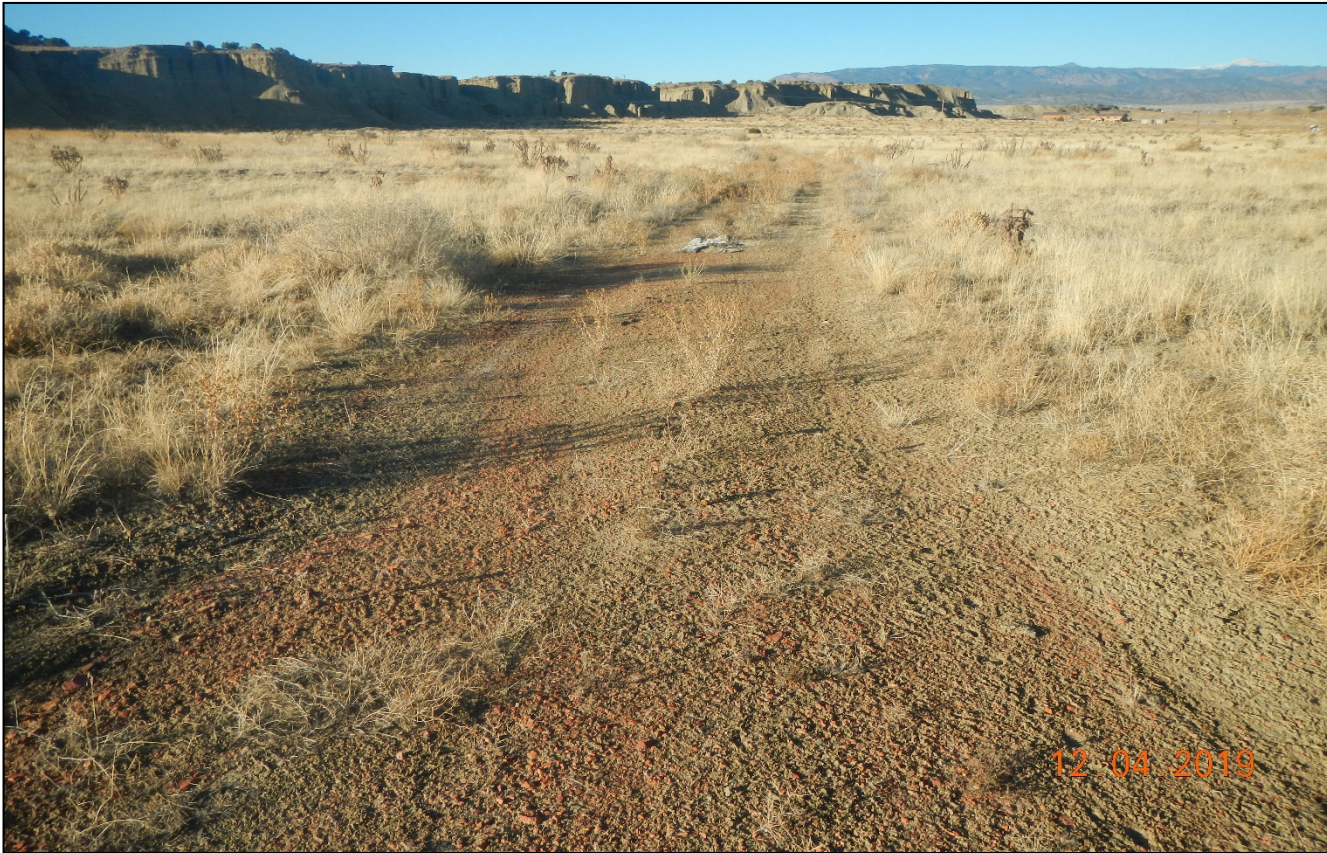
**Photo 3.** Facing northwest toward the access road. This portion of the access road which goes to the location must be reclaimed.

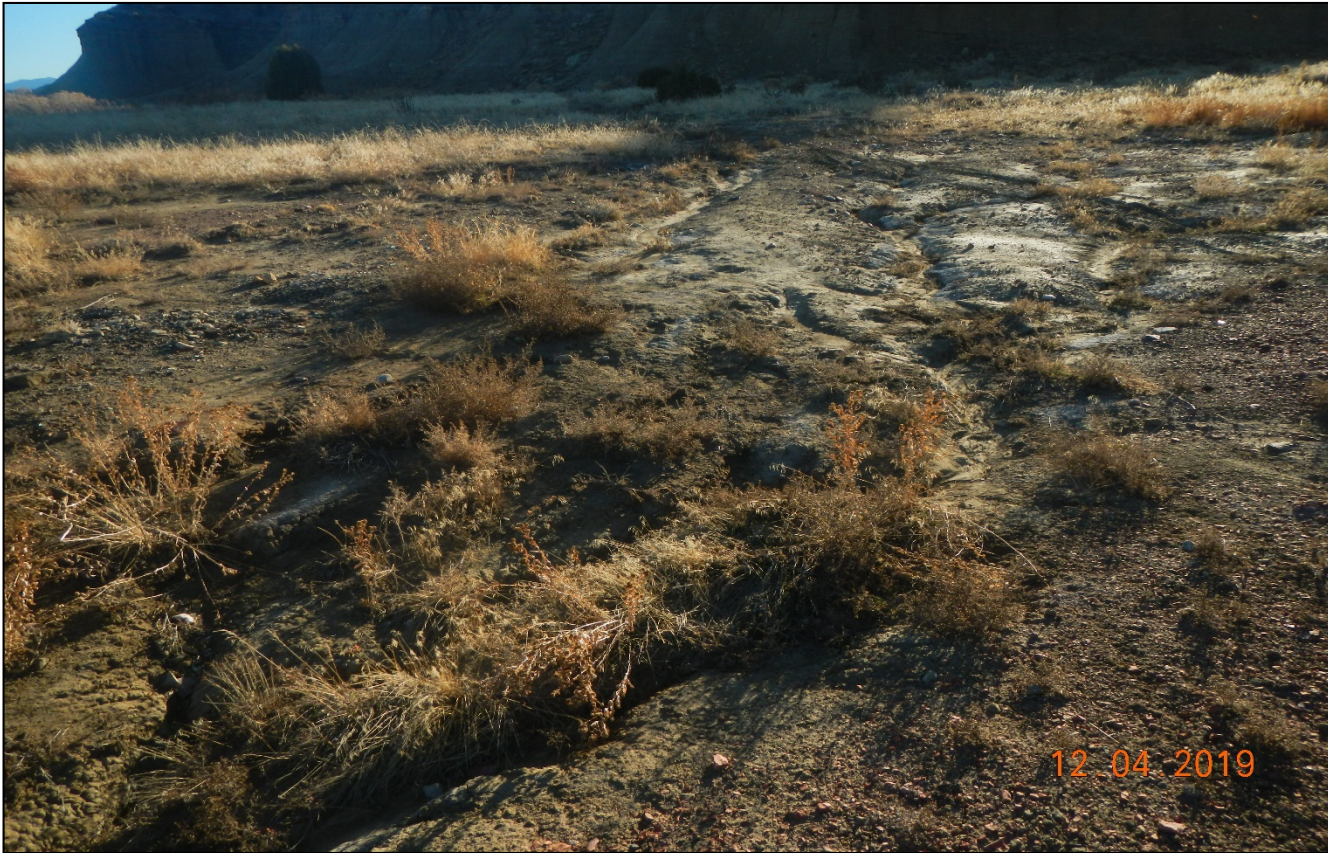
**Photo 4.** Facing southwest at the location there are erosion issues at the location and reclamation has not been performed.

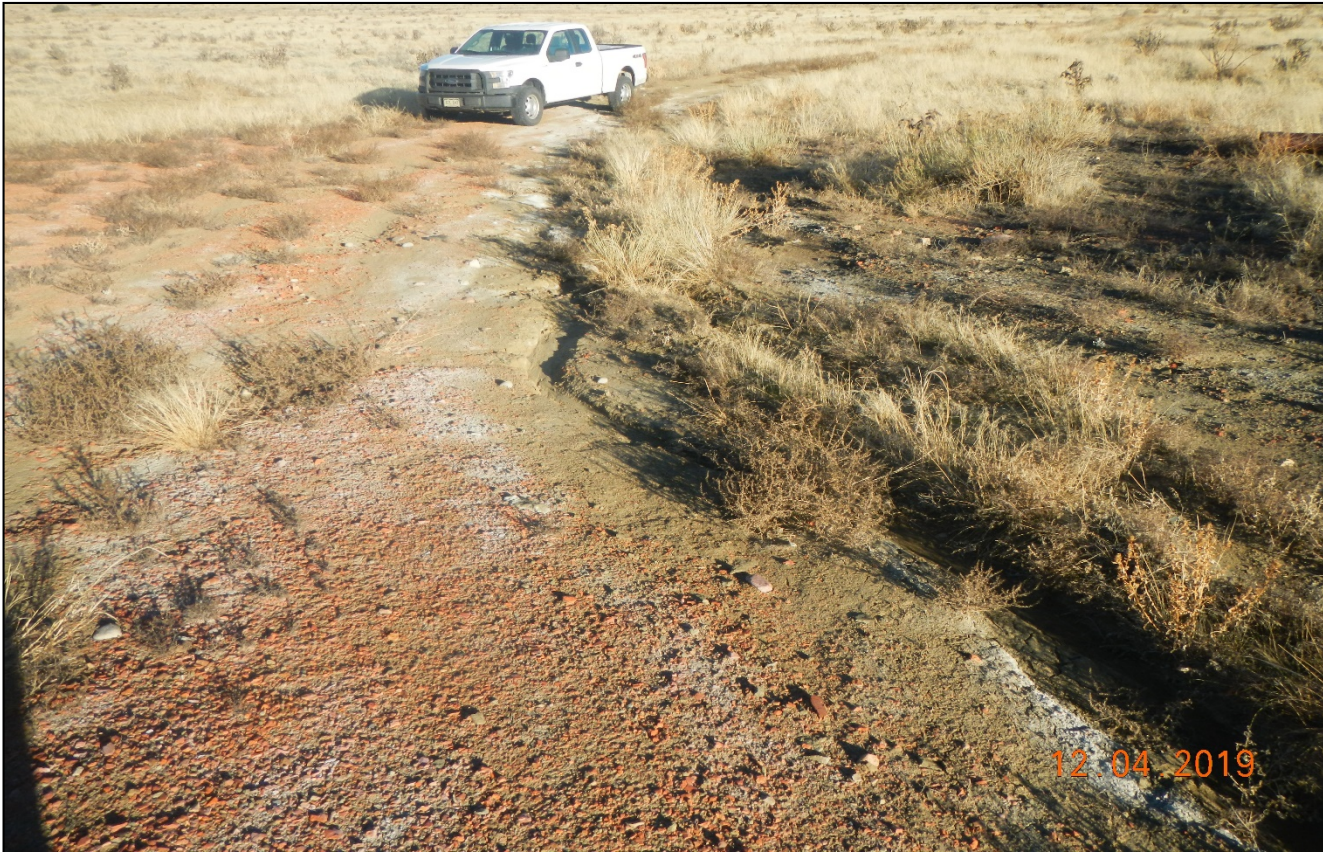
**Photo 5.** Facing back toward the east. The location has not been reclaimed and erosion is occurring.

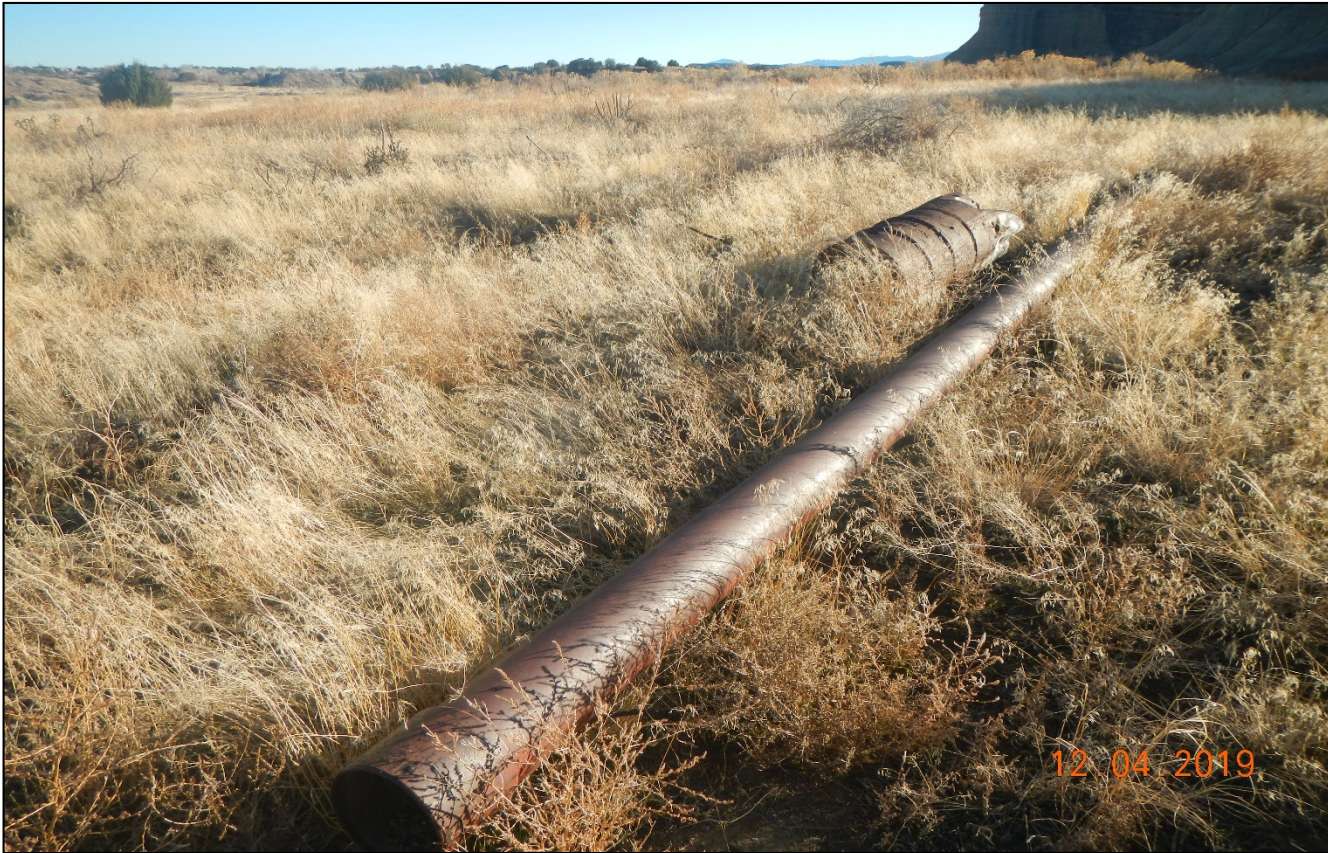
**Photo 6.** There is equipment and debris that remains at the location.

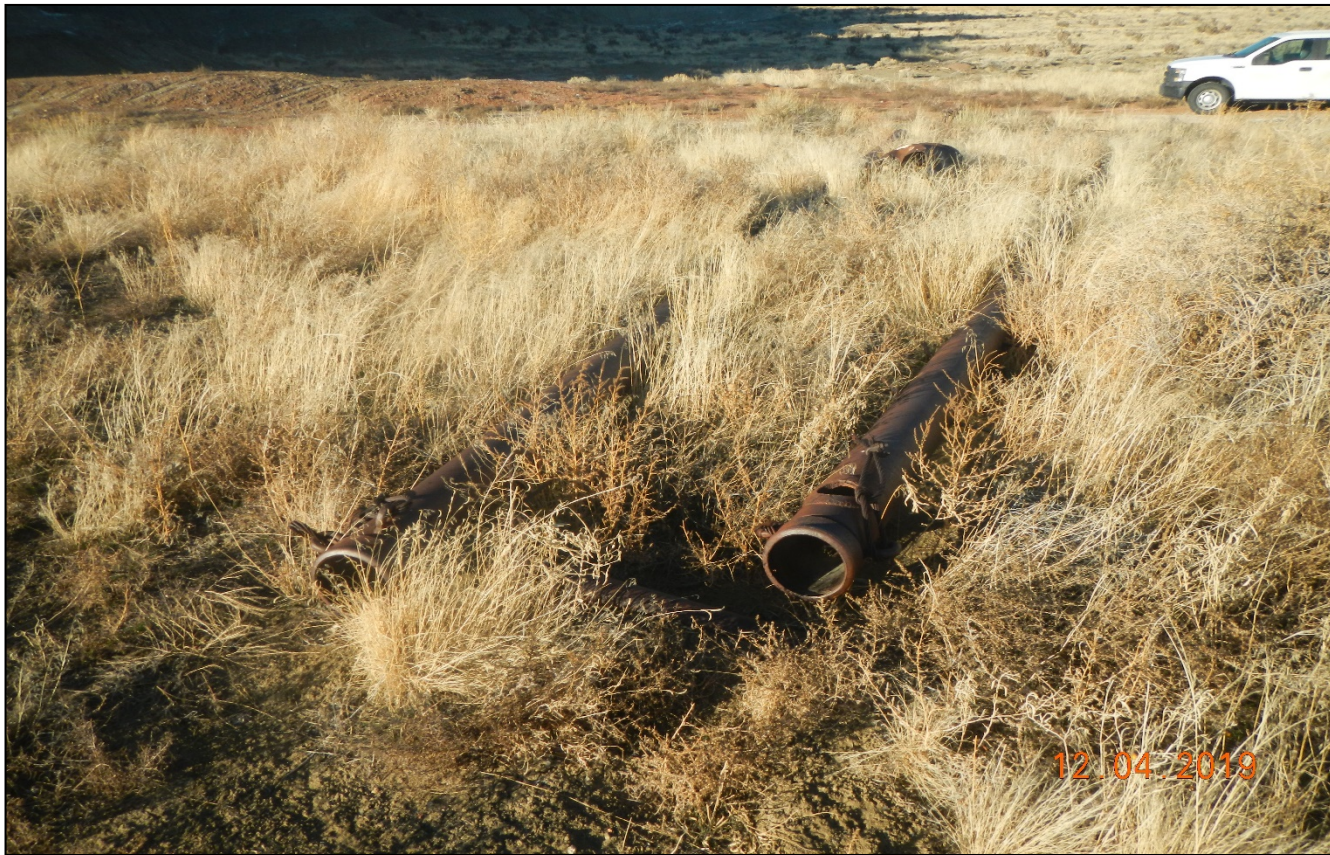
**Photo 7.** There is equipment and debris that remains at the location.

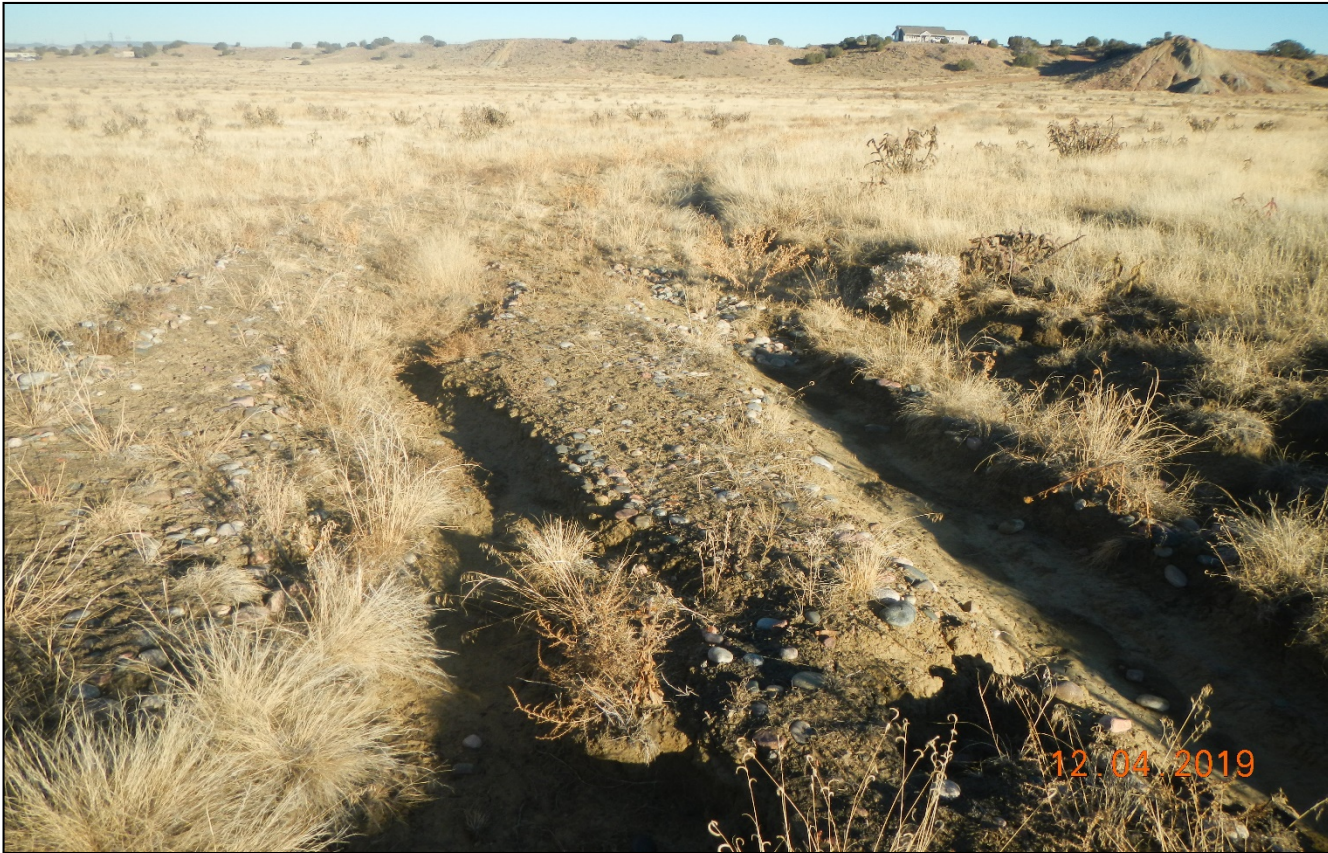
**Photo 8.** Facing back toward the east. The location has not been reclaimed and erosion is occurring.
