Inspection Photos

API: 05-043-05088

Operator: JAVERNICK OIL

Inspection Date: 12/4/2019

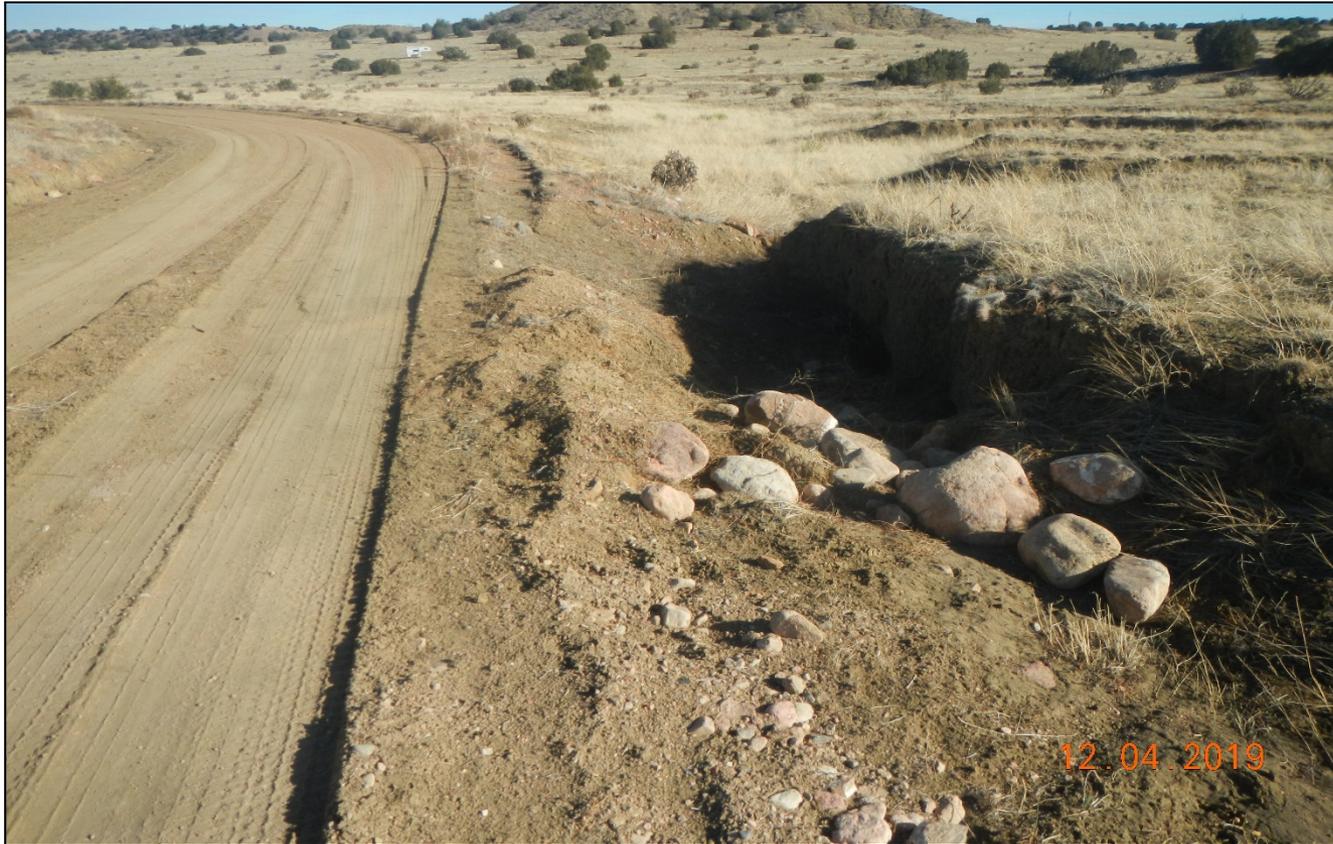
Photo 1. The erosion along the access road has not been repaired and stabilized. It appears rocks were placed at the erosion channel but are inadequate and not installed per good engineering practice. (Lat/Long:38.33276,-105.11330)

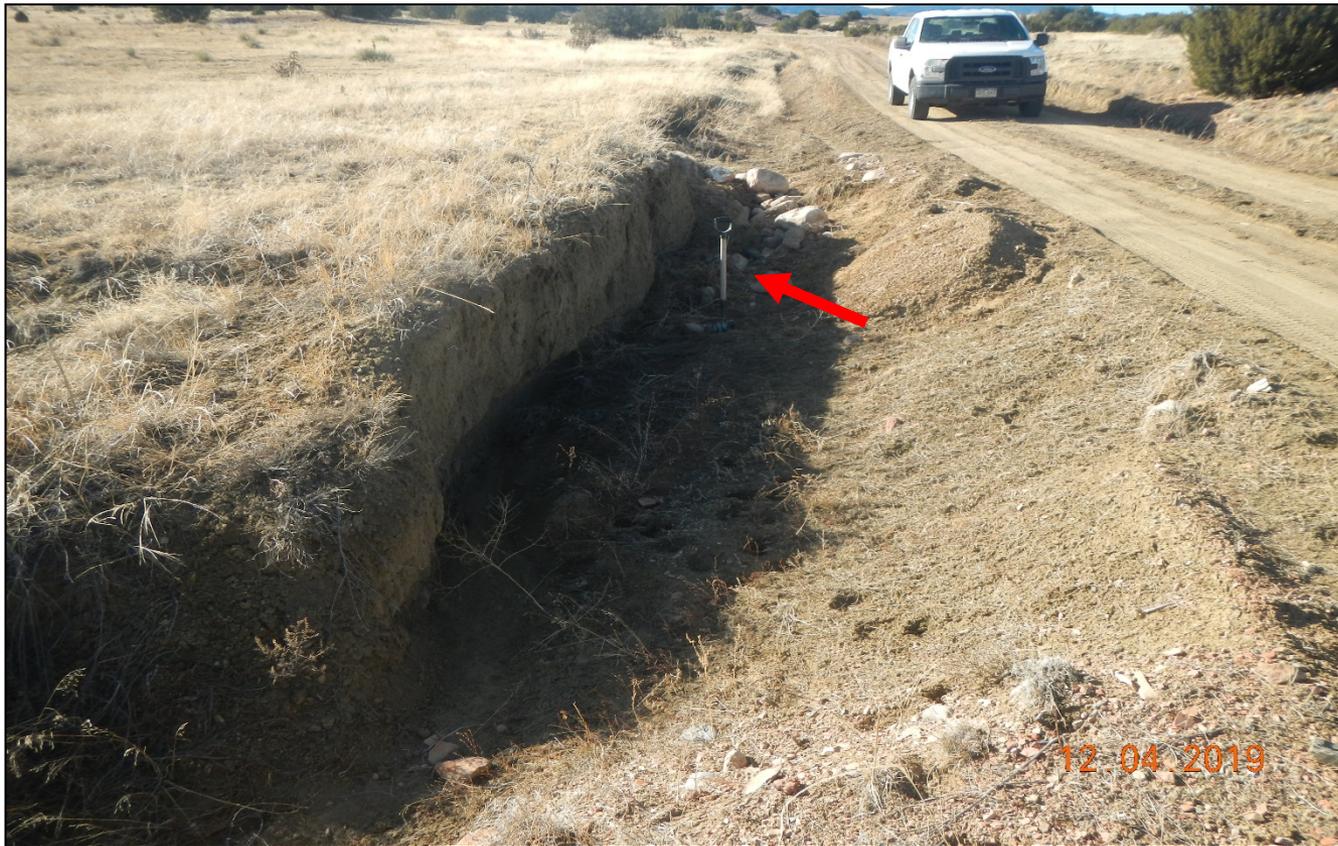
Photo 2. View of the erosion channel along the access road. Arrow points to 3.5 ft. shovel placed in the channel to show depth and size.

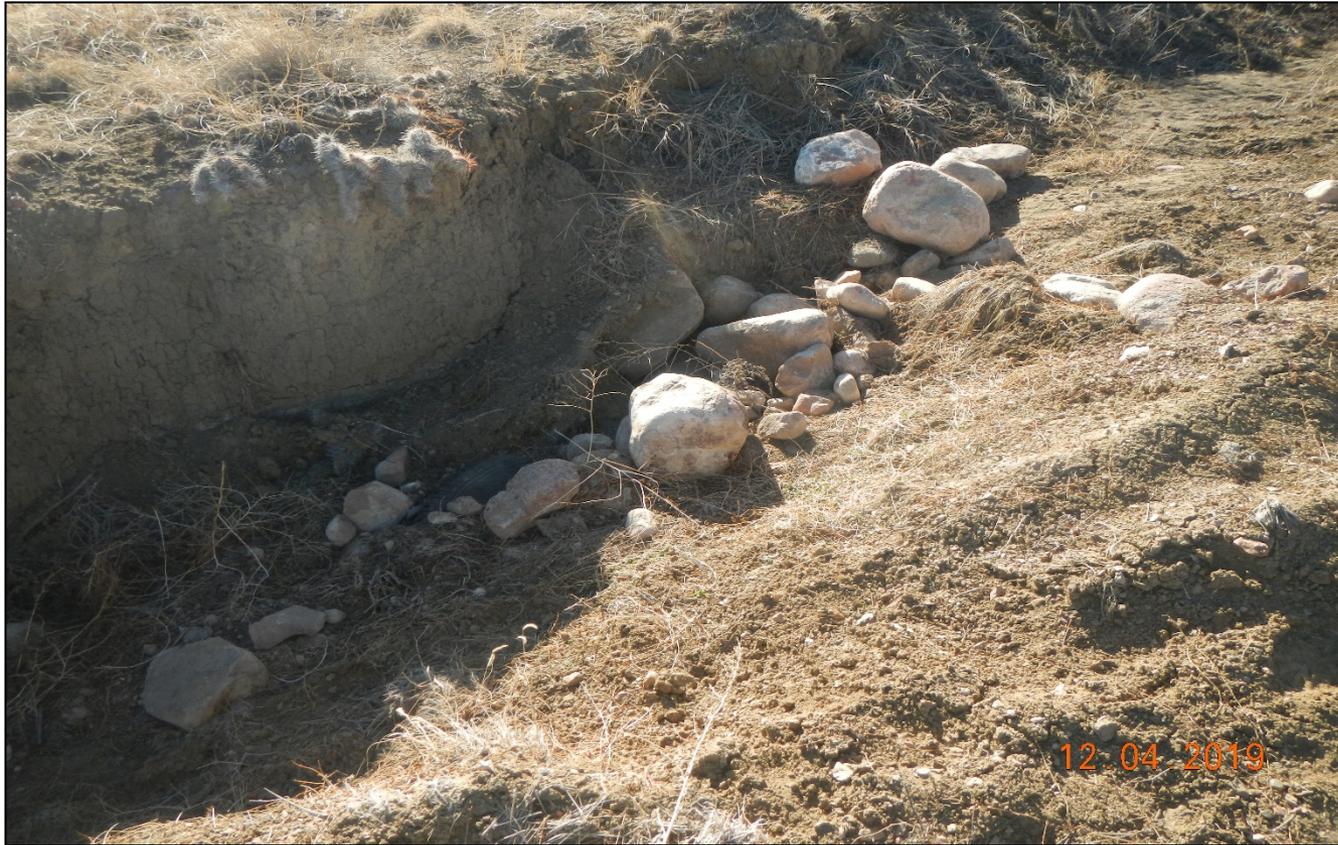
Photo 3. View of rocks placed in channel which is not properly installed and is not an effective stormwater control.

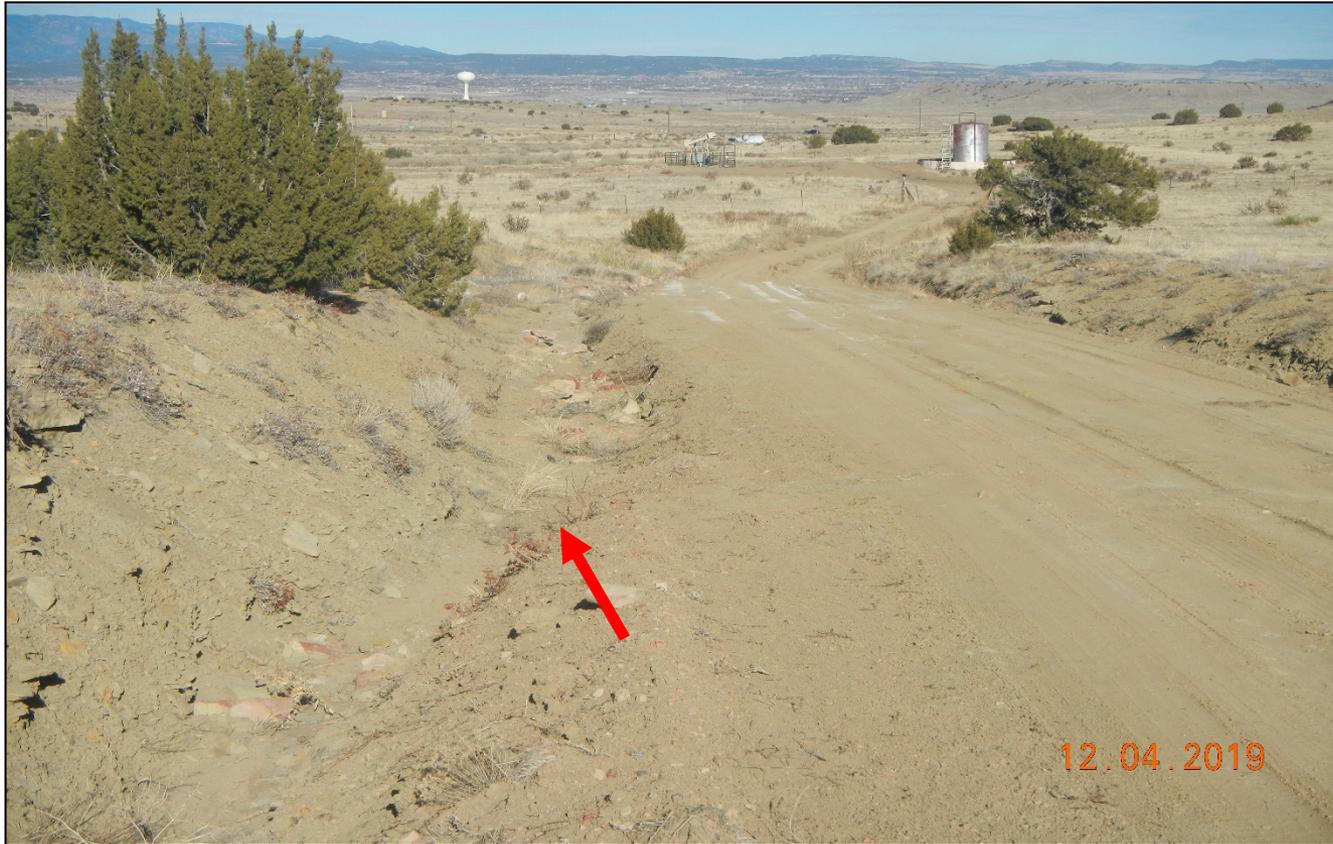
Photo 4. There is erosion occurring along the road toward the location. No BMP's are installed to prevent erosion.

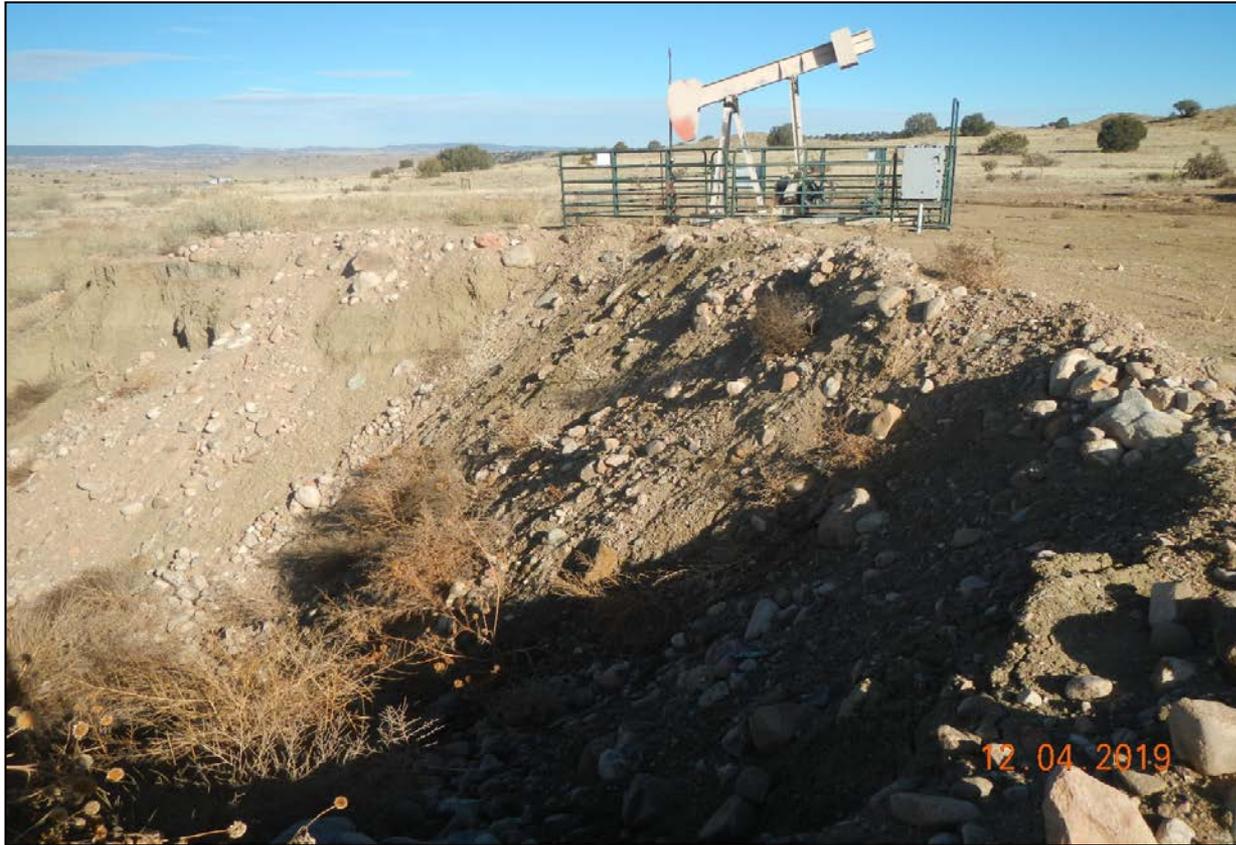
Photo 6. It appears additional material has been placed in the embankment near the wellhead. This material is loose and not stabilized.

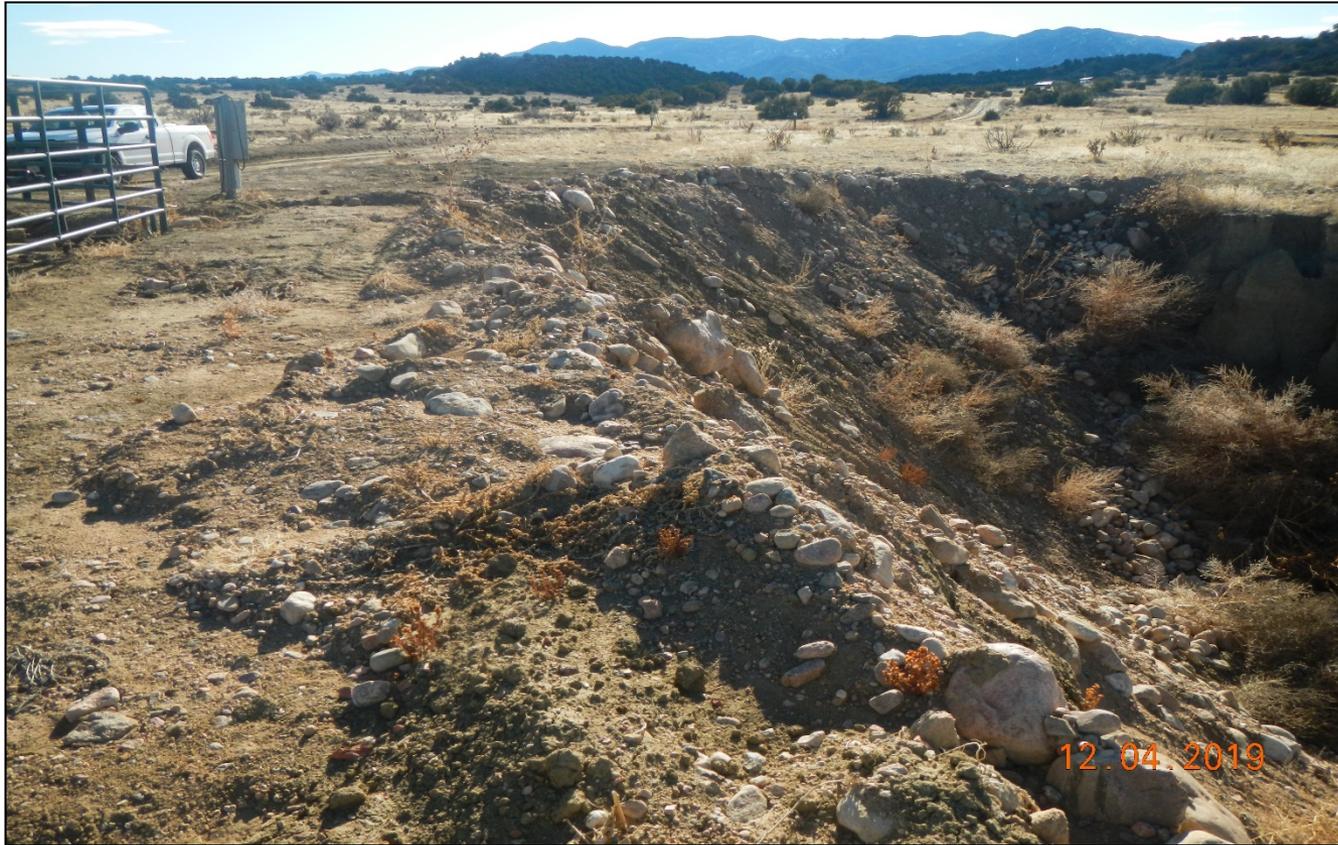
Photo 7. View of the western project area from the western edge facing southward. Wellhead is adjacent to an erosion channel. This area needs immediate stabilization to prevent any further erosion.

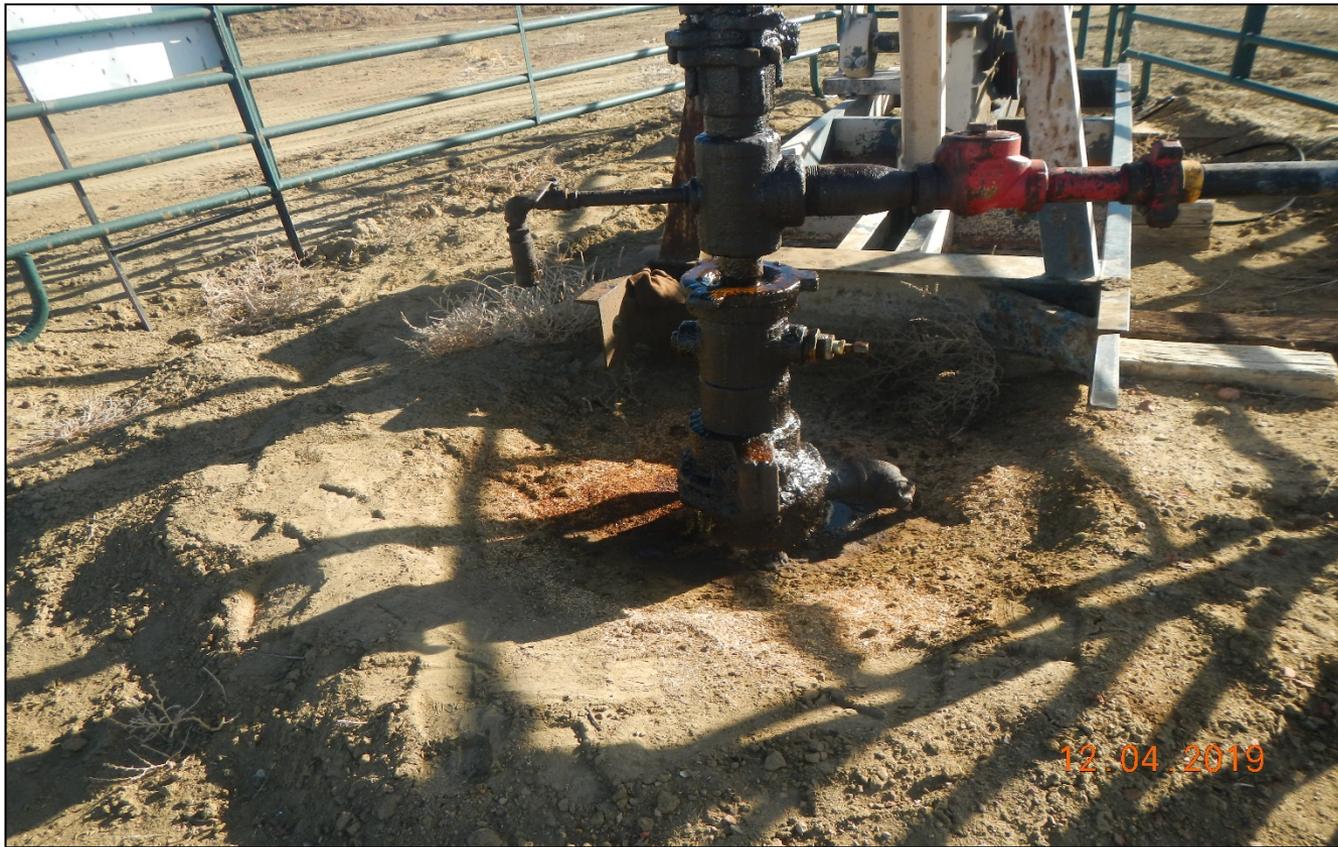
Photo 8. Oil leakage was observed from the wellhead.
