Inspection Photos

API: 05-043-40016

Operator: JAVERNICK OIL

Inspection Date: 12/4/2019

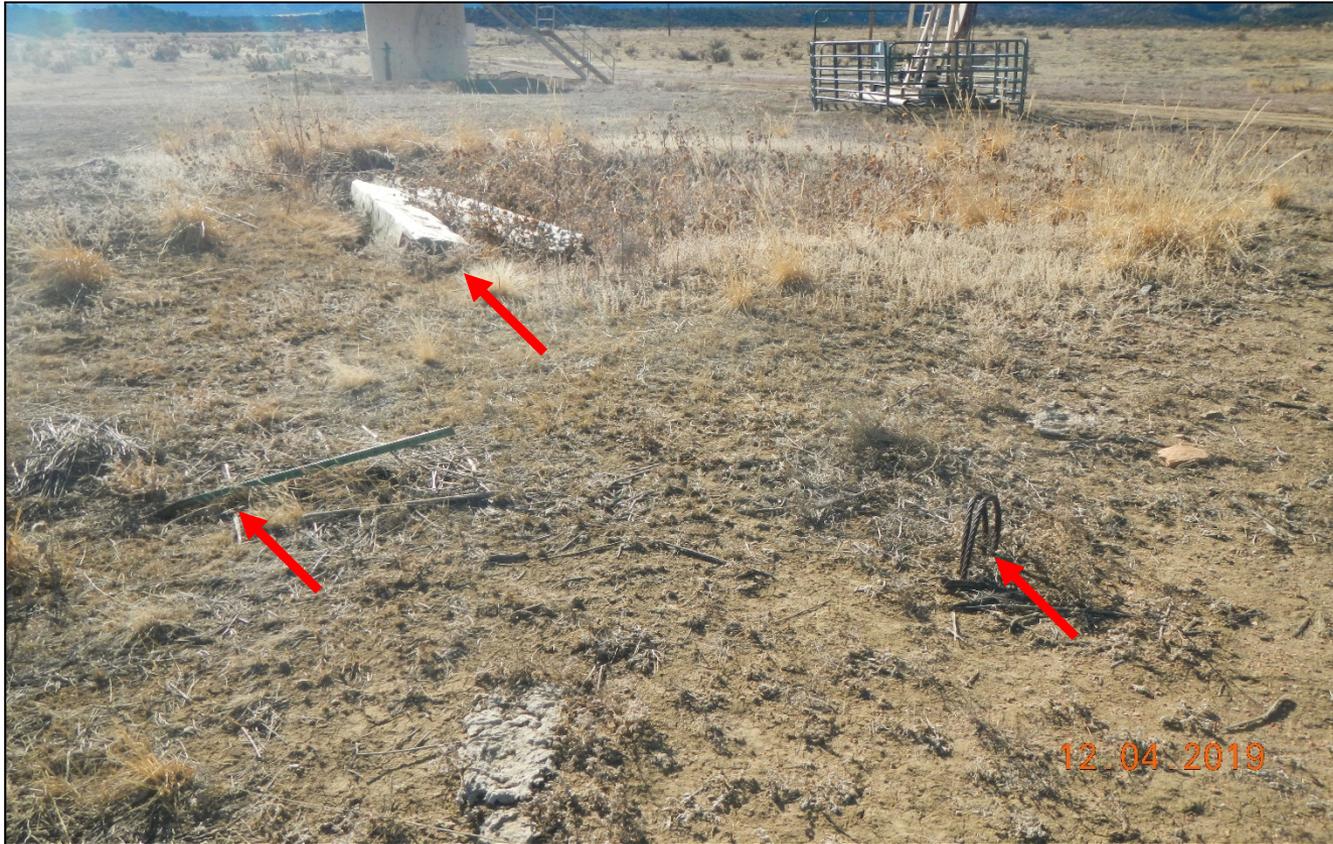
Photo 1. Facing southwest toward the location. There is a metal pipe, cable, and wood beams. This appears to be unused equipment and needs to be removed.

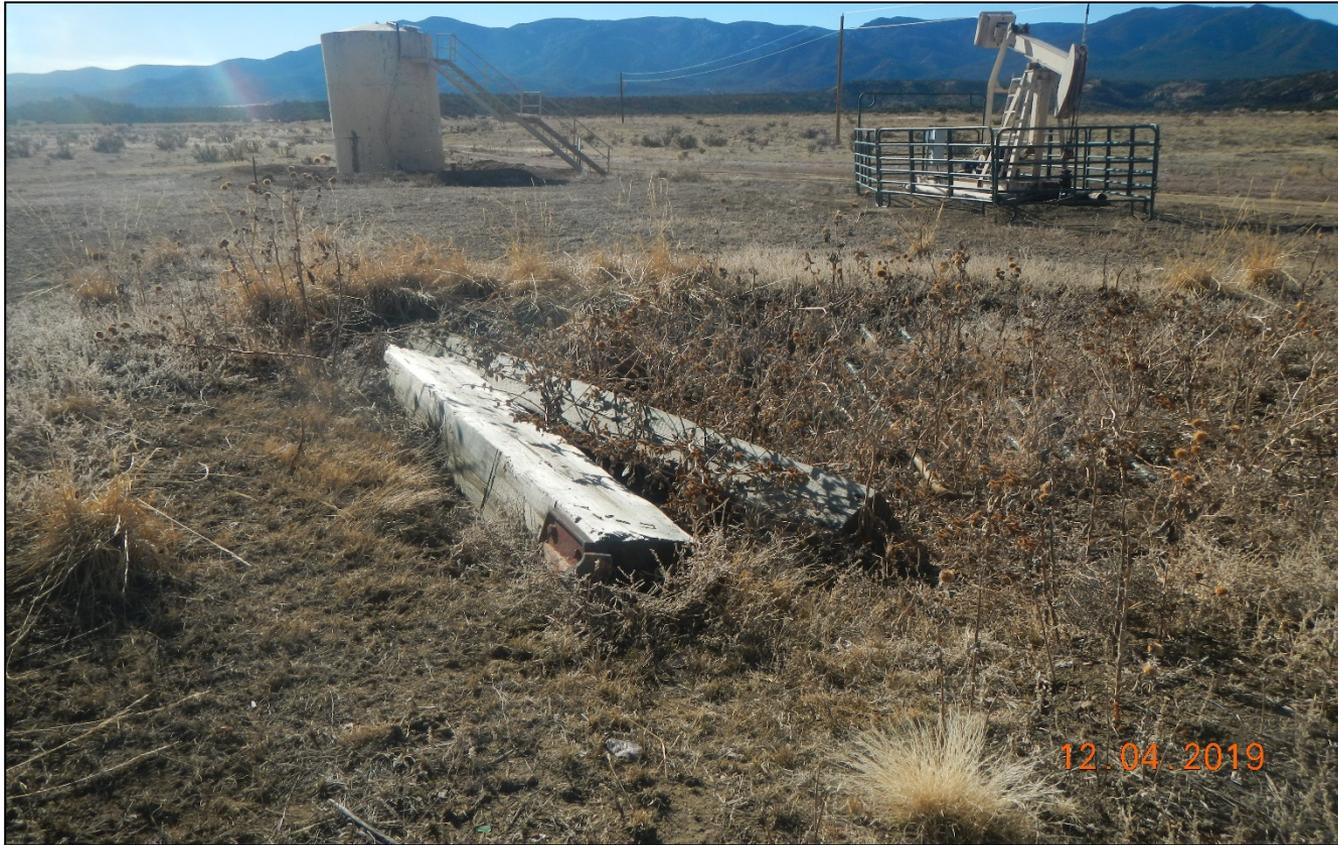
Photo 2. Wood beams and metal panel are located at north side of the location. Unused equipment needs to be removed.

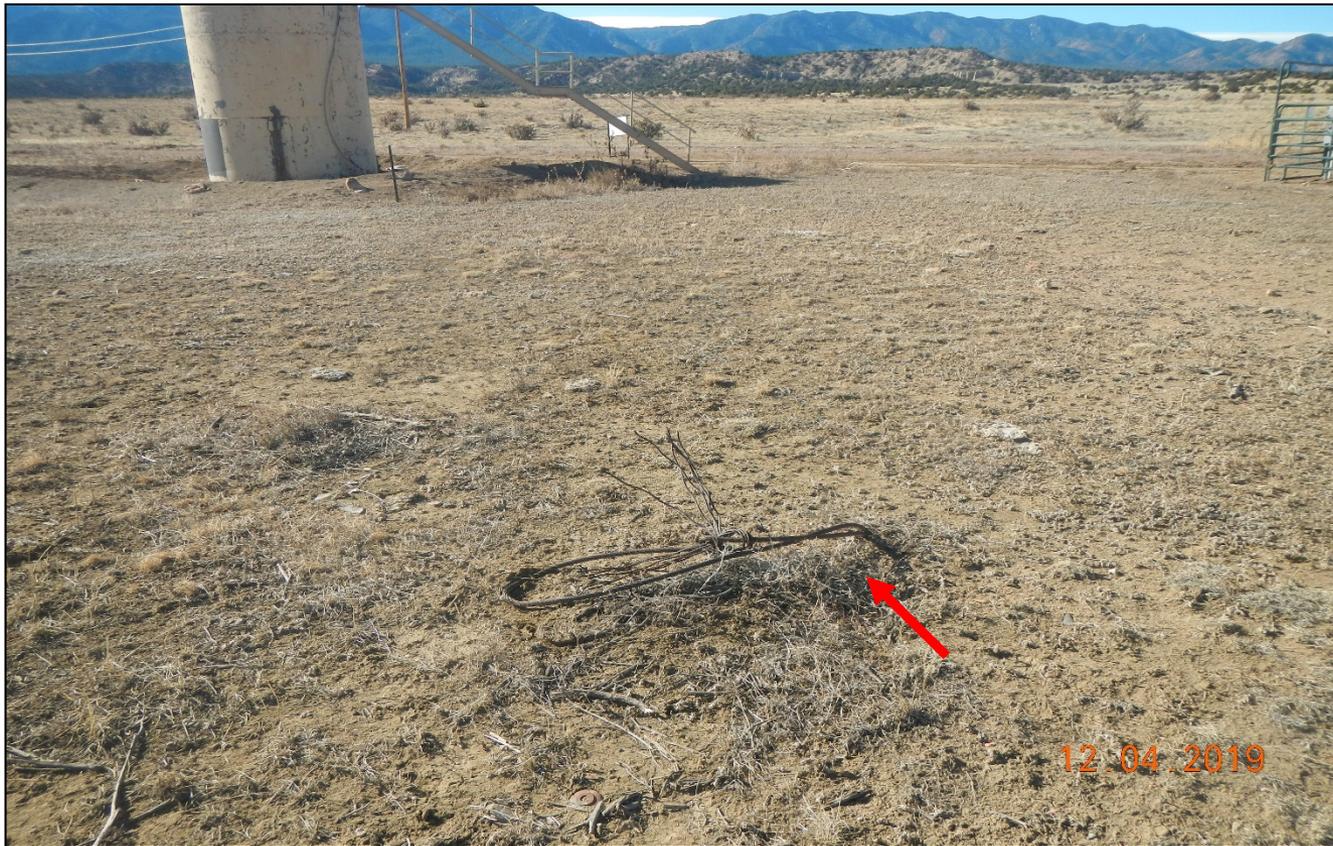
Photo 3. Metal cable extends from the ground east of the well.
