Inspection Photos

API: 05-043-06224

Operator: JAVERNICK OIL

Inspection Date: 12/4/2019

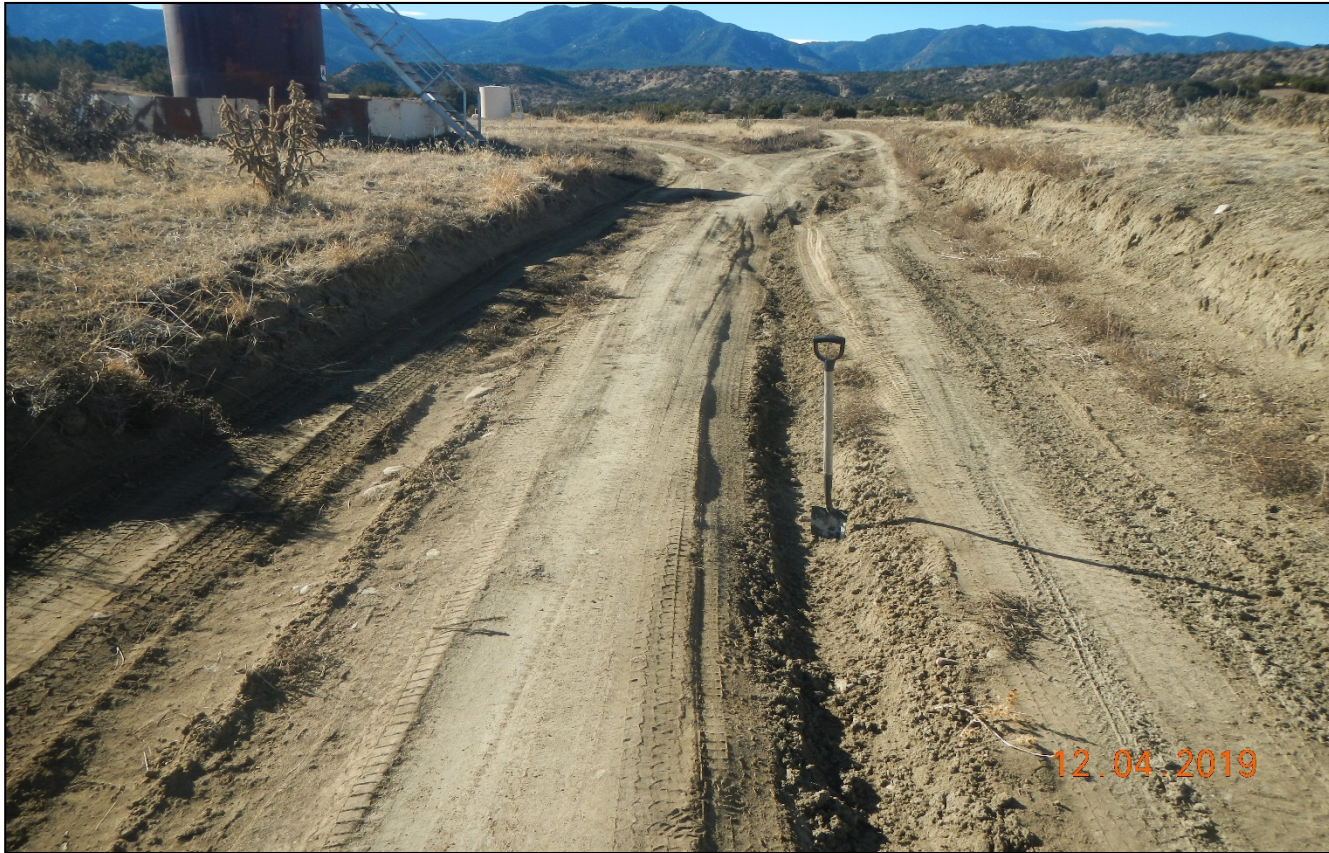
Photo 1. Facing southwest along the access road. There is vehicle rutting and erosion along the access road toward the location.

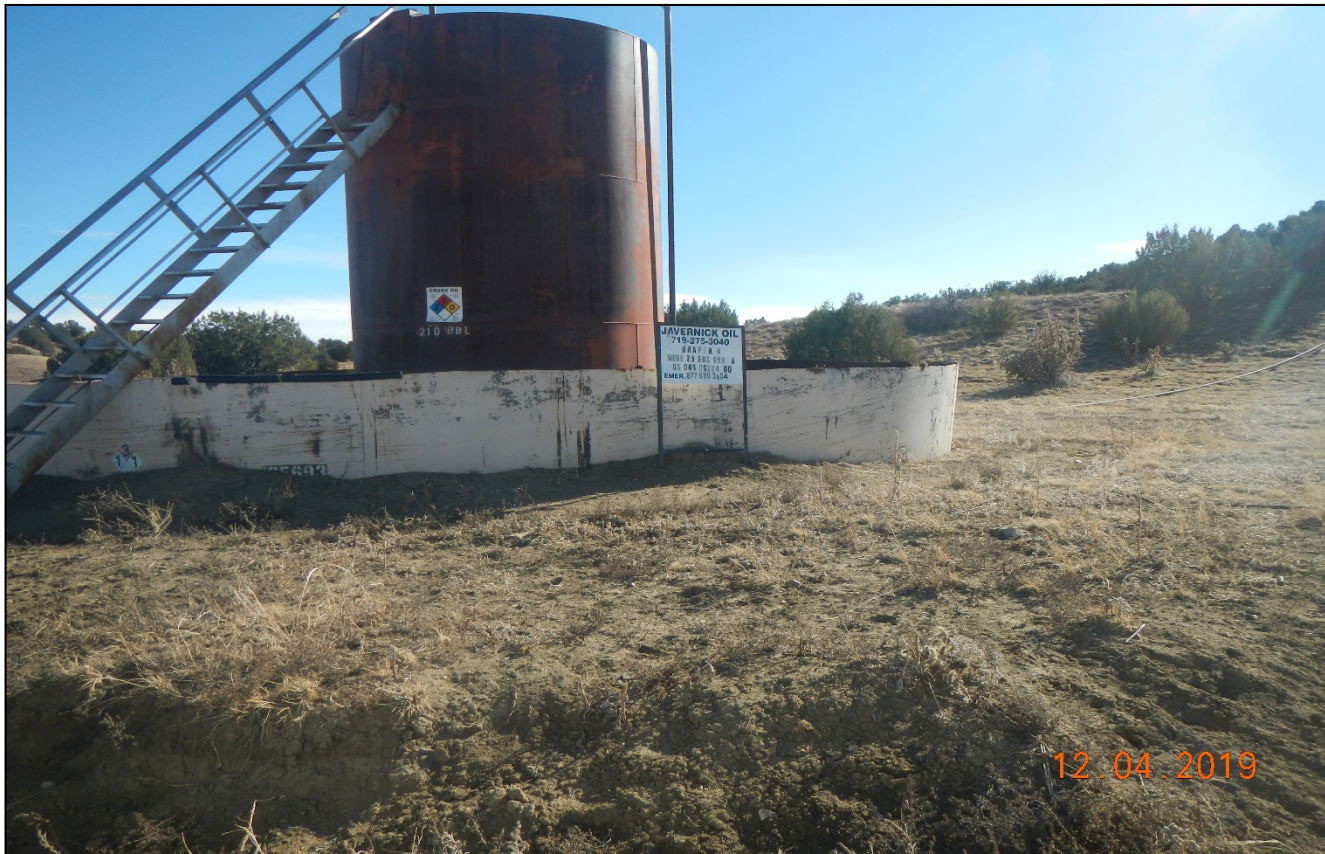
Photo 2. Facing toward the tank battery.

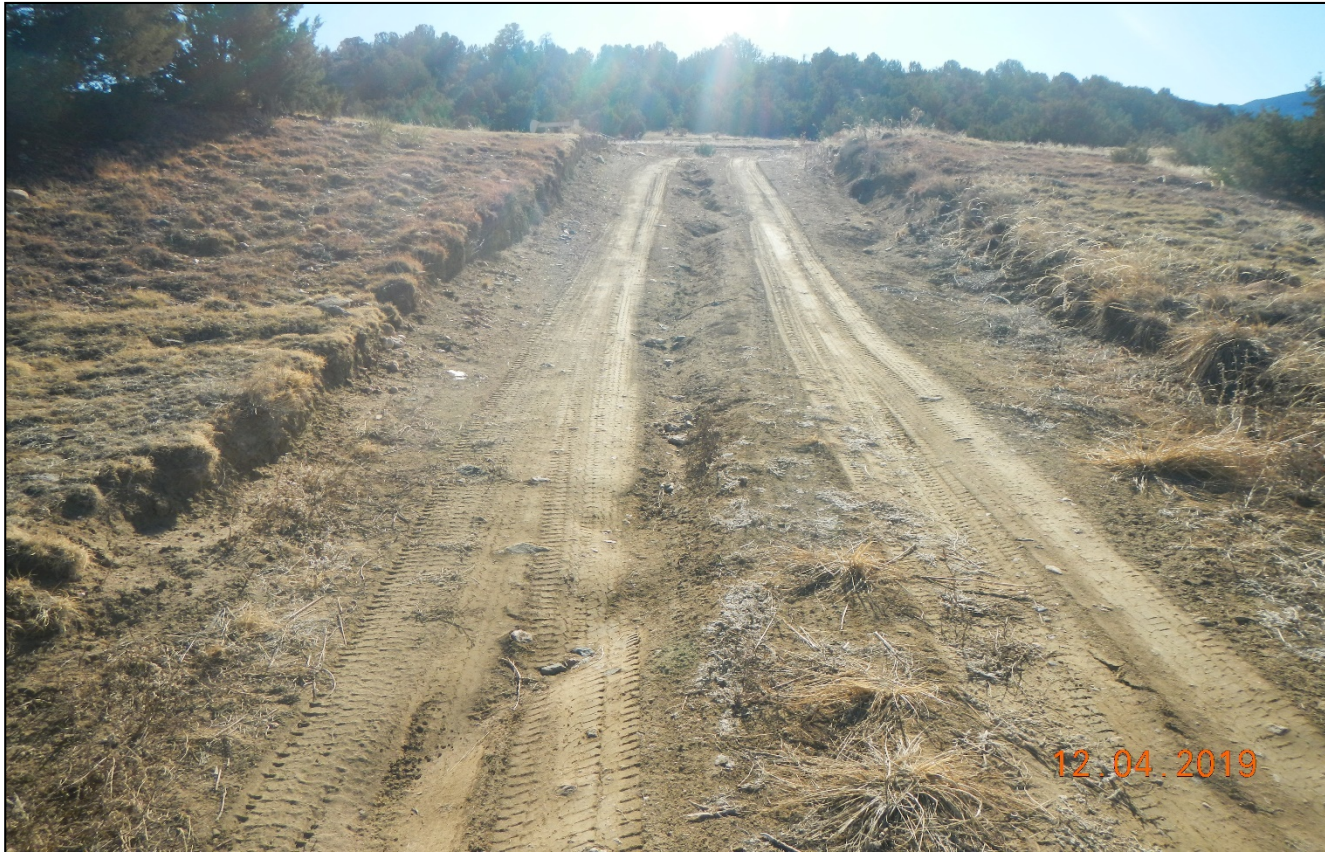
Photo 3. Facing south along the access road. There is vehicle rutting and erosion along the access road toward the location.

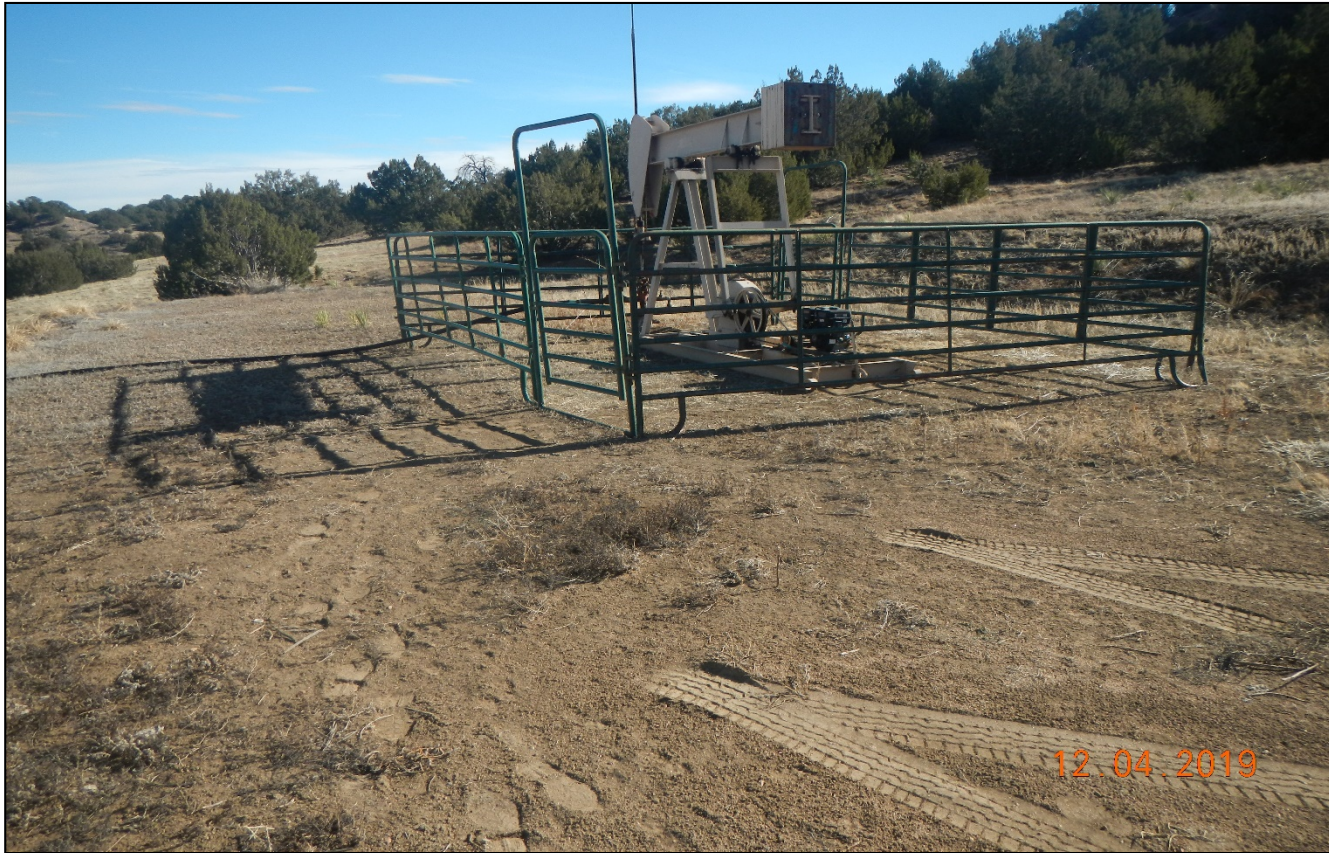
Photo 4. Facing toward the well.

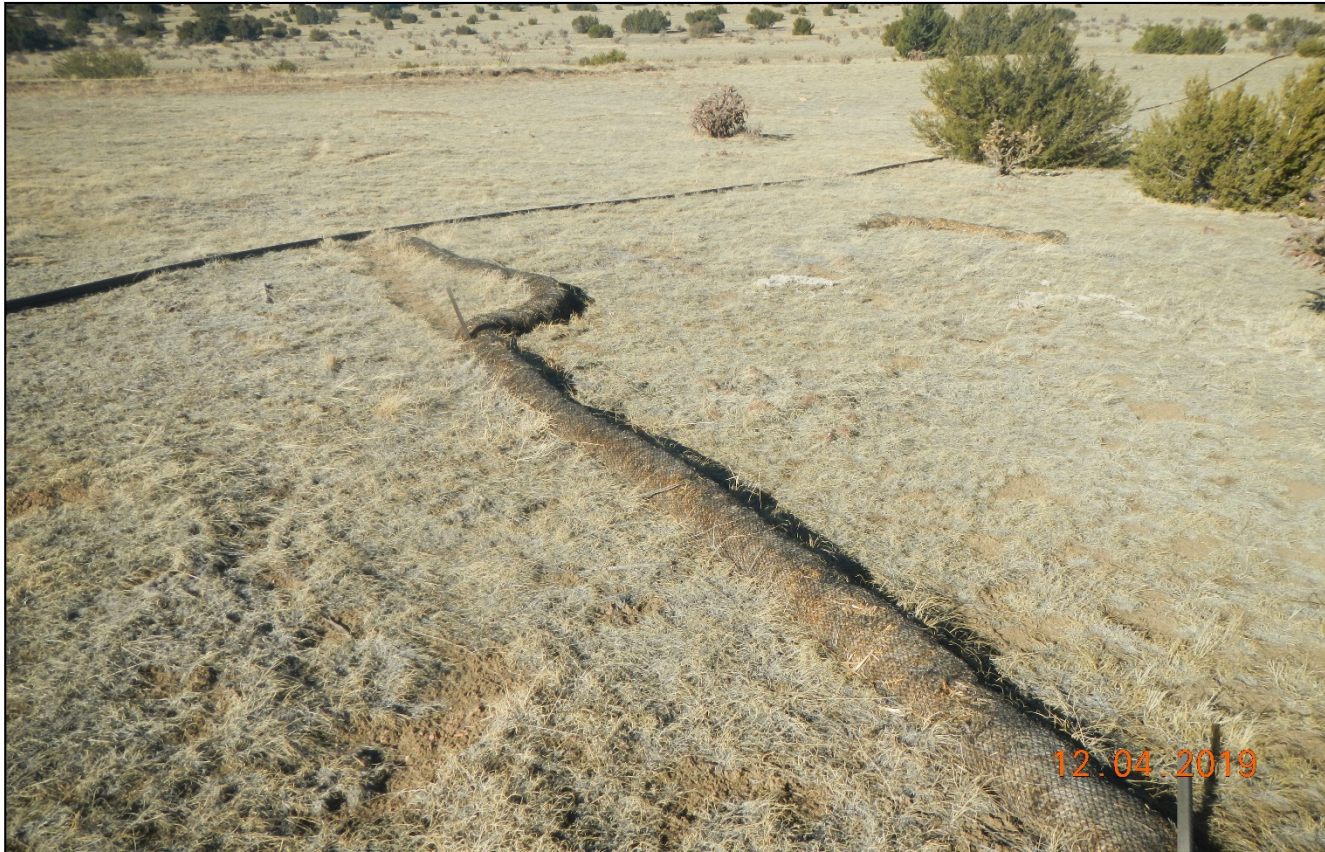
Photo 5. There are degraded and displace wattles at the north side of the location.
