Inspection Photos

API: 05-043-40014

Operator: JAVERNICK OIL

Inspection Date: 12/4/2019

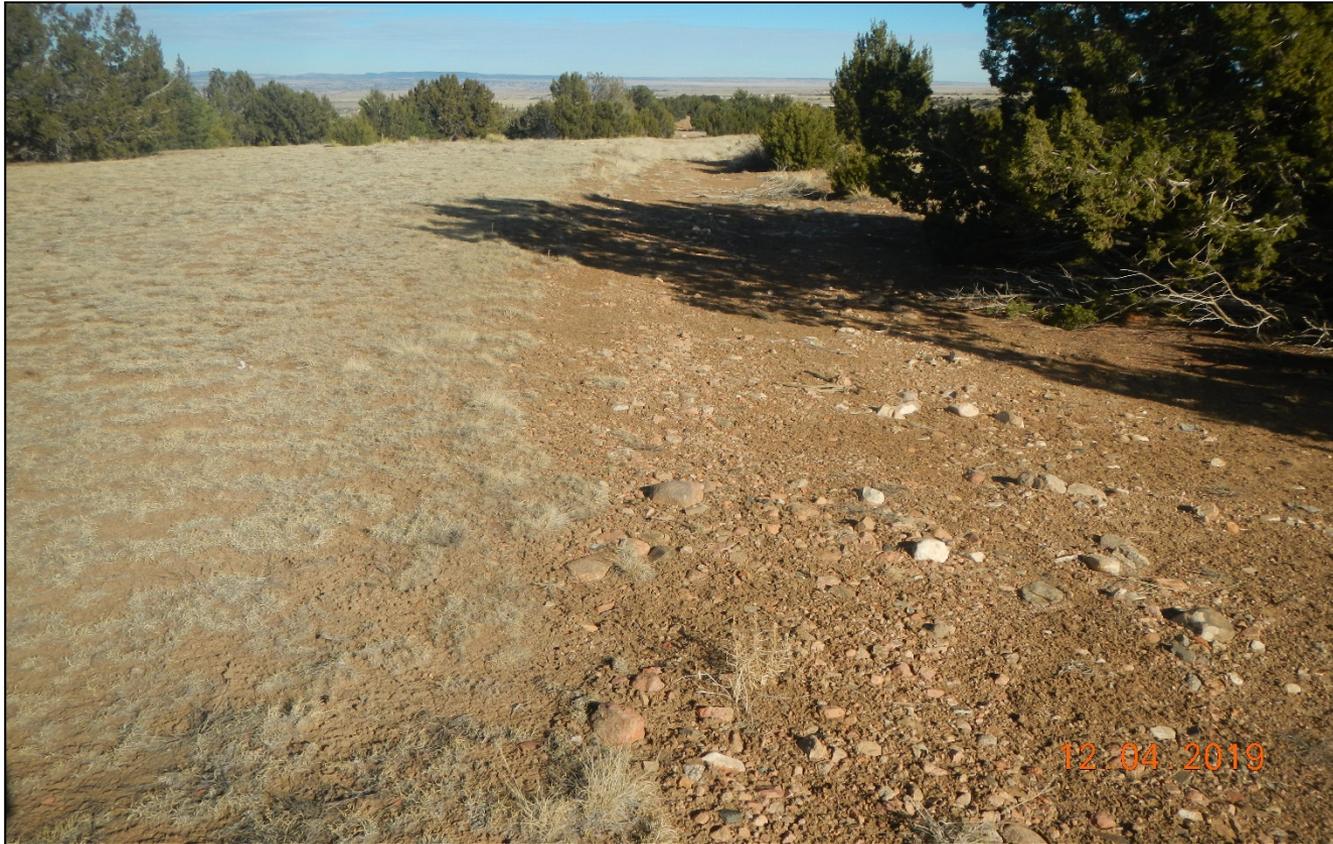
Photo 1. Facing north at the access road from CR 103. Access road has not been reclaimed and is bare of vegetation. Vegetation growth at left portion of the photo is undisturbed reference area.

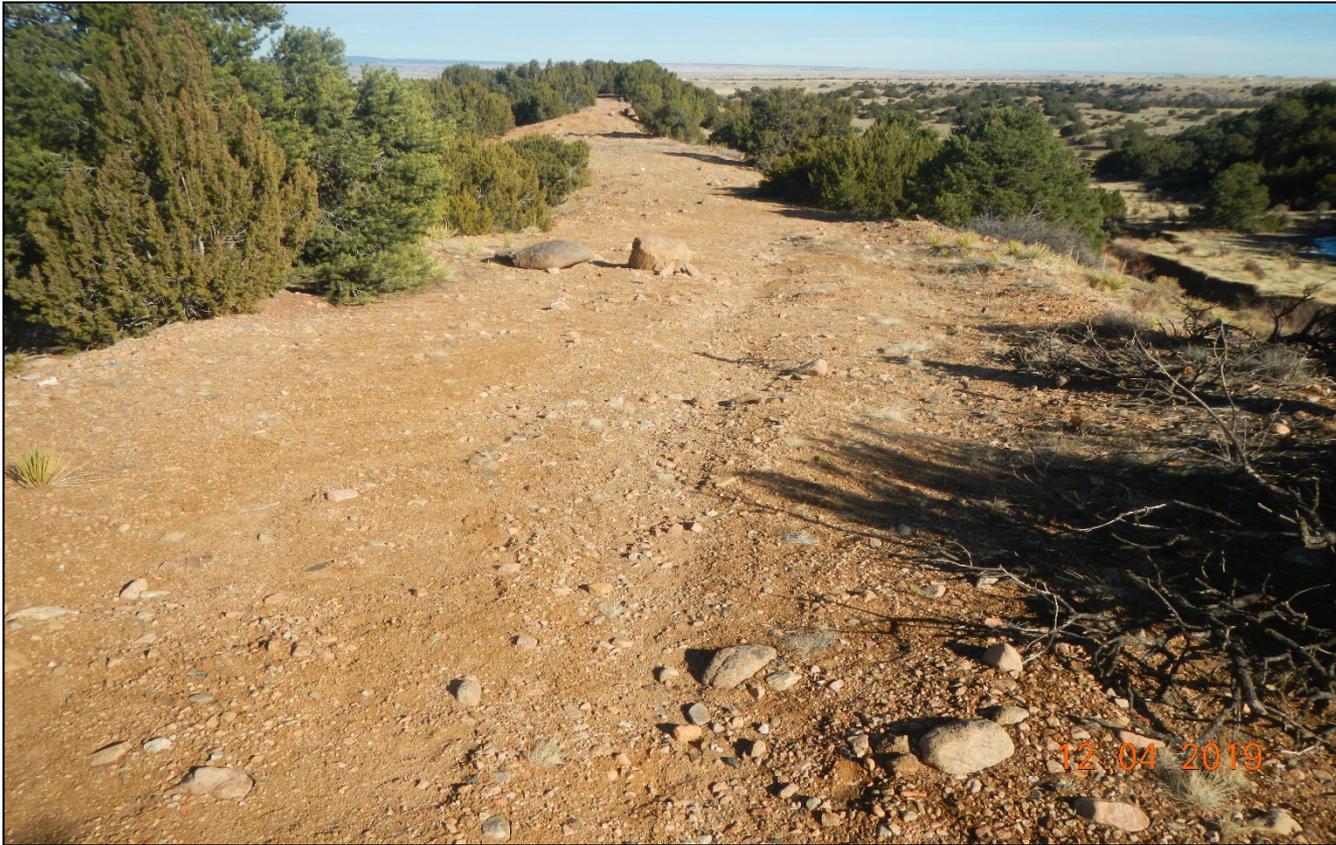
Photo 2. Facing northeast along the access road. The road has not been recontoured and reclaimed.

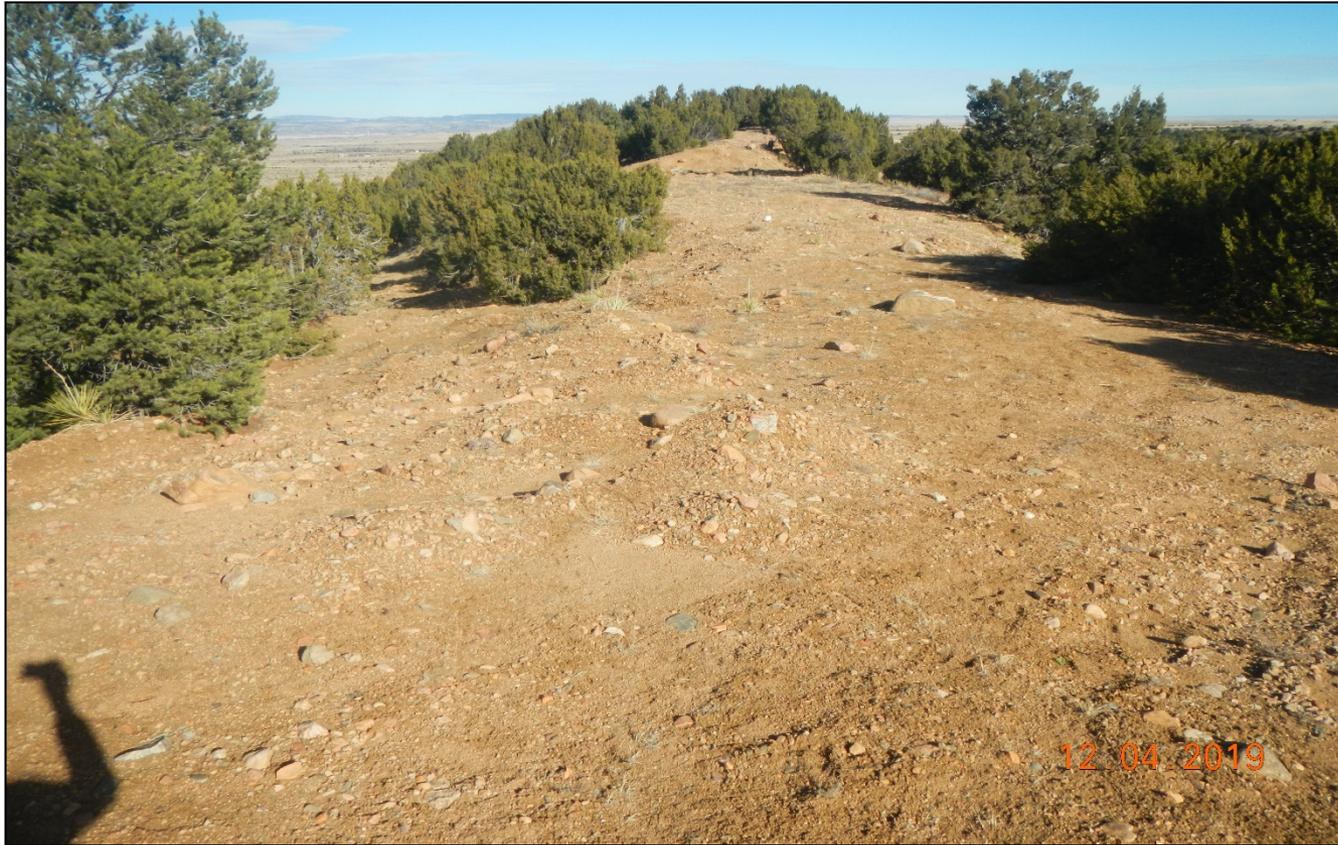
Photo 3. Facing northeast along the access road. The road has not been recontoured and reclaimed.

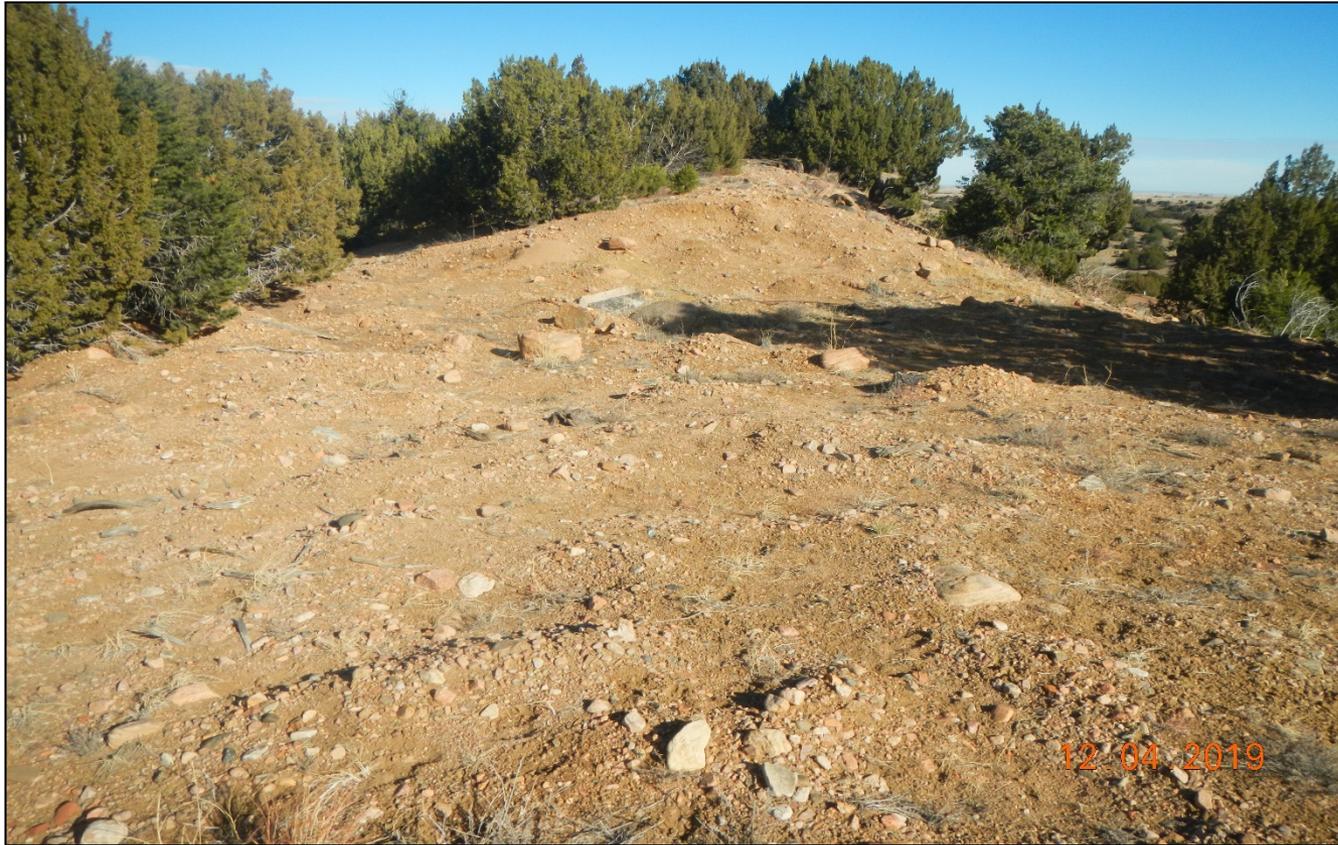
Photo 4. Facing northwest at the location which has not been recontoured and reclaimed.

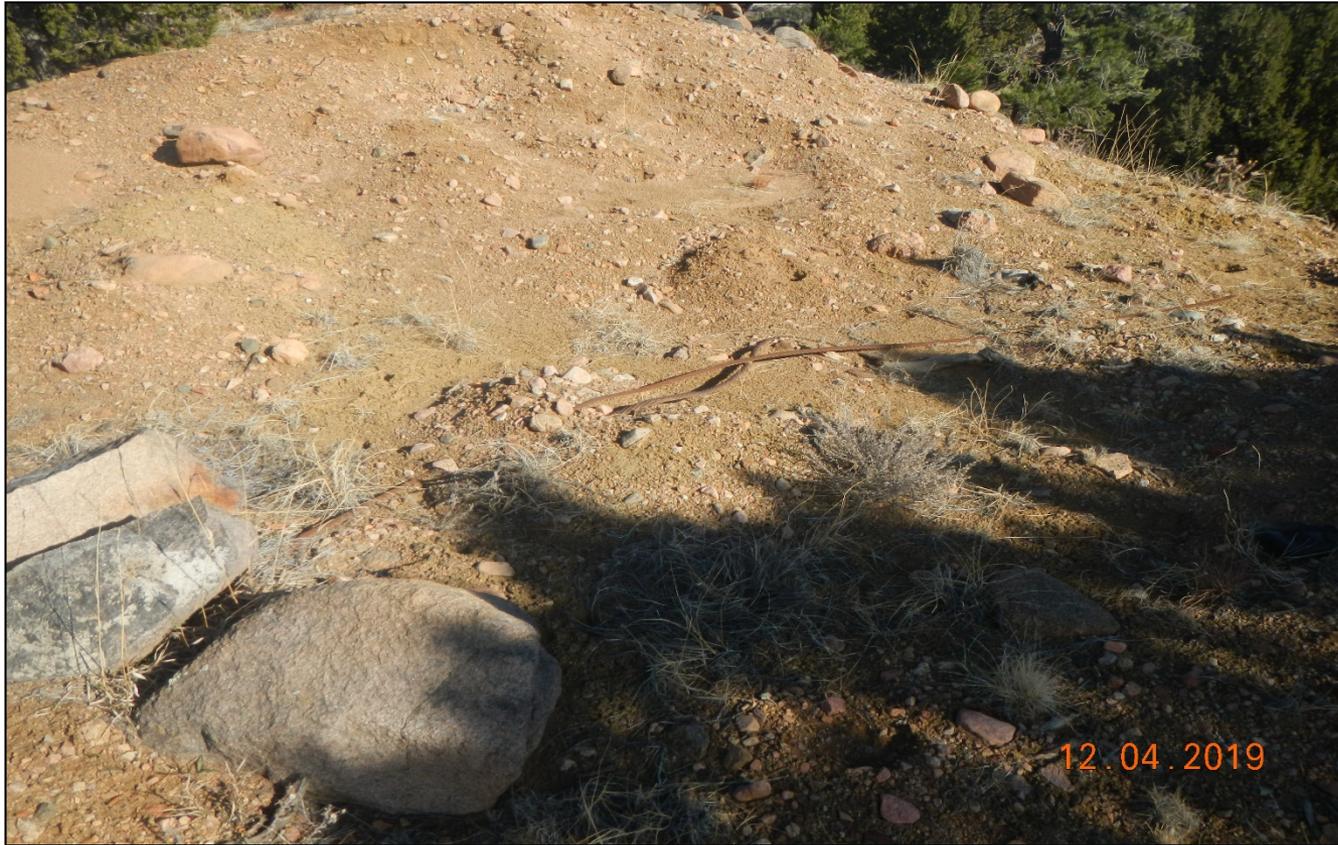
Photo 5. There is a metal cable that remains at the location.

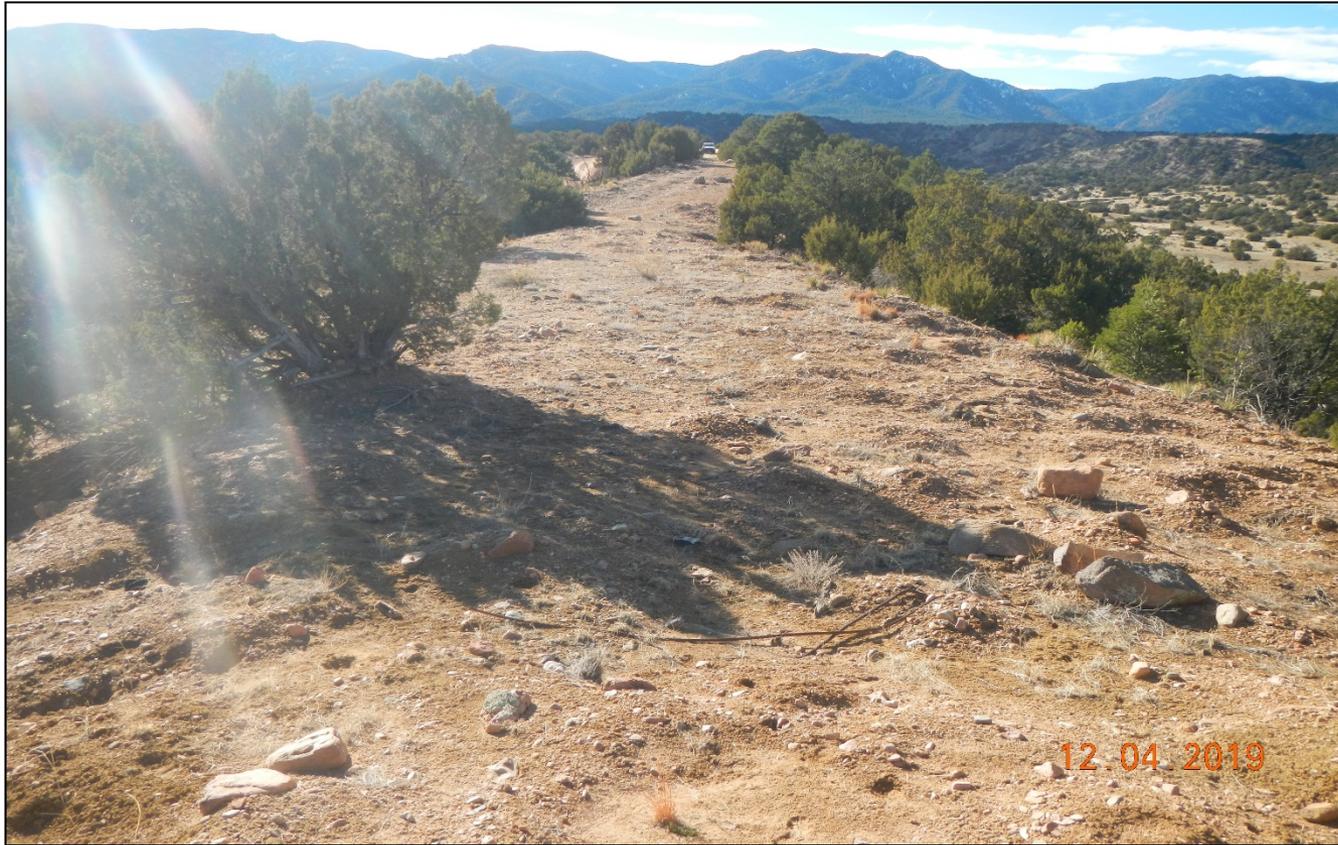
Photo 6. Facing back toward the southwest at the location and access road.

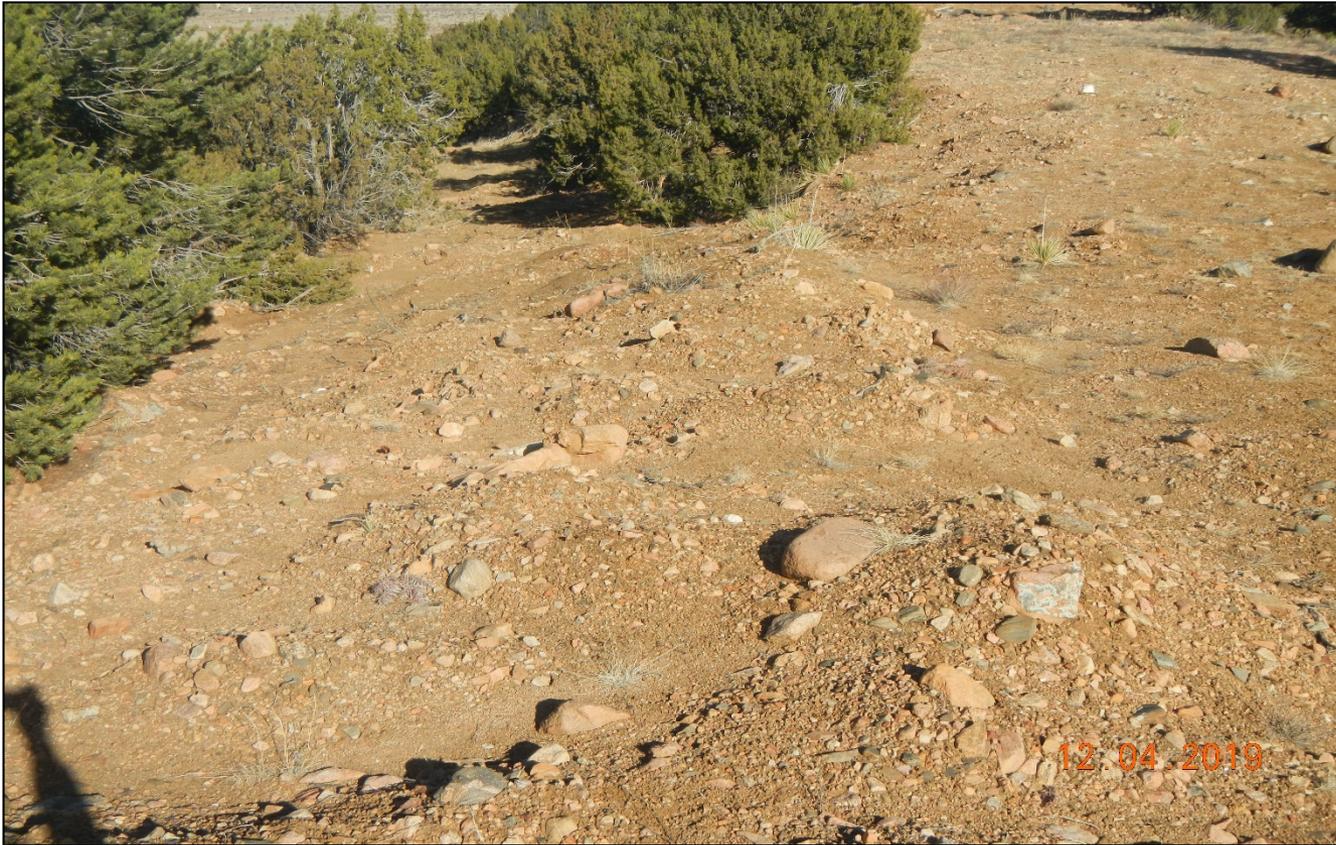
Photo 7. There is an access road that leads northeast to the Drapper 4 well site which has not been recontoured and reclaimed.

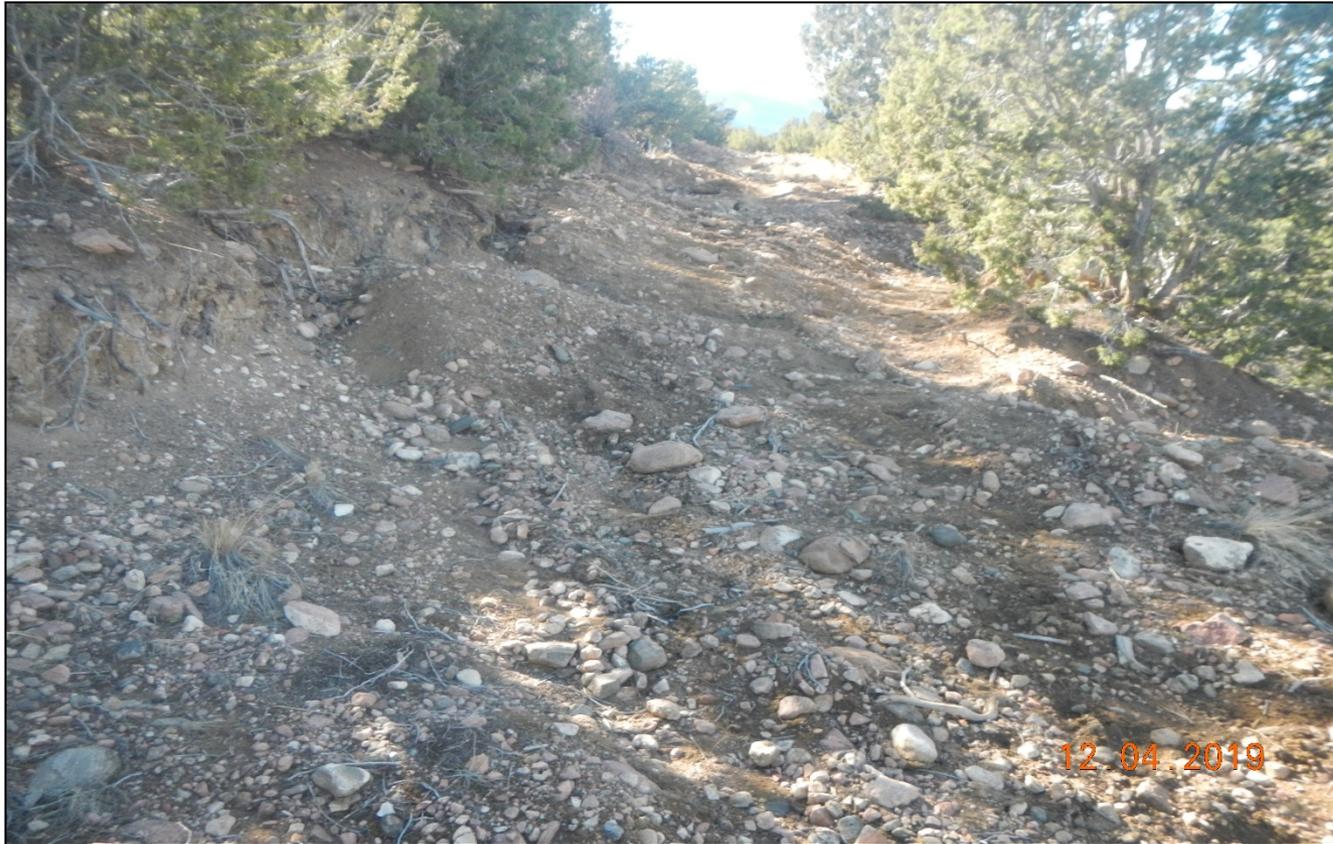
Photo 8. Facing southwest along the access road between the Hassler 24 and Drapper 4 well site. It appears soil material has been pushed over the road however, the recontouring and reclamation have not been completed.

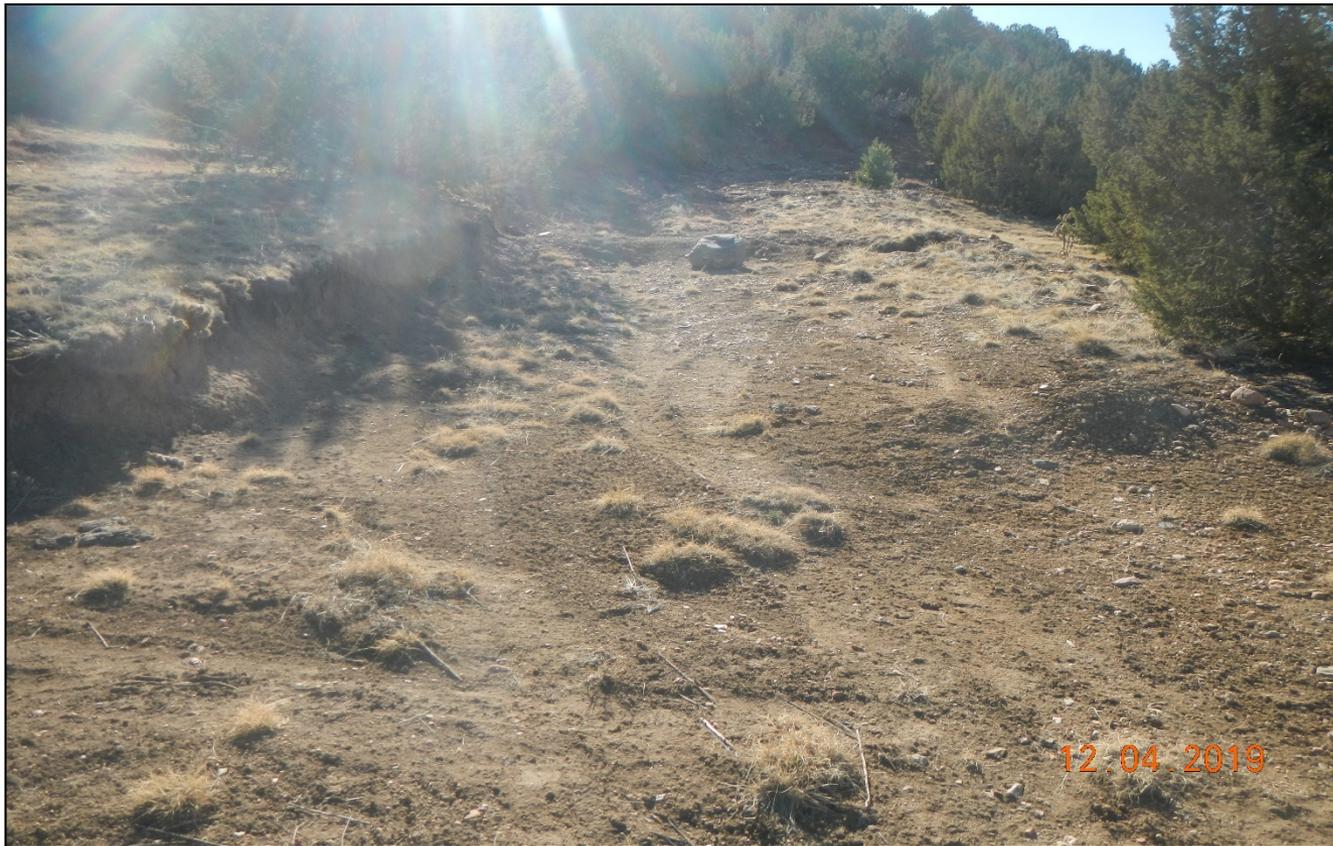
Photo 9. The old access road begins near the Drapper 4 well site. The access road has not been recontoured and reclaimed.
