Inspection Photos
Operator: Williford Resources
Location/API #: 067-06625
Date: 11-19-2019

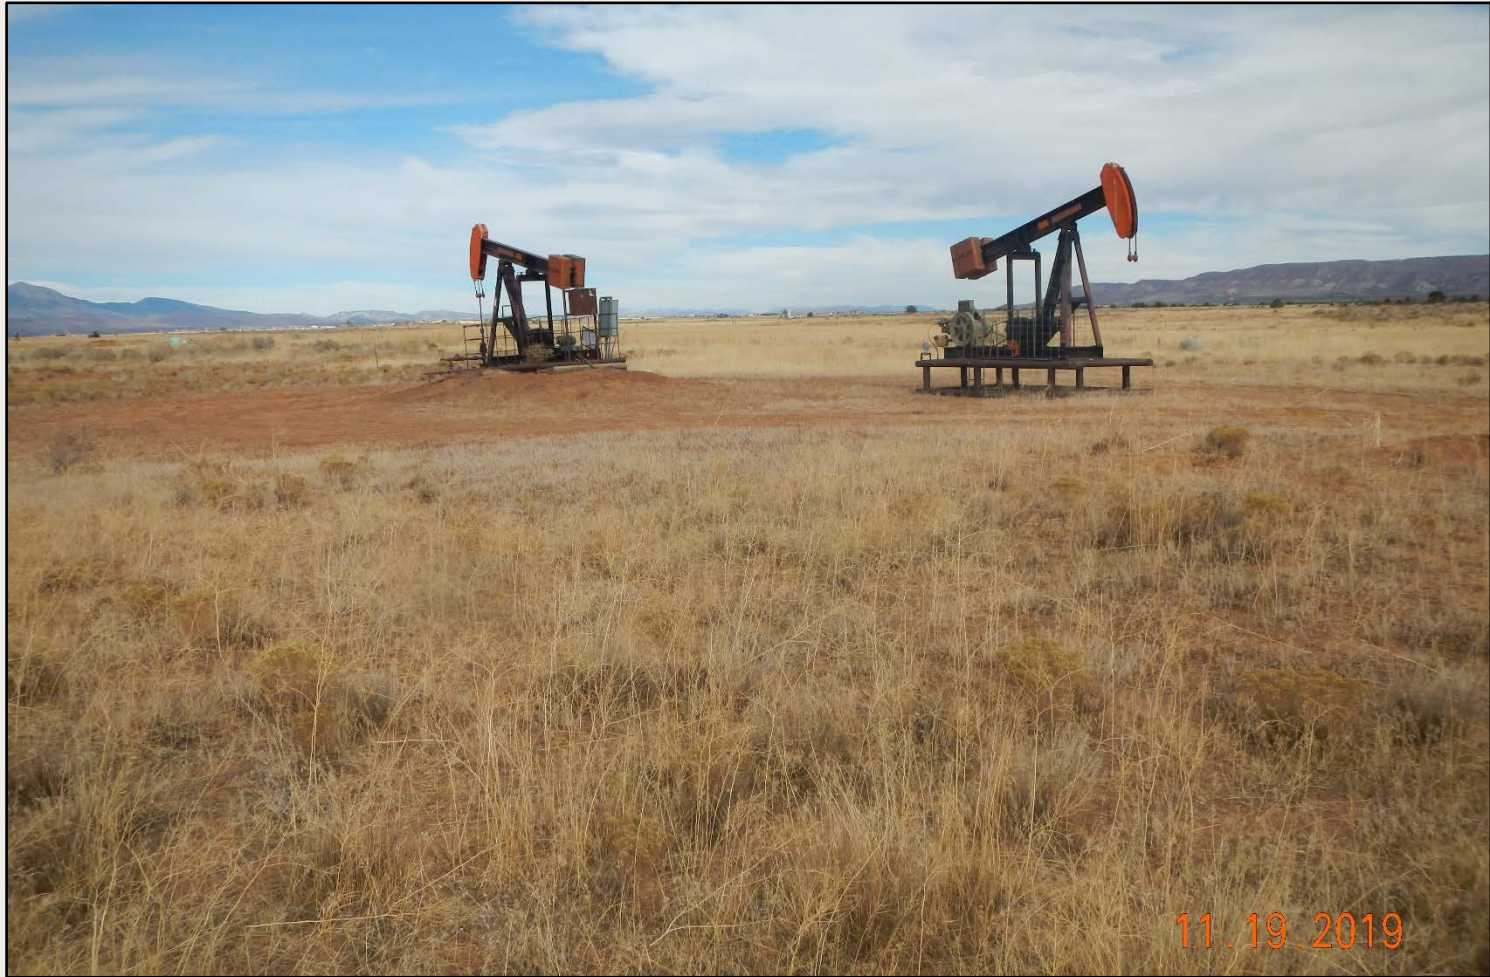
Photo 1. View of the project area from the southwestern corner facing center. Pump jack on the right of photo is not in use and needs to be removed.

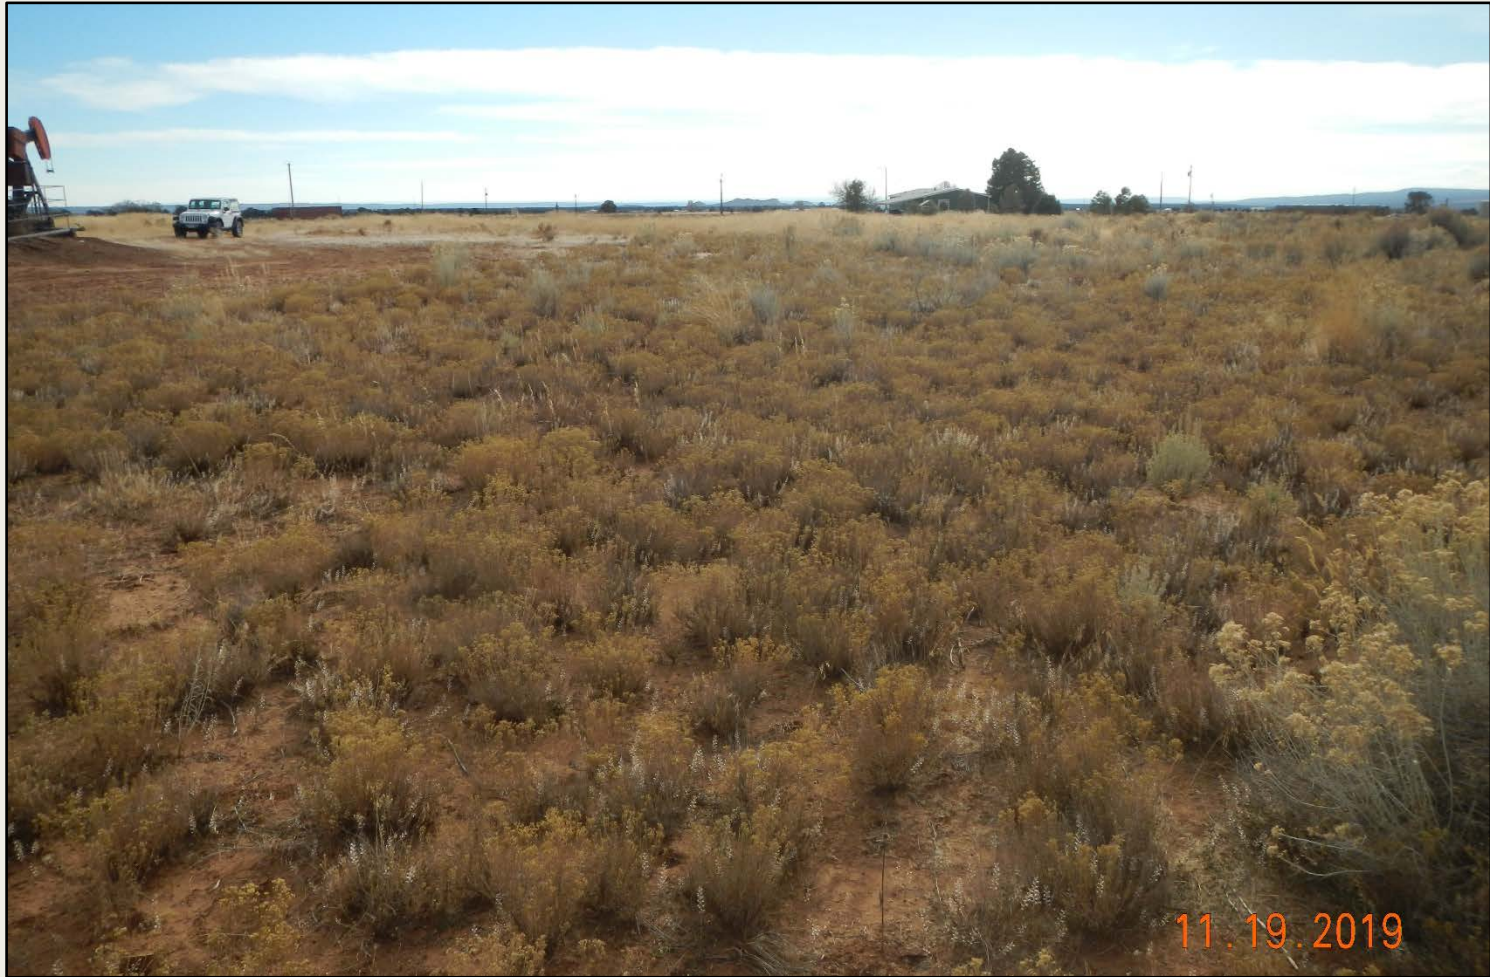
Photo 2. View of the western project area from the northwestern corner facing southward. Revegetation is progressing in portions of the project area with mixed wheatgrasses and subshrubs such as crested wheatgrass and snakeweed, as well as annual weeds such as cheatgrass and alysium.

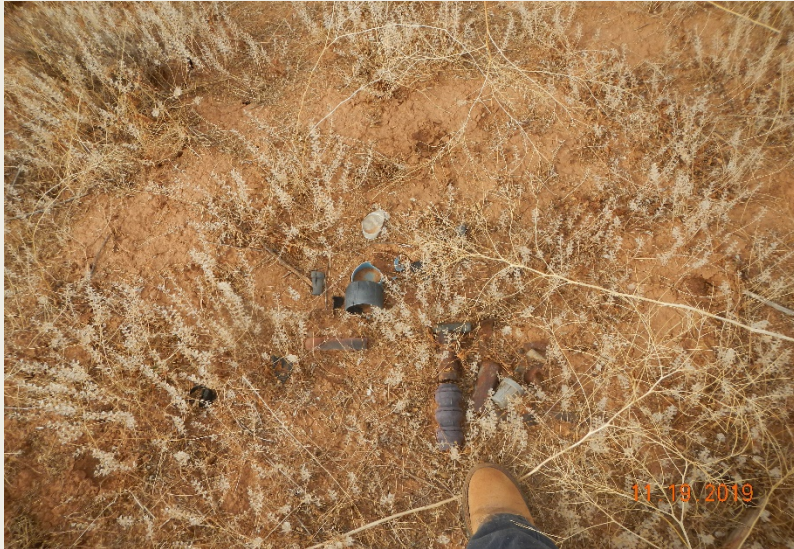
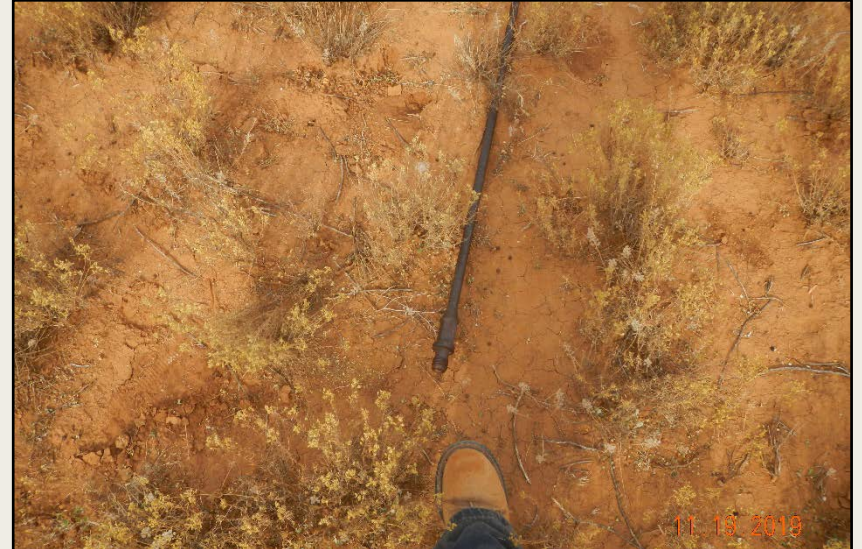
Photos 3/4. View of waste and debris that needs to be removed, within the outer reclamation areas.

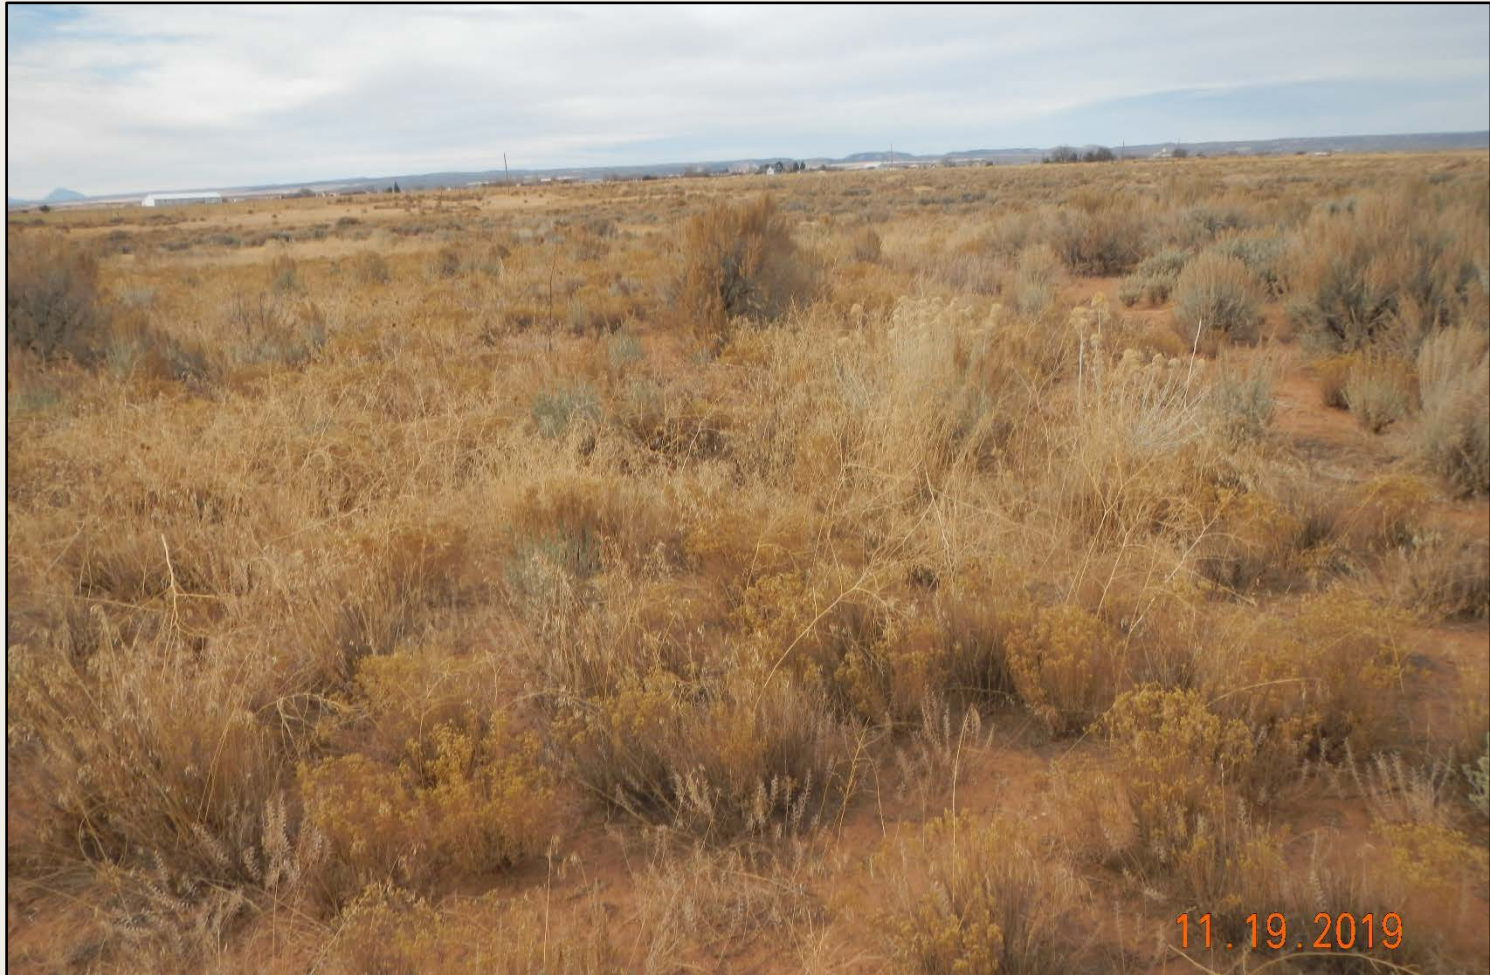
Photo 5. View of reference area, comprised of sagebrush shrubland/grass field mosaic, with grasses (crested wheatgrass) and subshrubs (snakeweed) in openings.
