Inspection Photos
Operator: Williford Resources
Location/API #: 067-06560
Date: 11-19-2019

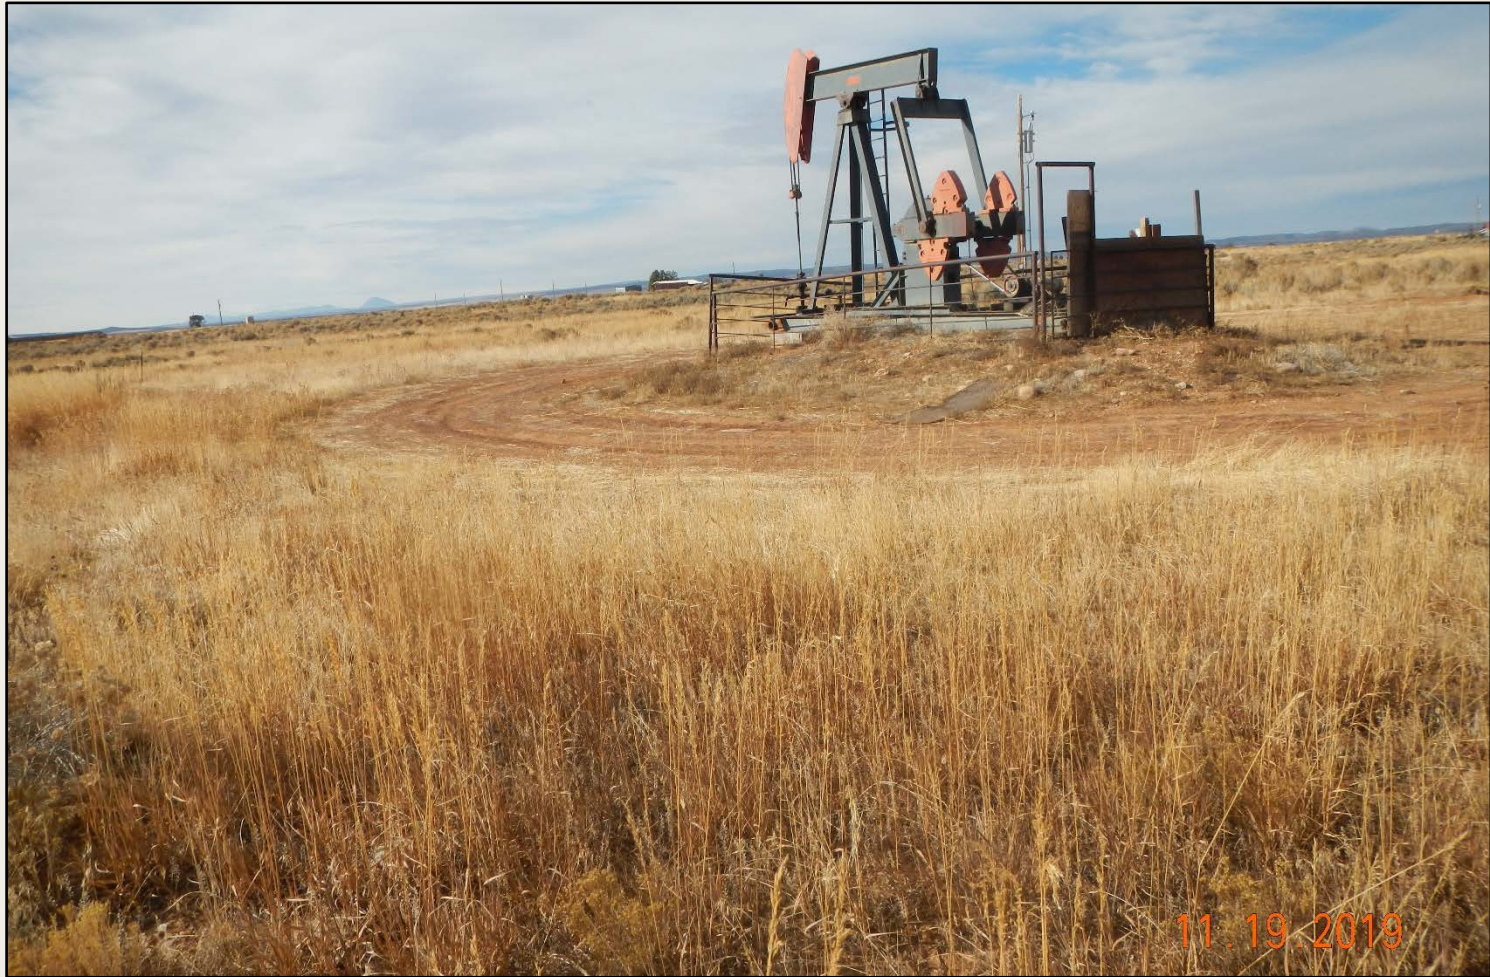
Photo 1. View of the project area from the southeastern corner facing center.

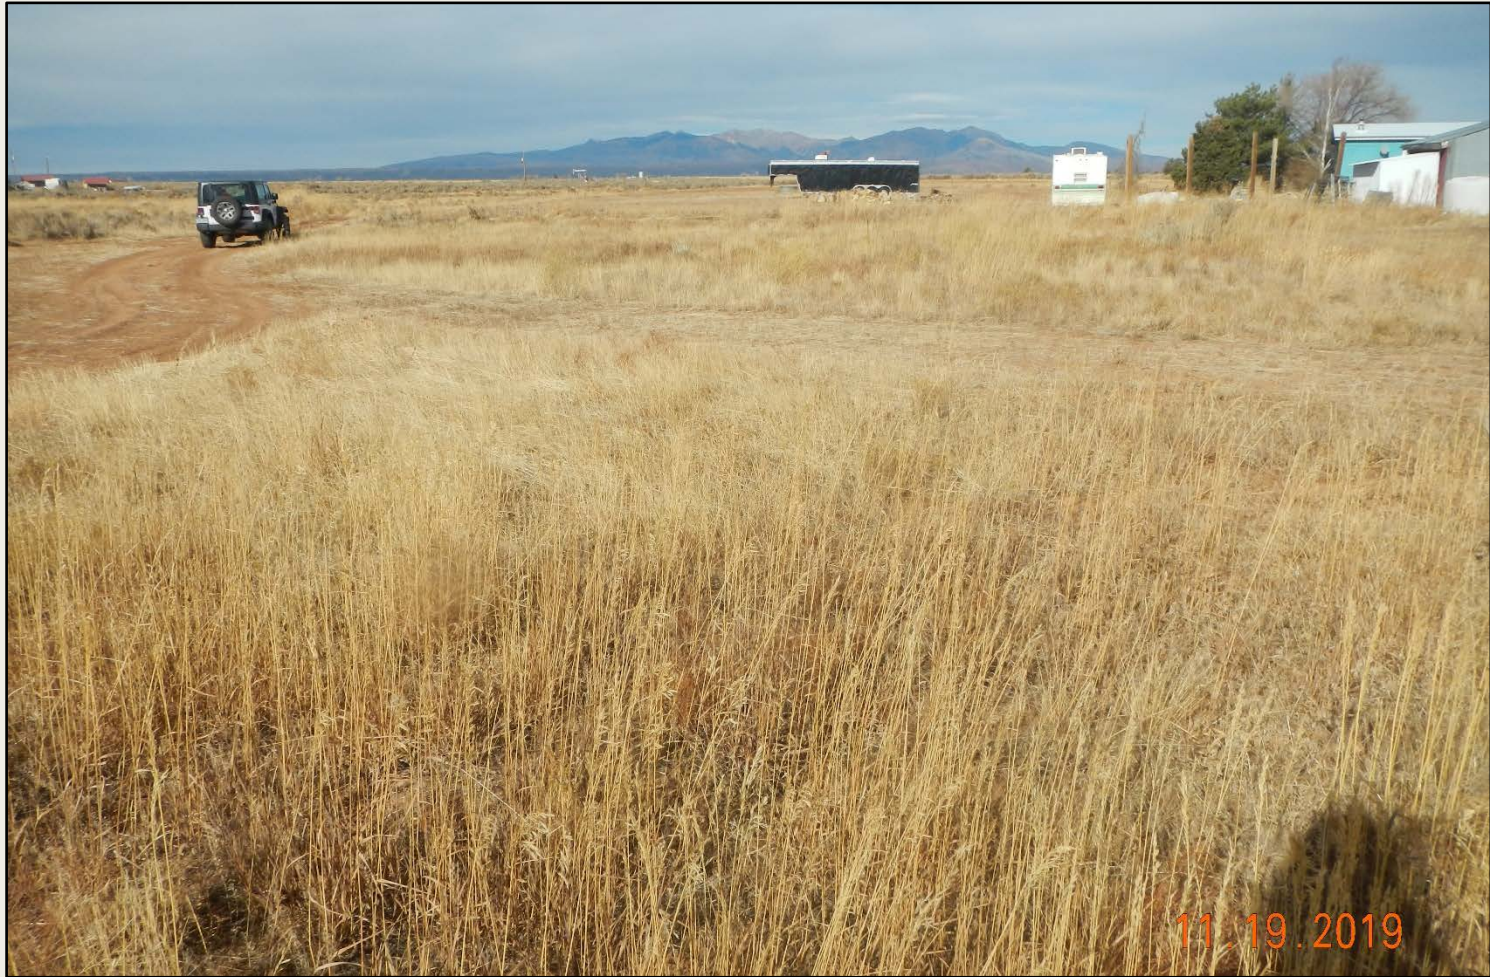
Photo 2. View of the eastern project area from the southeastern corner facing northward. Revegetation is progressing with smooth brome, sagebrush, and snakeweed.

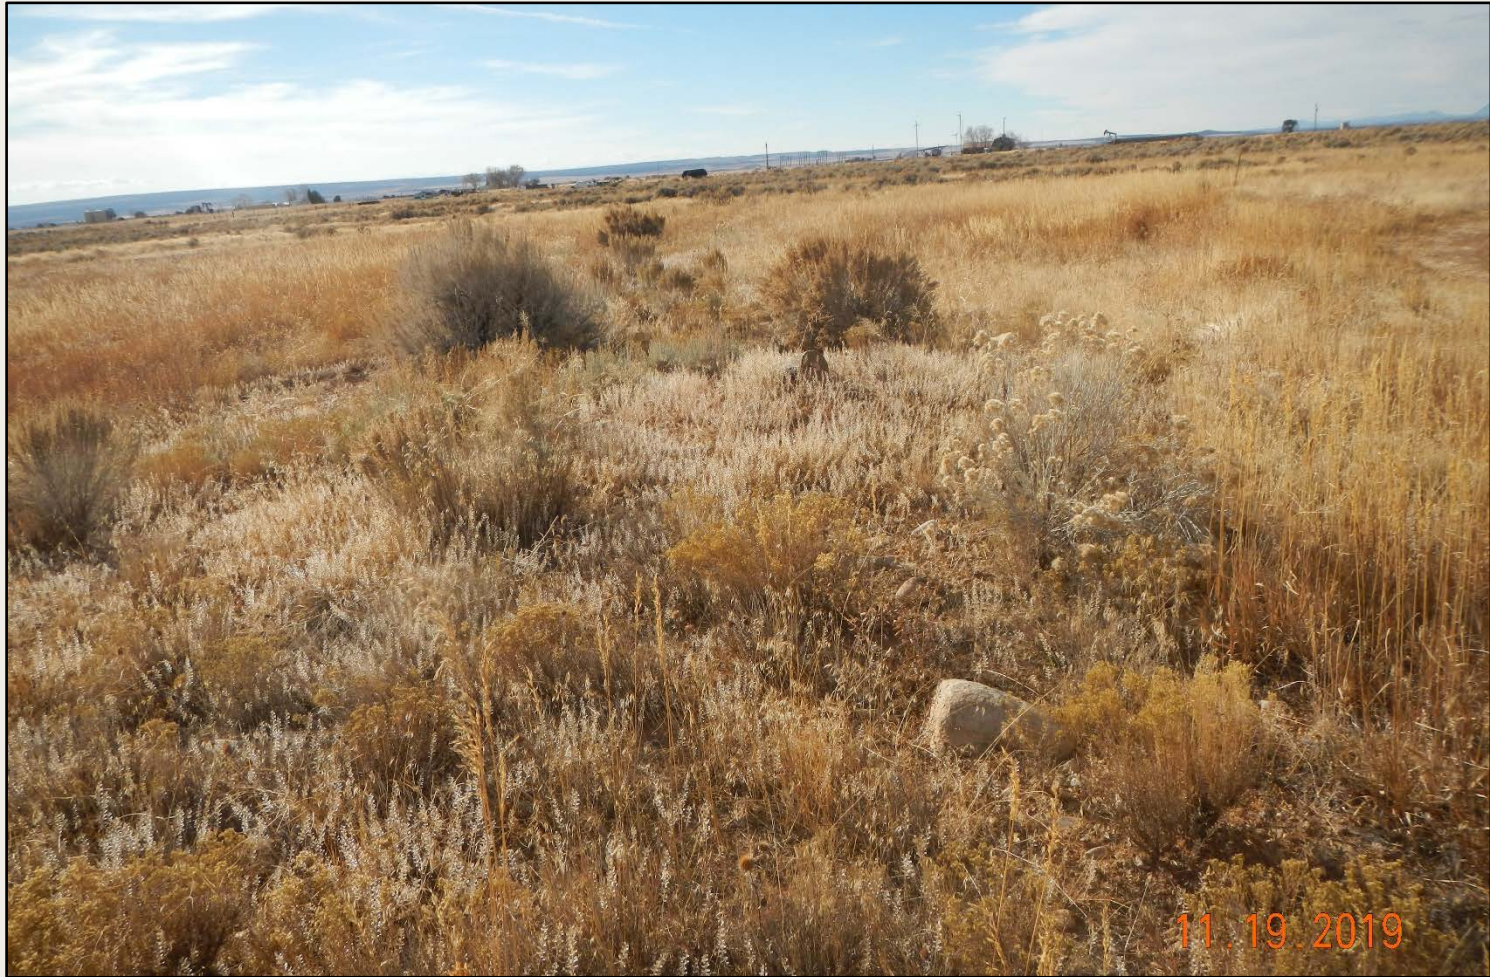
Photo 3. View of the southern project area from the southeastern corner facing westward.

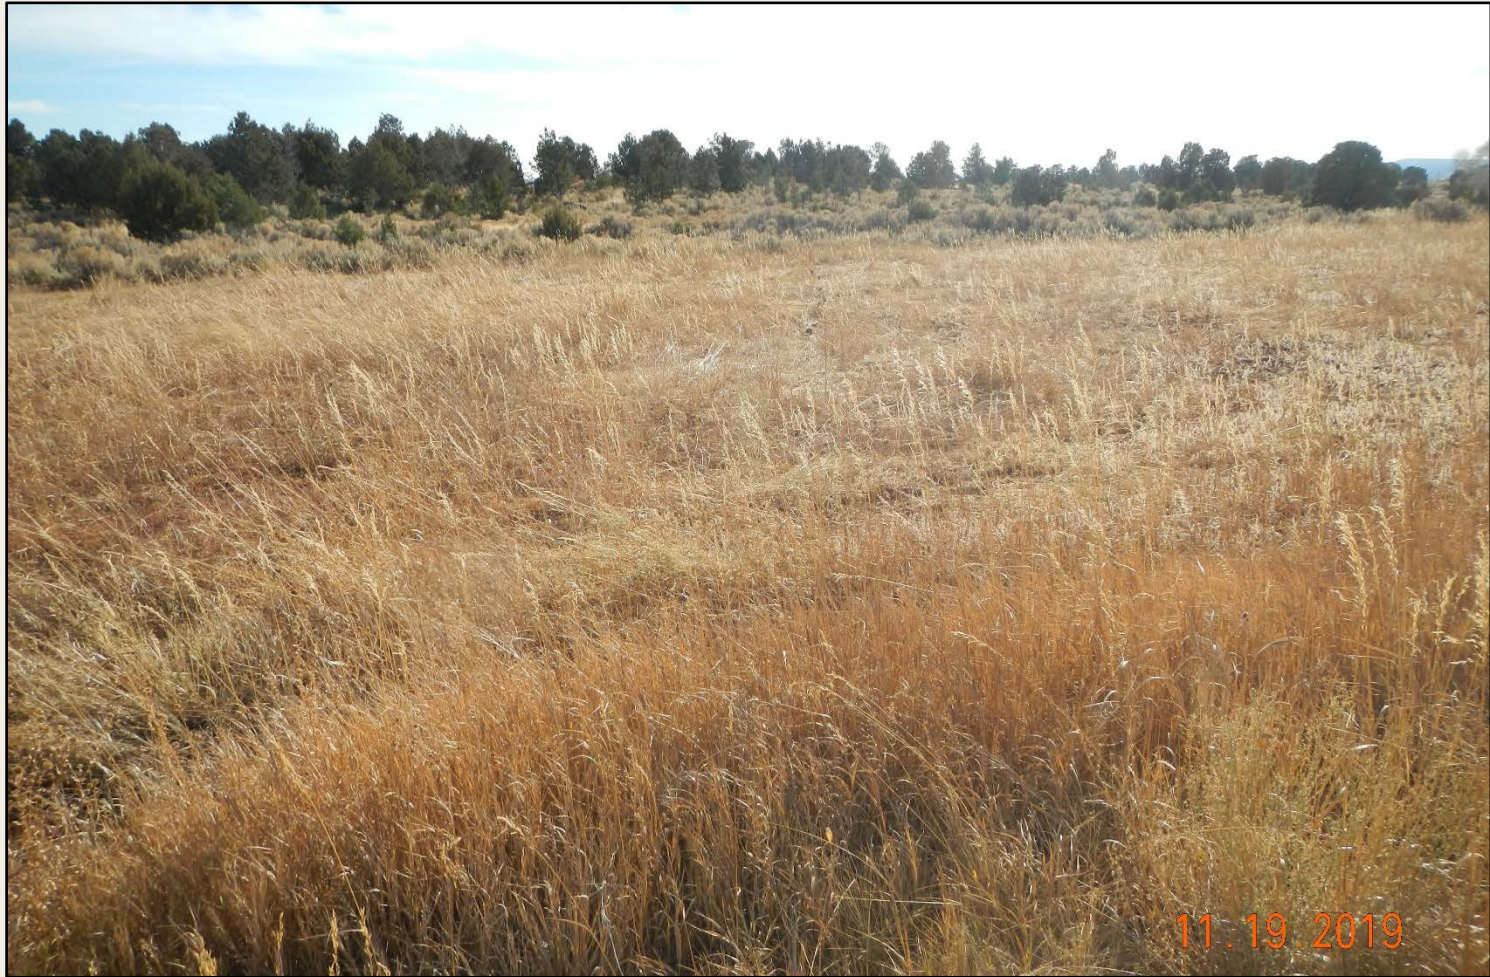
Photo 4. View of reference area, comprised of sagebrush shrubland/grassland mosaic with sagebrush, pinyon and juniper trees, smooth brome, and snakeweed.
