Inspection Photos
Operator: Williford Resources
Location/API #: 067-06645
Date: 11-19-2019

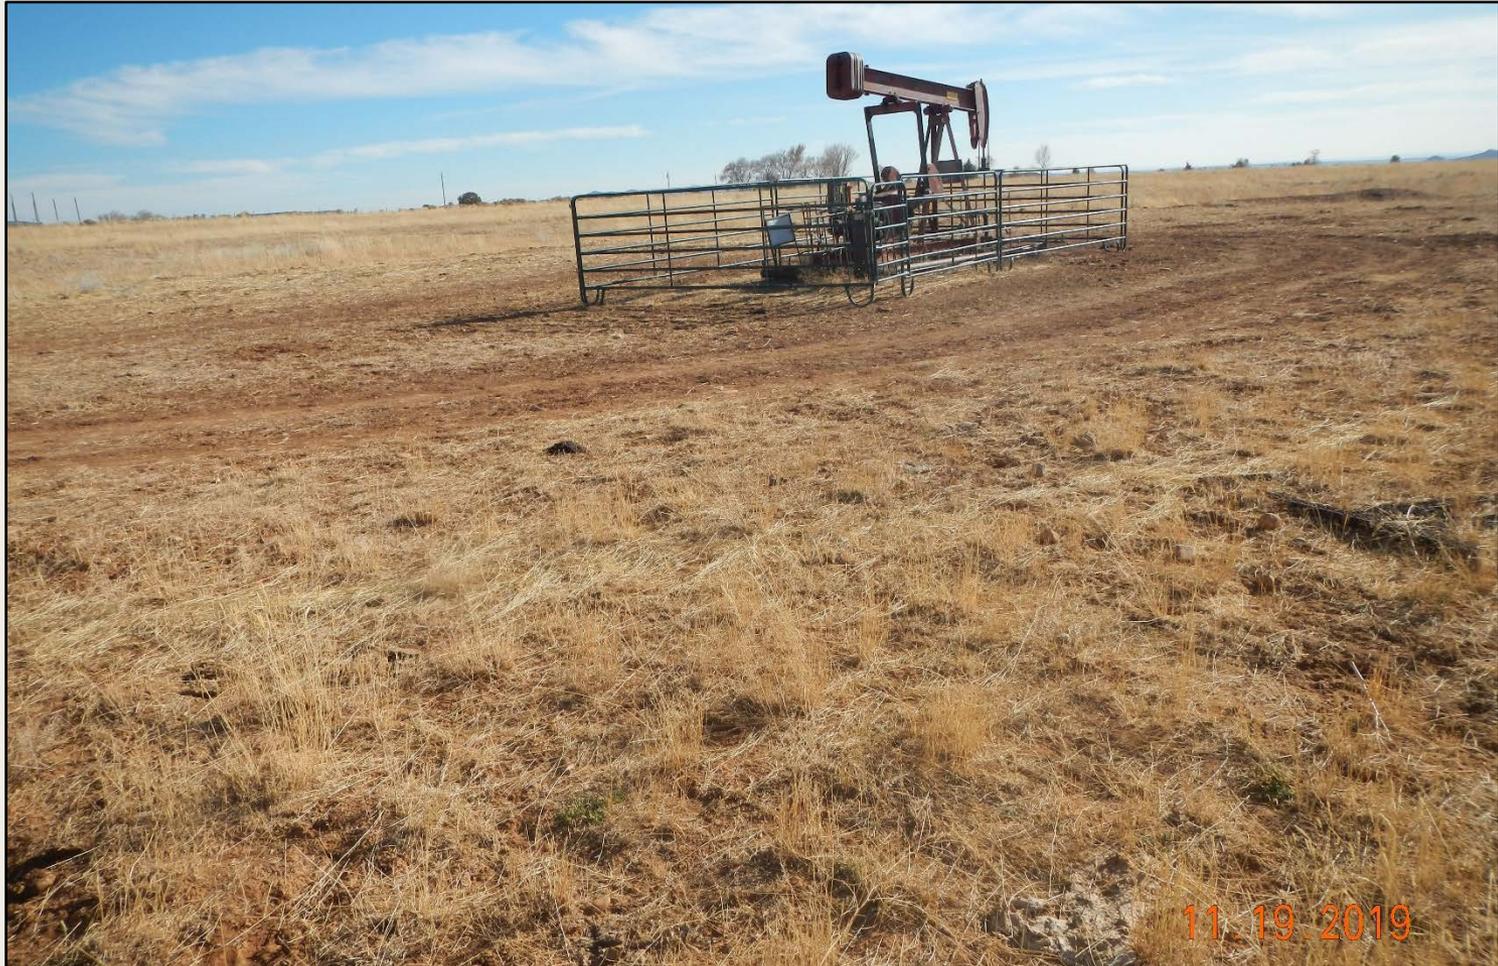
Photo 1. View of the project area from the northwestern corner facing center.

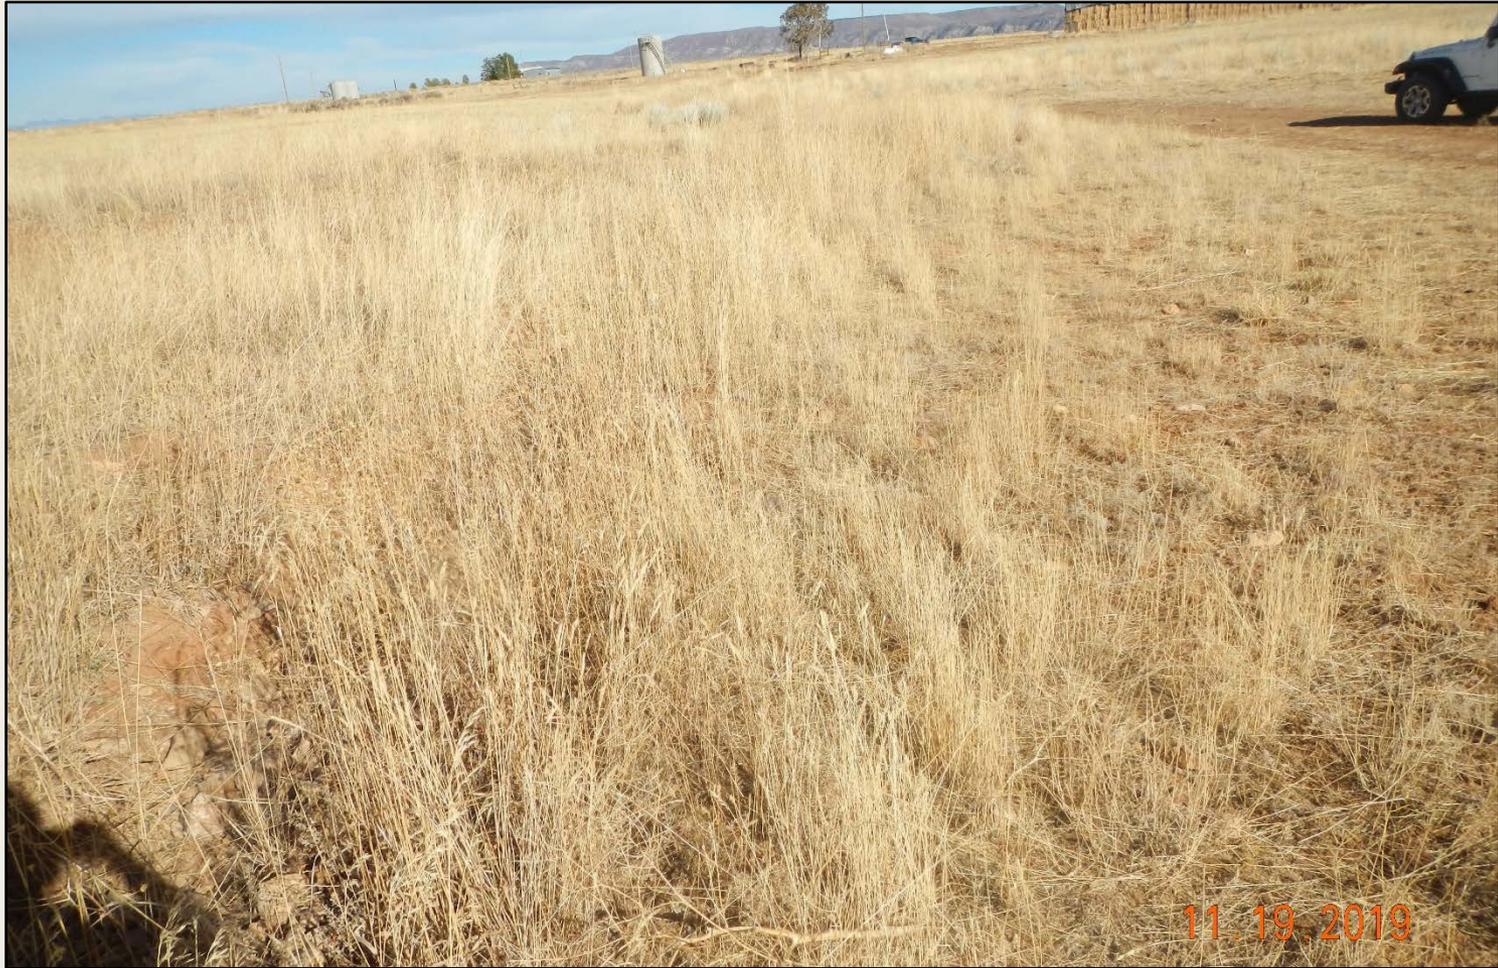
Photo 2. View of the northern project area from the northwestern corner facing eastward. Revegetation is progressing, largely with crested wheatgrass.

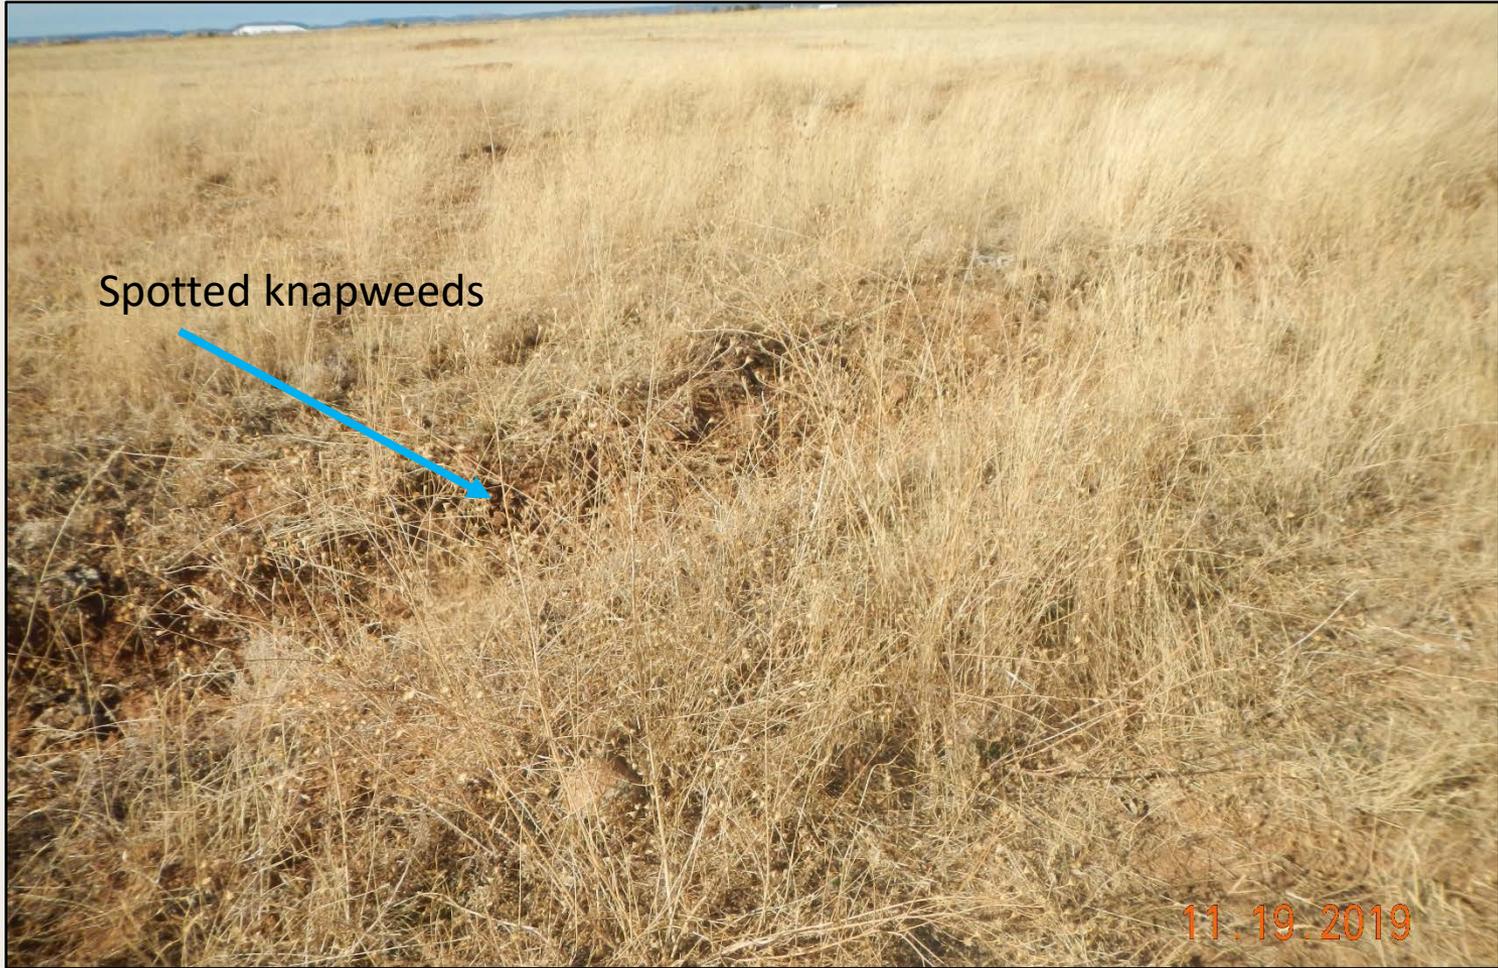
Photo 3. View of spotted knapweeds within the western project area.

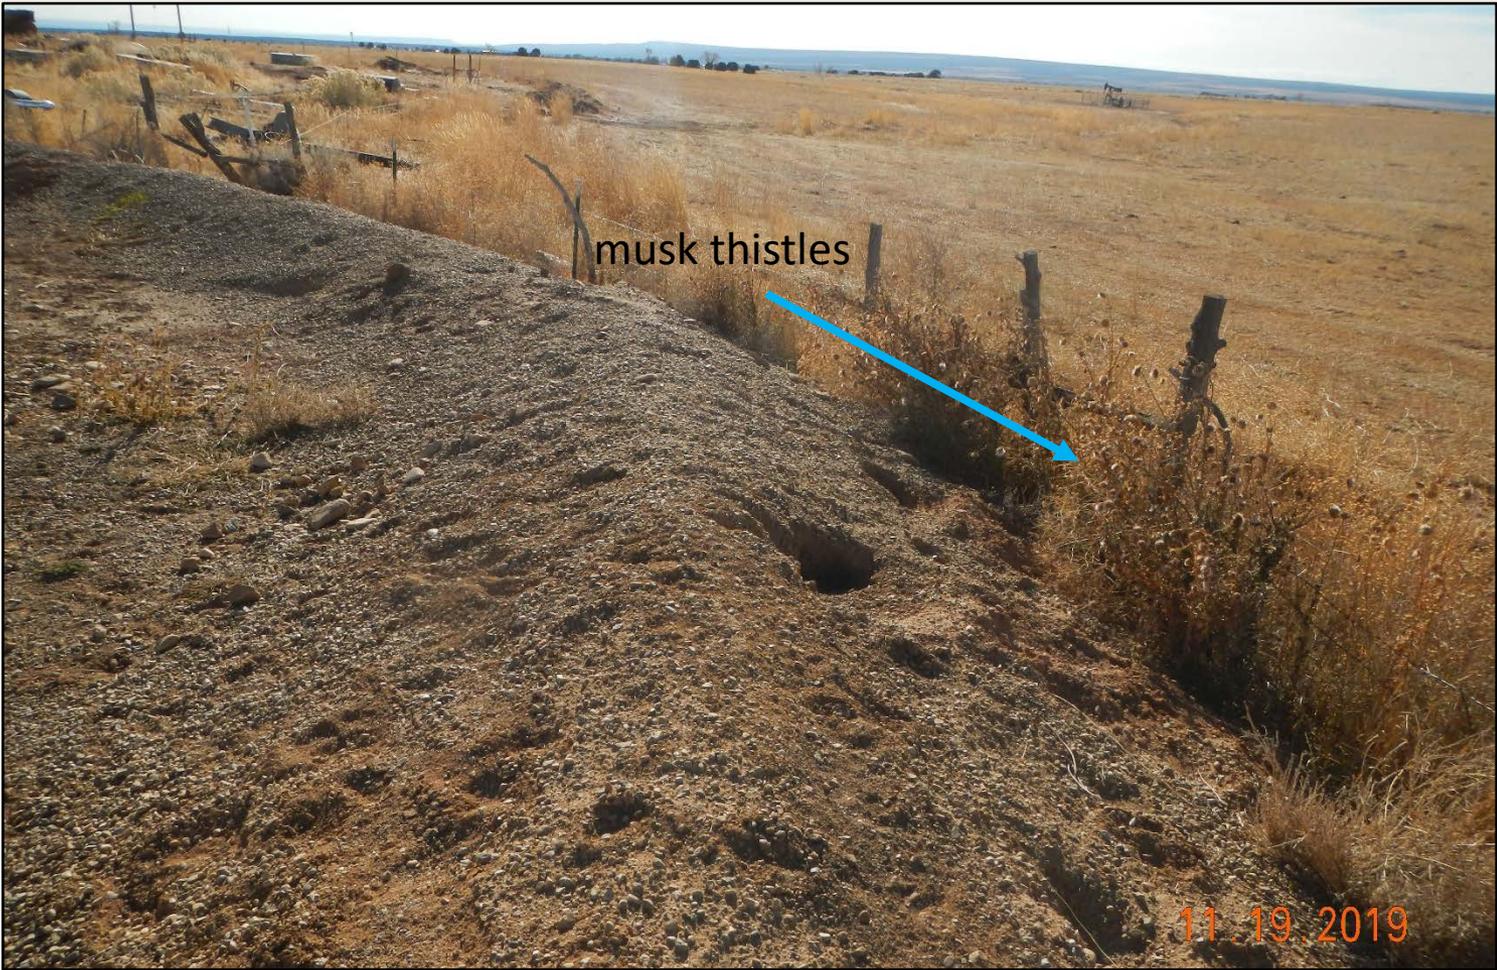
Photo 4. View of musk thistles along the fenceline at the tank battery.

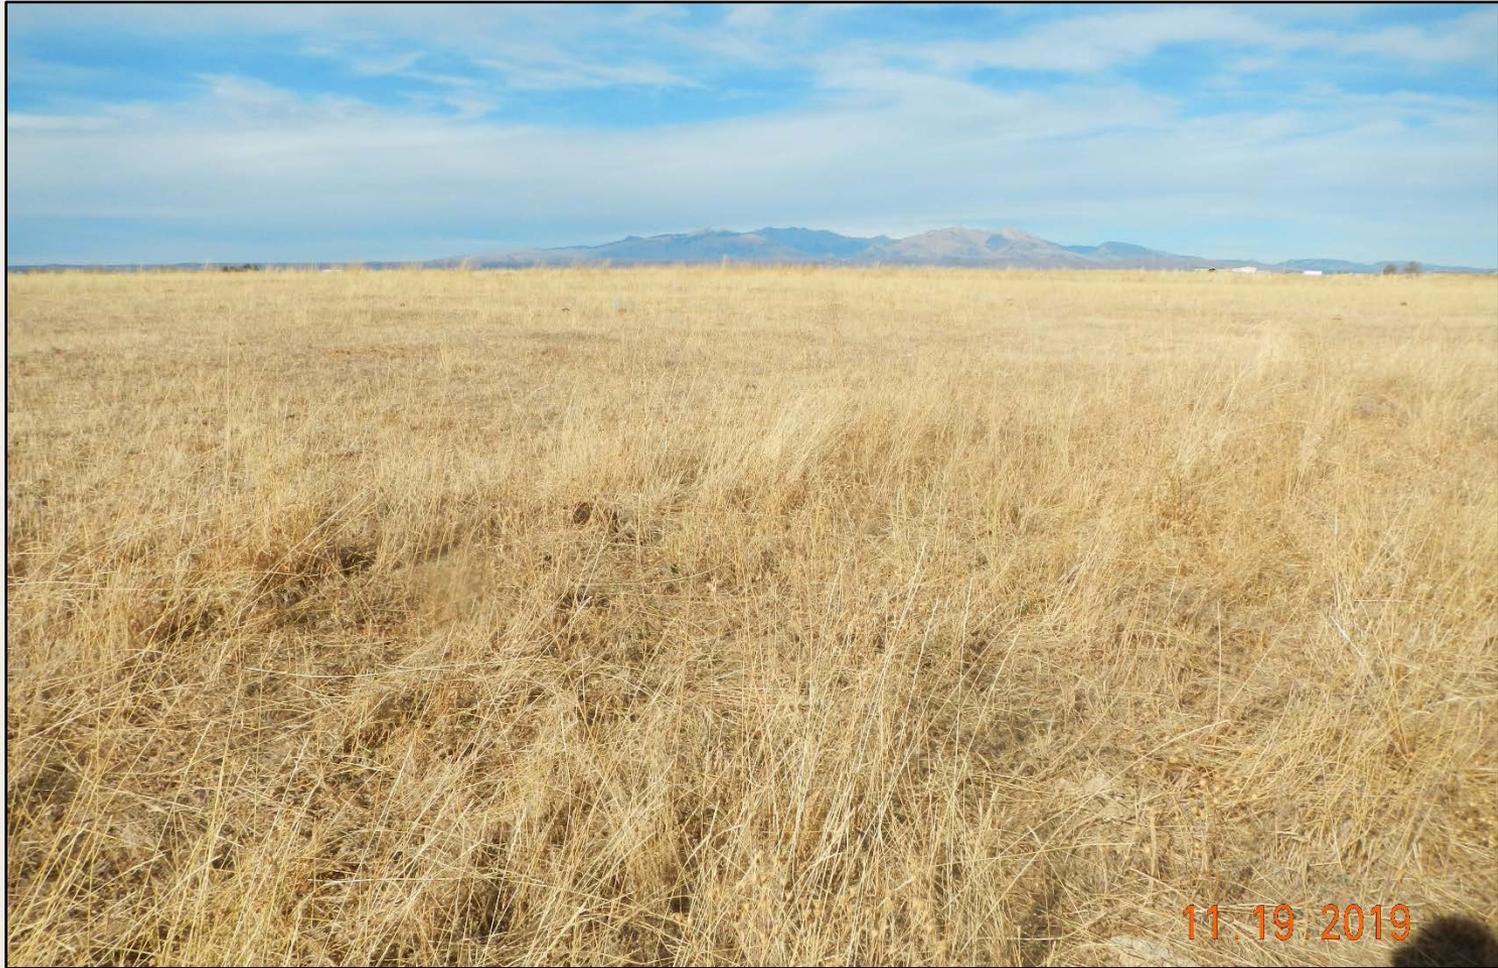
Photo 5. View of reference area, largely comprised of crested wheatgrass, and other wheatgrasses largely in dormant vegetative condition.
