# Construction and Stormwater Inspection

December 9, 2019

Operator: CONFLUENCE DJ LLC- #10518

Inspection Photos  
Location Name: Missouri /31  
Location ID: 453535

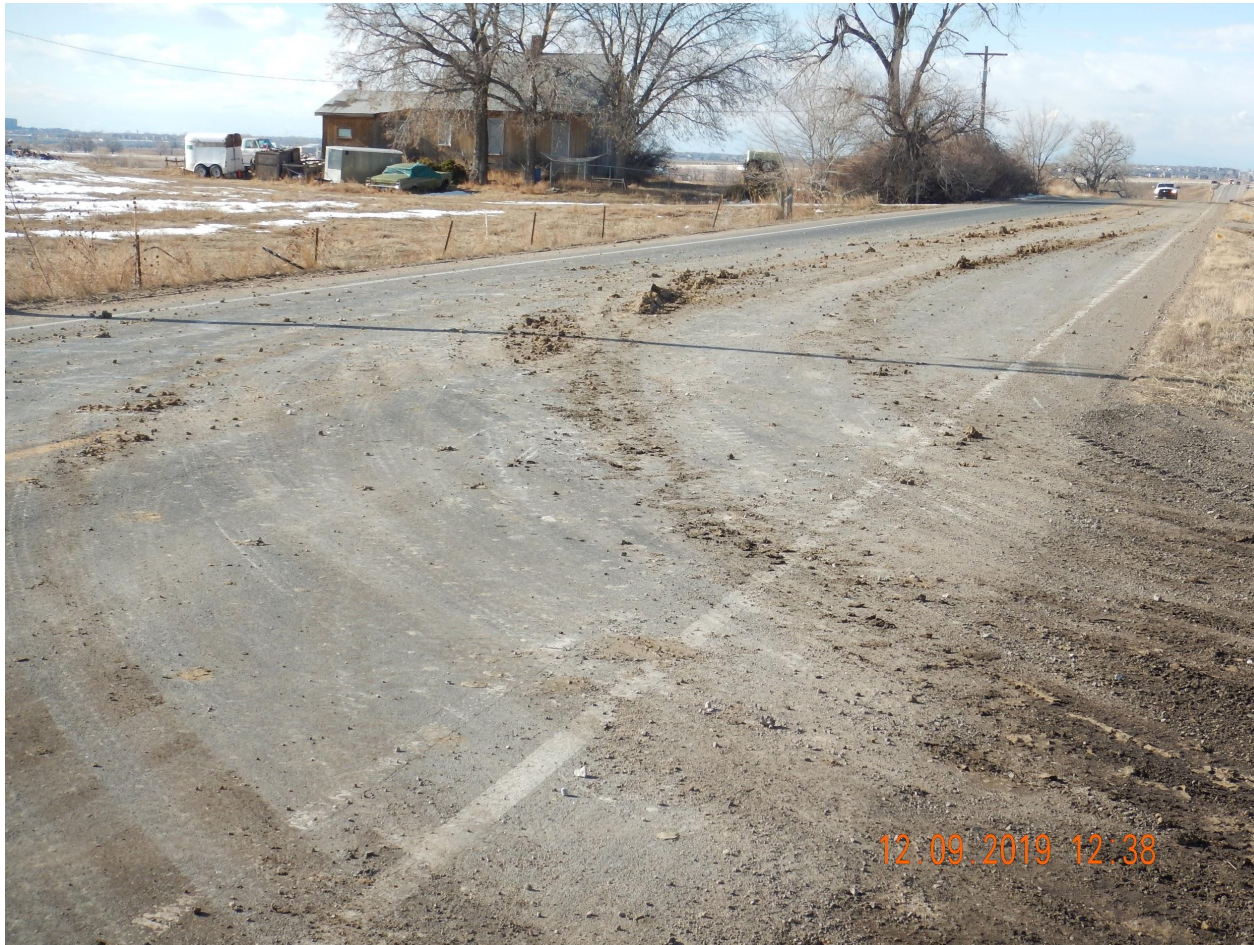
**Photo 1.** Photo taken from the entrance of the location off CR 2, facing West. Photo illustrates sediment track out onto CR 2. The current vehicle tracking device BMPs are not adequate to be in compliance with Rule 1002.f.(2)F.

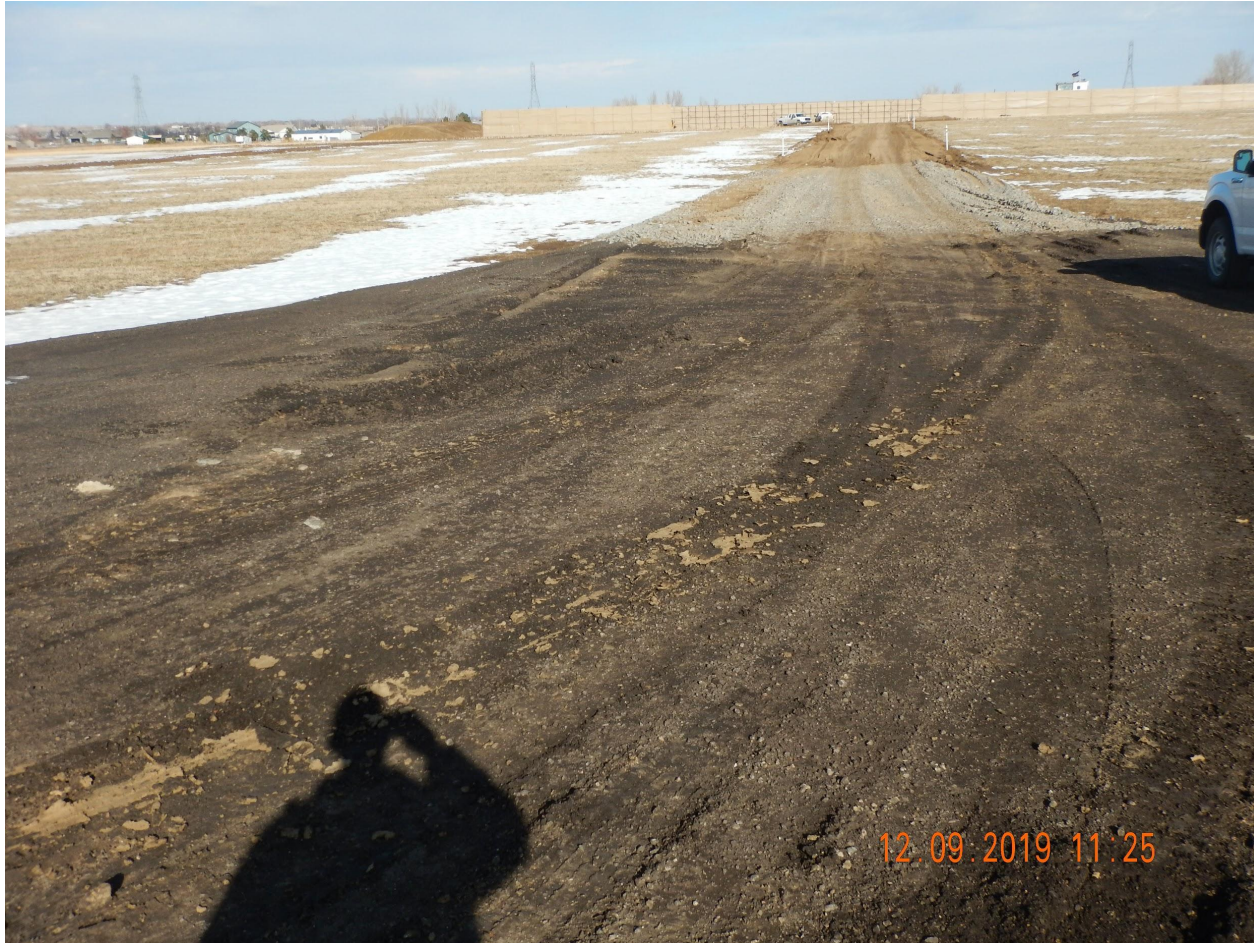
**Photo 2.** Photo taken from the entrance of the location, facing North. The current vehicle tracking device BMPs are not adequate to be in compliance with Rule 1002.f.(2)F.

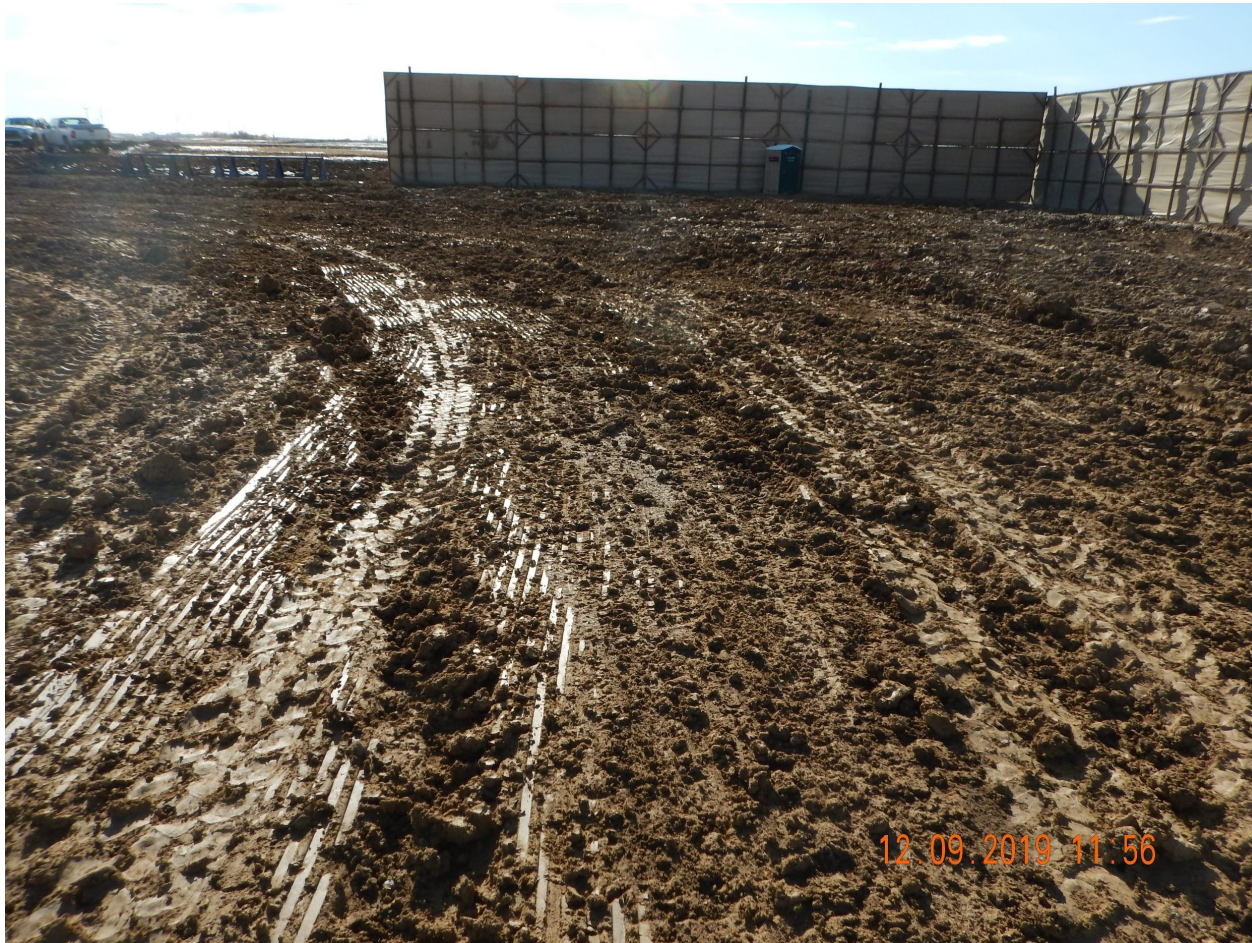
**Photo 3.** Photo taken from the location, facing South. Photo illustrates the current muddy conditions. Operator has not plated the location making it susceptible to muddy conditions and continued track out.

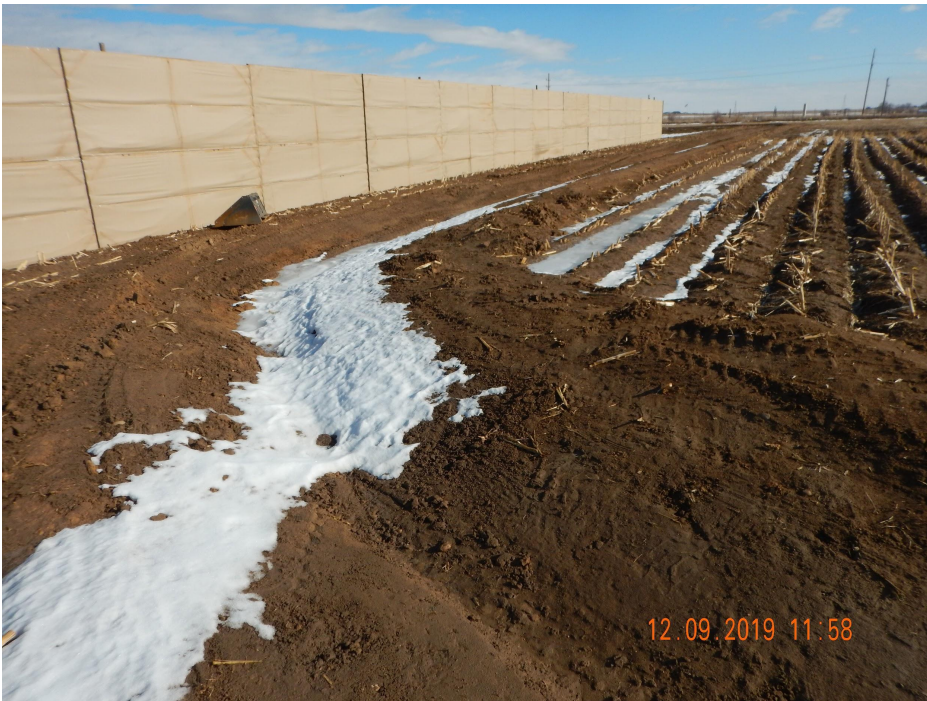
**Photo 4.** Photo taken from the southern location, facing East. Photo illustrates a ditch and berm BMP that has been installed around the entire perimeter of location.

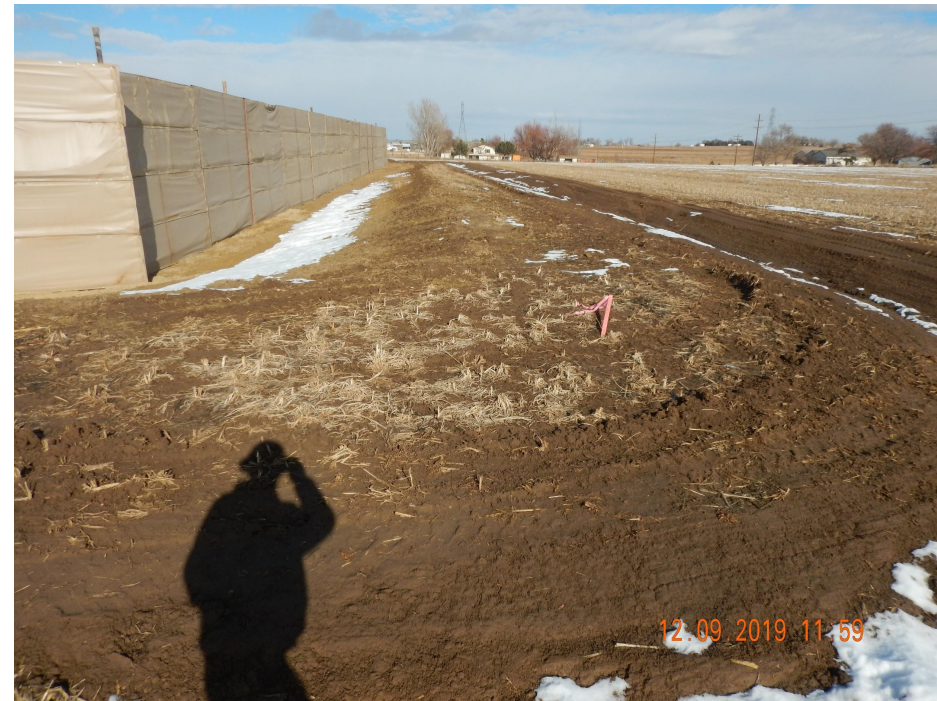
**Photo 5.** Photo taken from the southeastern location, facing North. See comments under Photo 4.

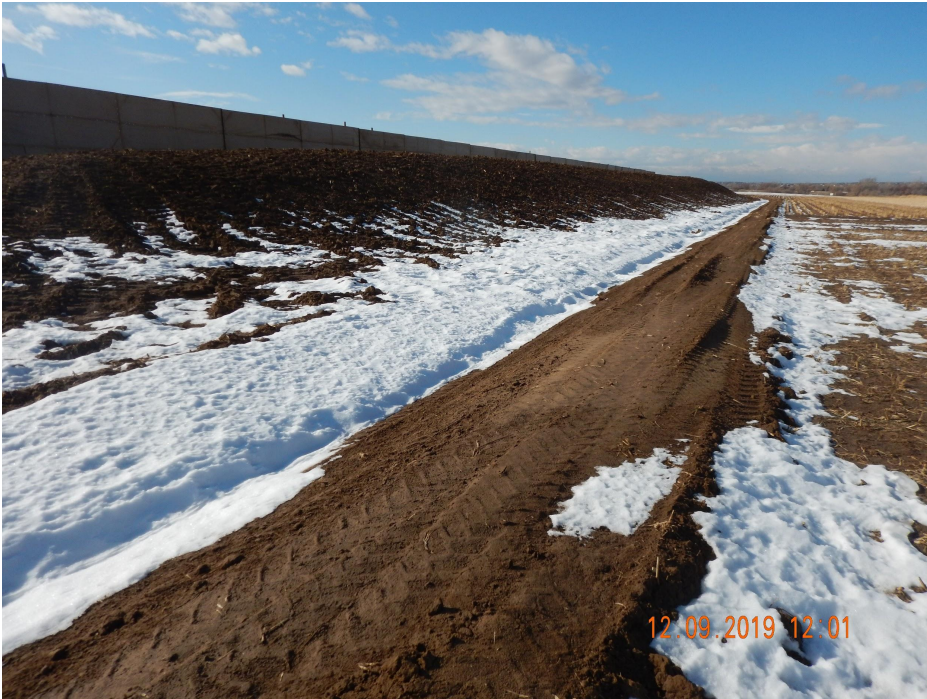
**Photo 6.** Photo taken from the northern location, facing West. See comments under Photo 4.

Photo also illustrates the northern topsoil stockpile which has been temporarily stabilized with equipment tracking.

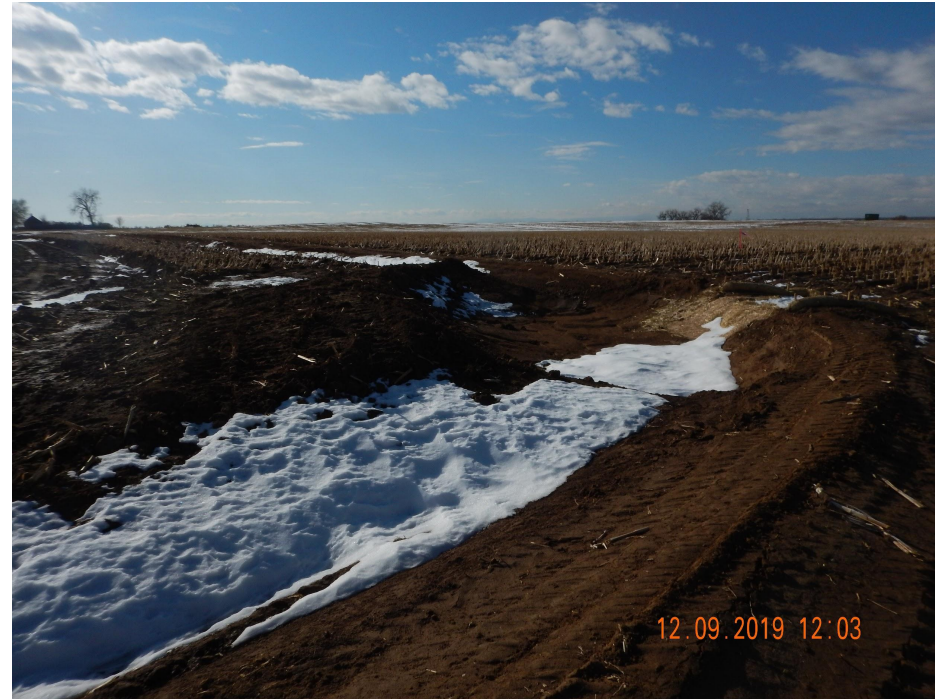
**Photo 7.** Photo taken from the northwestern location, facing West. Photo illustrates a sediment trap BMP.

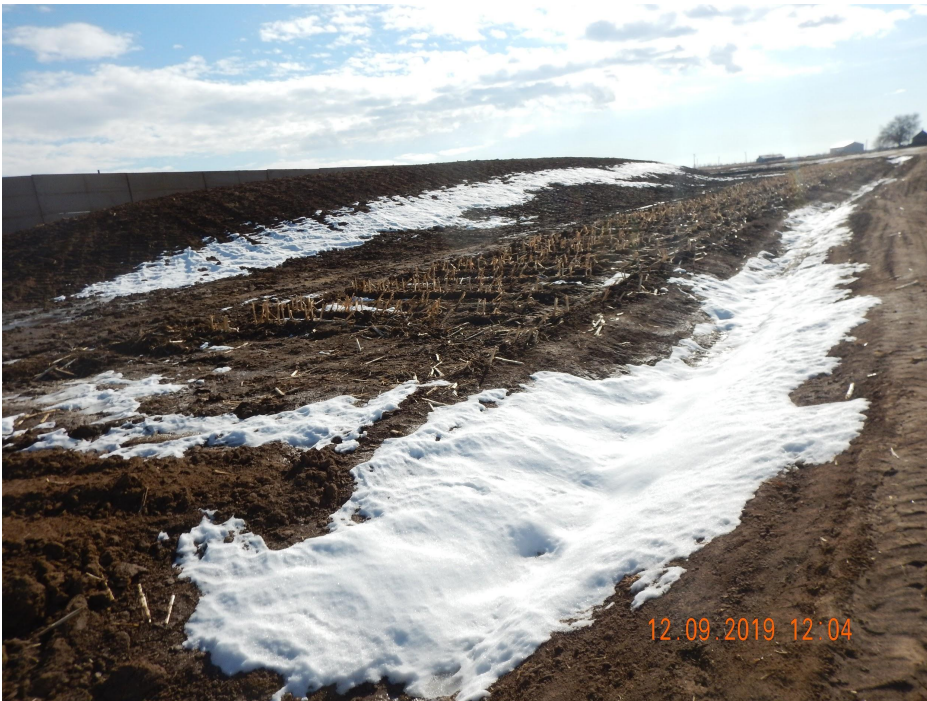
**Photo 8.** Photo taken from the northwestern location, facing South. See comments under Photo 4.

Photo also illustrates the western topsoil stockpile which has been temporarily stabilized with equipment tracking.

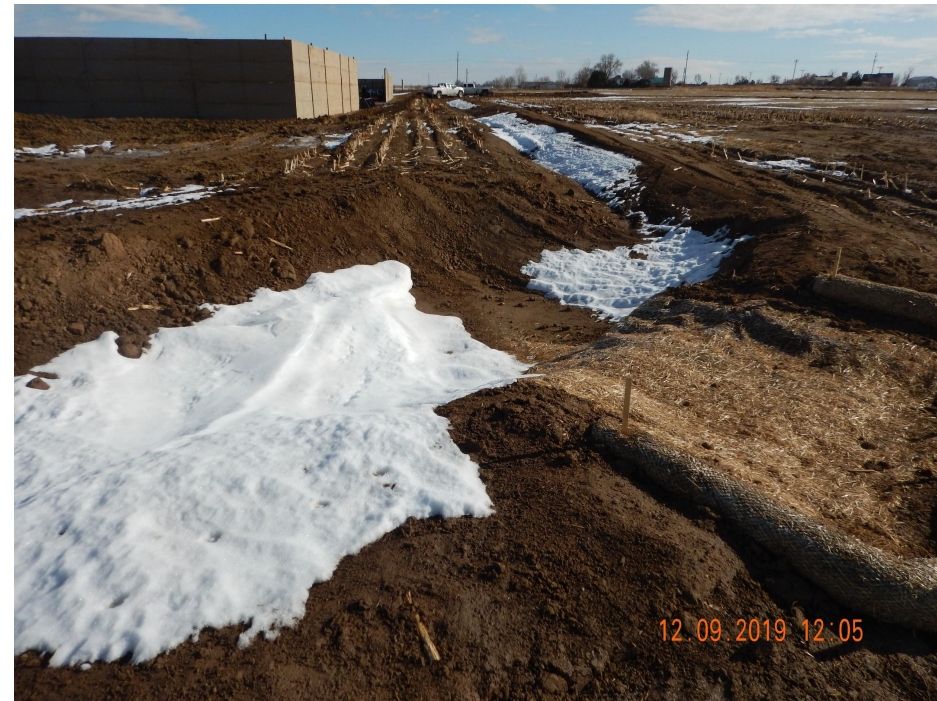
**Photo 9.** Photo taken from the southwestern location, facing East. Photo illustrates a sediment trap BMP.
