Inspection Photos
Operator: Williford Resources
Location/API #: 067-06821
Date: 11-19-2019

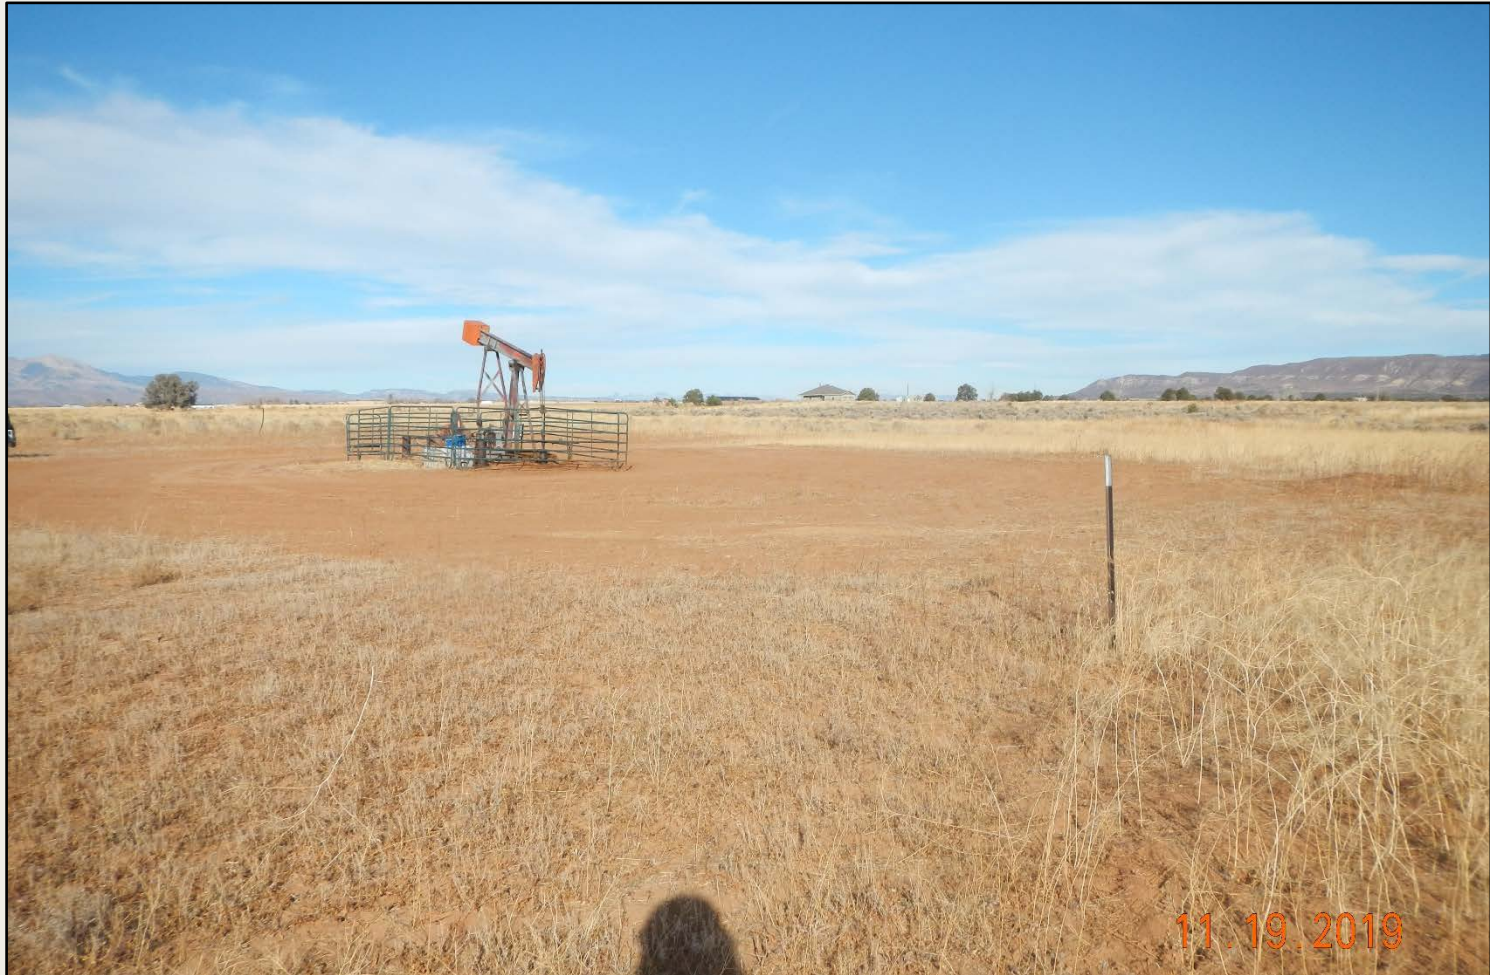
Photo 1. View of the project area from the southwestern corner facing center.

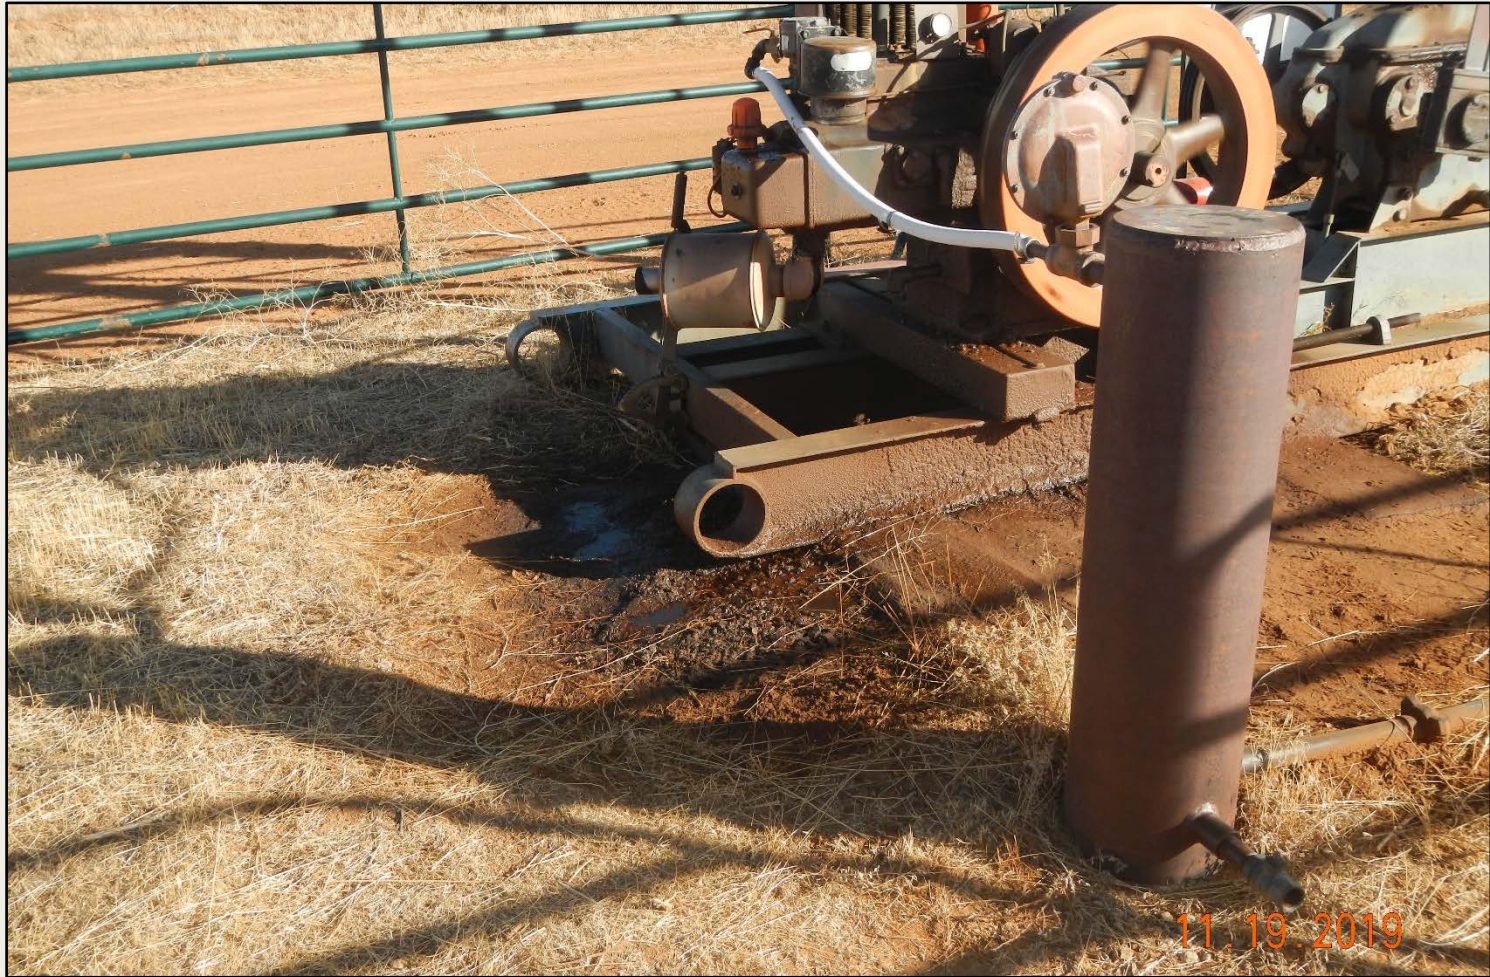
Photo 2. View of oily material and stained soils around pump jack.

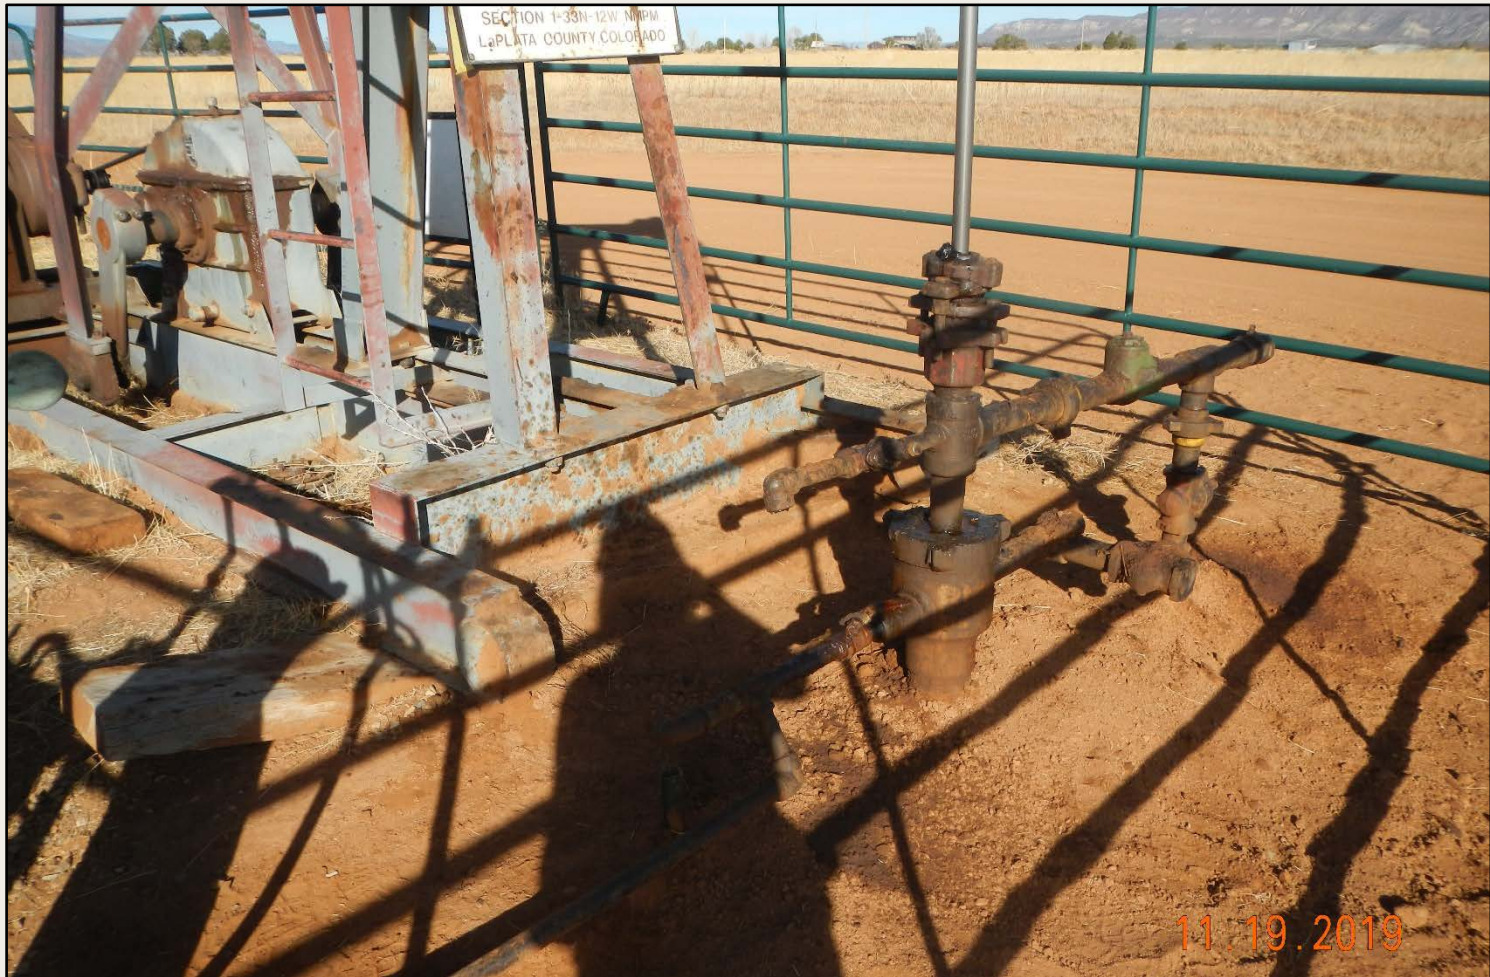
Photo 3. View of wellhead. Stained soils present around the well head.

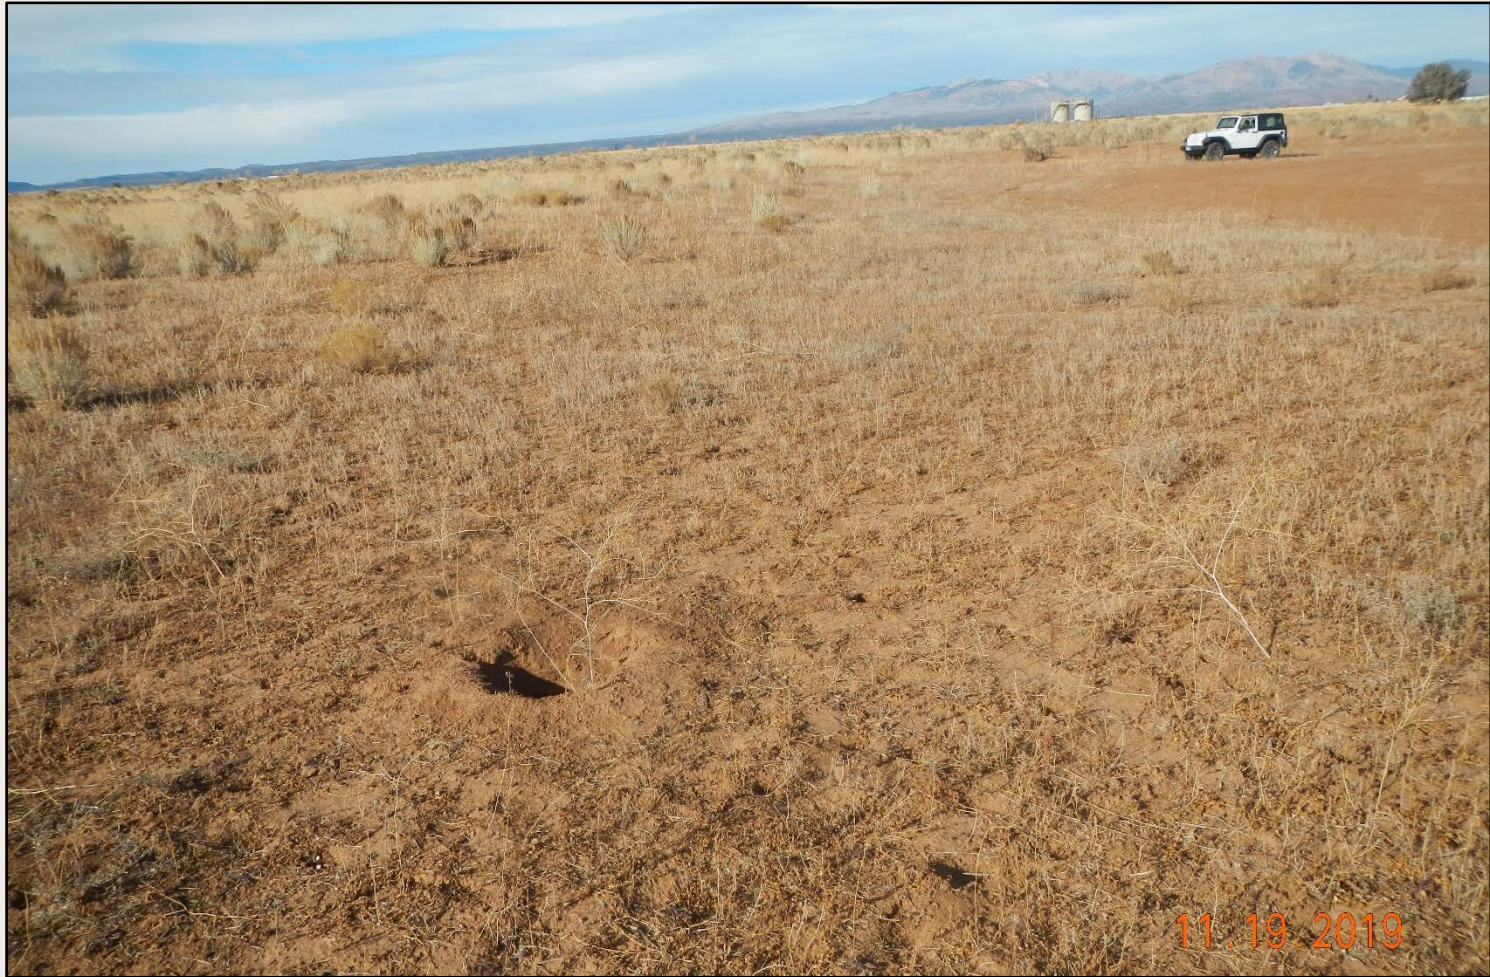
Photo 4. View of the western project area from the southwestern corner facing northward. Vegetation is largely in a dormant condition at this time, largely comprised of mixed wheatgrasses, snakeweed, sagebrush, and annual weeds.

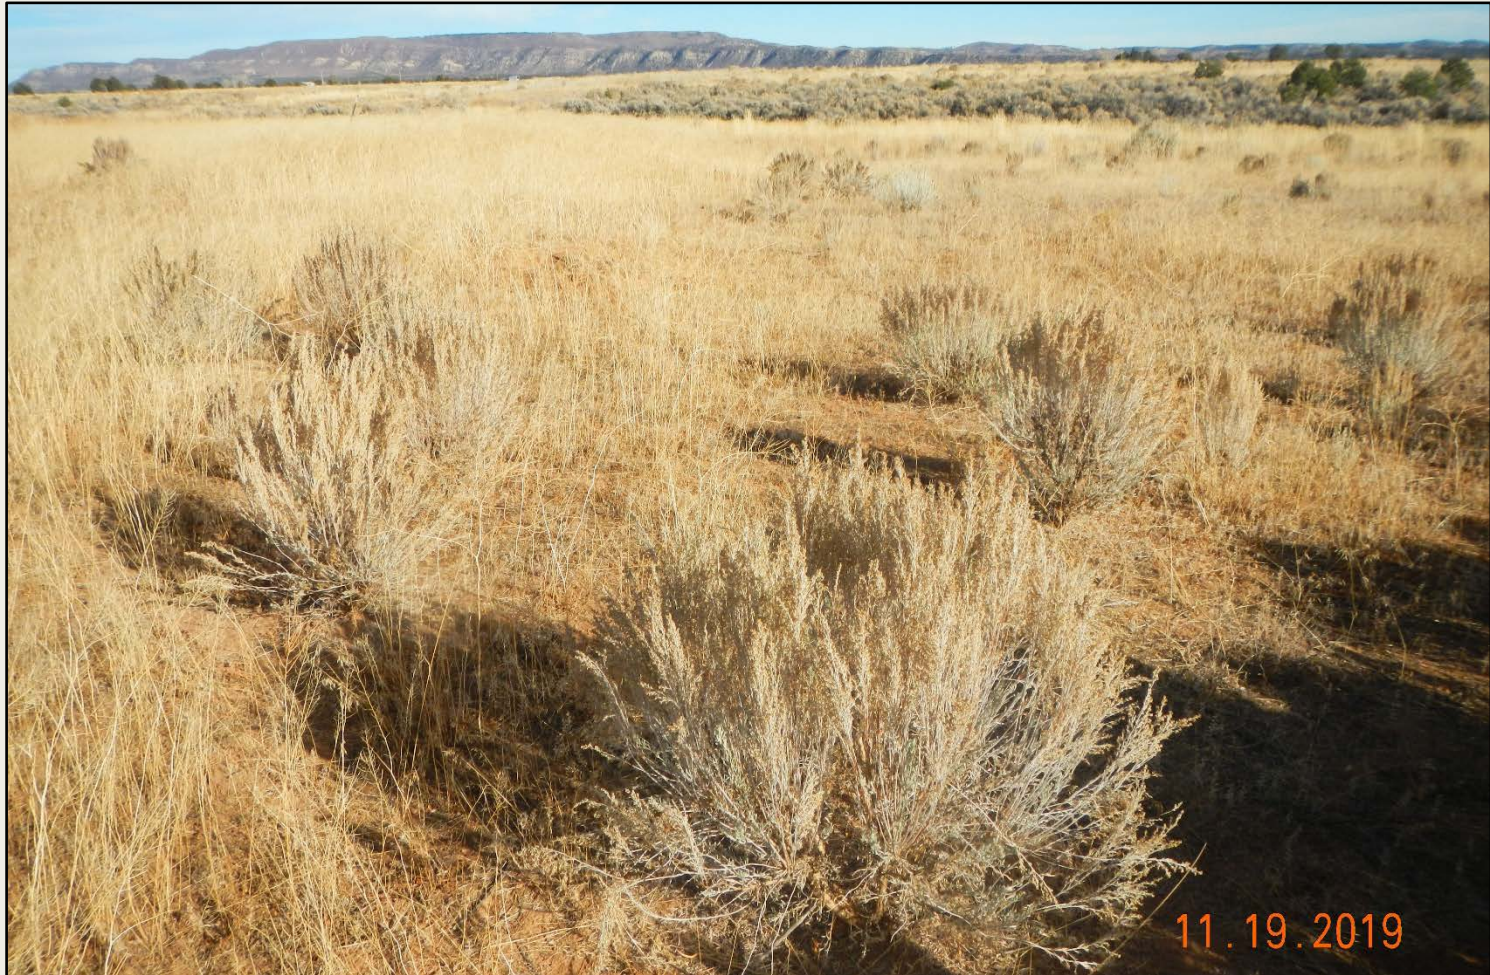
Photo 5. View of reference area, largely comprised of sagebrush, mixed wheatgrasses, and annual weeds.
