**Inspection Photos**  
**Operator: Williford Resources**  
**Location/API #: 067-06557**  
**Date: 11-19-2019**

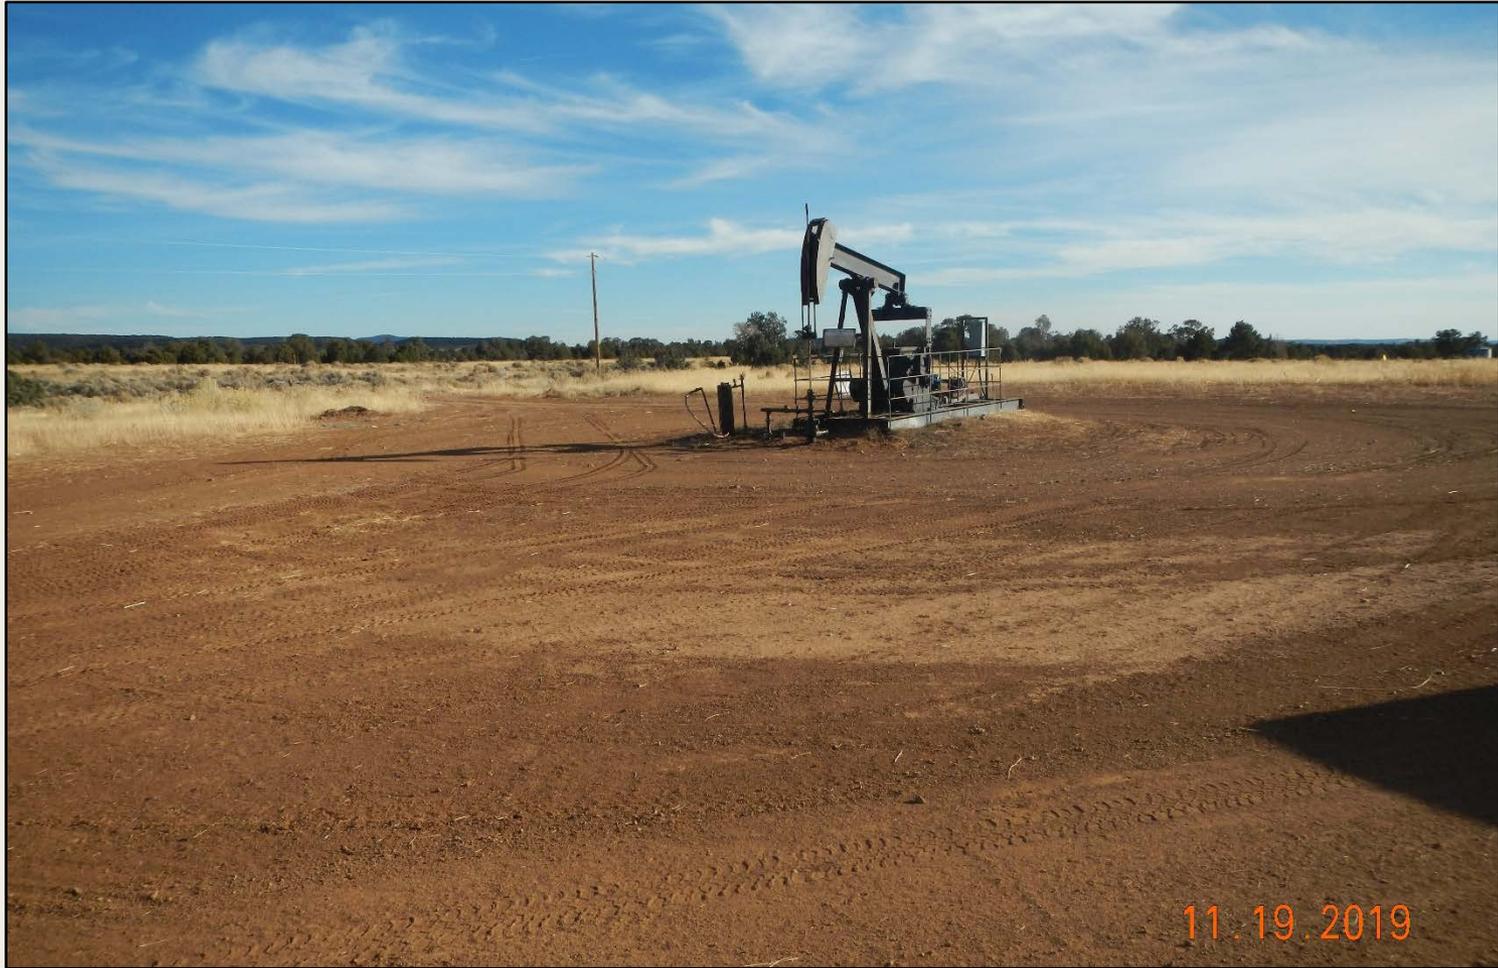
Photo 1. View of the project area from the northwestern corner facing center.

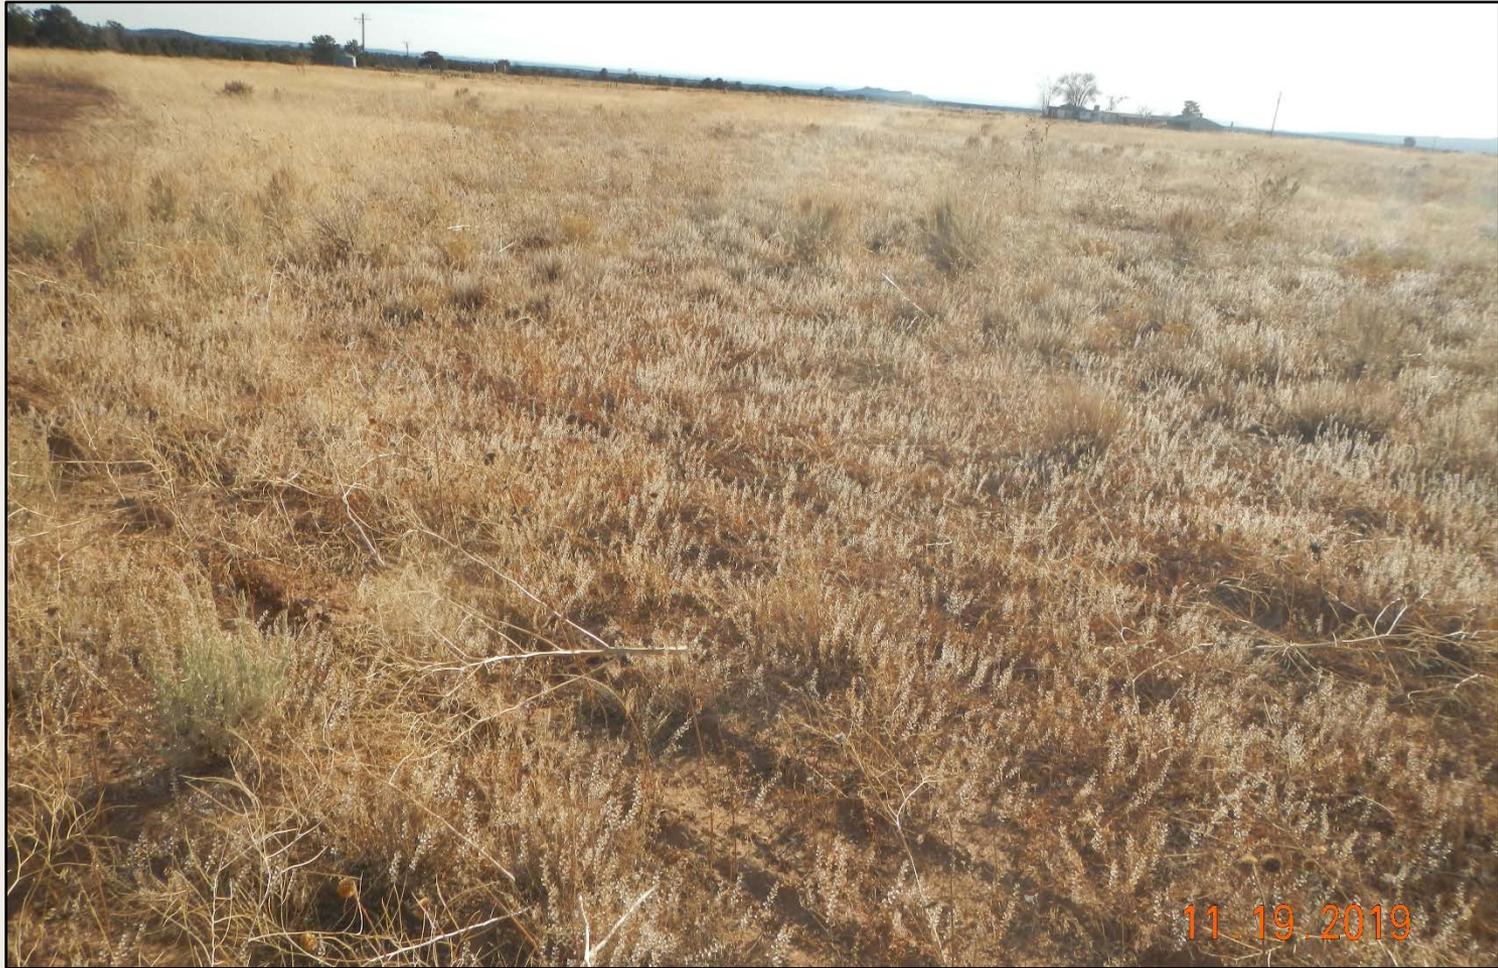
Photo 2. View of the western project area from the northwestern corner facing southward. Vegetation is largely in a dormant condition at this time, but largely comprised of mixed wheatgrasses, snakeweed, sagebrush, and annual weeds.

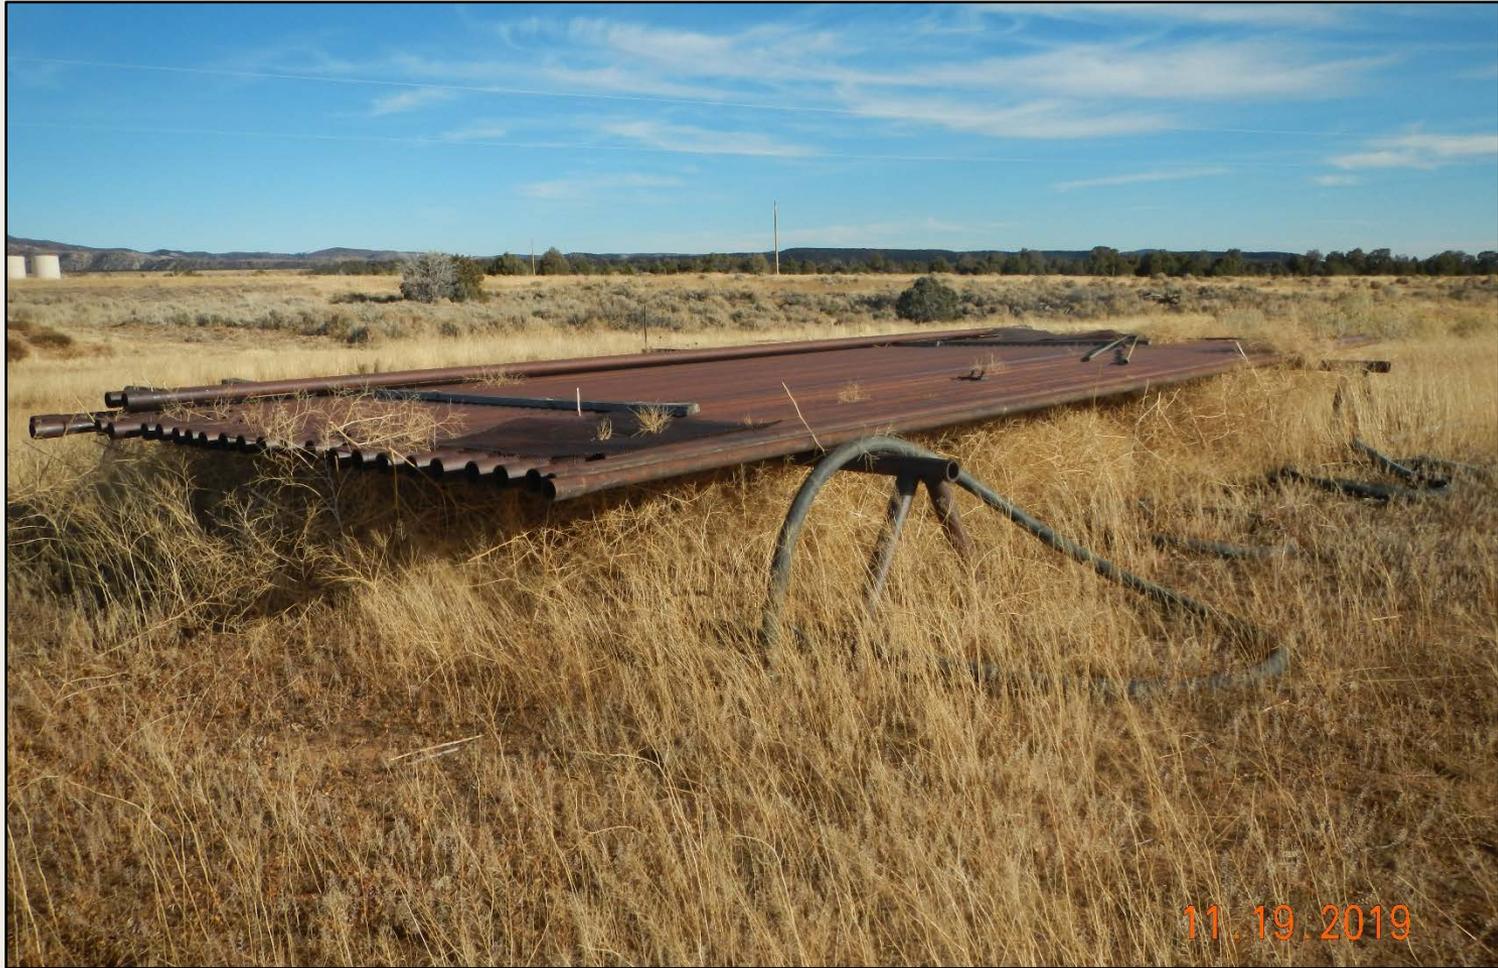
Photo 3. View of unused tubing stored within the project area.

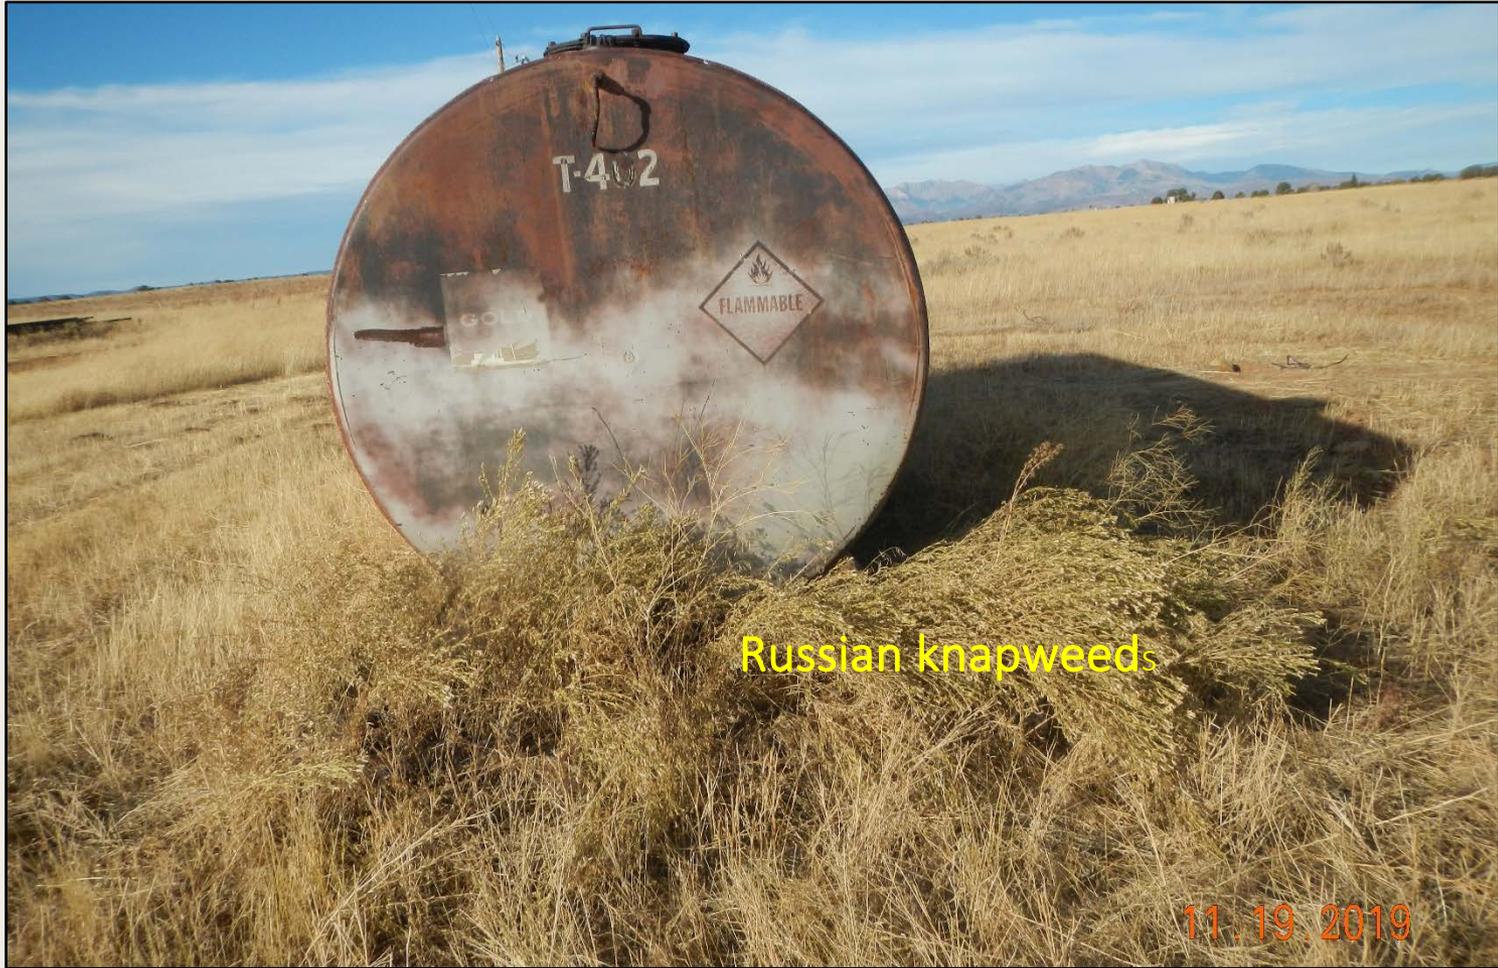
Photo 4. View of unused tank within the northeastern project area. Russian knapweeds are growing around the tank.

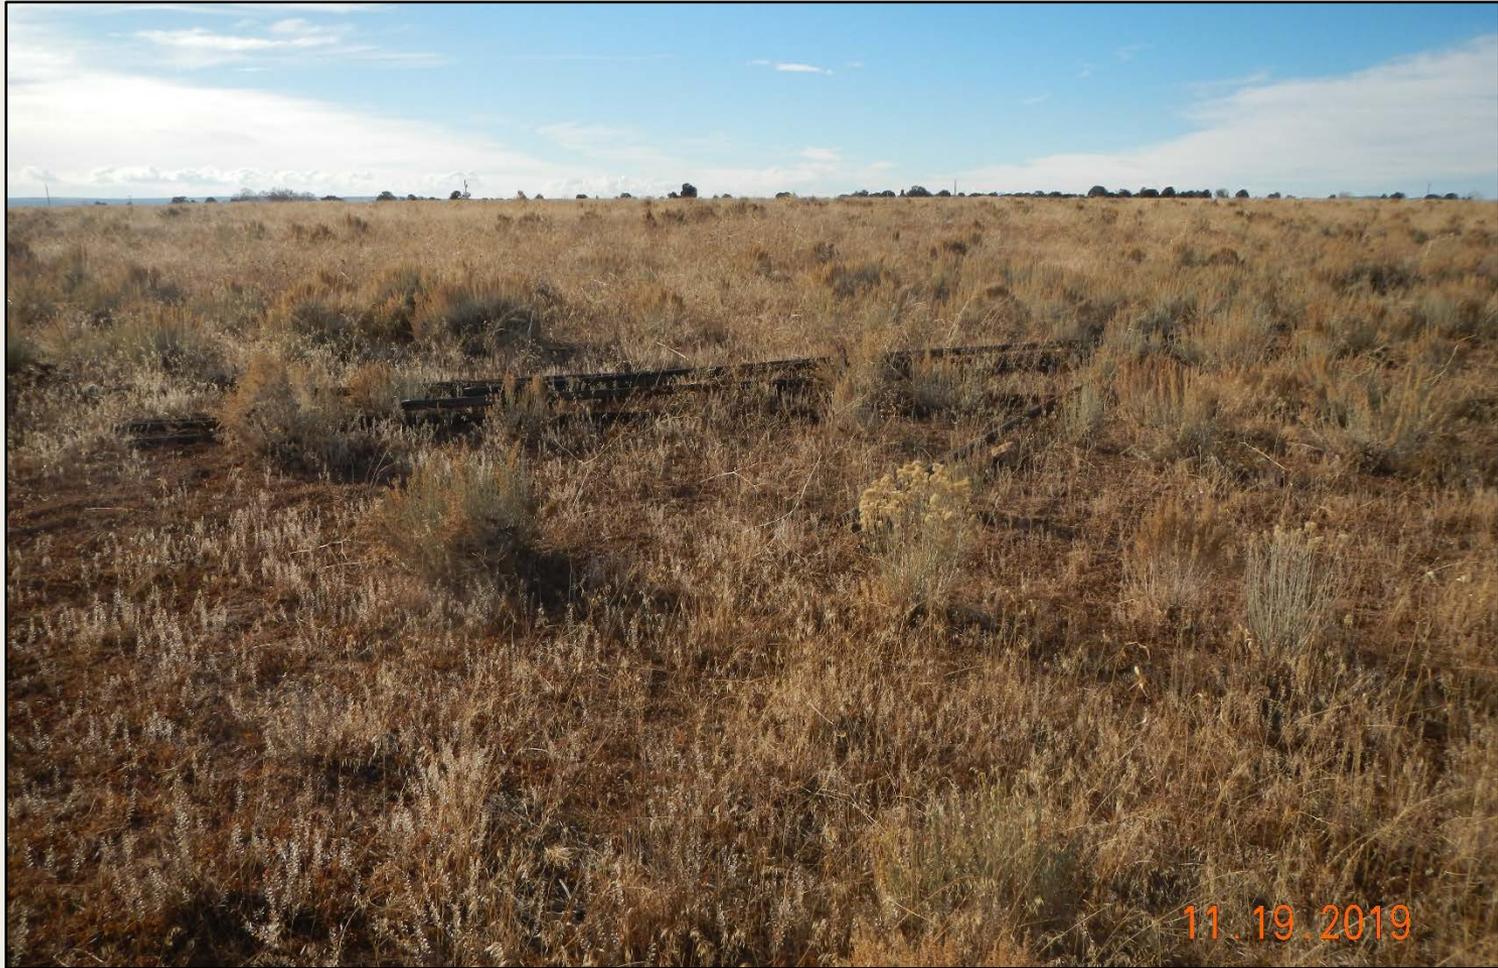
Photo 5. View of more tubing stored near the project area.

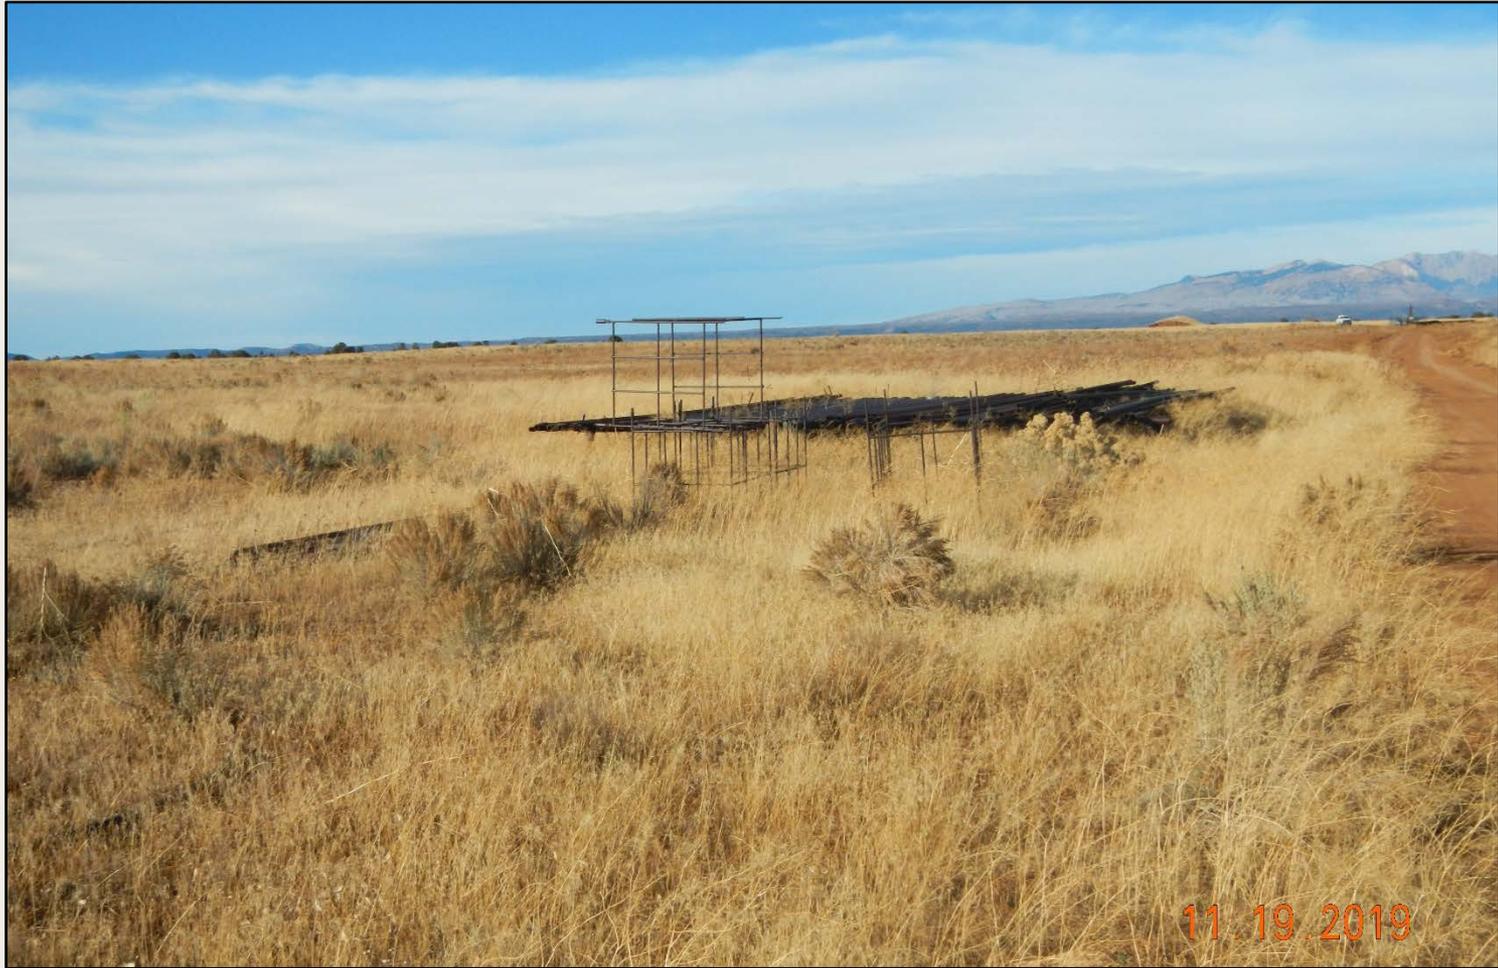
Photo 6. View of more unused tubing stored north of the project area.

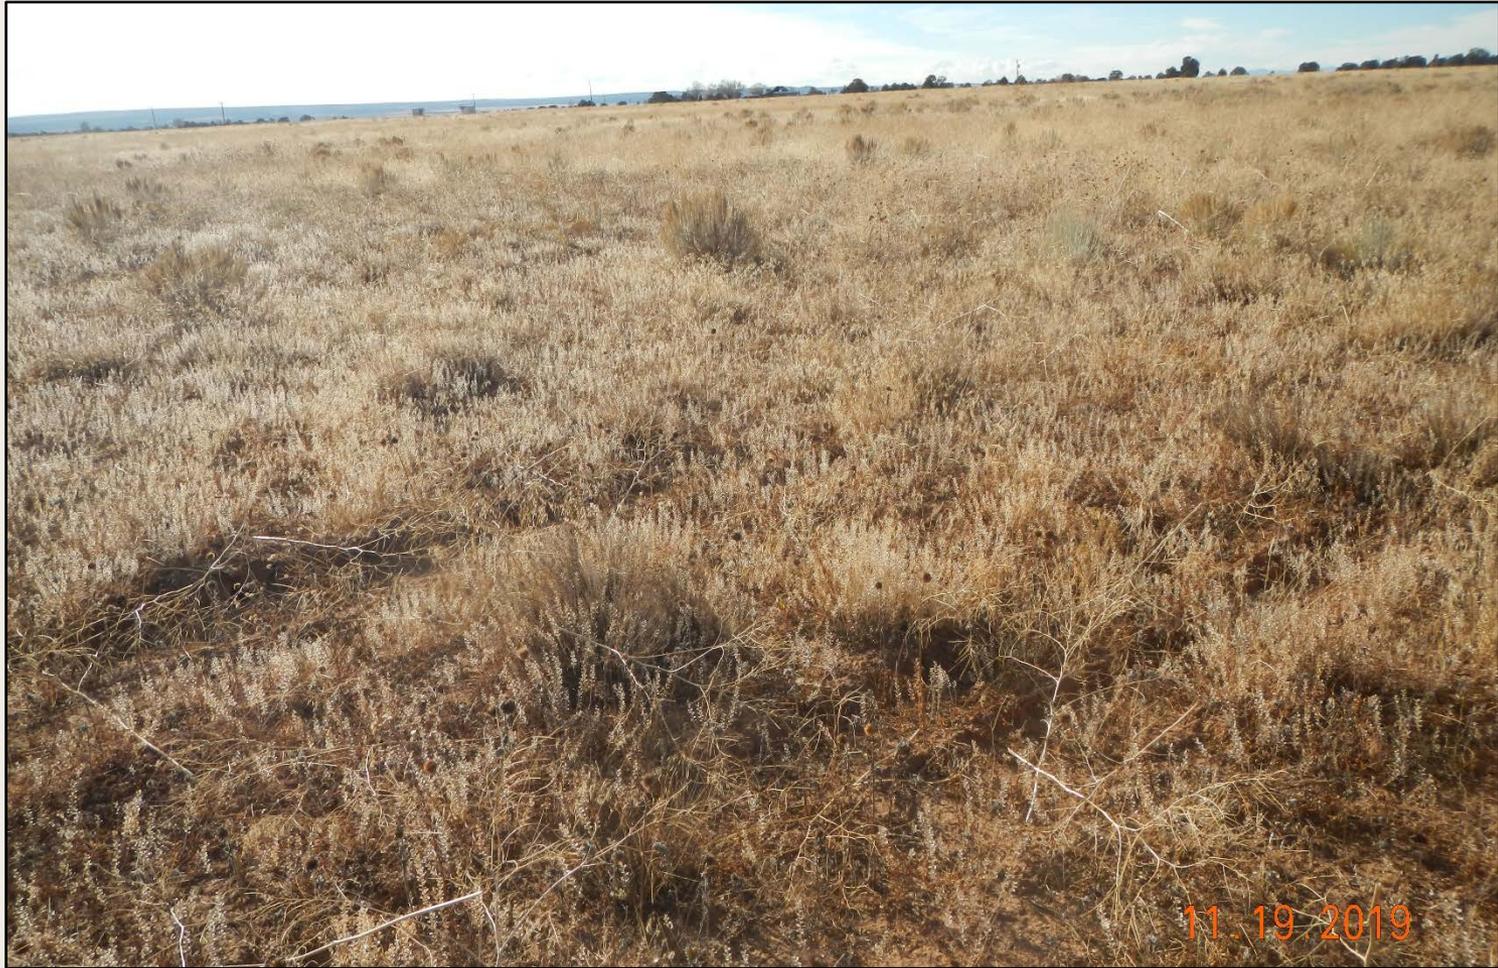
Photo 7. View of reference area, largely comprised of sagebrush, mixed wheatgrasses, and annual weeds such as yellow tumbled mustard and *Alyssum simplex*.
