Inspection Photos
Operator: Williford Resources
Location/API #: 067-06607
Date: 11-19-2019

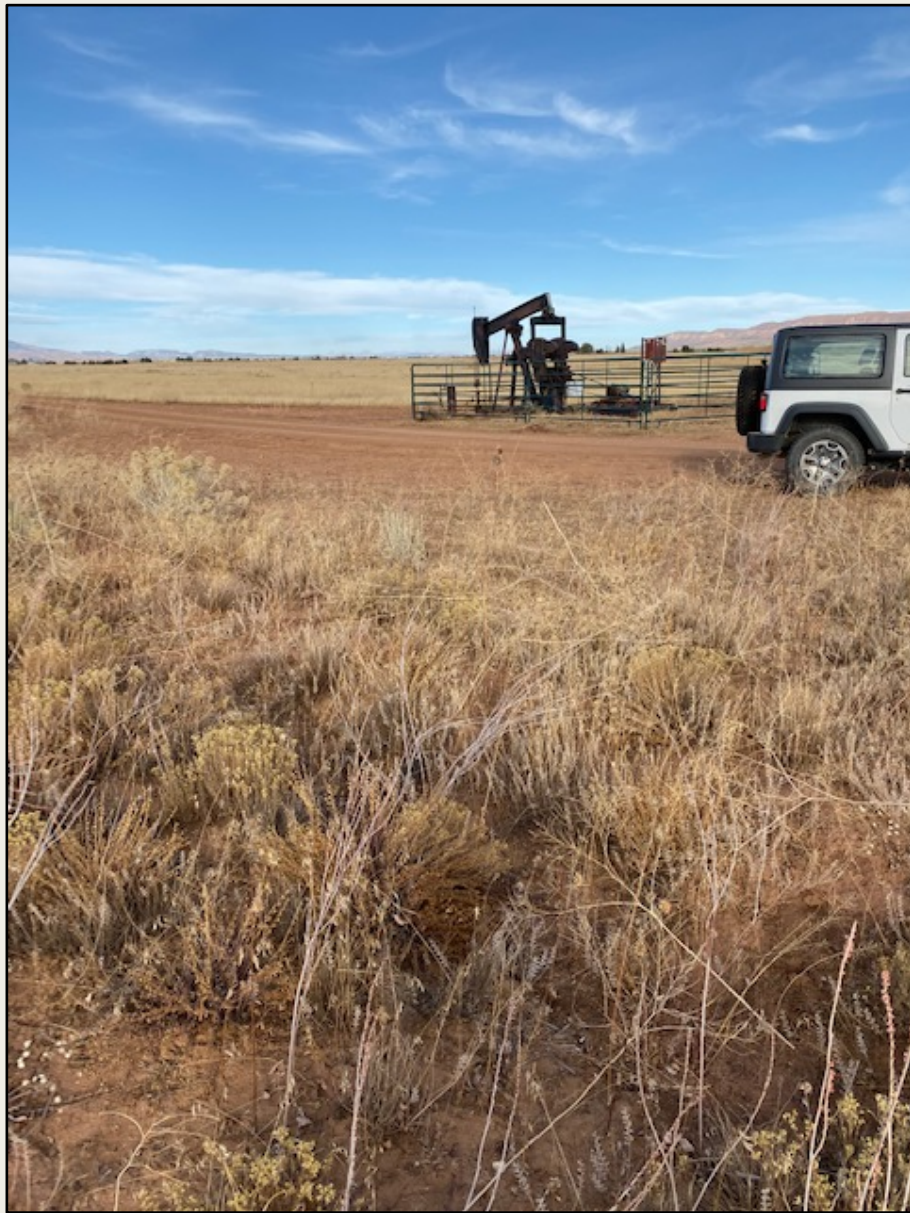
Photo 1. View of the project area from the southwestern corner facing center.

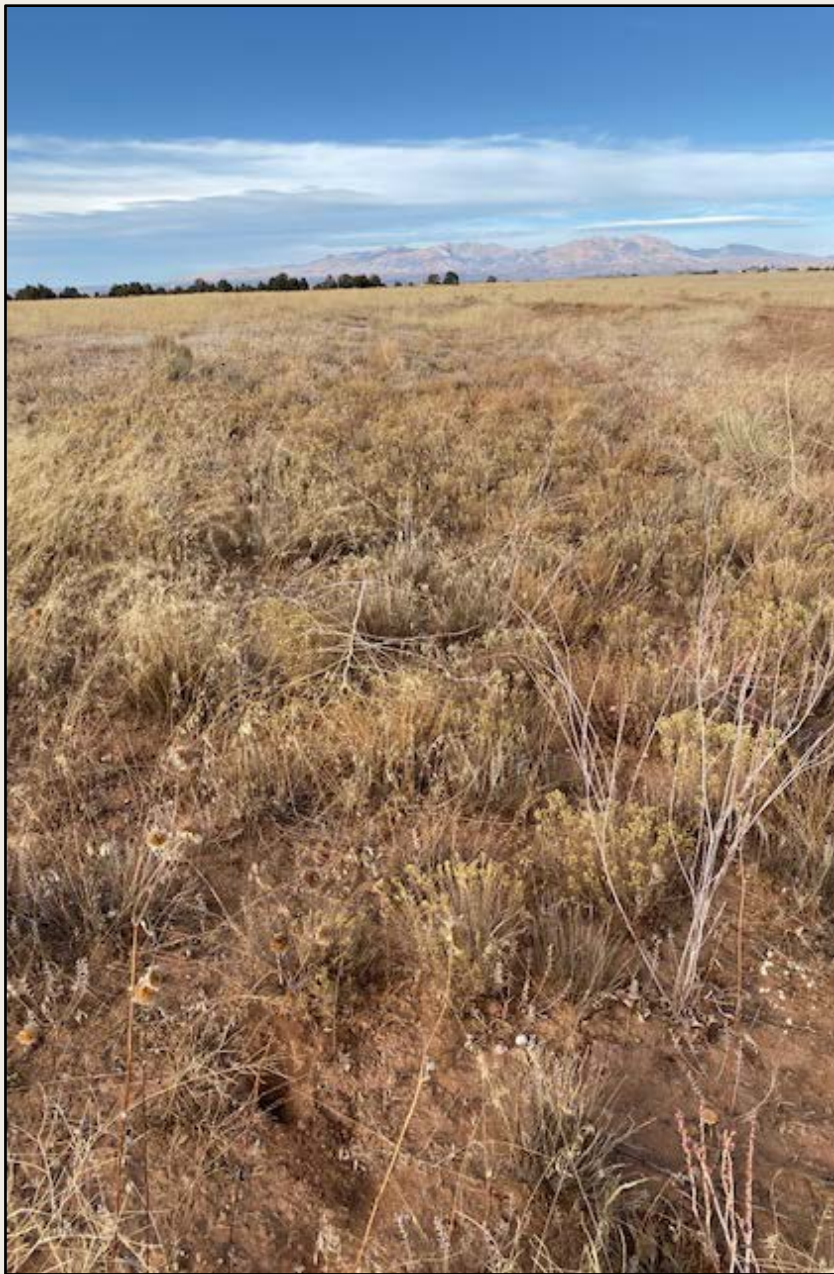
Photo 2. View of the western project area from the southwestern corner facing northward. Vegetation is largely in a dormant condition at this time, but largely comprised of mixed wheatgrasses, snakeweed, sagebrush, and annual weeds.

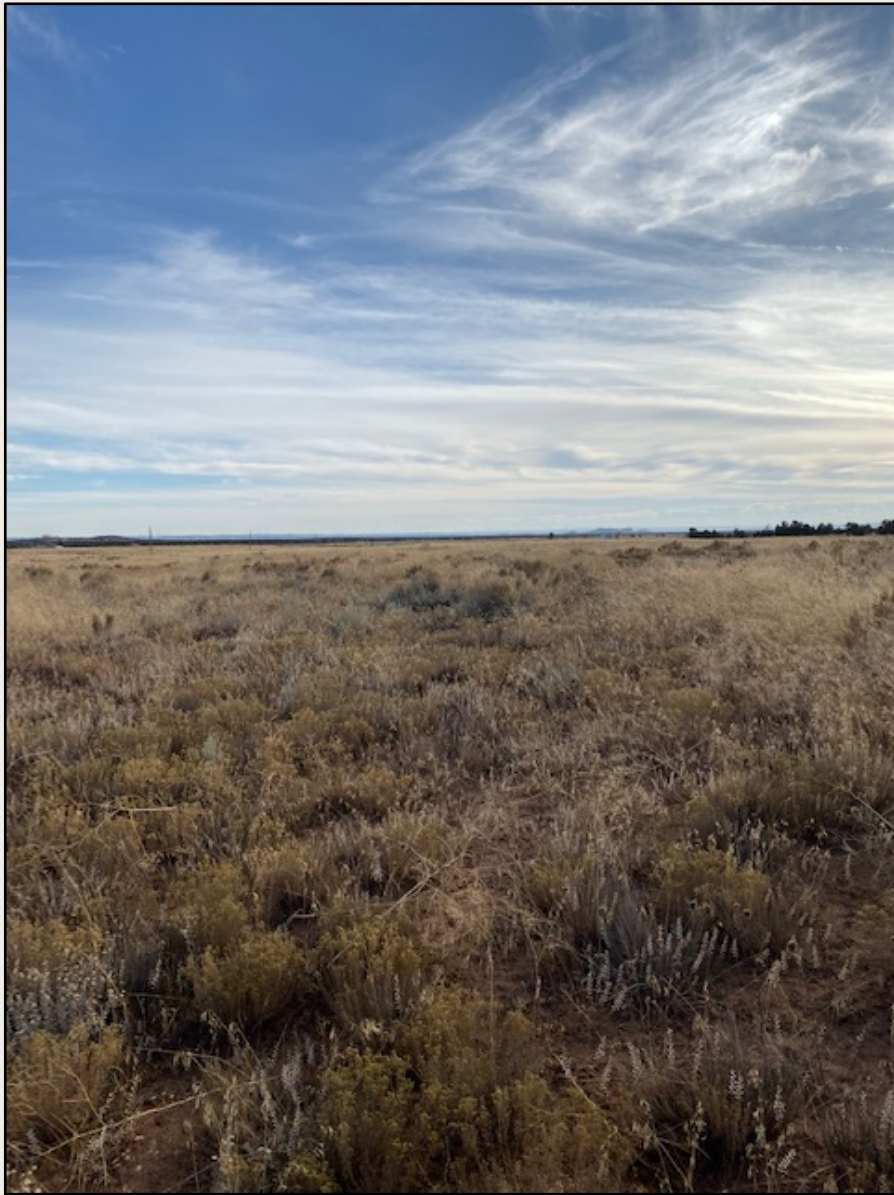
Photo 3. View of reference area, largely comprised of sagebrush, mixed wheatgrasses, and snakeweed.
