Inspection Photos
Operator: Williford Resources
Location/API #: 067-06347
Date: 11-19-2019

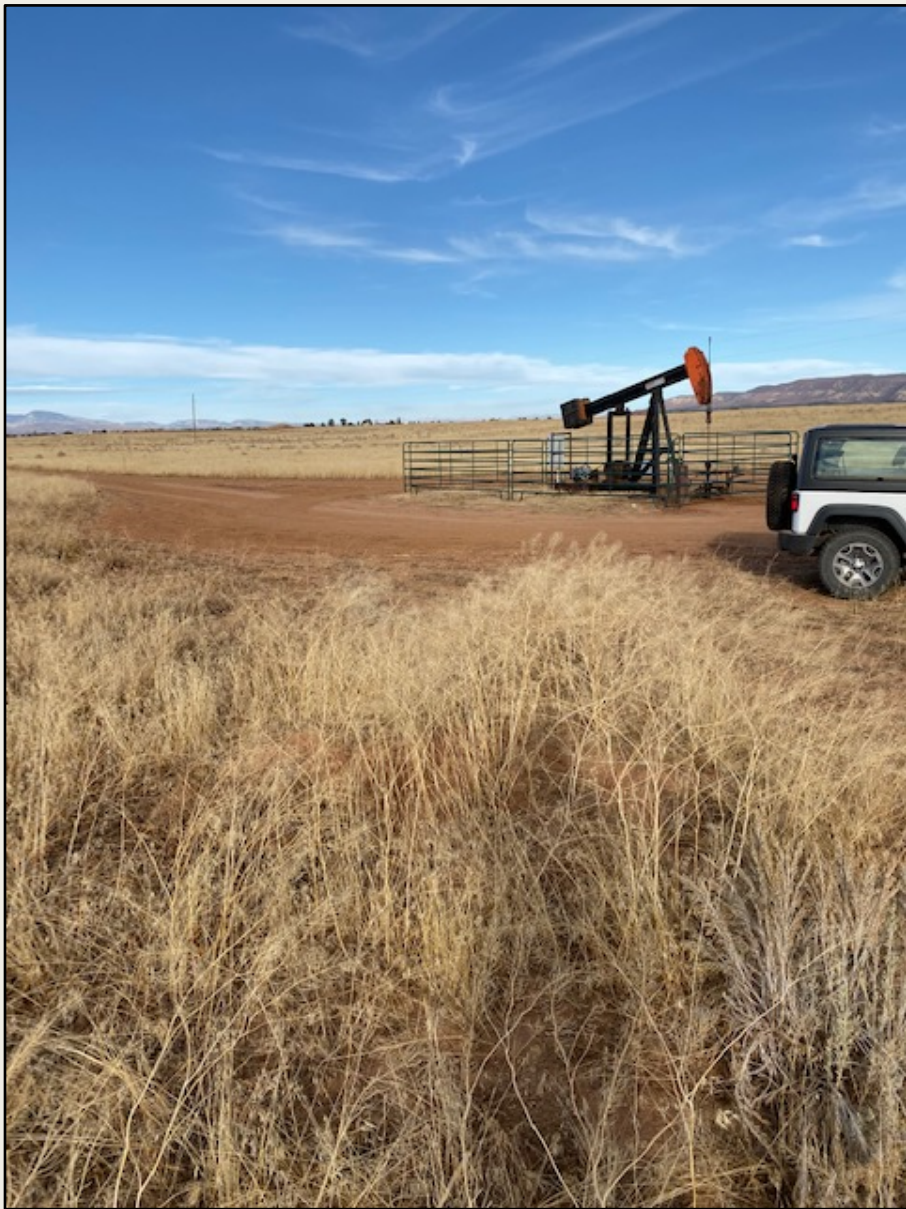
Photo 1. View of the project area from the southwestern corner facing center.

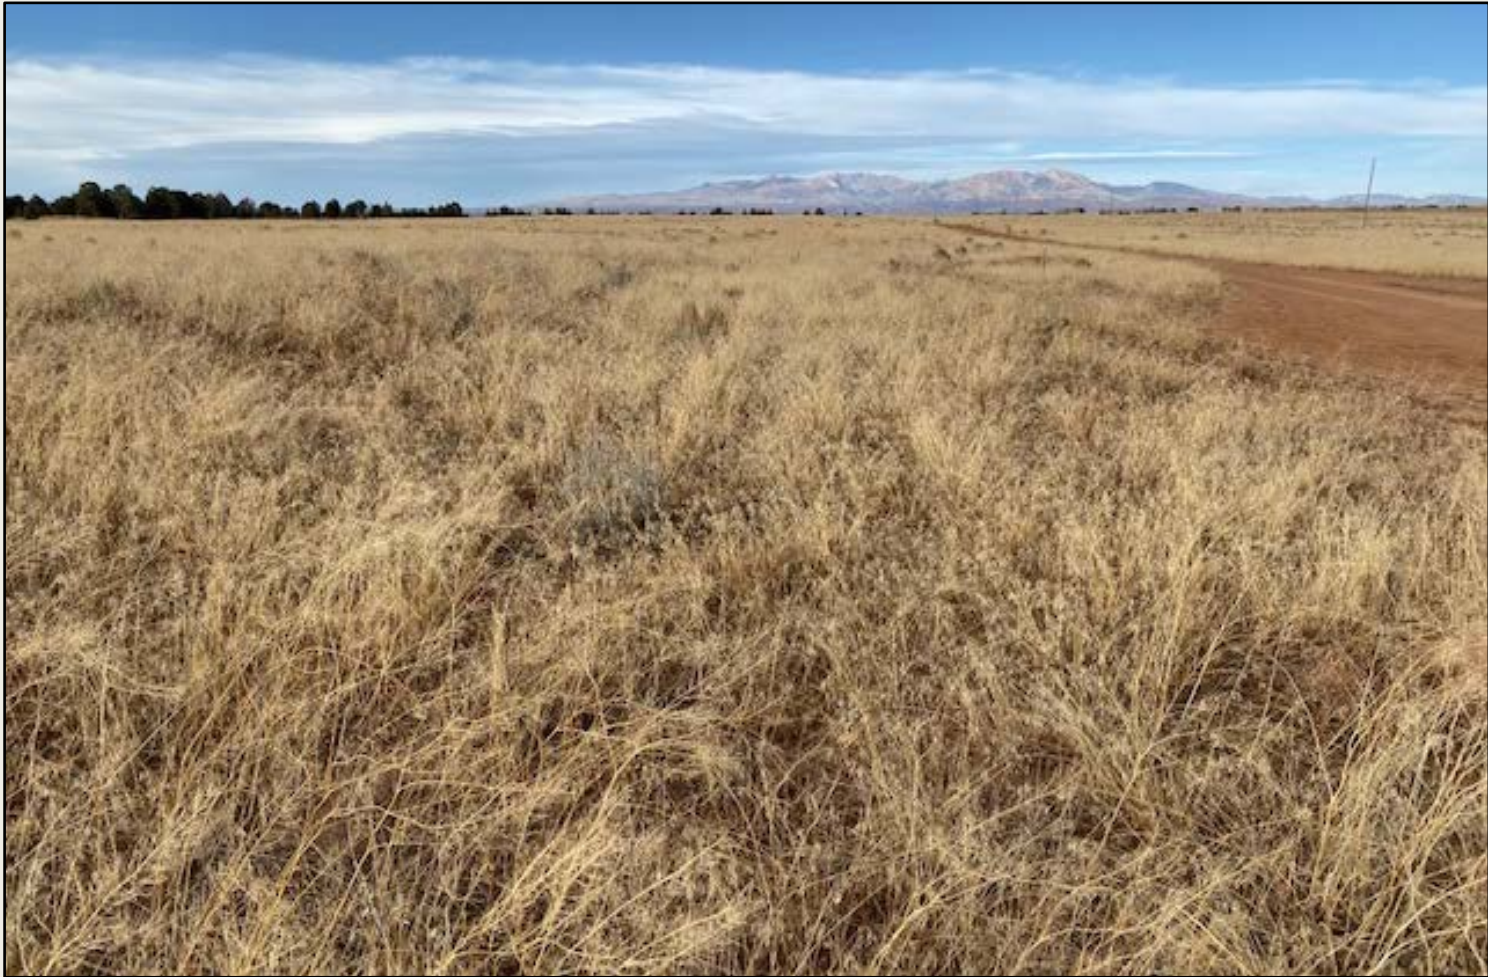
Photo 2. View of the western project area from the southwestern corner facing northward. Vegetation is largely in a dormant condition at this time, but largely comprised of mixed wheatgrasses, snakeweed, sagebrush, and annual mustards.

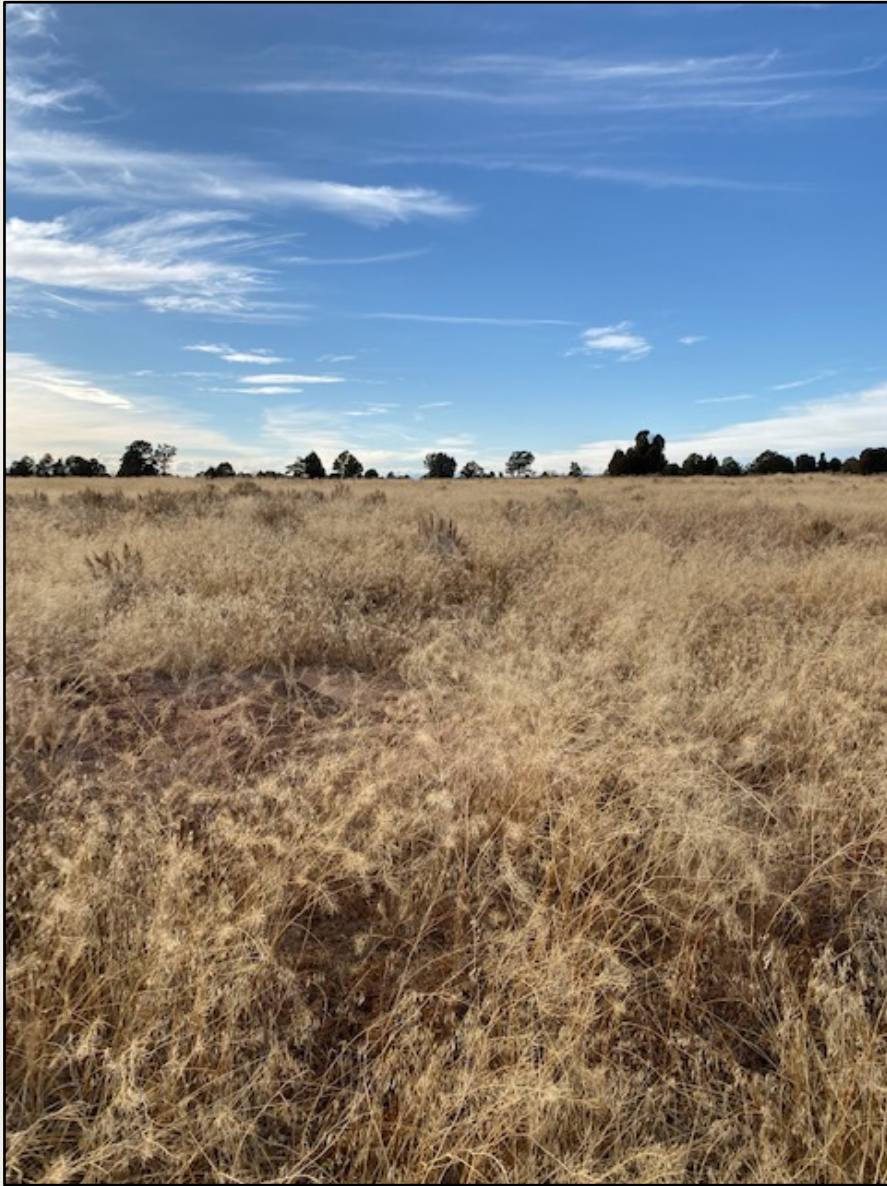
Photo 3. View of reference area, largely comprised of sagebrush, mixed wheatgrasses, and annual weeds such as yellow tumbled mustard.
