## Inspection Photos

Location Name: CAERUS PICEANCE LLC KEINATH FEDERAL-68S96W /18SWNE

Location ID: 334316

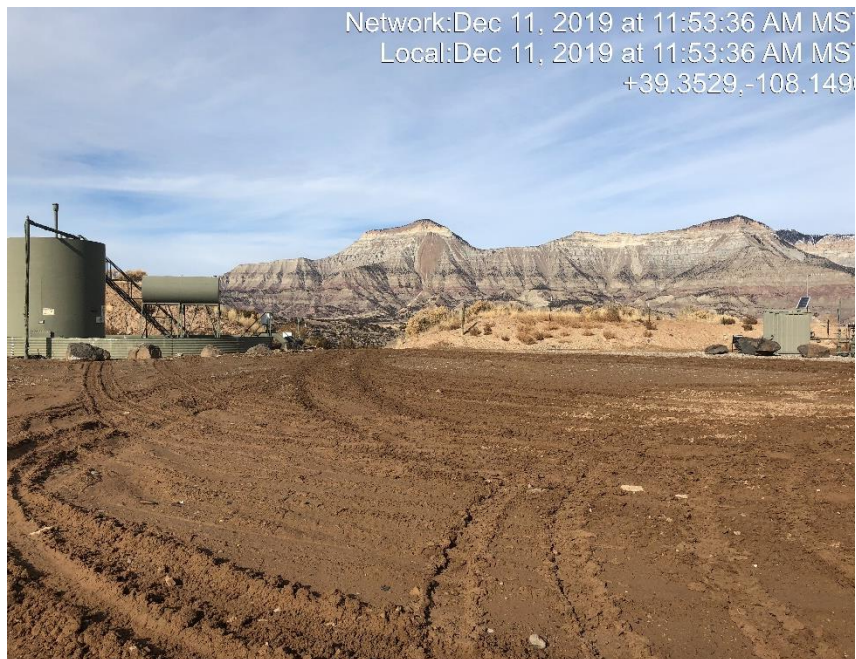
Photo #0223 photo from SW corner of location.

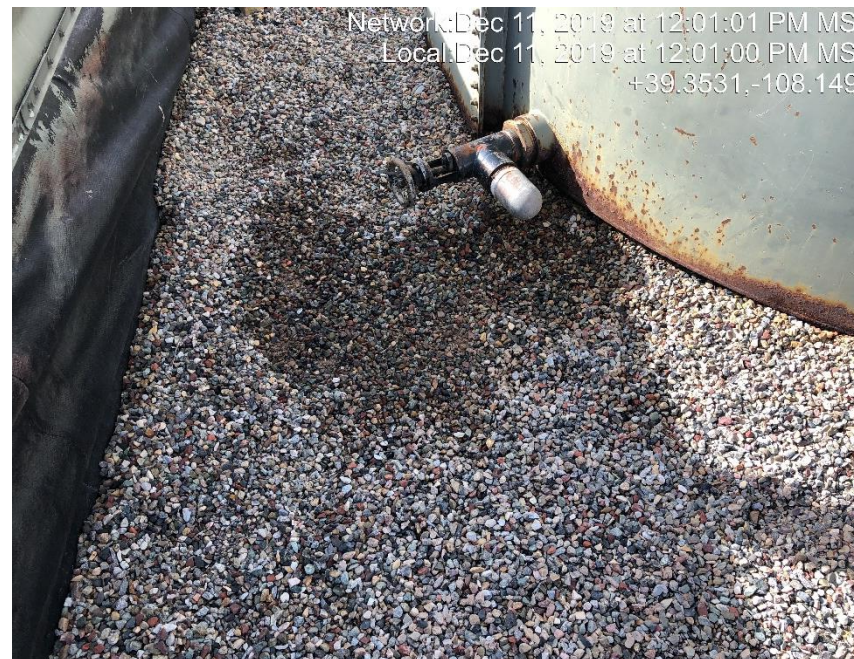
Photo #0227 stained gravel under drain valve.

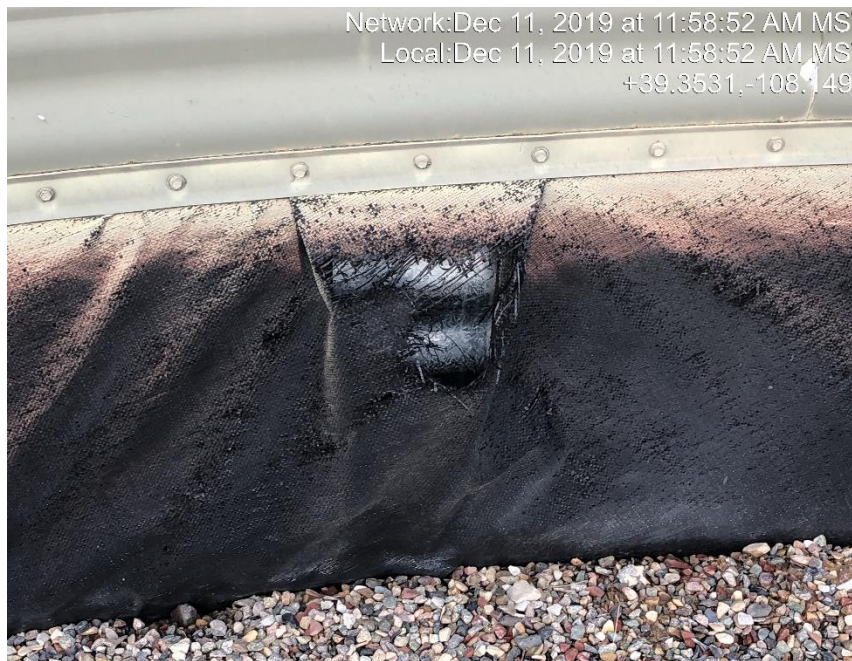
**Photo #0225 Multiple holes in tank containment liner.**

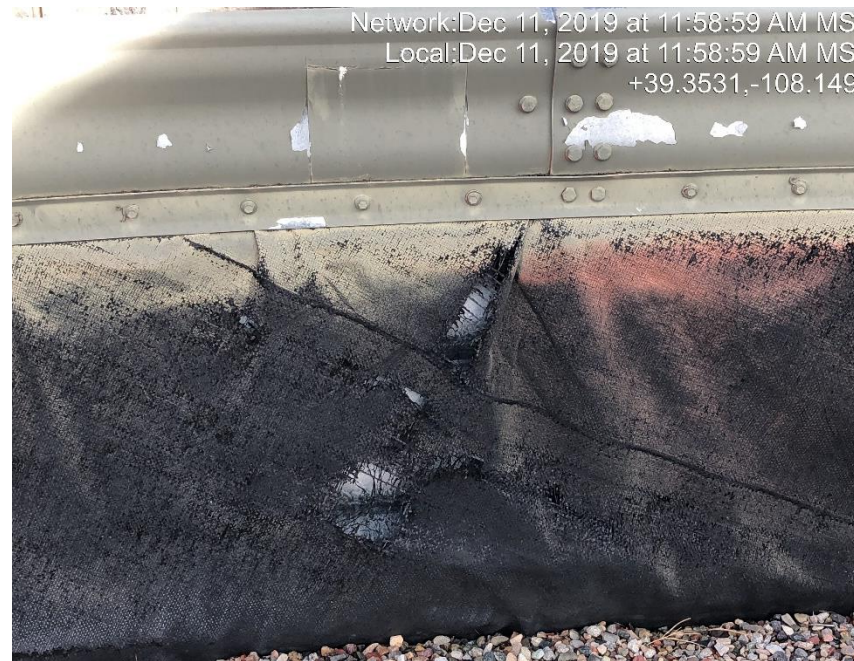
**Photo #0226 Multiple holes in tank containment liner.**
