Interim Reclamation and Stormwater Inspection

December 9, 2019

Operator: KERR MCGEE OIL & GAS ONSHORE LP- #47120

Location ID: 453447

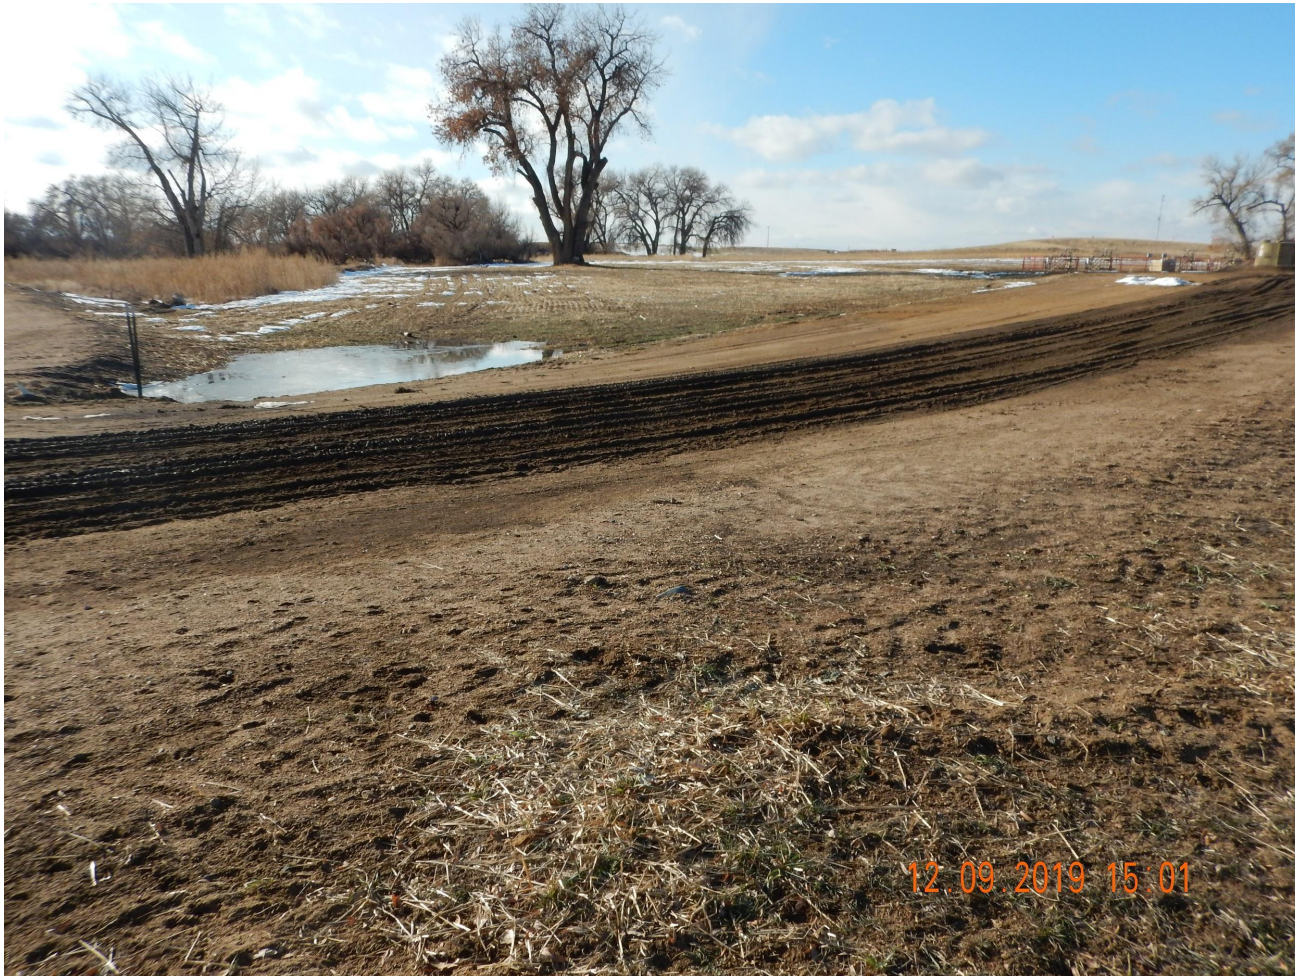
Photo 1. Photo taken from the southern location, facing West. Photo illustrates Operator has performed Interim Reclamation activities with the evidence of drill rows, straw crimped mulch and germination.

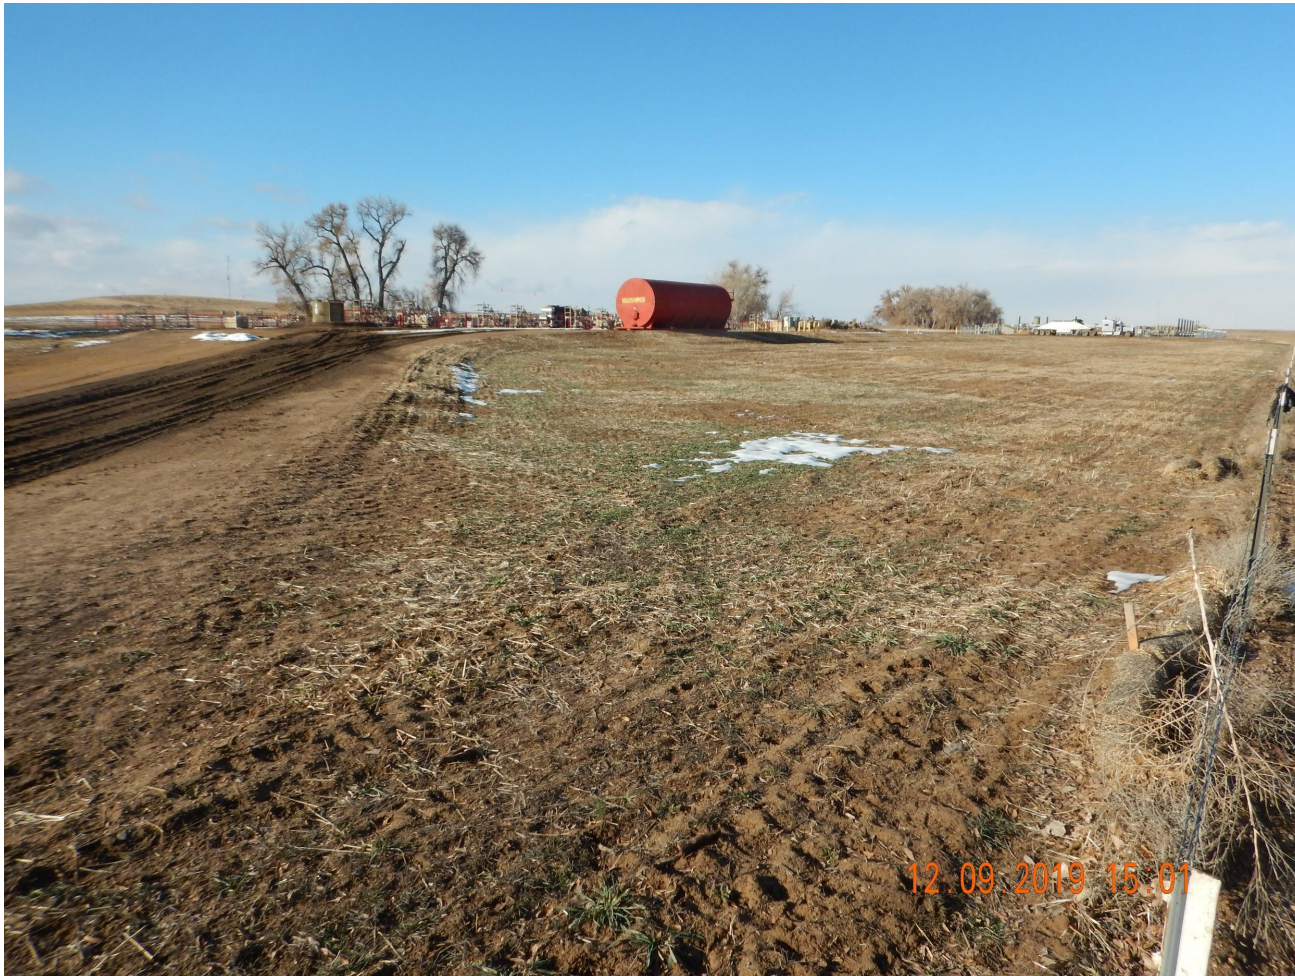
Photo 2. Photo taken from the southern location, facing North. See comments under Photo 1.

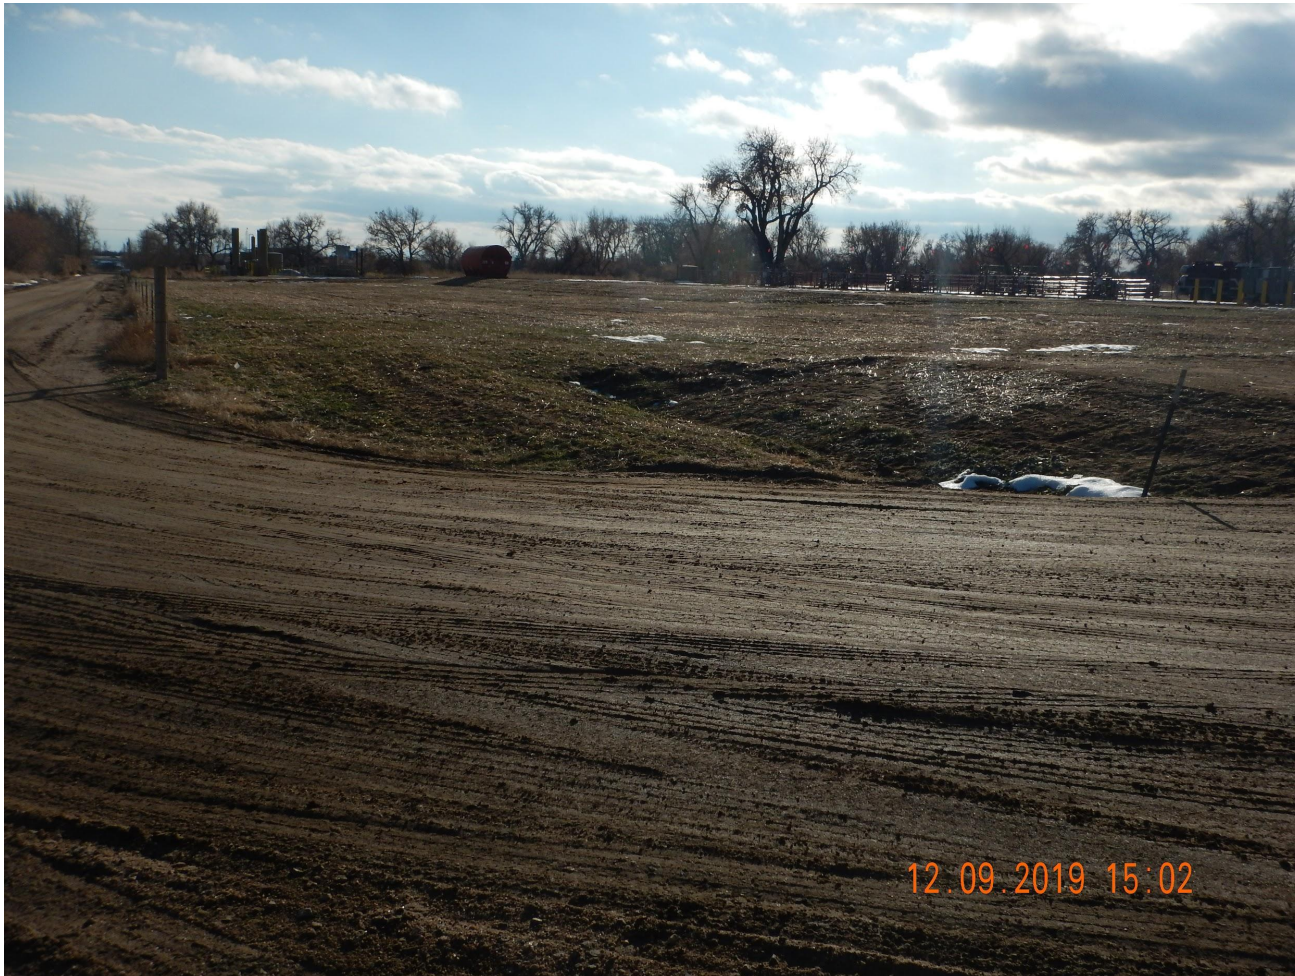
Photo 3. Photo taken from the central location, facing South. See comments under Photo 1.

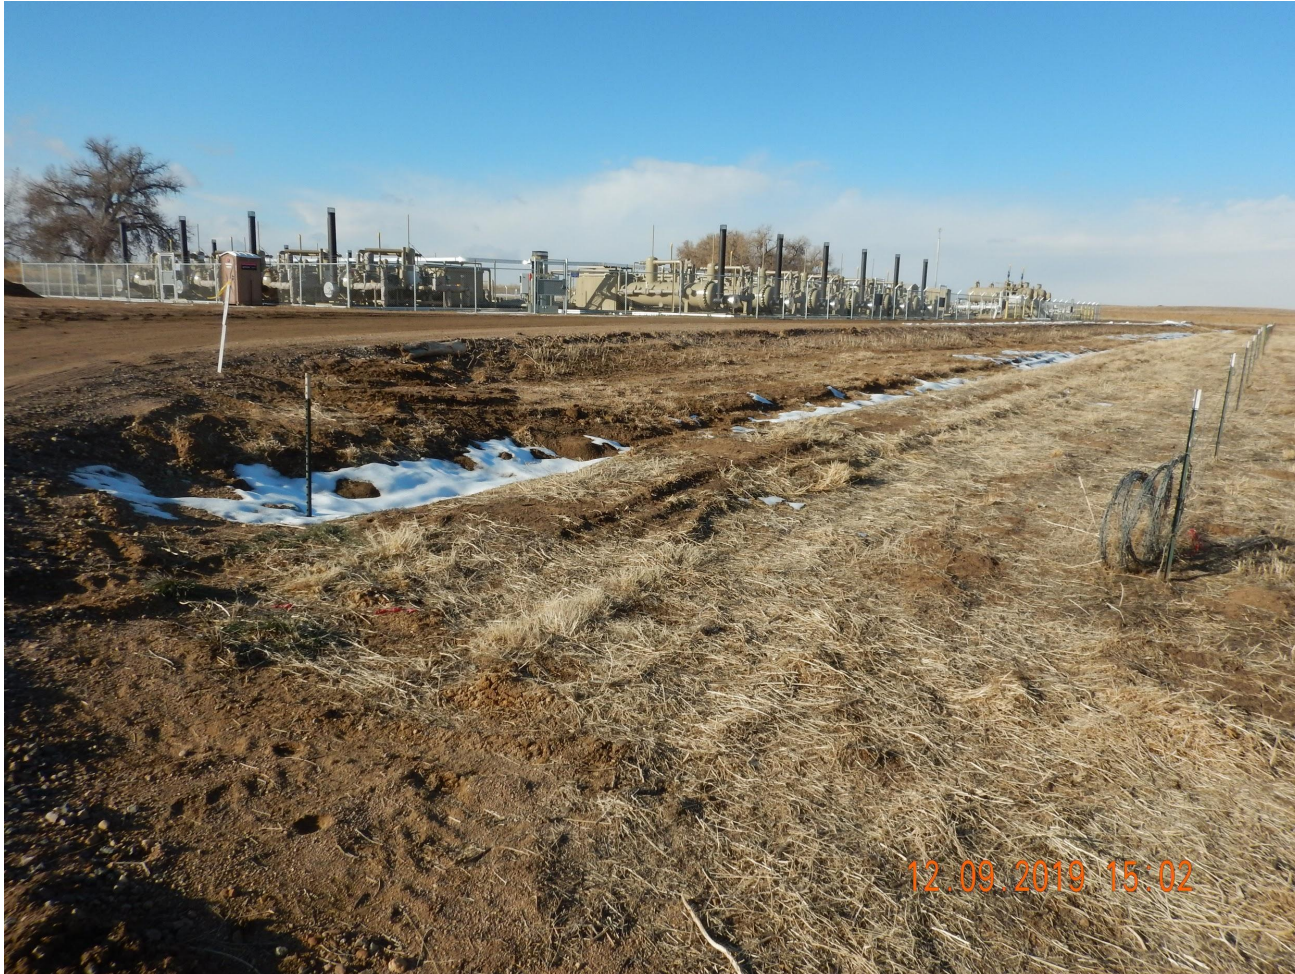
Photo 4. Photo taken from the central location, facing North. See comments under Photo 1. Also, photo illustrates perimeter ditch and berm BMP installed along the eastern location that appears to be in proper functioning condition at the time of this inspection.
