Inspection Photos
Operator: BP America
Location/API #: 067-09031
Date: 12-10-2019

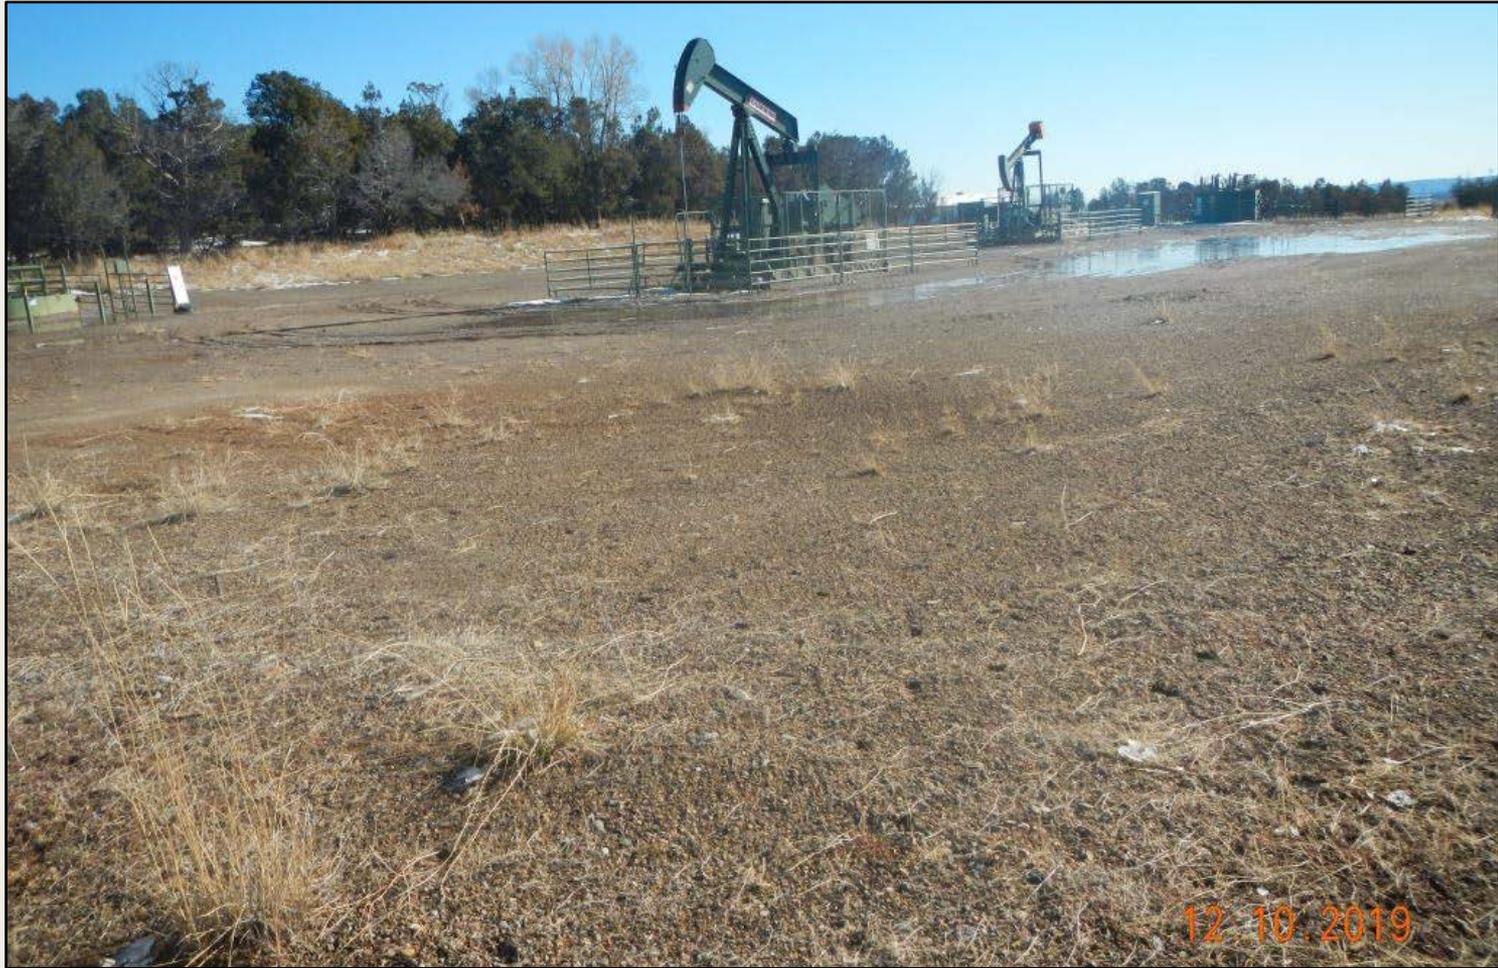
Photo 1. View of the project area from the northwestern corner facing center.

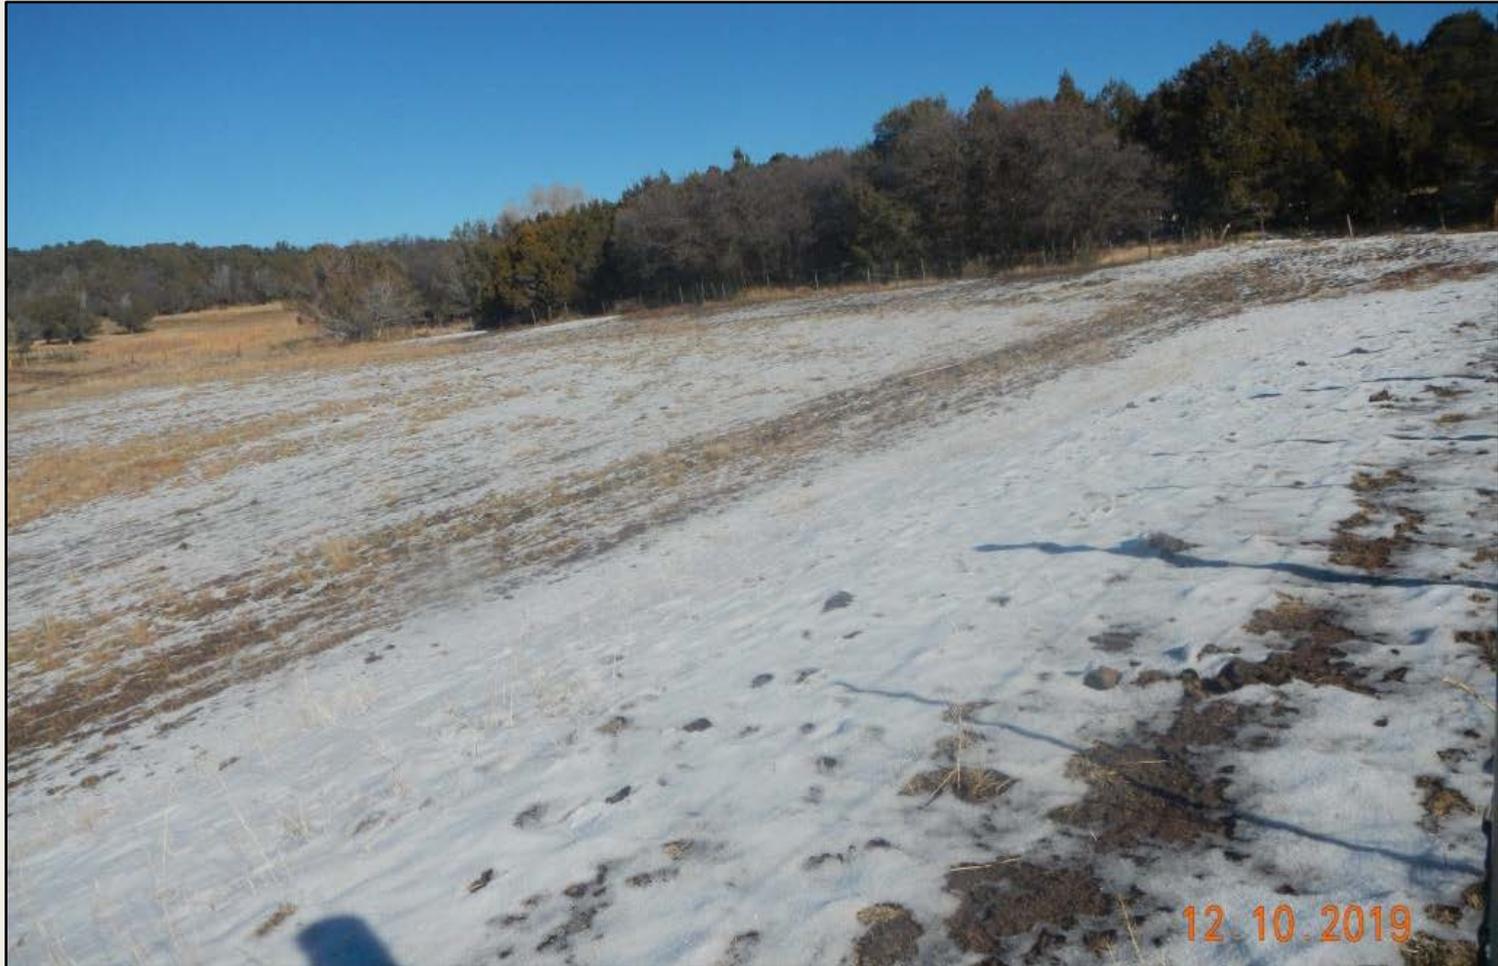
Photo 2. View of the northern fill slope from the northwestern corner facing eastward. Revegetation is in a dormant vegetative condition, and appears to be progressing with crop grasses similar to surrounding grass field.

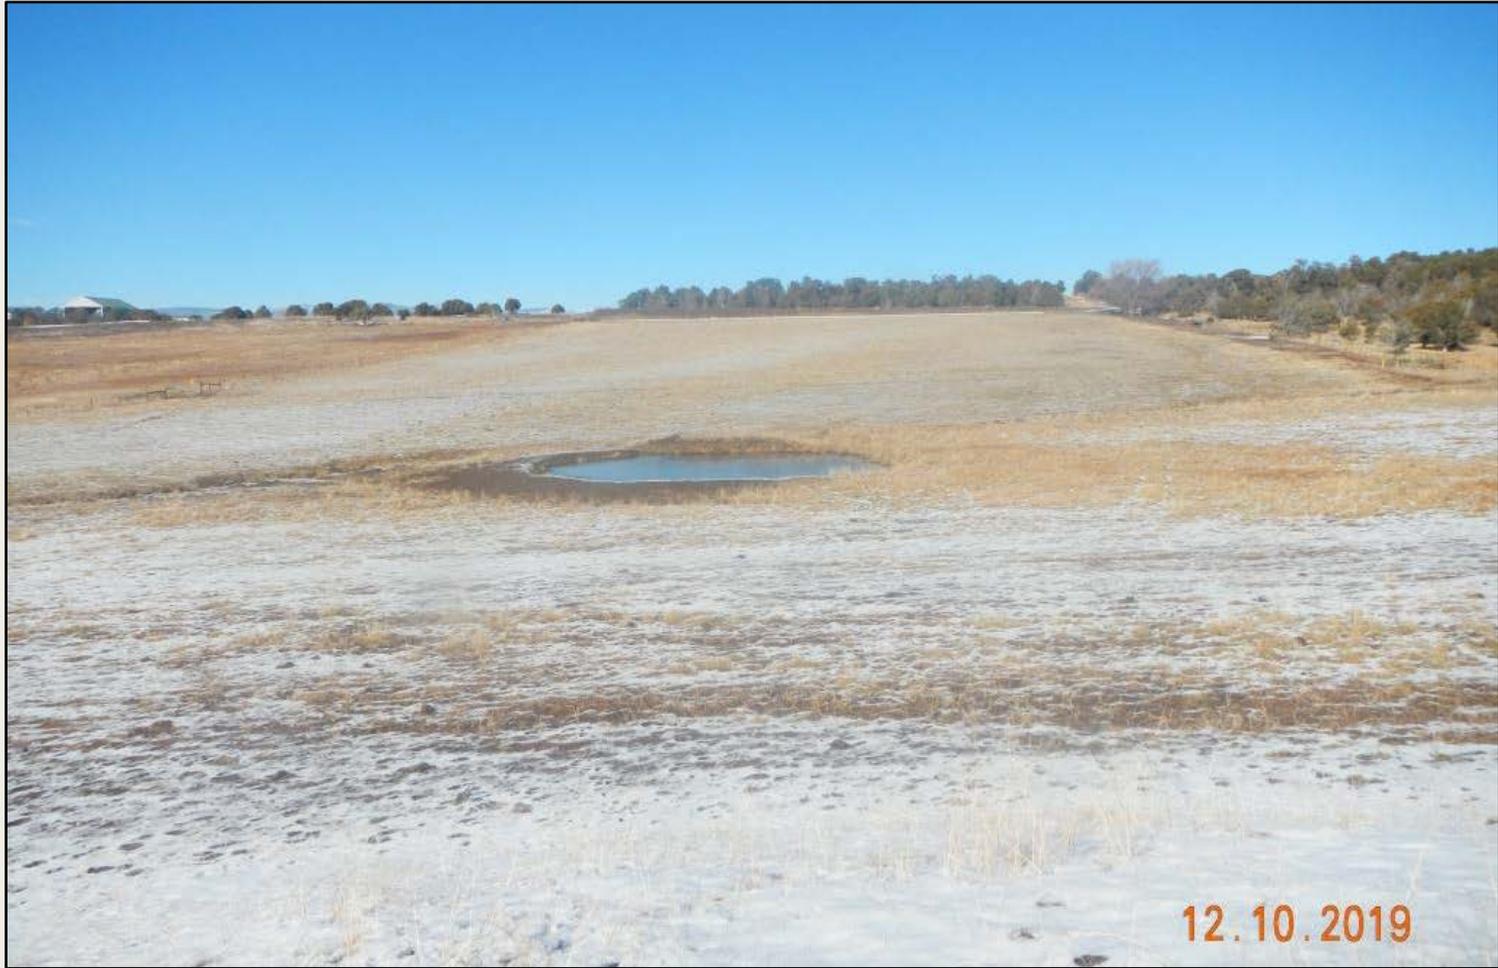
Photo 4. View of reference area, comprised of irrigated crop field.
