Inspection Photos
Operator: BP America
Location/API #: 067-09938
Date: 12-13-2019

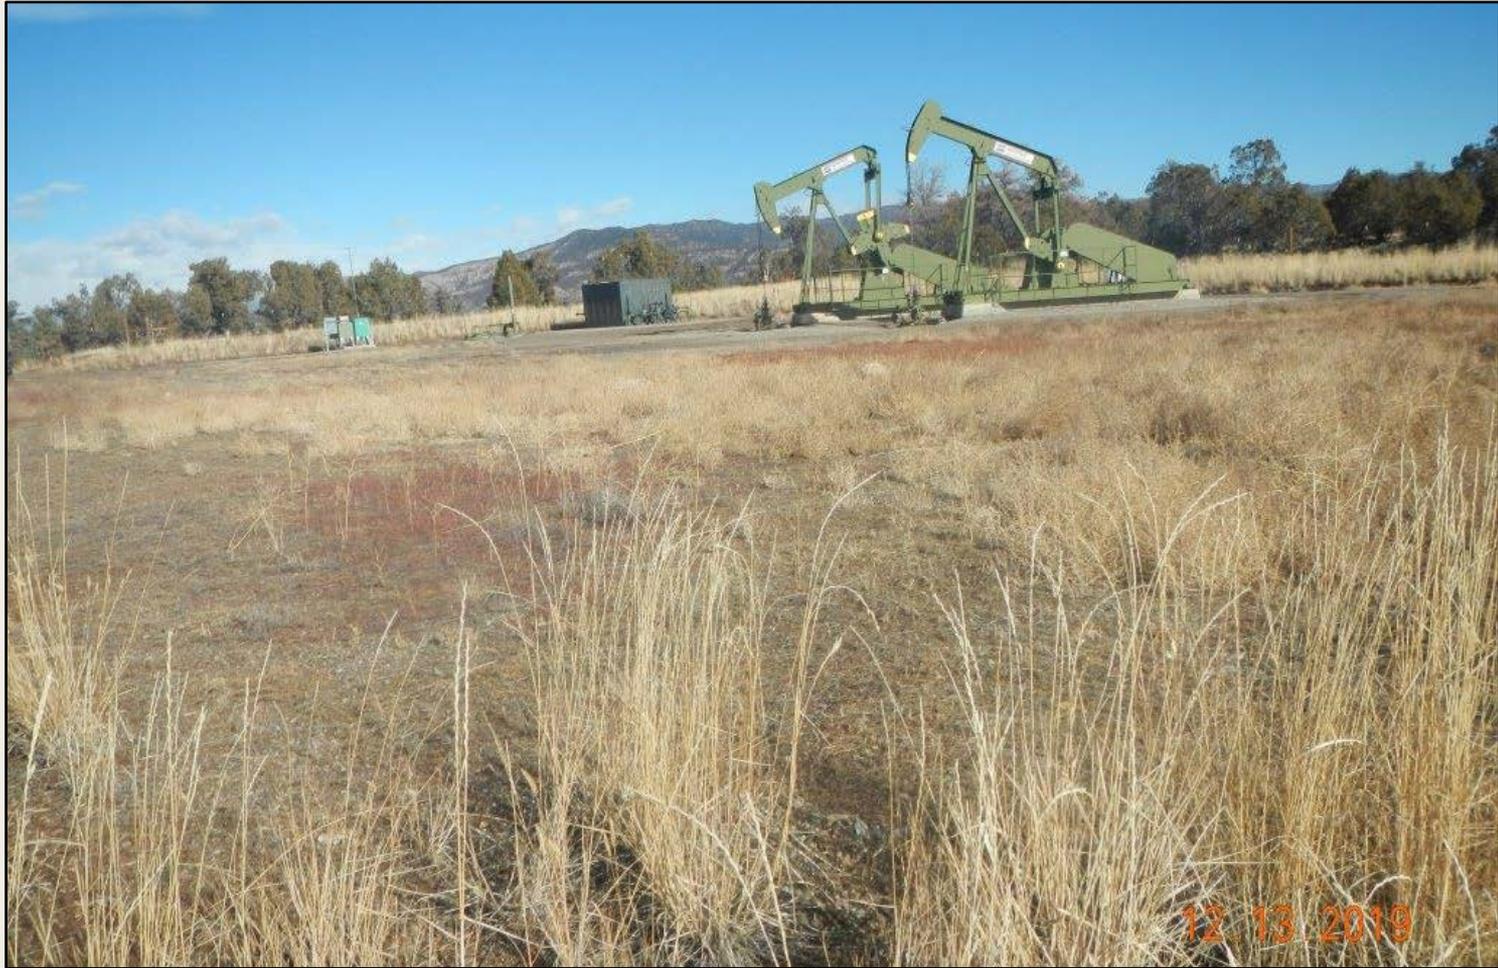
Photo 1. View of the project area from the southwestern corner facing center. Russian thistle debris in background needs to be removed.

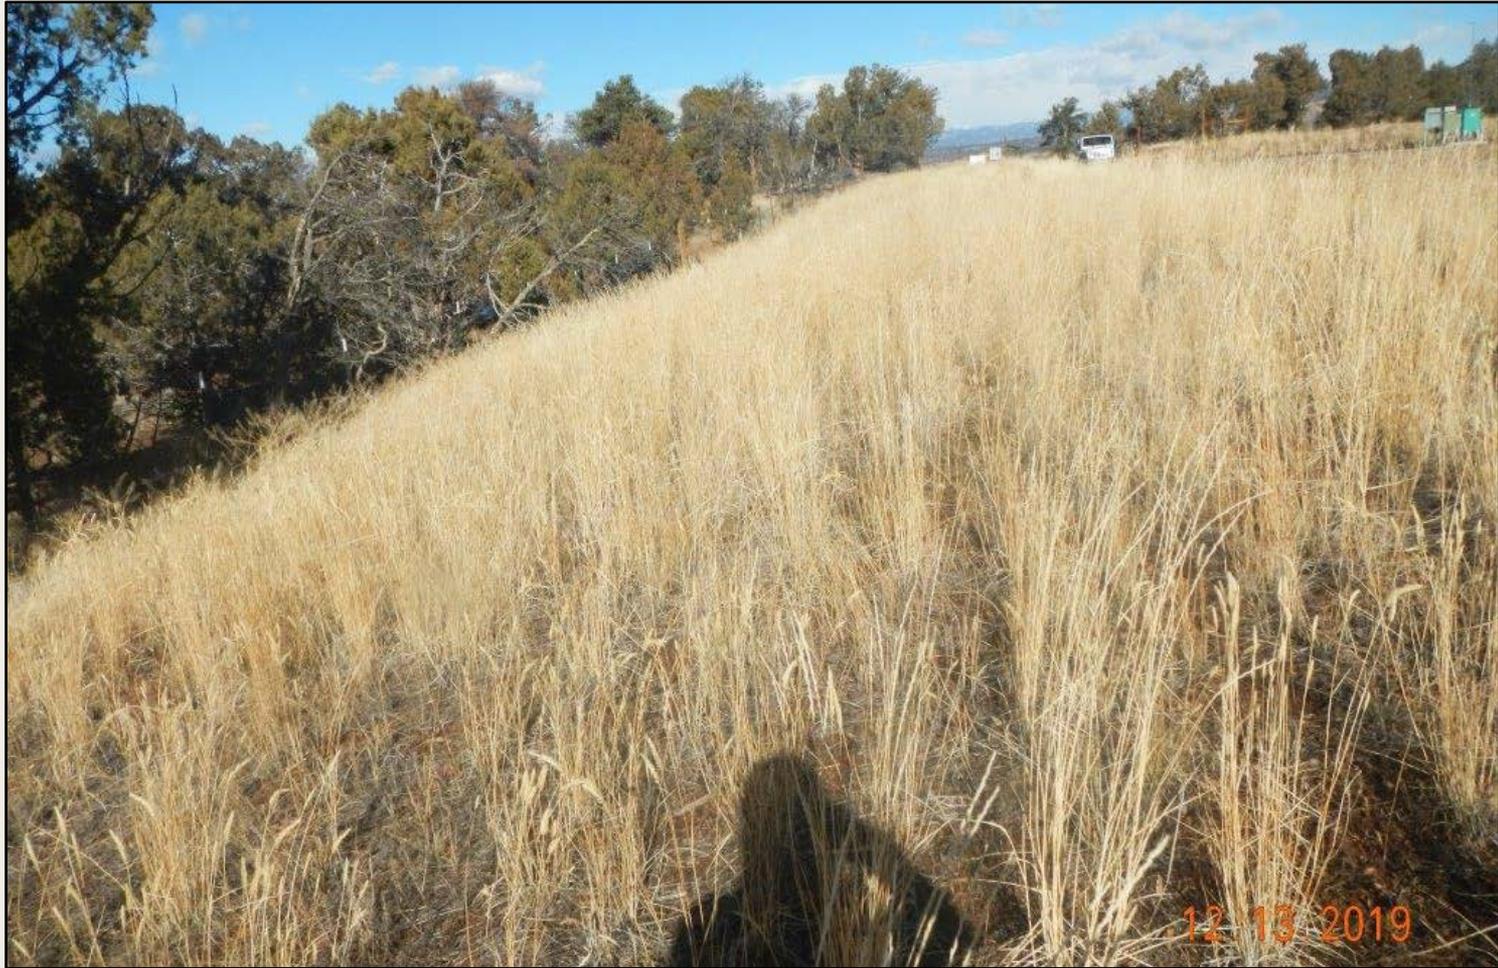
Photo 2. View of the western project area from the southwestern corner facing northward. Revegetation is progressing with grasses such as crested and intermediate wheatgrass. These non-native species are not representative of reference area vegetation.

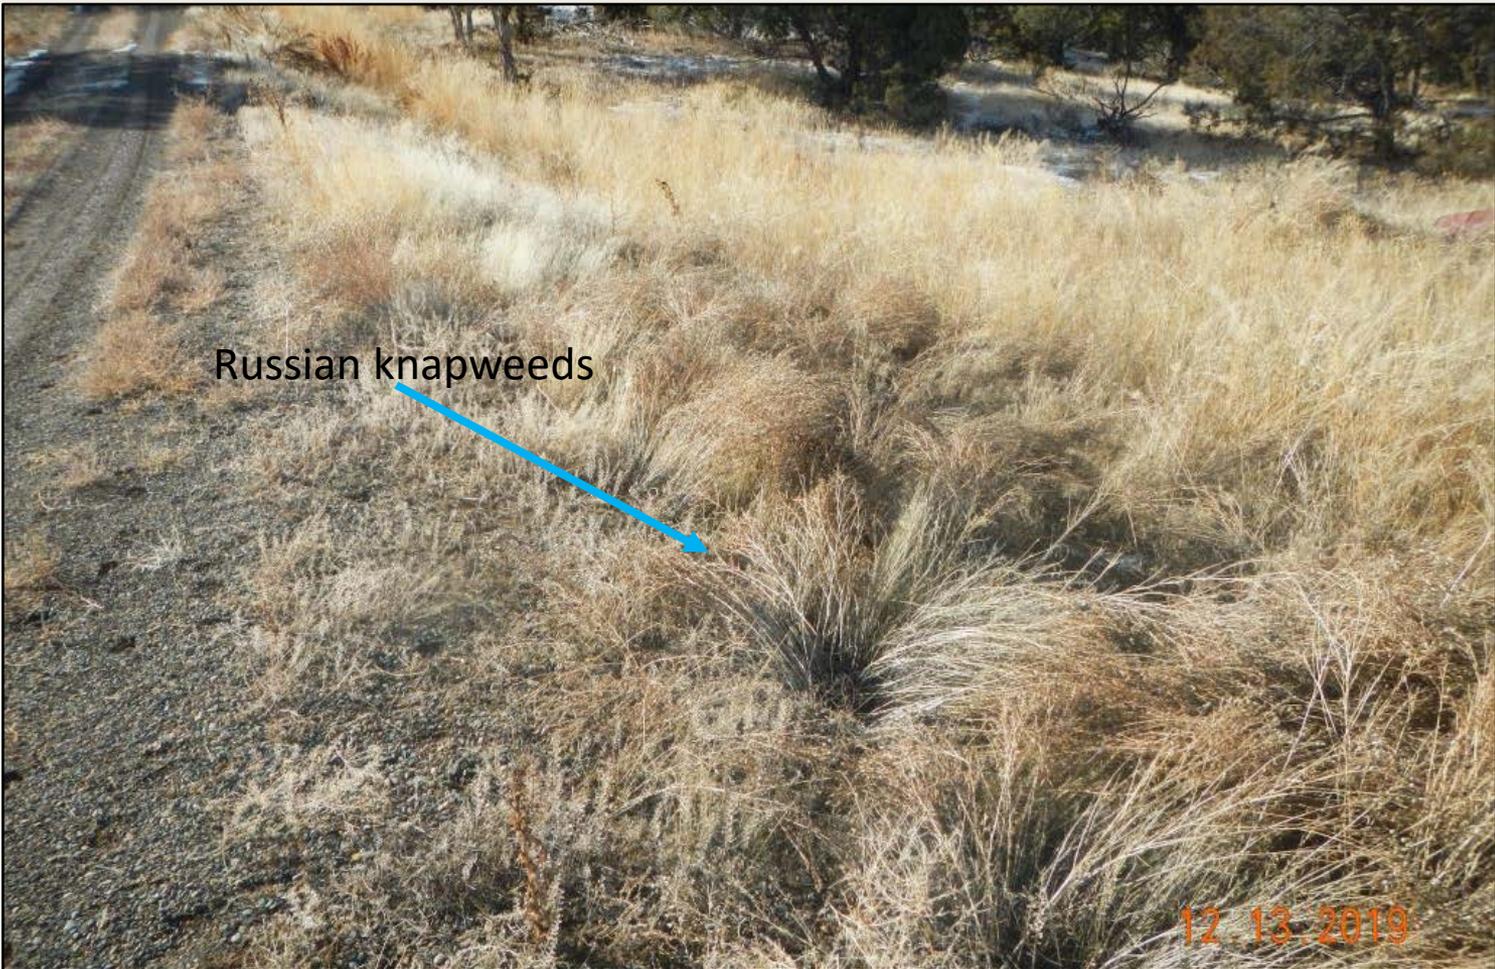
Photo 3. View of Russian knapweed infestation along the edge of the access road. Thousands of individuals observed.

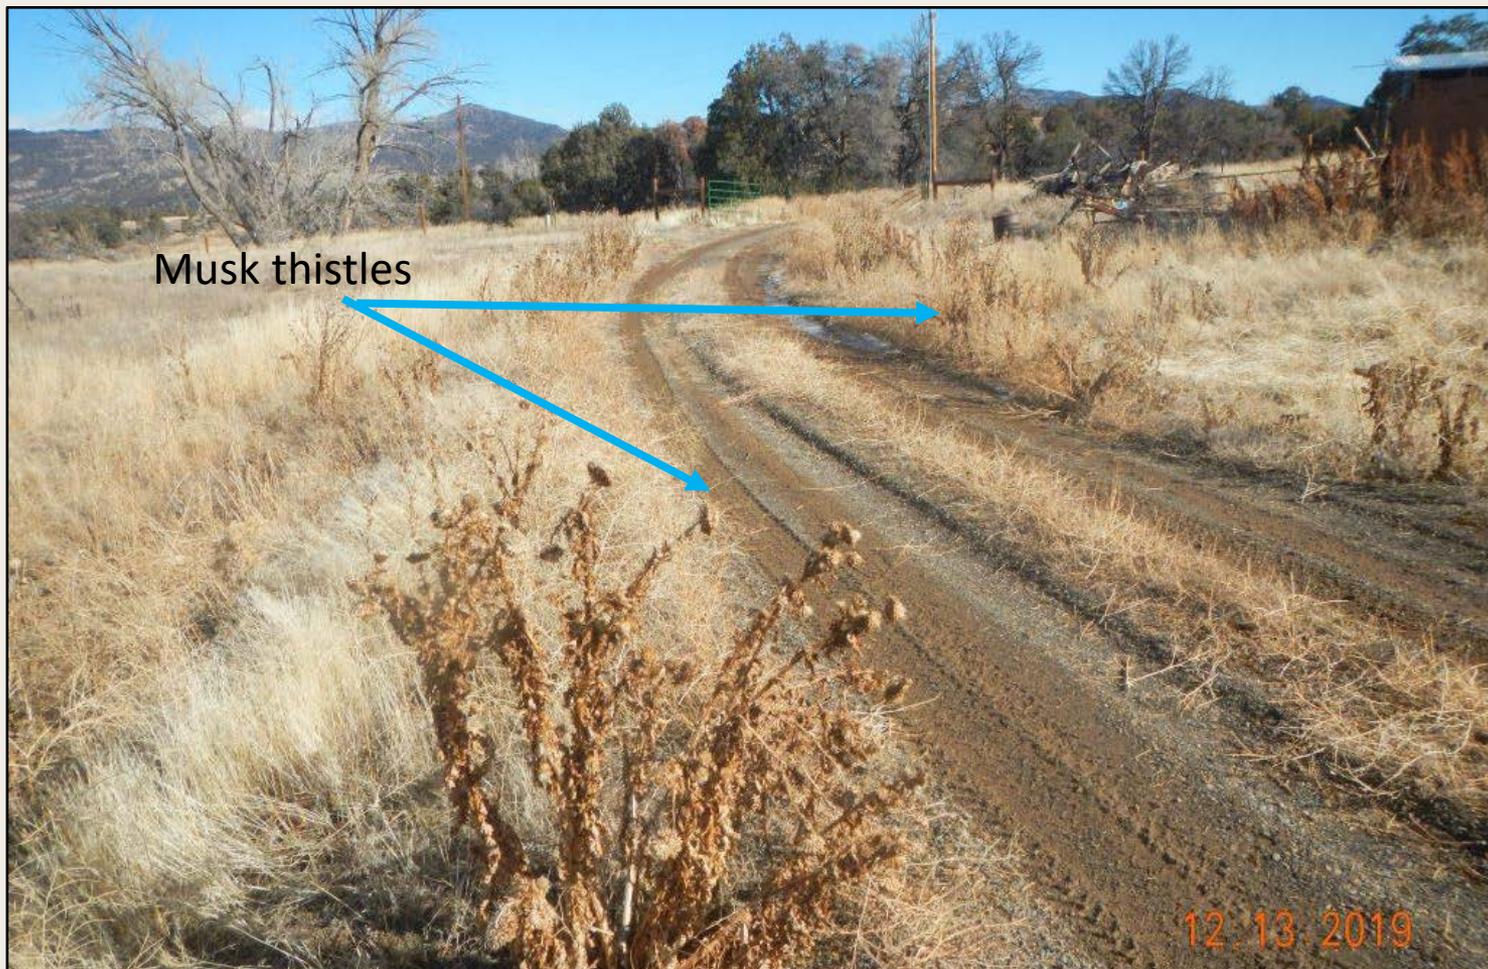
Photo 4. View of the musk thistles in post-flowering condition, growing along the access road.
