Inspection Photos  
Operator: BP America  
Location/API #: 067-06640  
Date: 12-13-2019

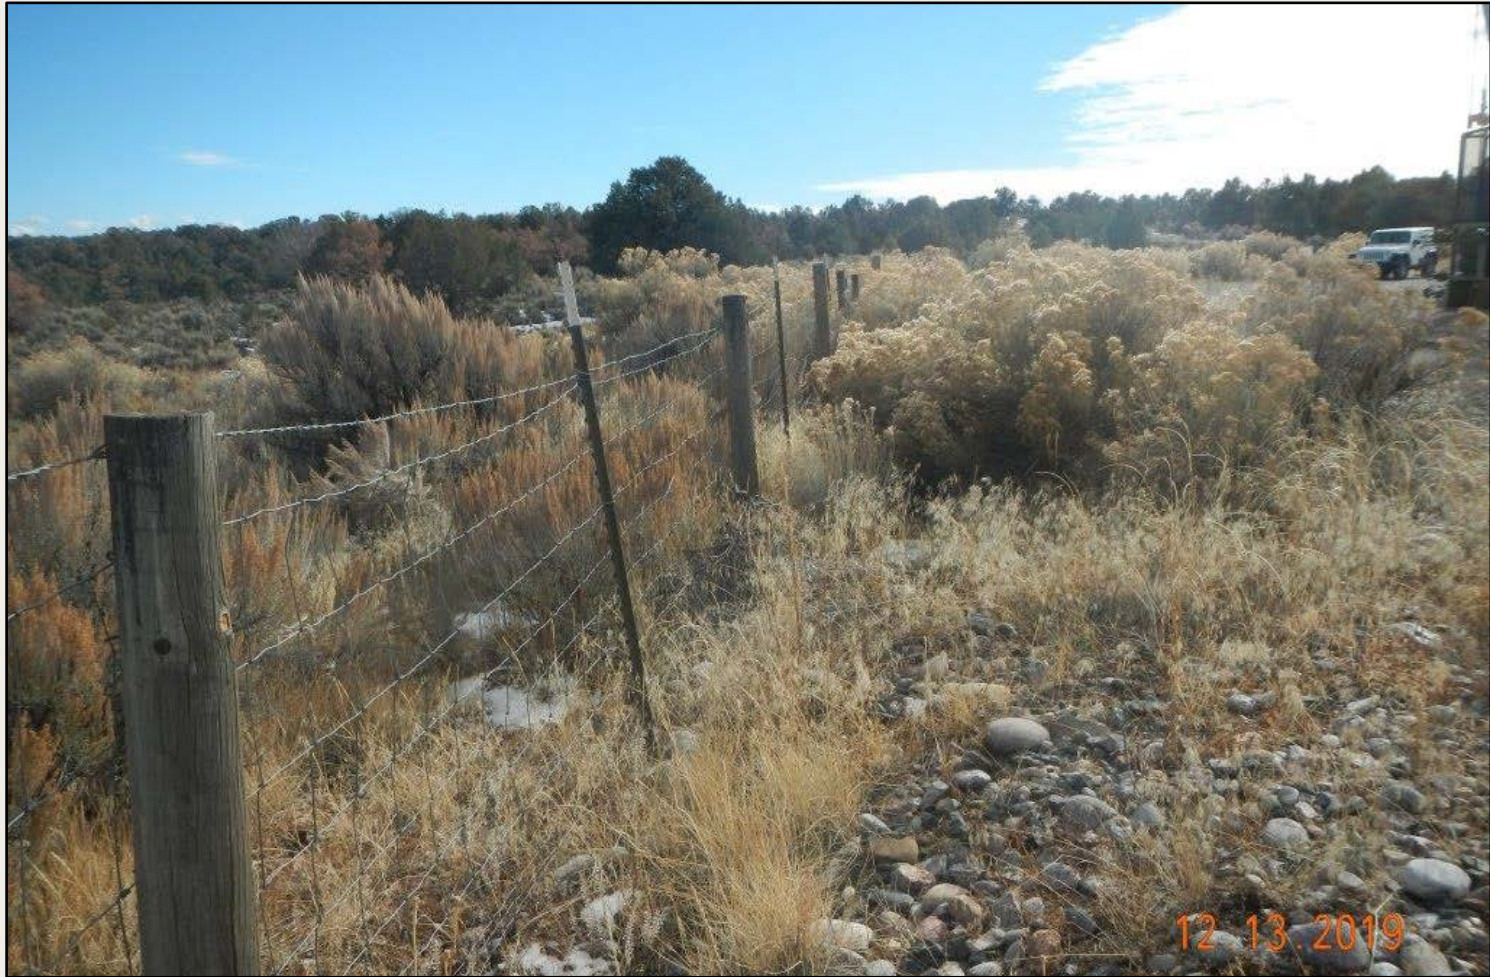
Photo 1. View of the eastern project area from the northeastern corner facing southward. Revegetation is progressing with grasses such as sand dropseed and rubber rabbitbrush.

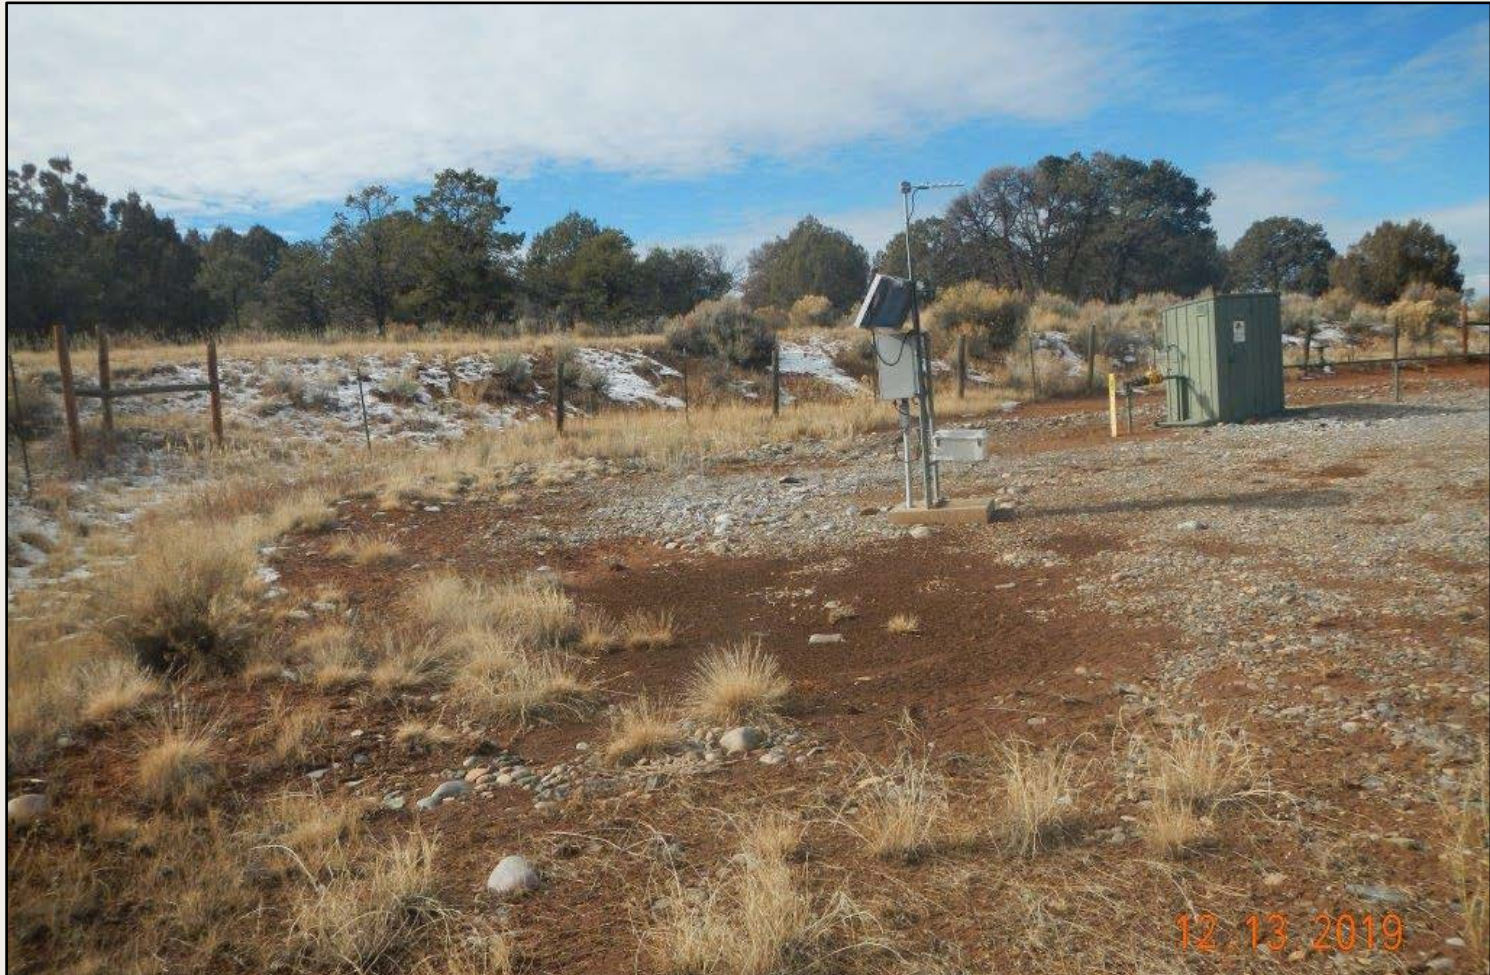
Photo 2. View of the southern project area from the well pad entrance facing westward.

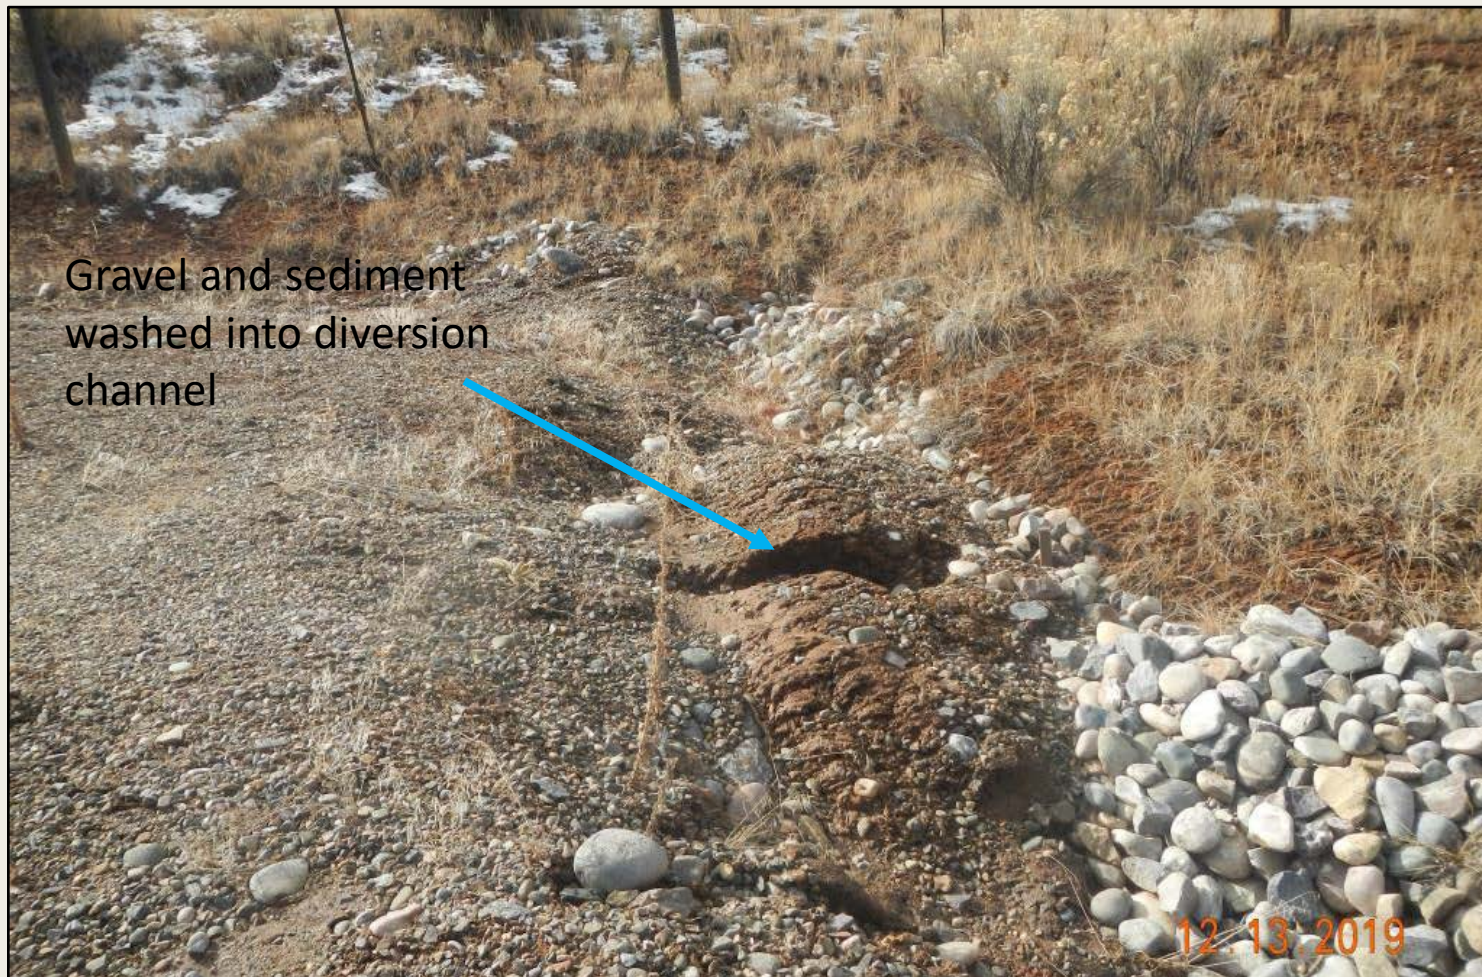
Photo 3. View of area within the northwestern well pad, where gravel and sediment washes off of the well pad into diversion channel. BMPs are full of gravel and sediment and do not appear to be the appropriate BMP for this area.

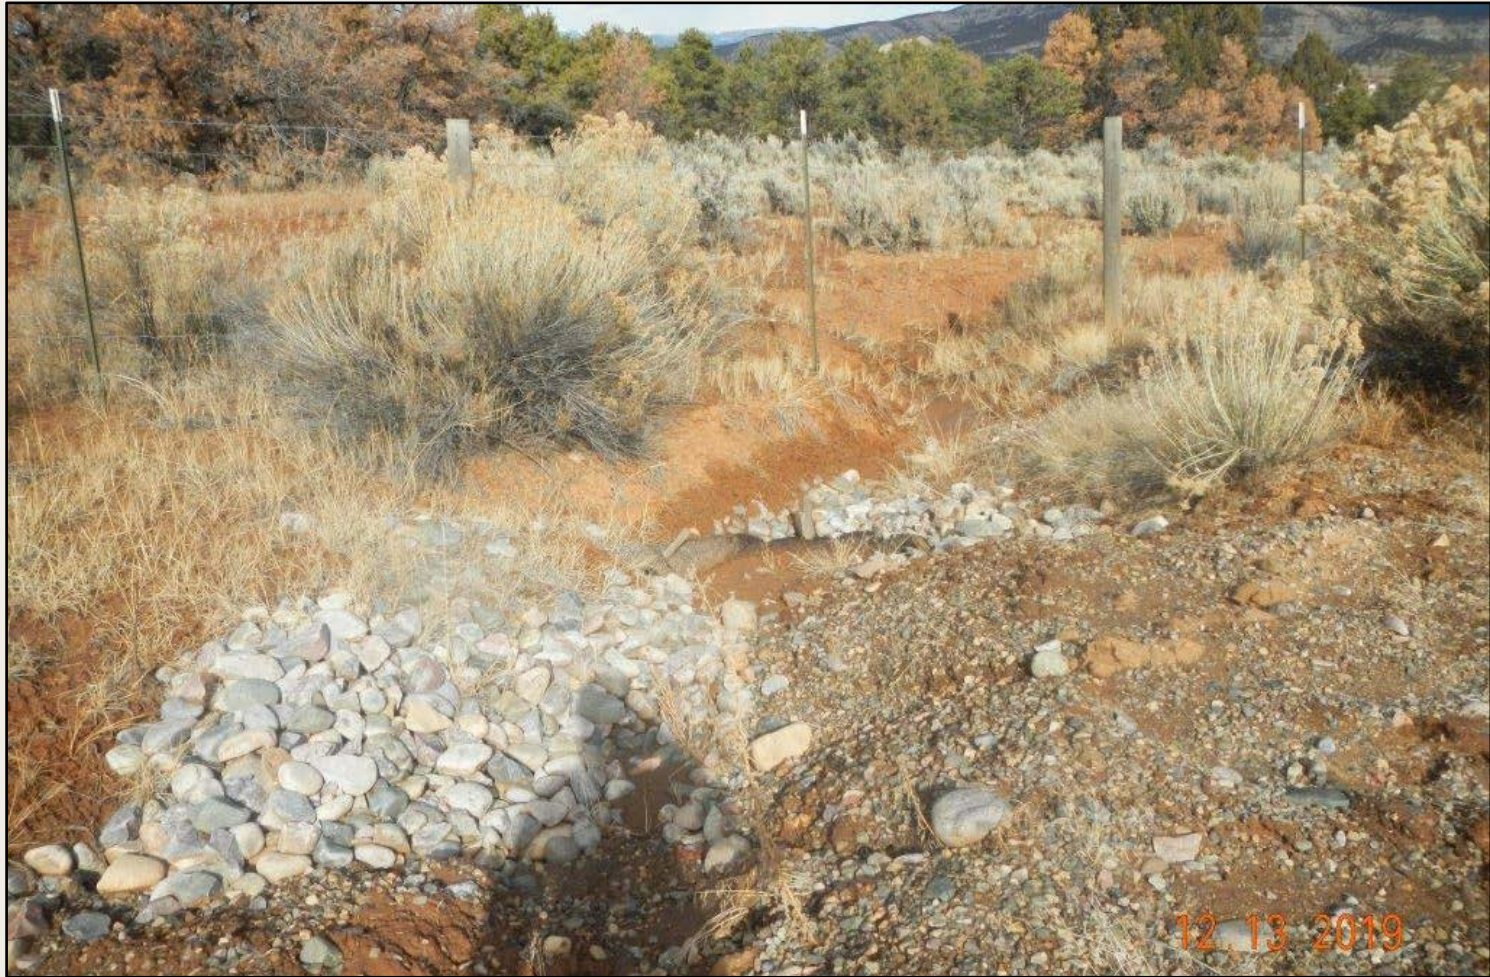
Photo 4. Another view of the northwestern project area facing northward. It appears well pad gravel and sediment washes off of the well pad into the diversion where BMPs are filling with sediment.

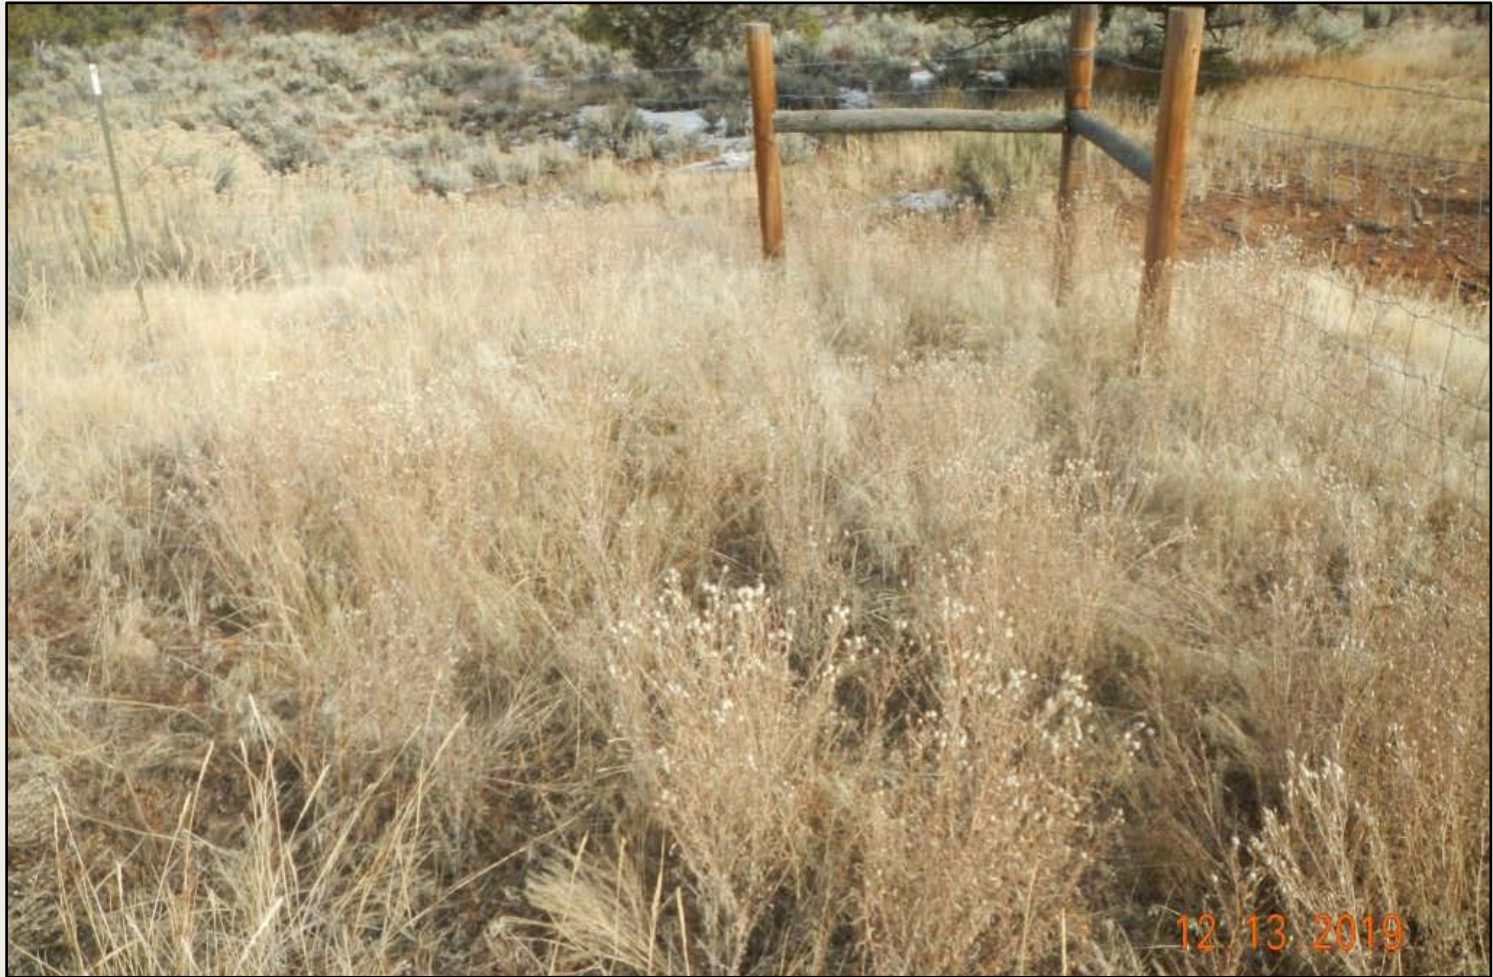
Photo 5. View of Russian knapweeds within the southeastern project area.

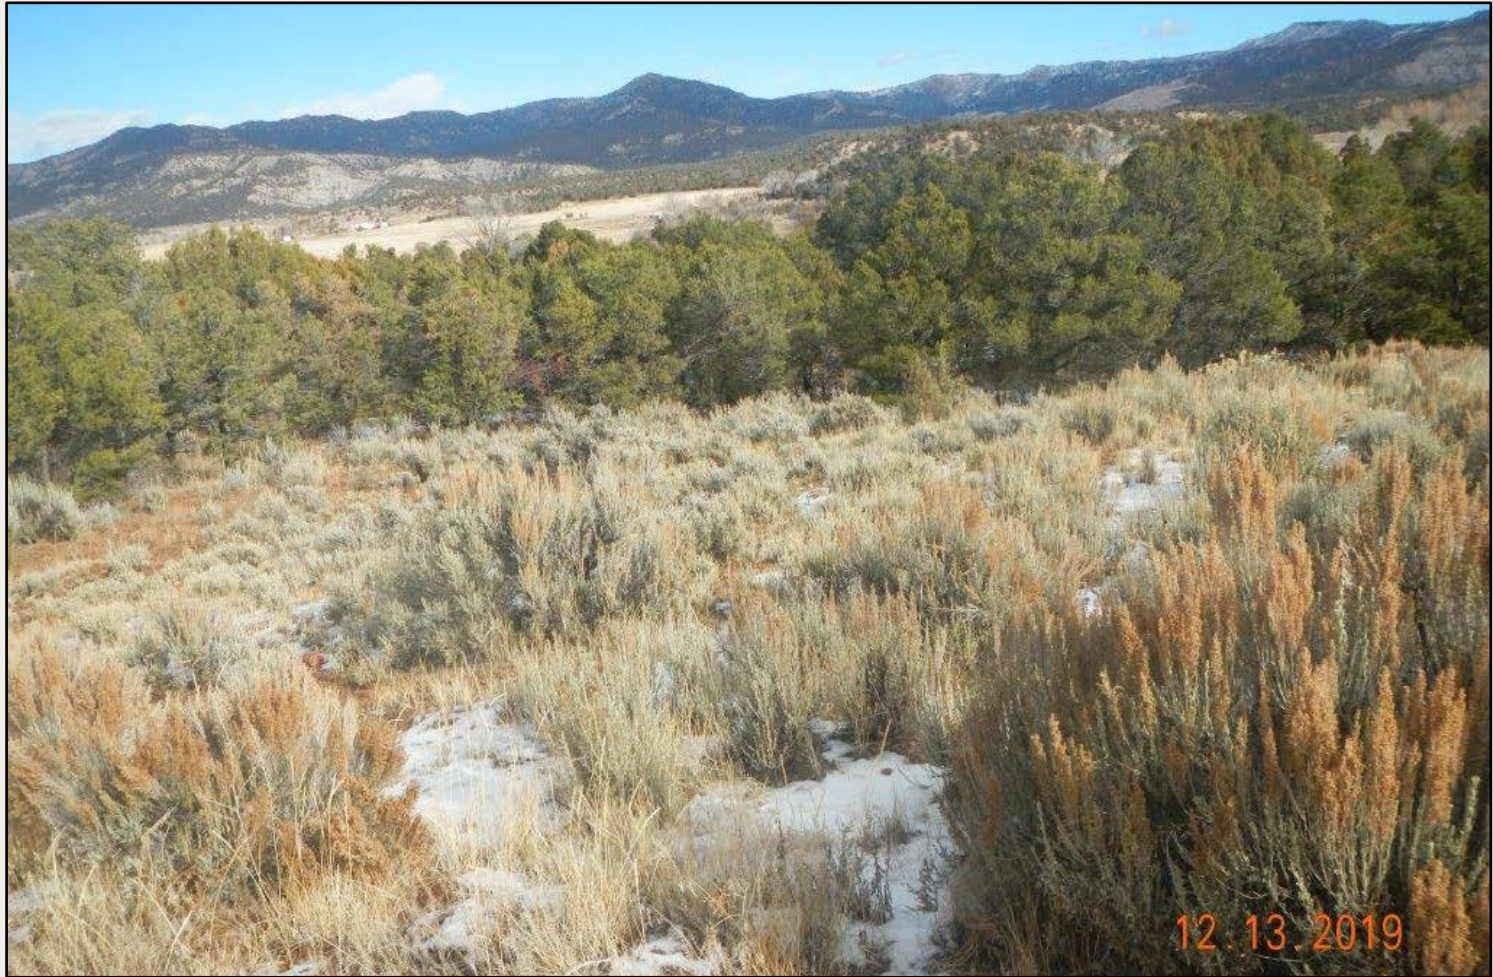
Photo 6. View of reference area, comprised of open pinyon juniper woodland with understory dominated by sagebrush and Indian ricegrass.
