Inspection Photos
Location Name: Carmin USX CC 05-17D
Location ID: 331510

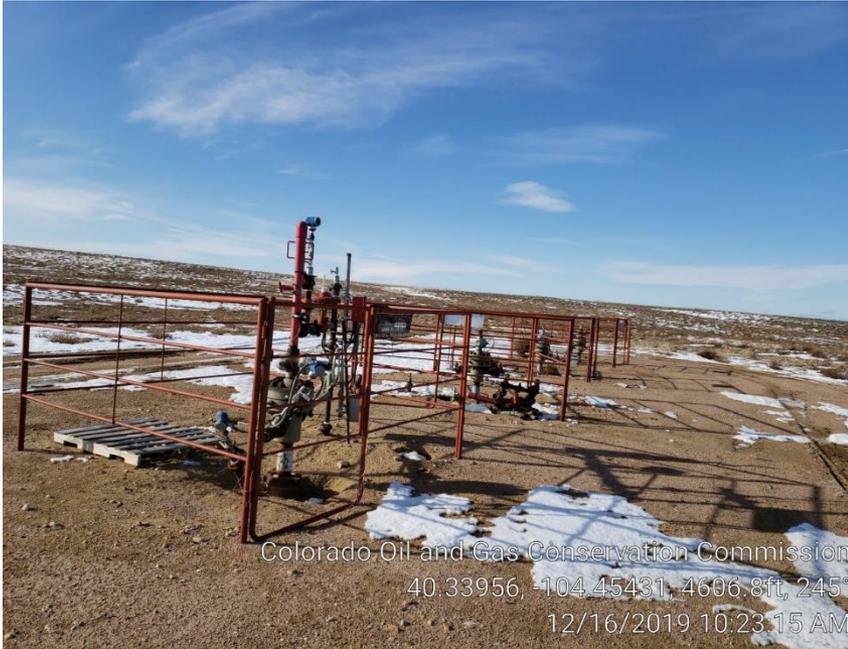
Photo #1 Wells

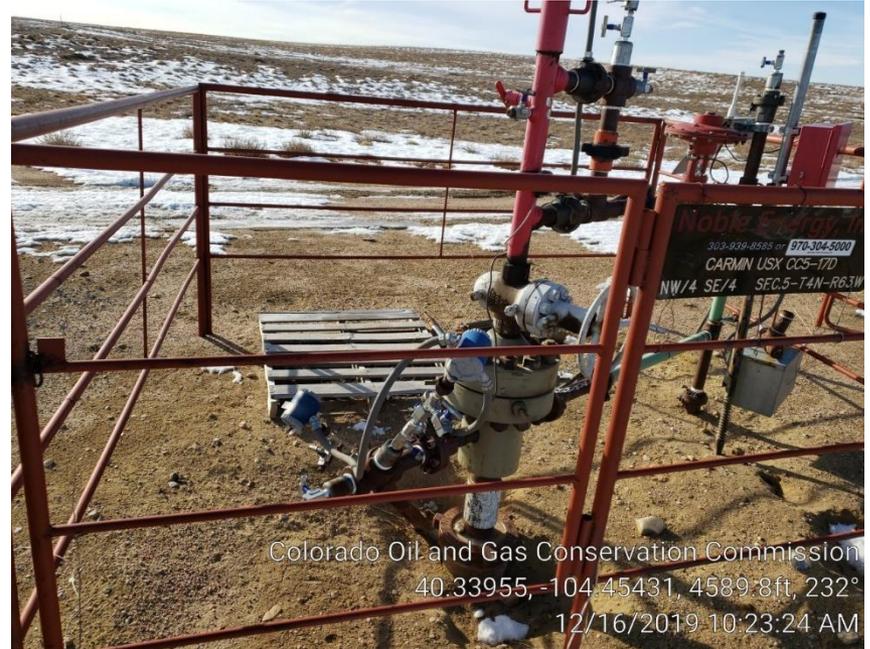
Photo #2 Wellhead, Sign & Trash

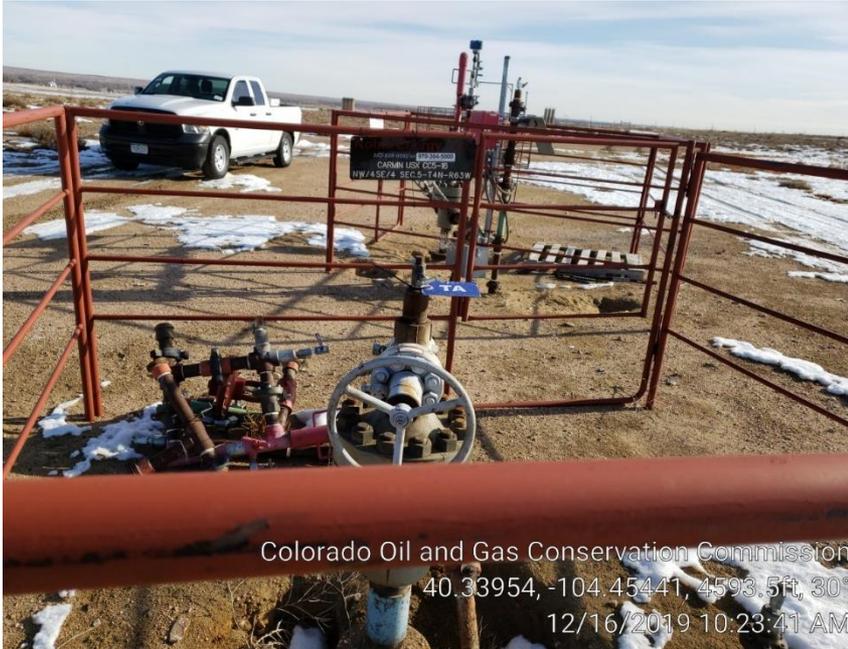
Photo #3 Well, Sign, & Variance Tag

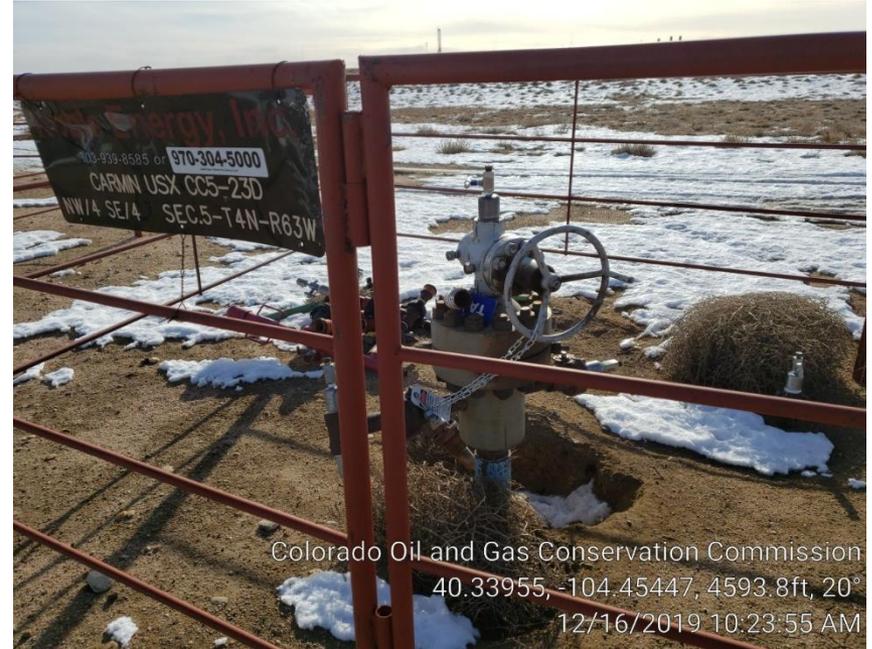
Photo #4 Well, Sign, & Variance Tag

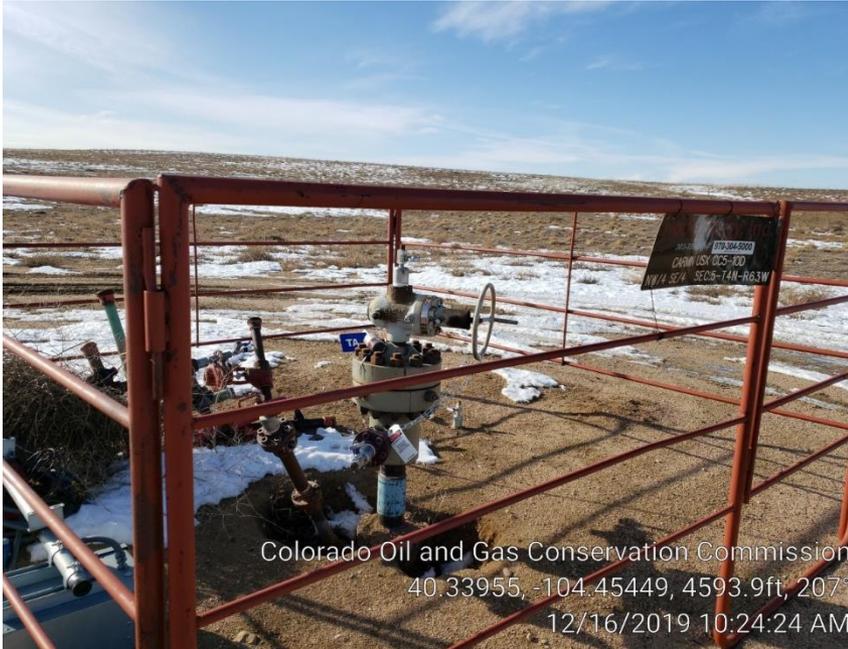
Photo #5 Well, Sign, & Variance Tag

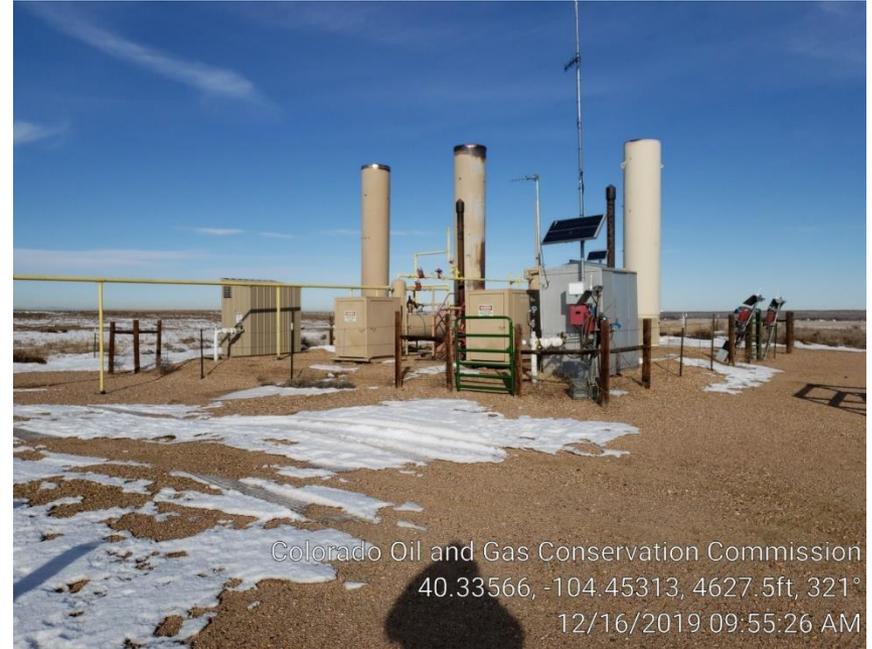
Photo #6 Separators, ECD's & Meter Runs

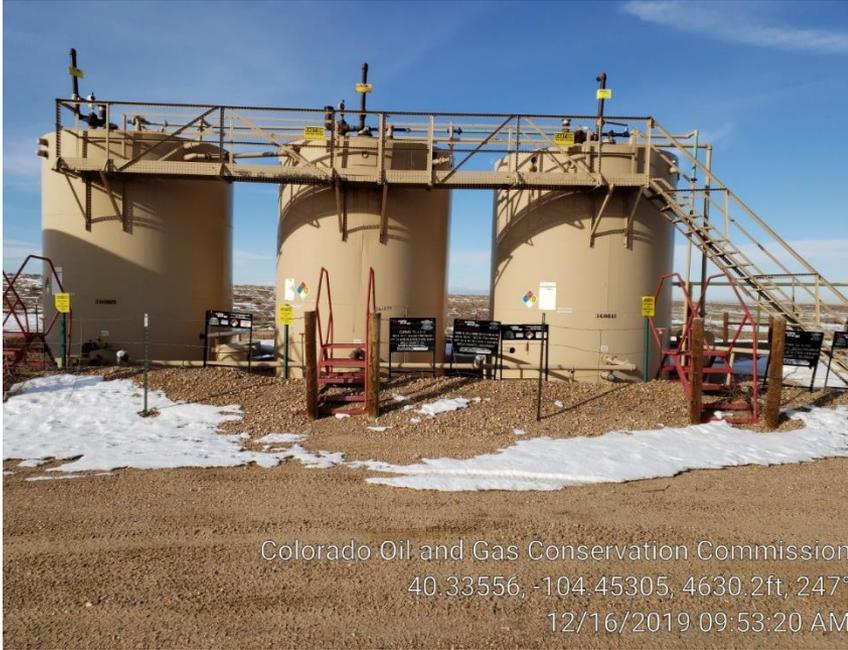
Photo #7 Tank Battery

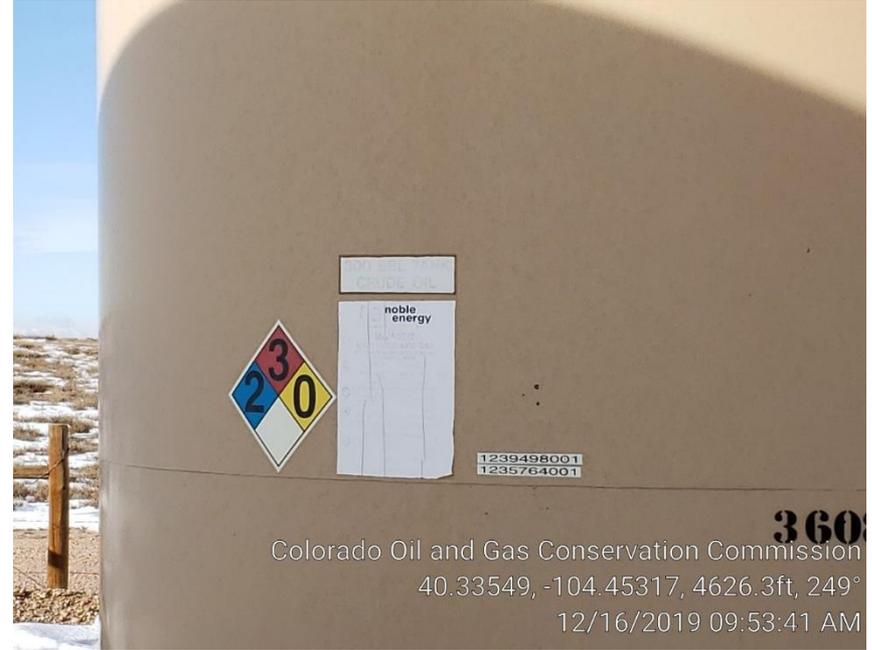
Photo #8 Faded Capacity Label

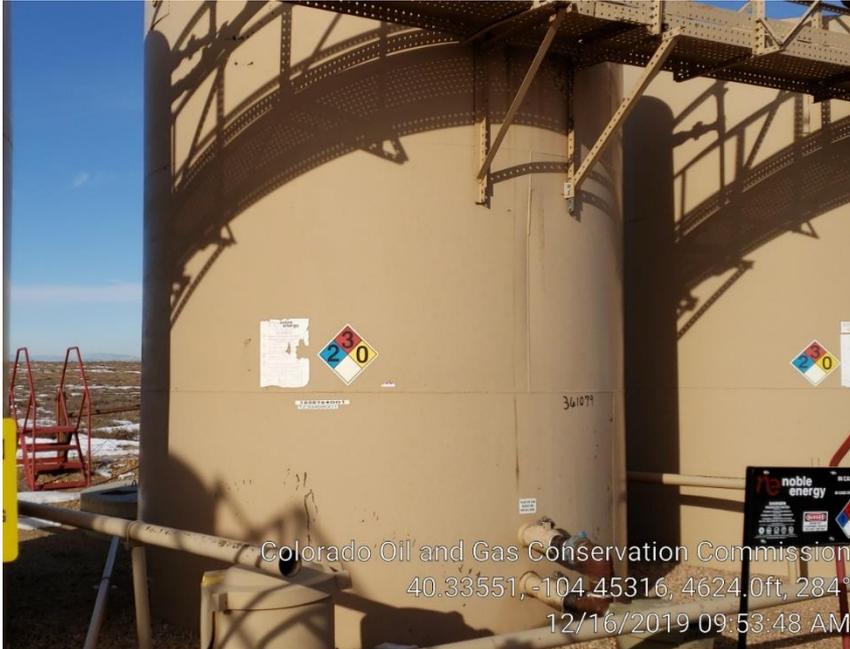
Photo #9 Missing Capacity Label

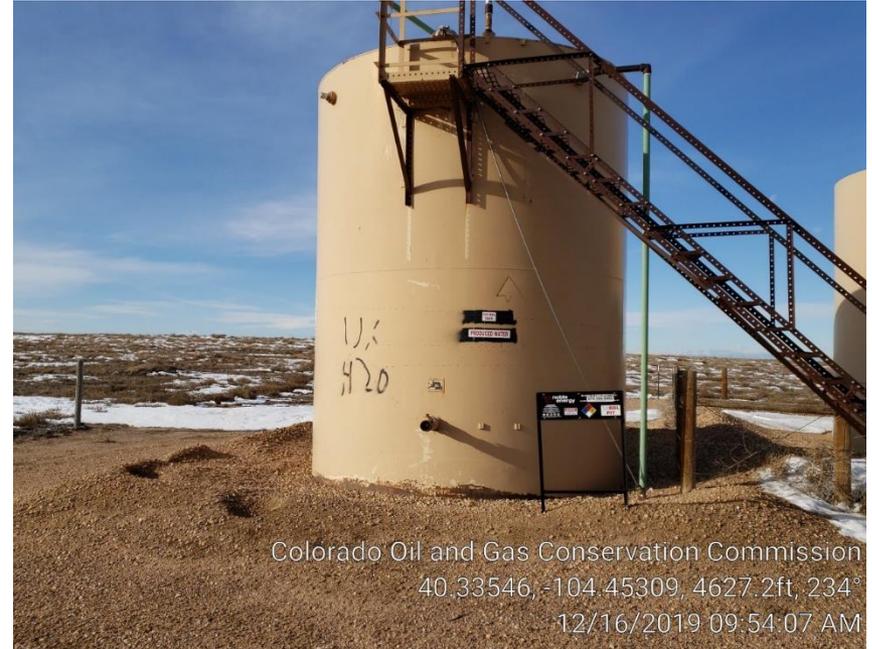
Photo #10 Water Tank/ Inadequate berms

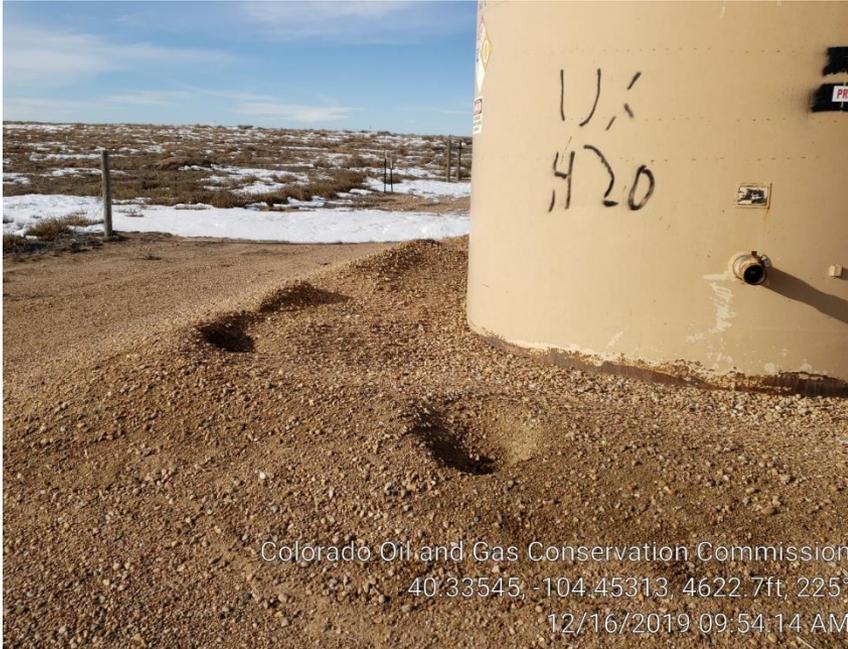
Photo #11 Inadequate berms

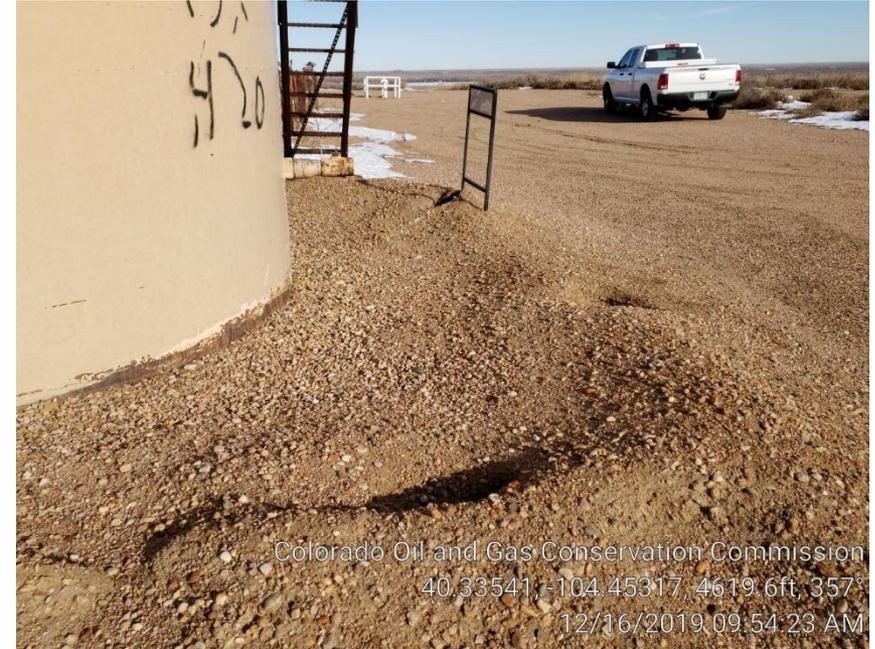
Photo #12 Inadequate berms
