# Interim Reclamation and Stormwater Inspection

December 11, 2019

Operator: SRC ENERGY INC- #10311

Location ID: 332974

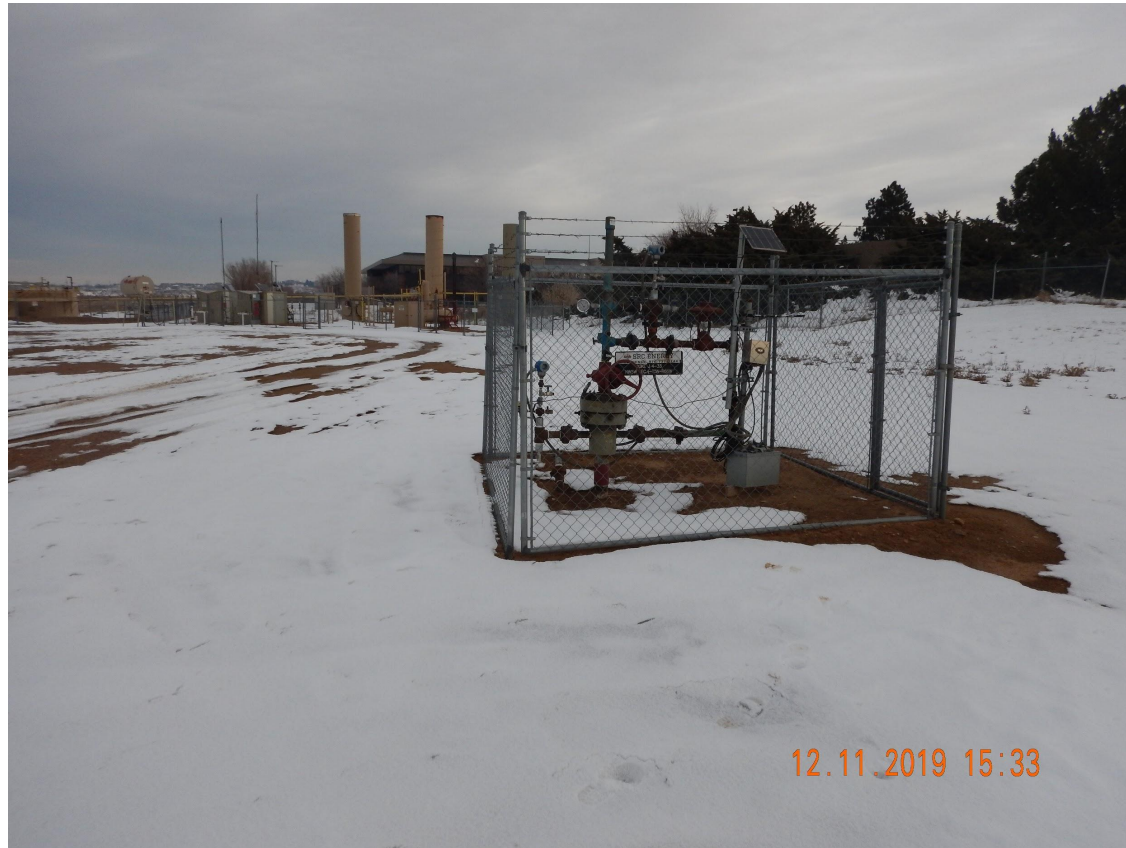
**Photo 1.** Photo taken from the location, facing East. Operator has perform interim reclamation to reduce disturbance areas only needed for production operations. At the time of this inspection, there was no stormwater erosion observed. At the time of this inspection, snow cover prevented COGCC staff from performing a vegetative assessment. COGCC staff will perform a follow up inspection to ensure compliance with Rule 1003 standards.

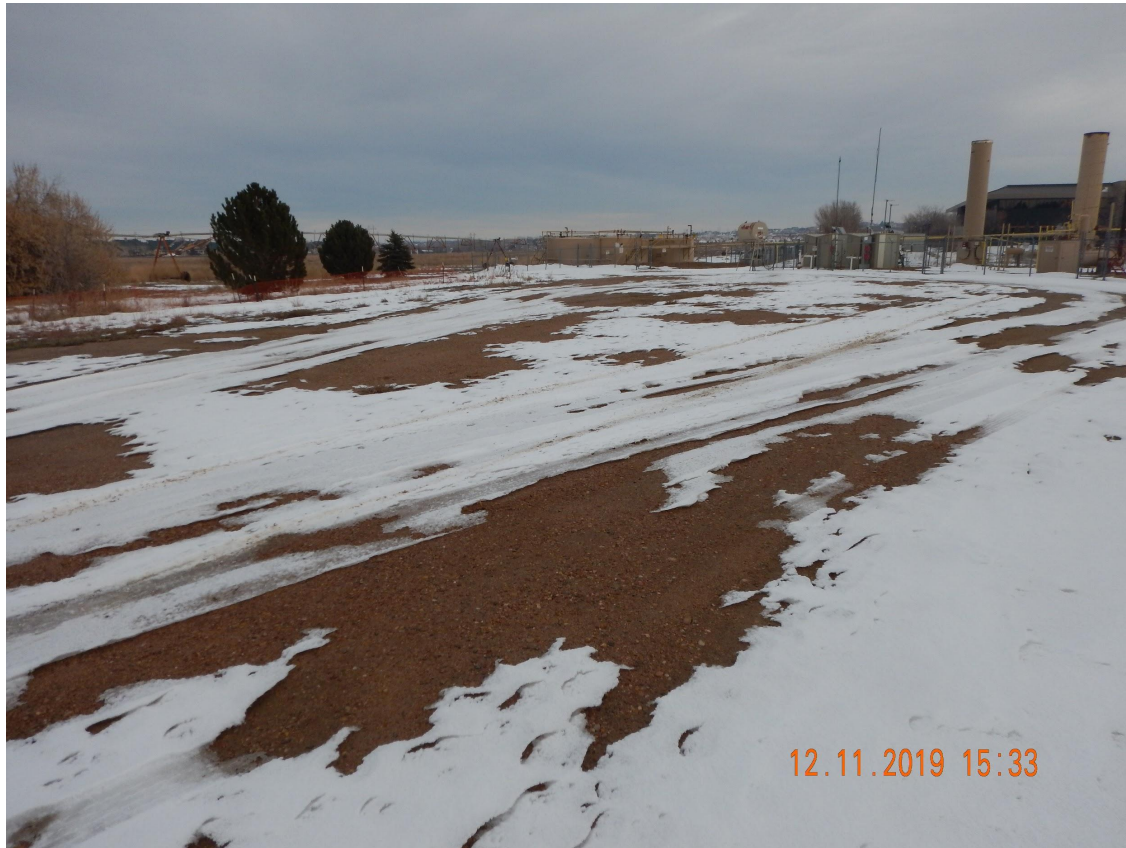
**Photo 2.** Photo taken from the central location, facing East. See comments under Photo 1.

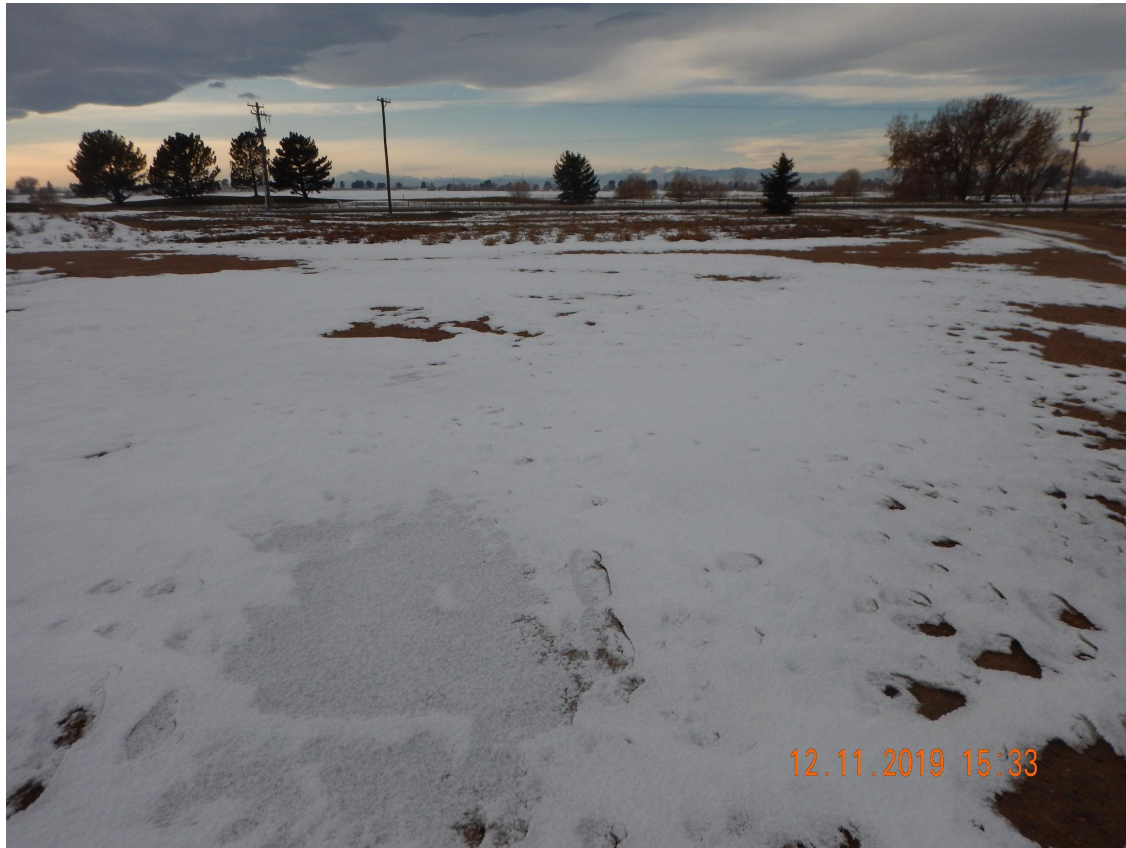
**Photo 3.** Photo taken from the central location, facing West. See comments under Photo 1.

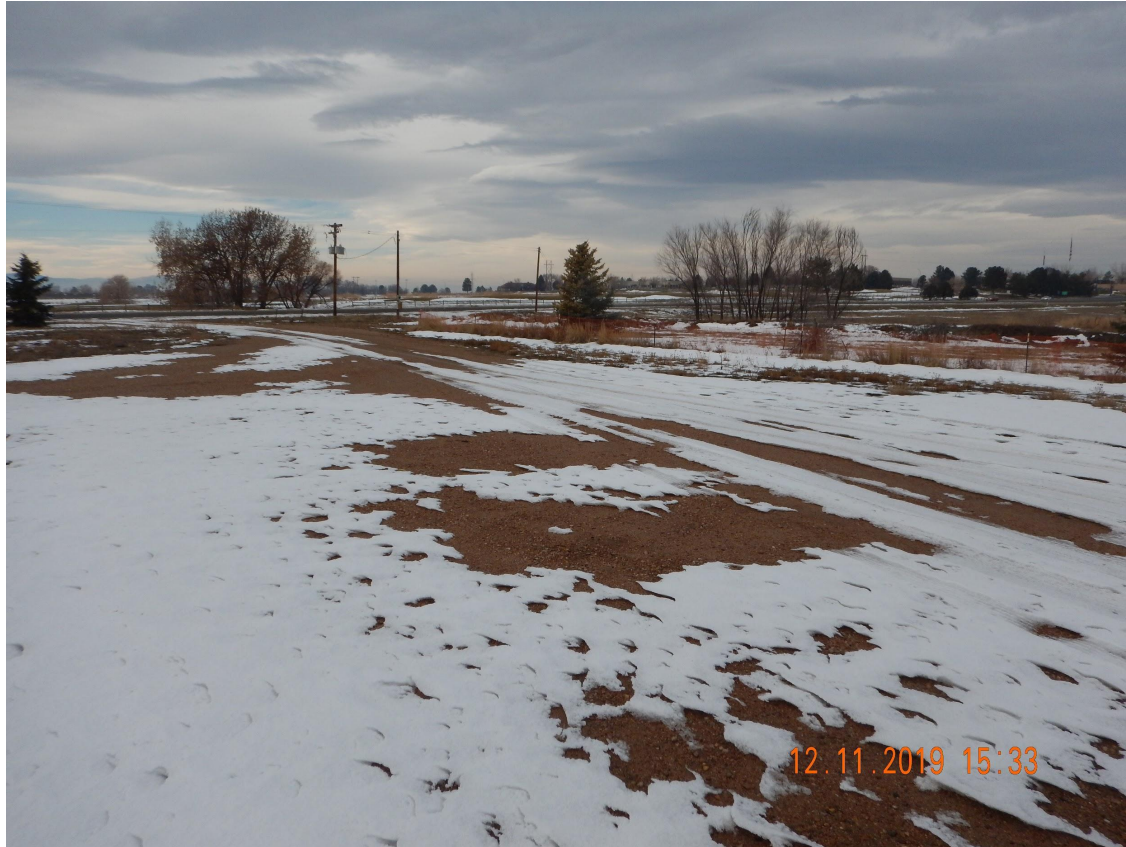
**Photo 4.** Photo taken from the central location, facing Northwest. See comments under Photo 1.
