**Inspection Photos**  
**Location Name: Perrin- Mahoney #1**  
**Location ID: 317951**

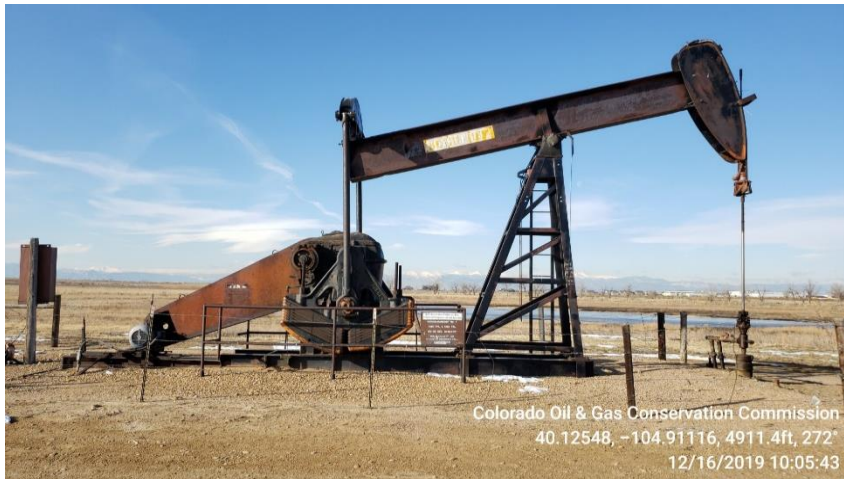
**Photo 1 WH sign & PU**

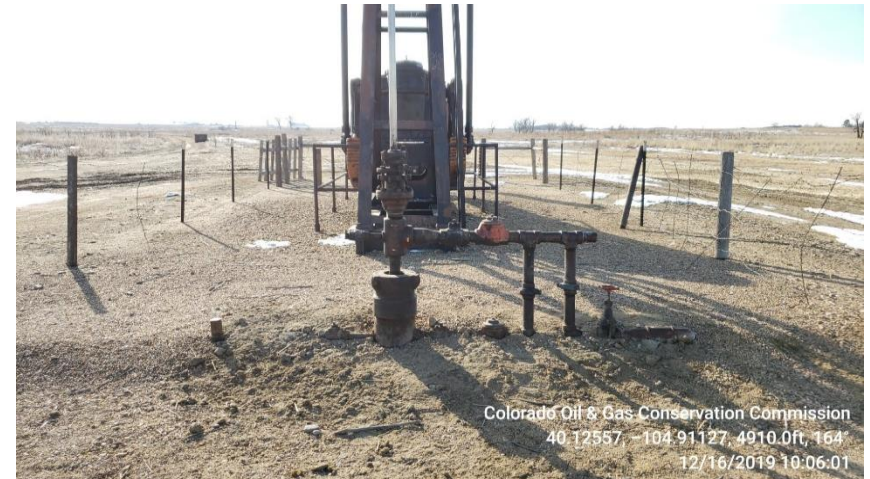
**Photo 2 WH**

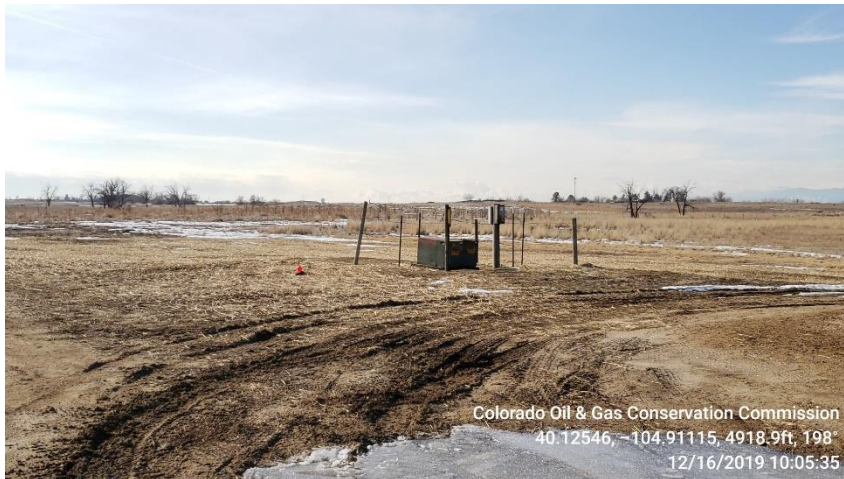
**Photo 3 Weeds on location appear to have been cut and removed**

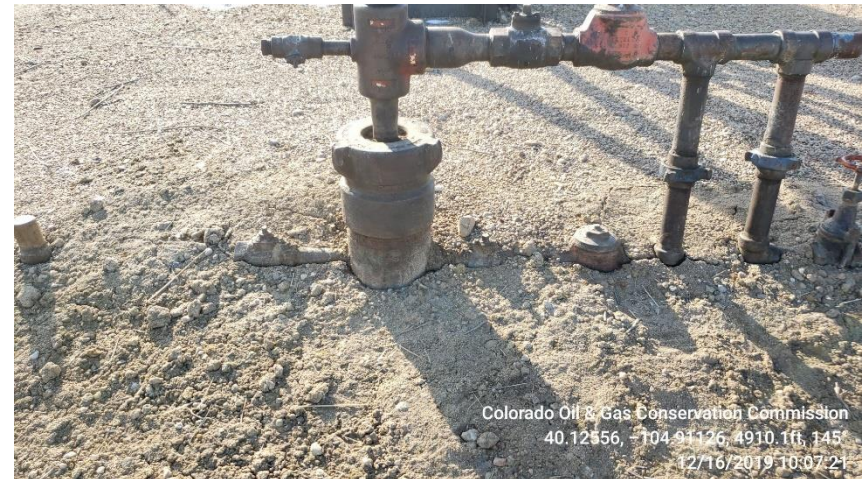
**Photo 4 Stained soil around WH appears to have been removed**

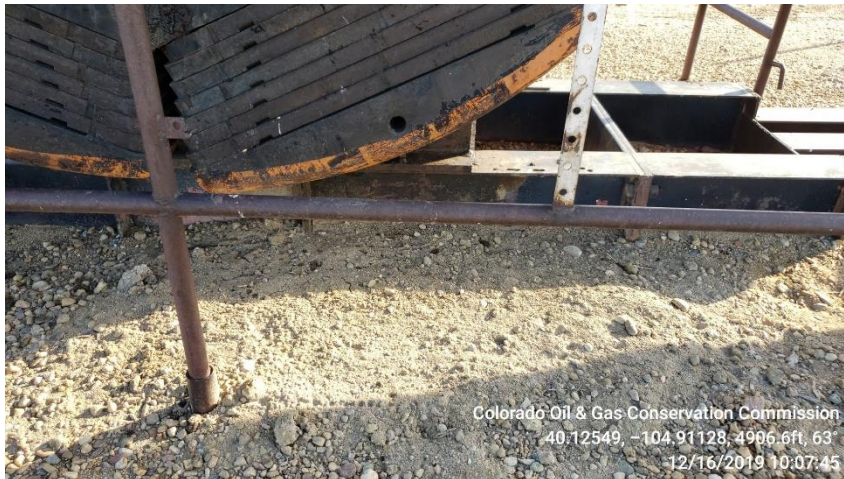
**Photo 5 Stained soil at PU base appears to have been removed**

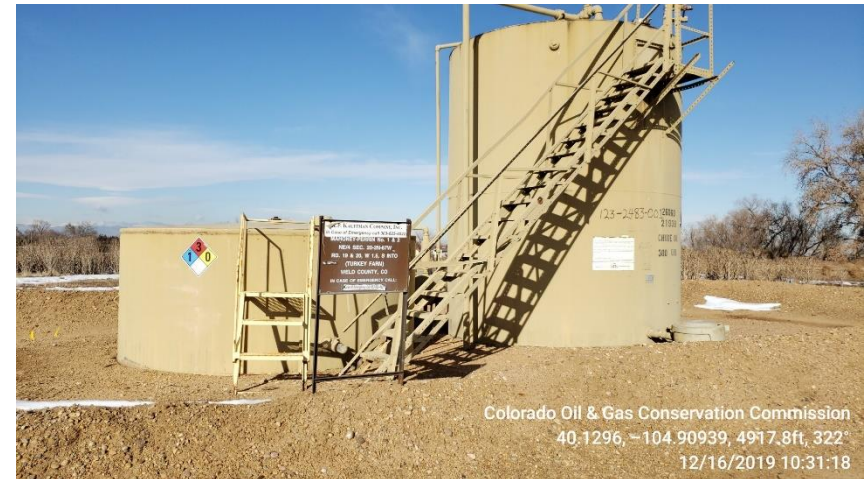
**Photo 6 TB sign**

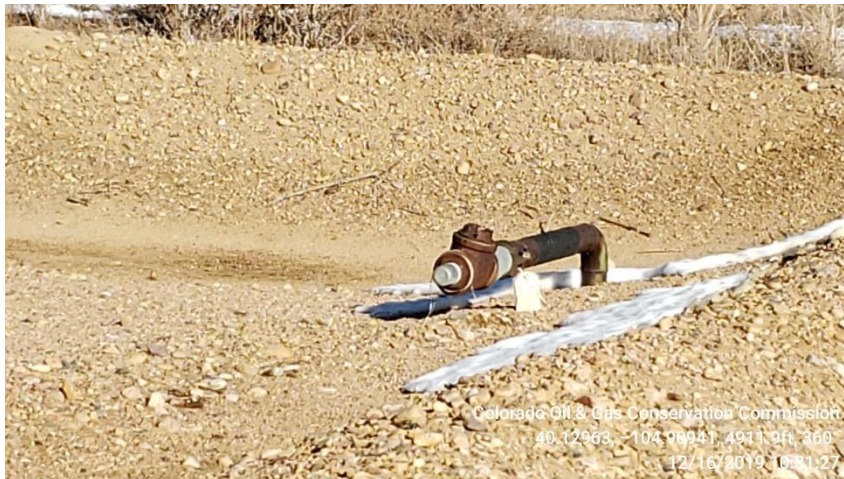
**Photo 7 flow line is now marked & tagged**

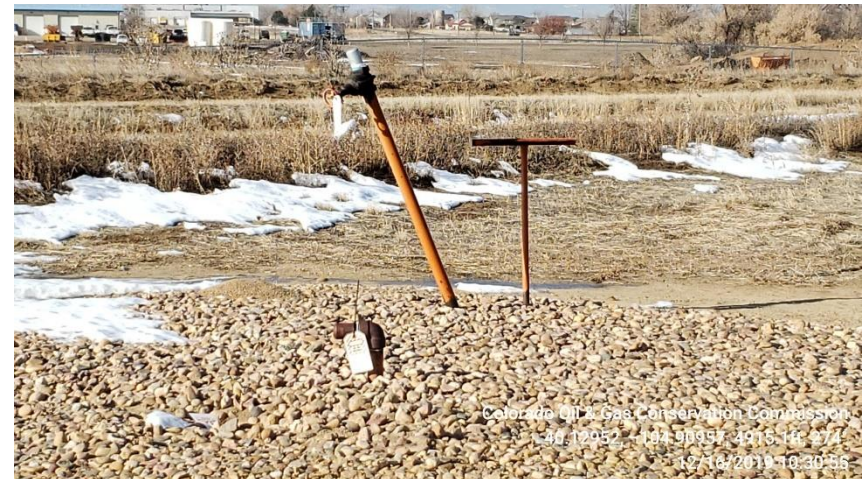
**Photo 8 flow lines are now marked & tagged**

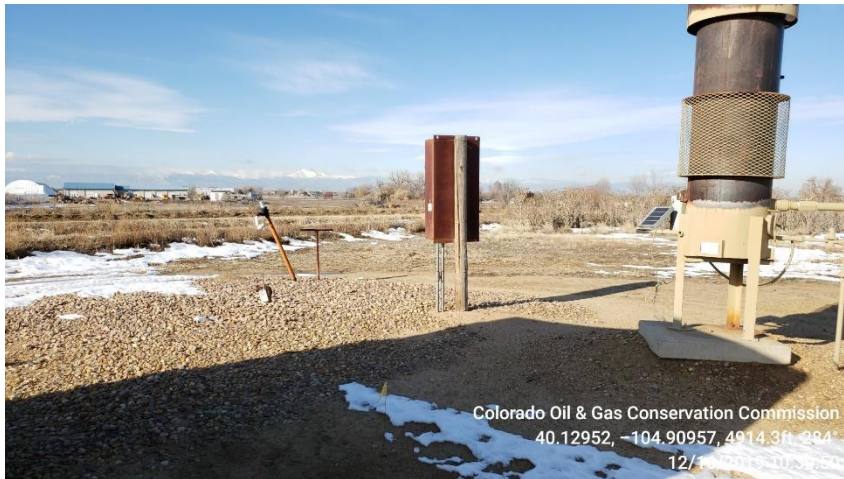
**Photo 9 ECD**

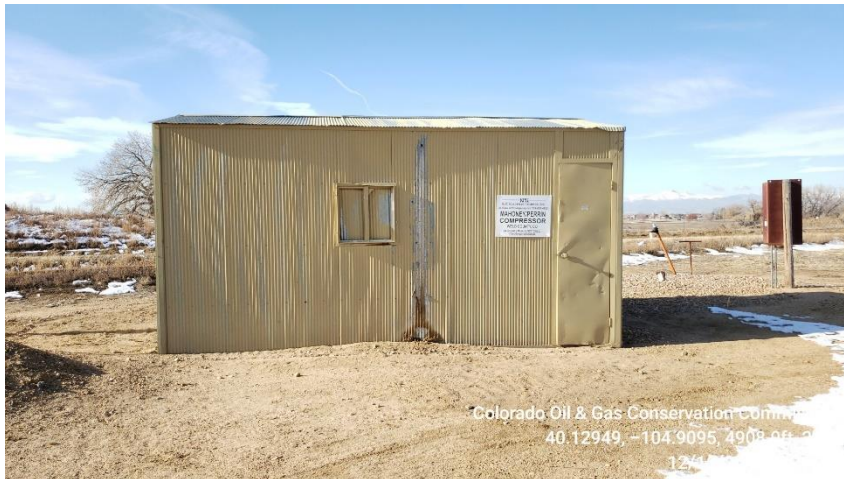
**Photo 11 Compressor house**

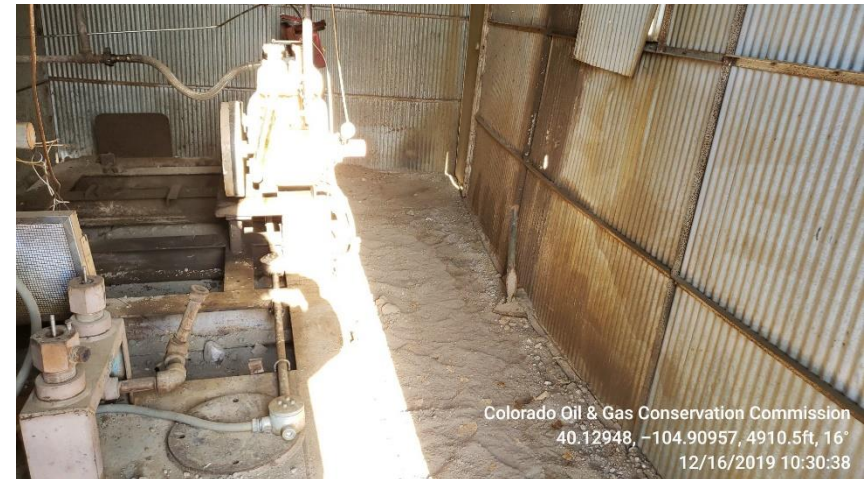
**Photo 12 stained soil appears to have been removed from comp. house**

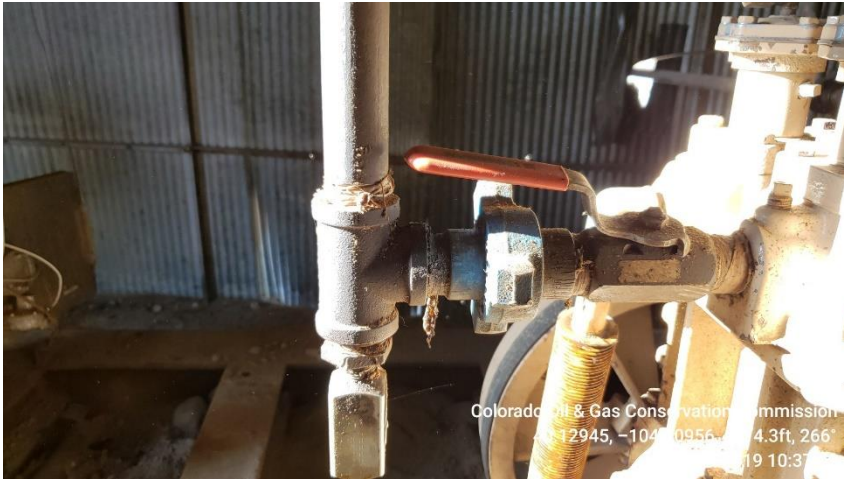
**Photo 13 hammer union appears to have been tightened**
