Inspection Photos
Operator: Hilcorp Energy
Location/API #: 067-08335
Date: 12-13-2019

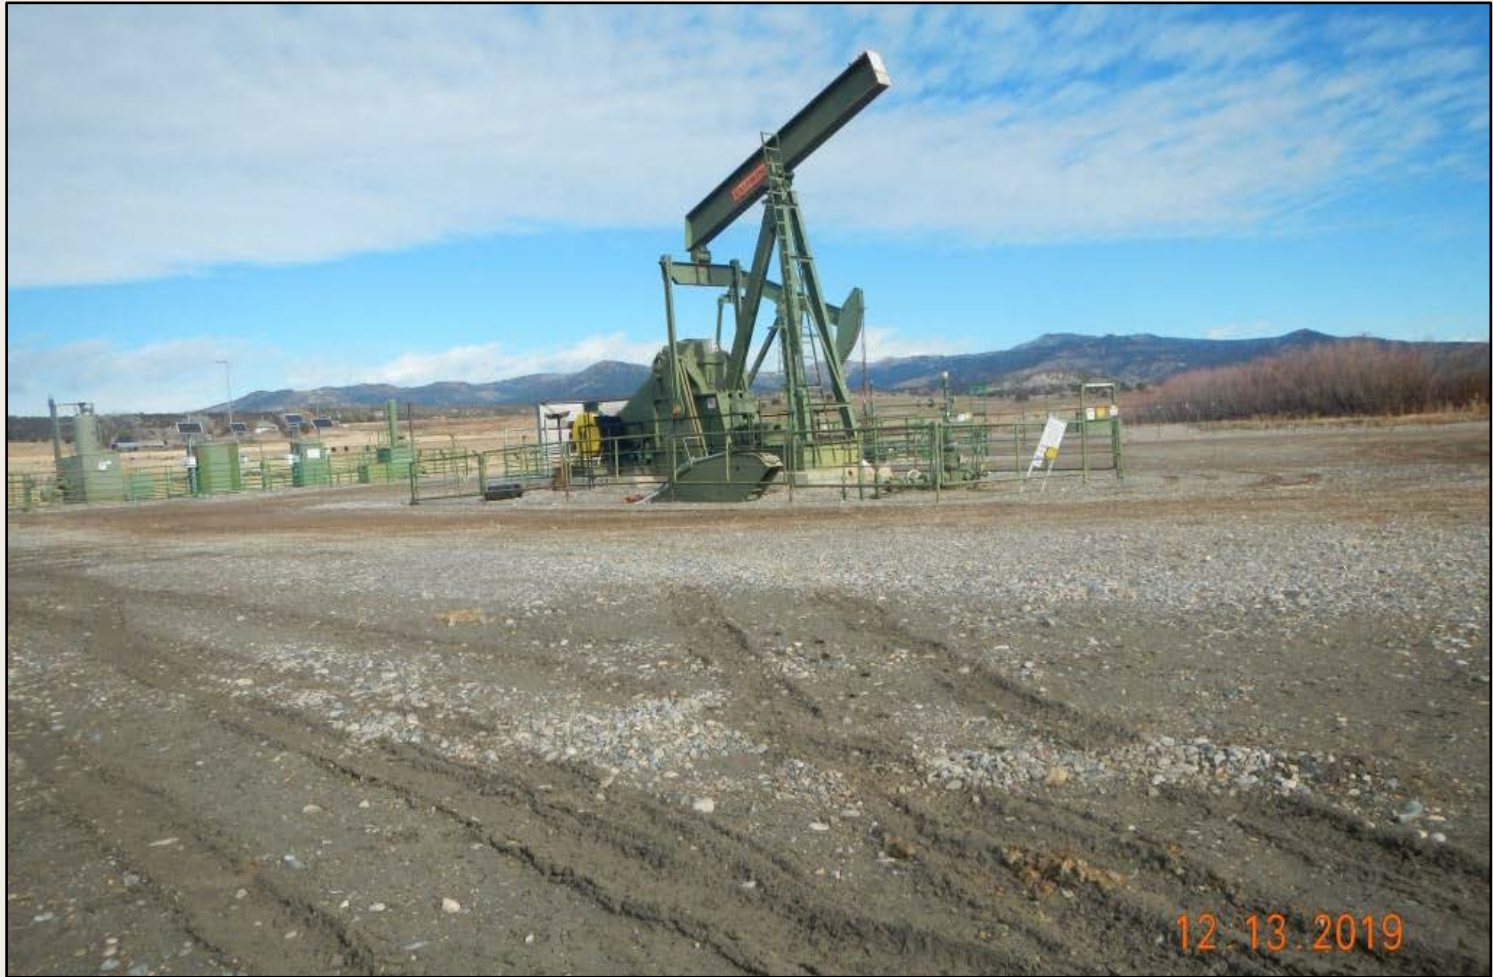
Photo 1. View of the project area from the southwestern corner facing center.

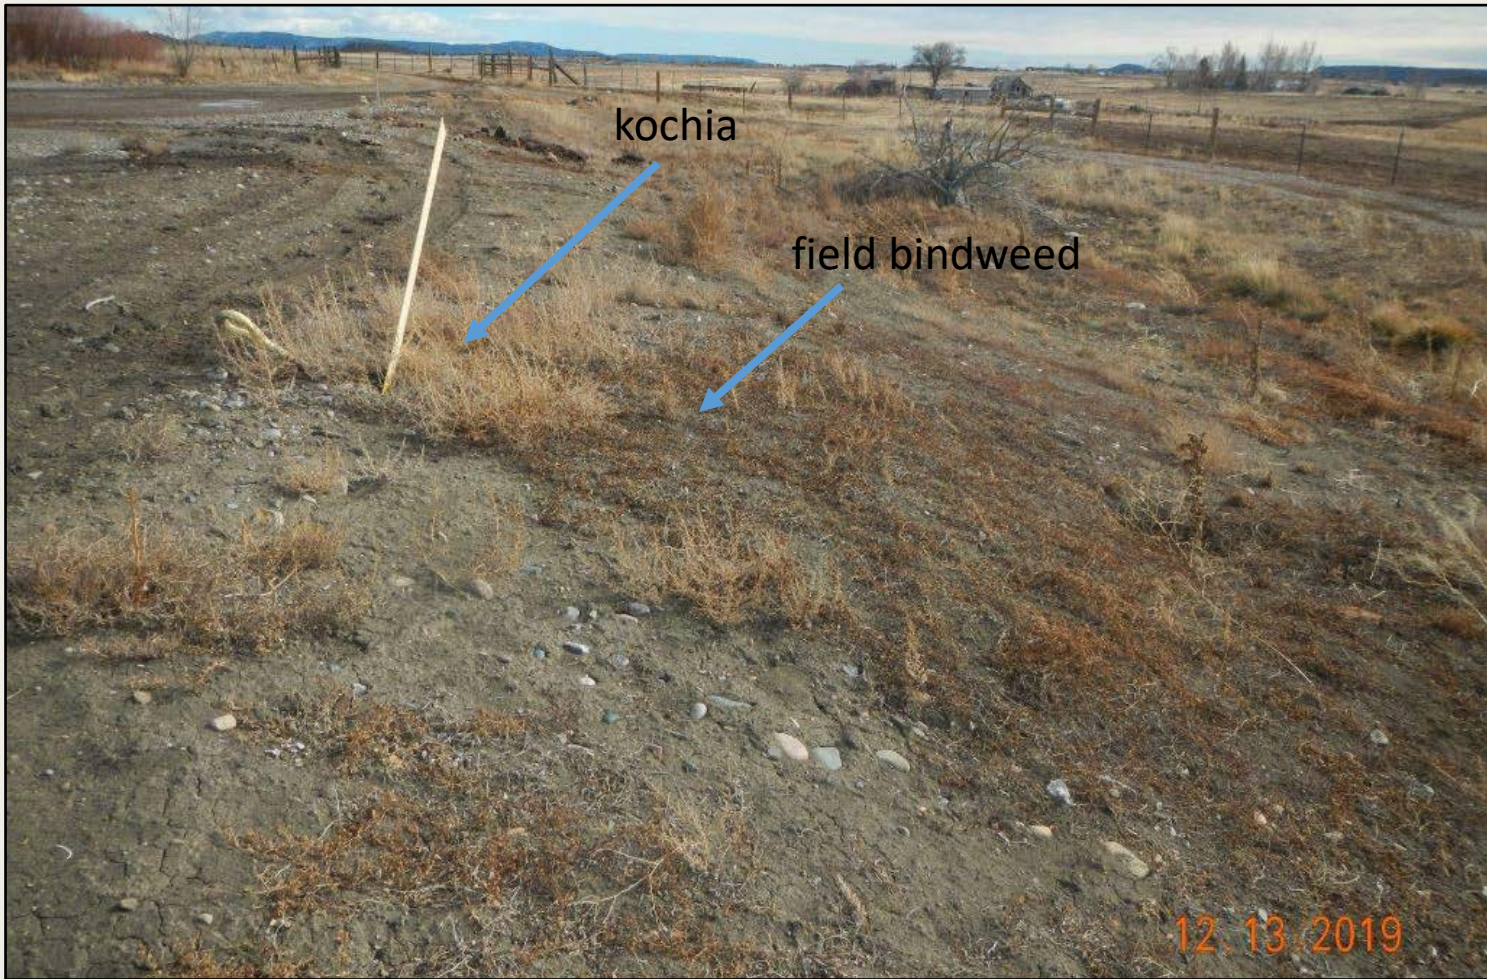
Photo 2. View of the southern project area from the southwestern corner facing eastward. Revegetation is failed here as only observed vegetation is comprised of weeds such as kochia and field bindweed.

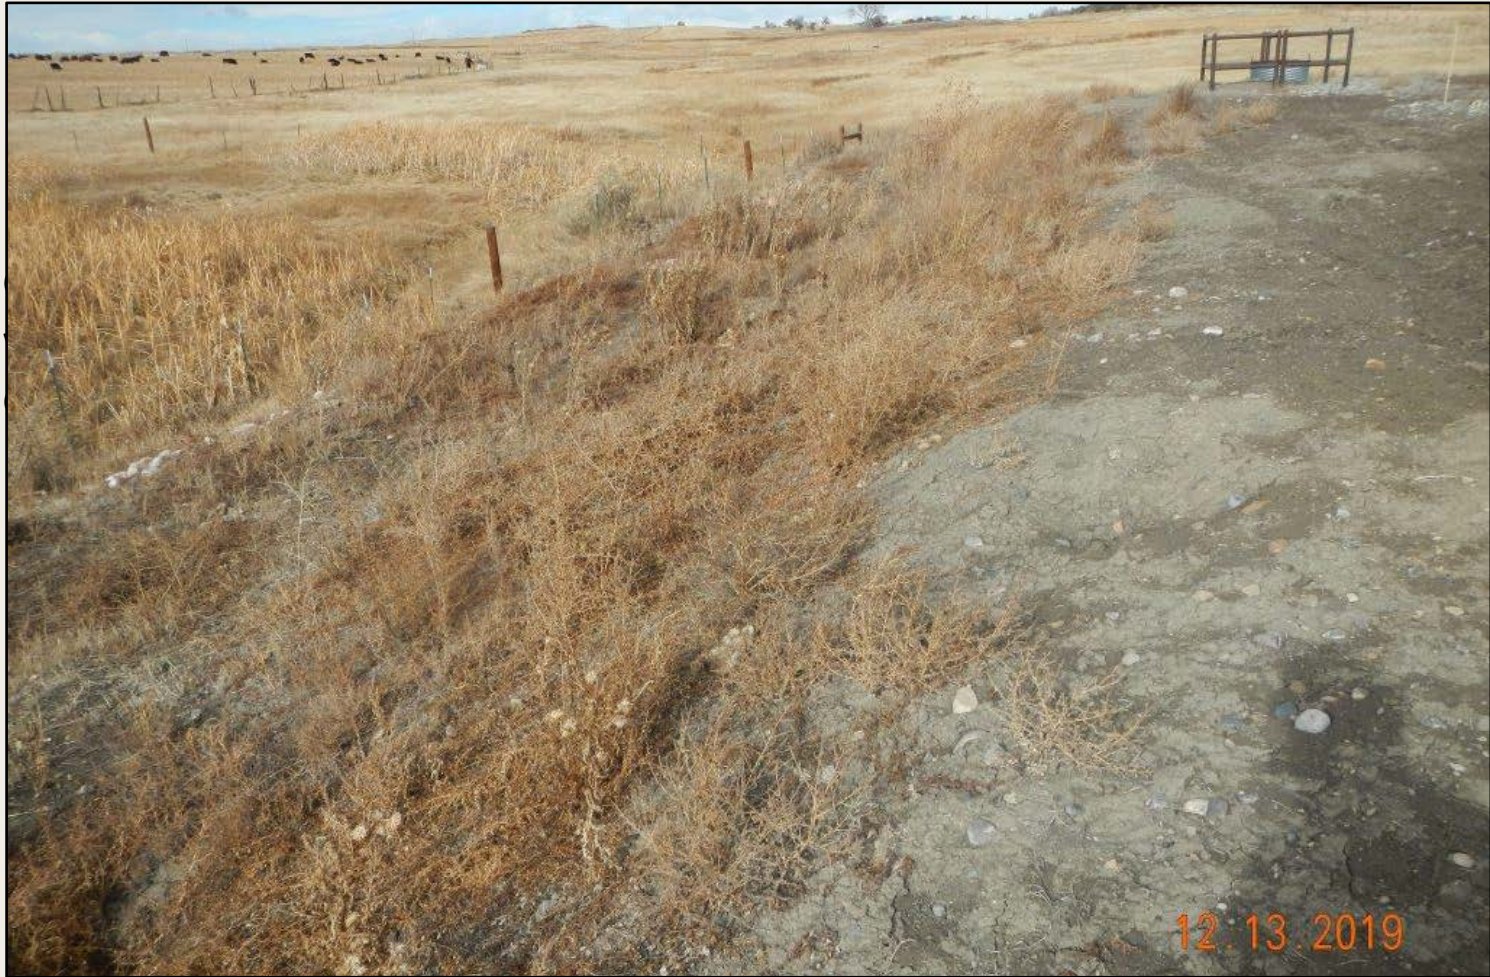
Photo 3. View of the northern project area from the northwestern corner facing eastward. Revegetation is failed here, as observable vegetation is comprised of kochia and field bindweed.

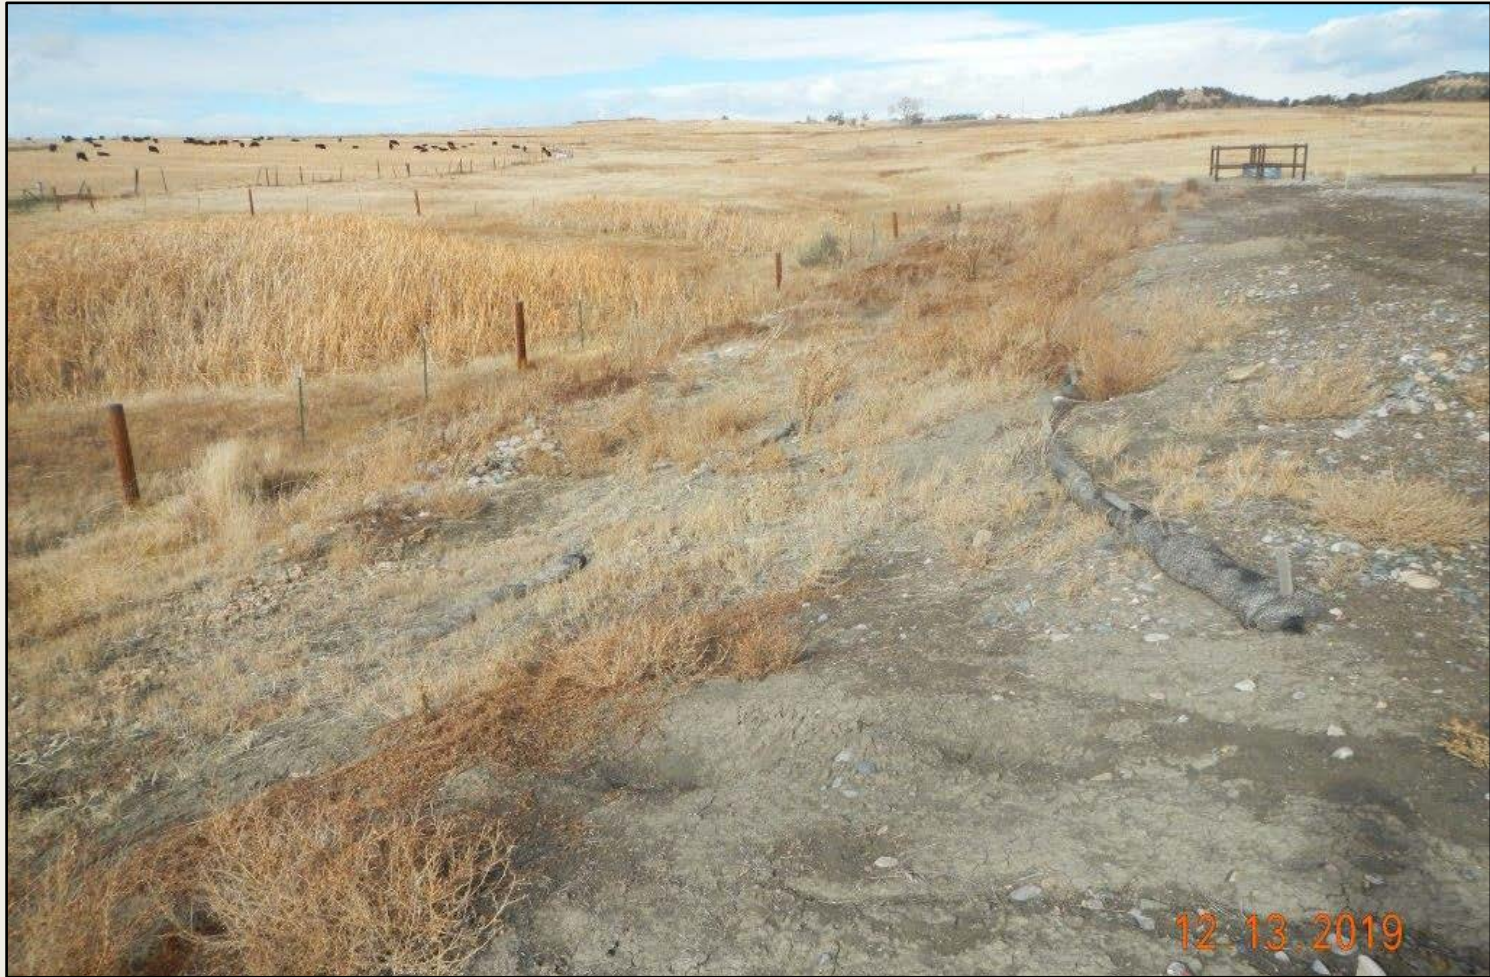
Photo 4. View of the western project area from the southwestern corner facing northward. Wattles are full of sediment and do not appear to be functioning.

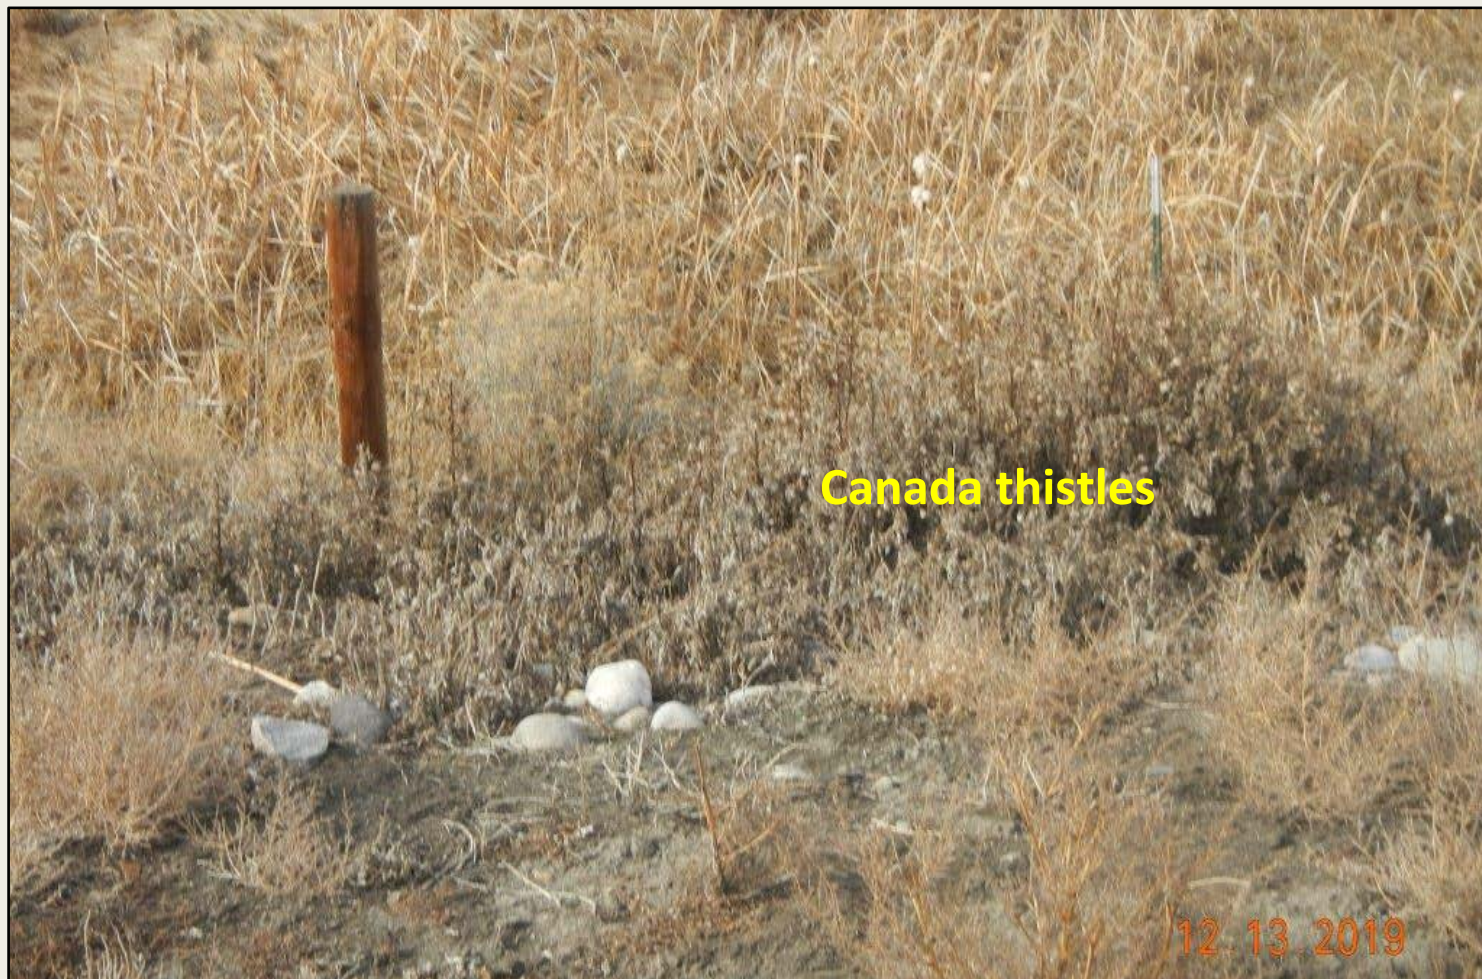
Photo 5. View of Canada thistles growing within the northwestern project area.

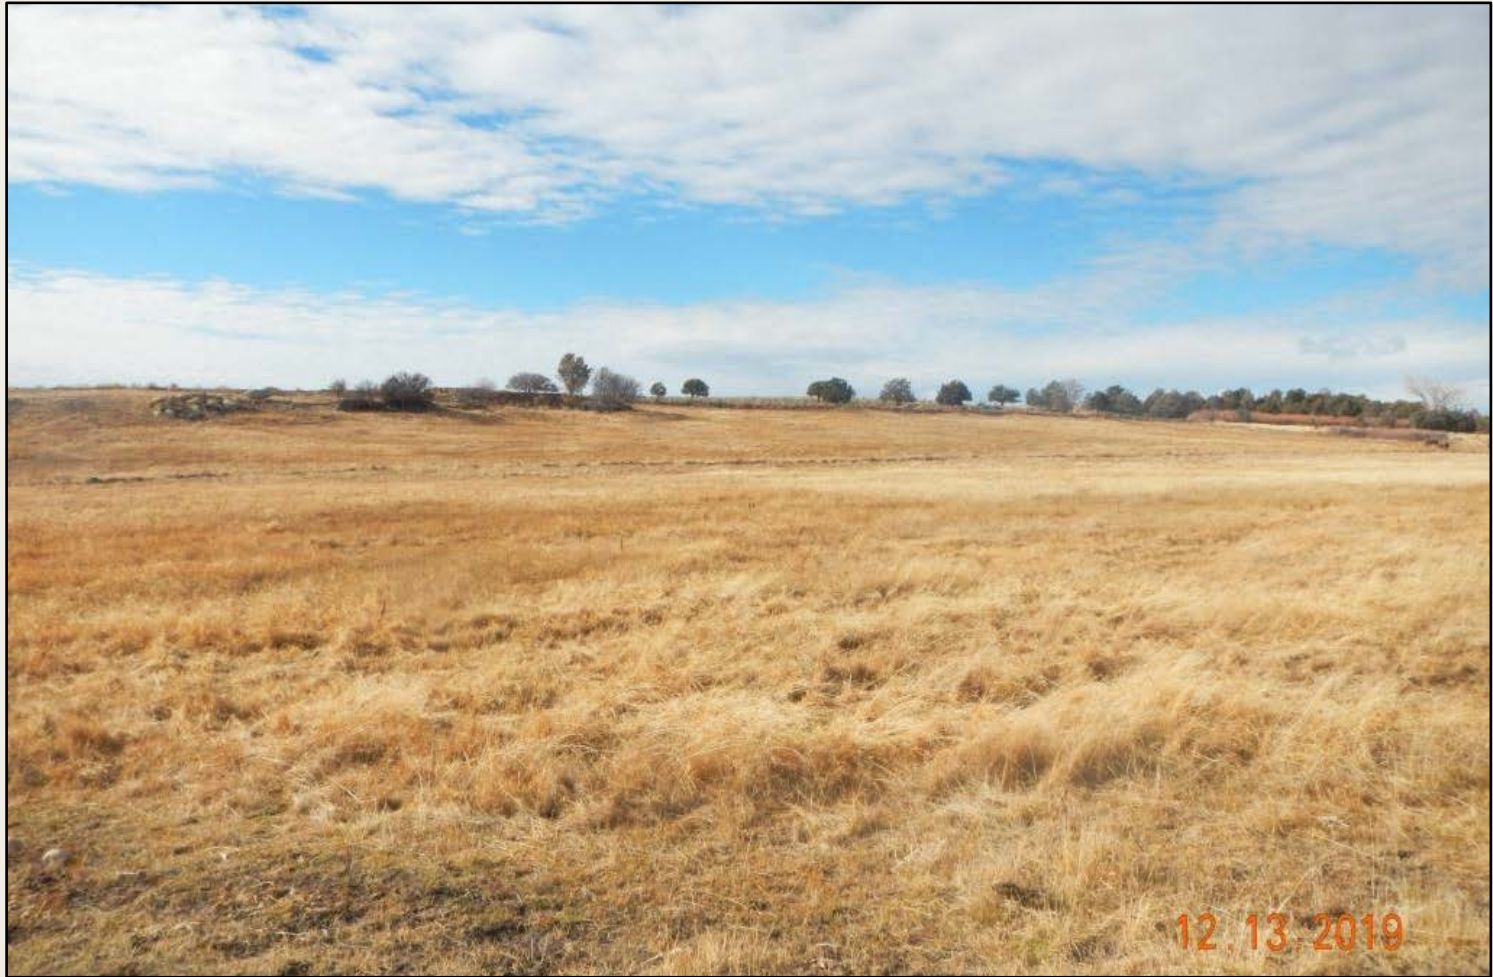
Photo 6. View of reference area, comprised of irrigated grass field.
