Inspection Photos

Operator: Hilcorp Energy
Location/API #: 067-06118
Date: 12-13-2019

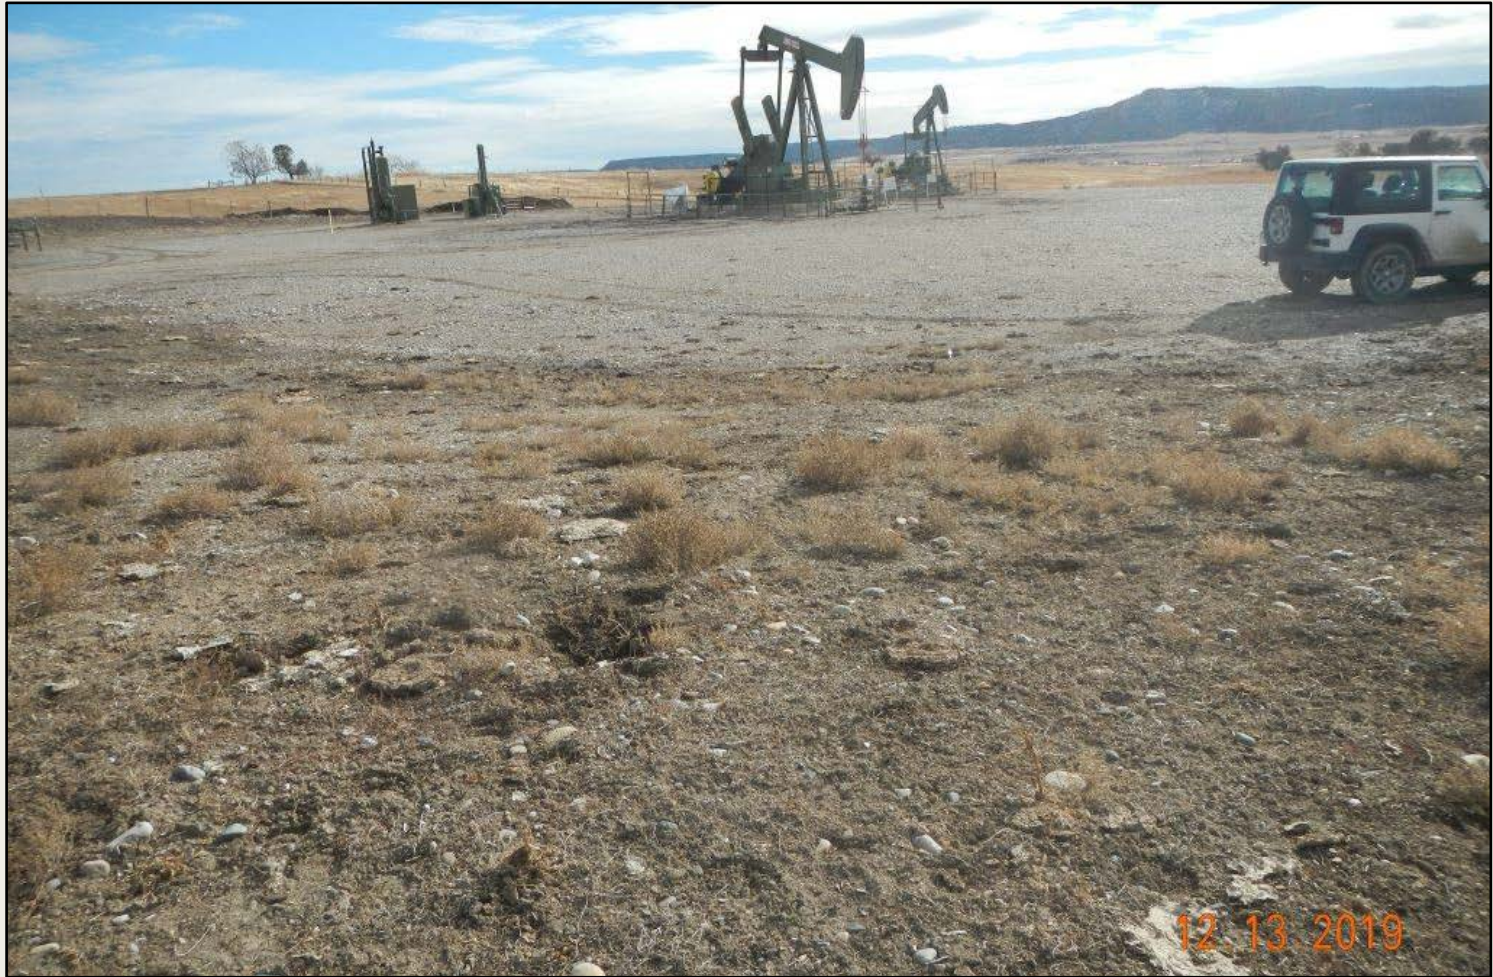
Photo 1. View of the project area from the northern corner facing center.

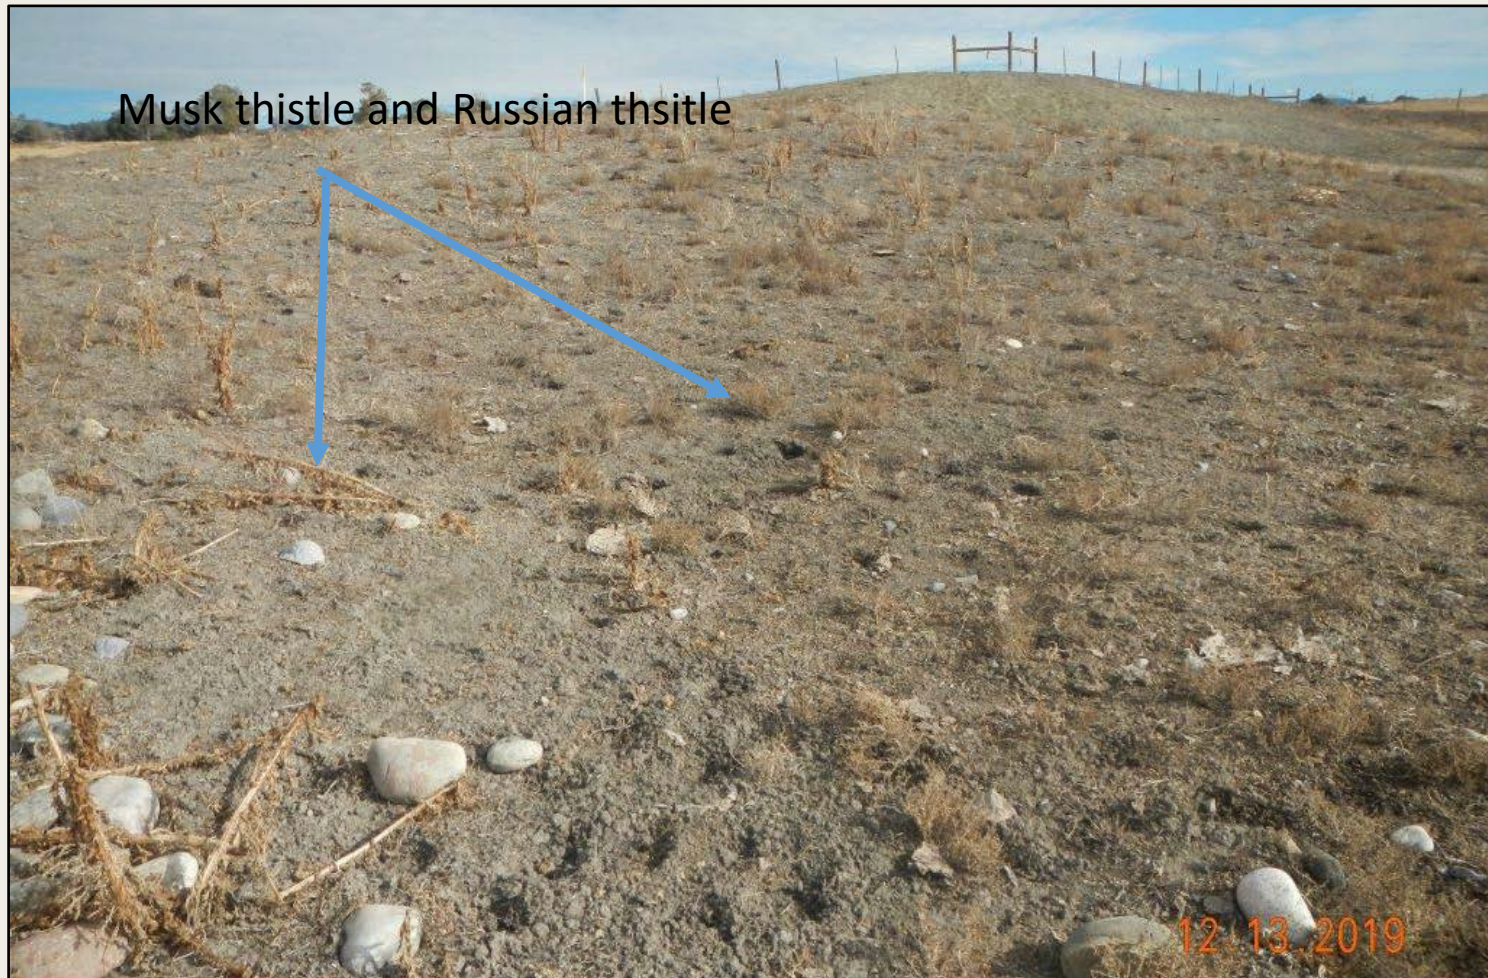
Photo 2. View of the northwestern project area from the northern corner facing northeastward. Observable vegetation is musk thistle and Russian thistle plants (weeds).

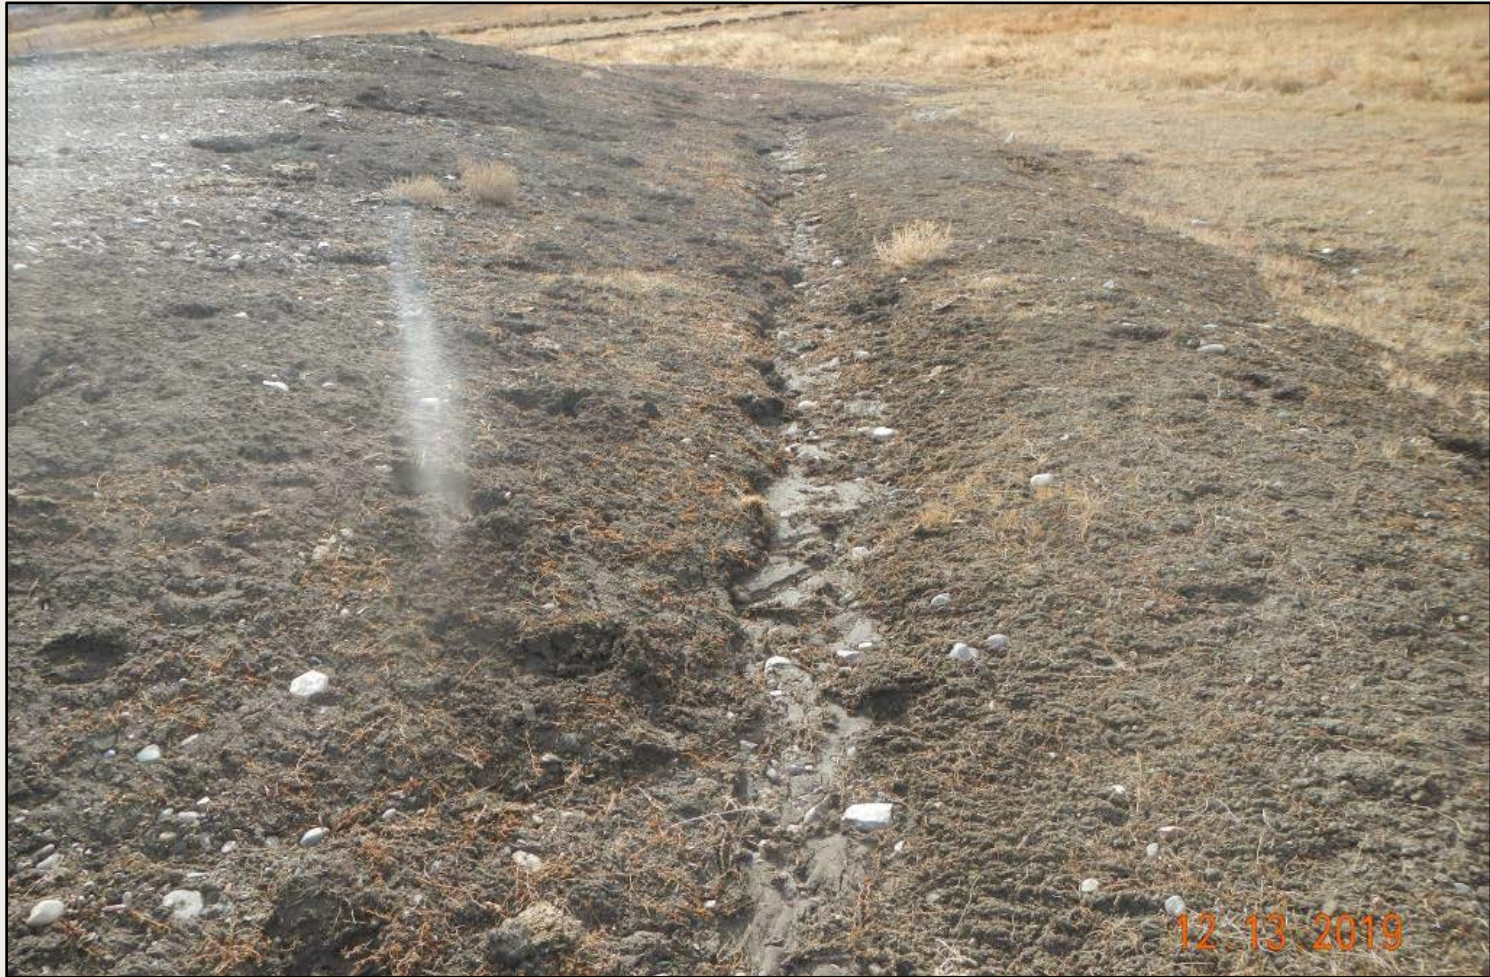
Photo 3. View of diversion and bare soils within the northwestern project area that are not stabilized.

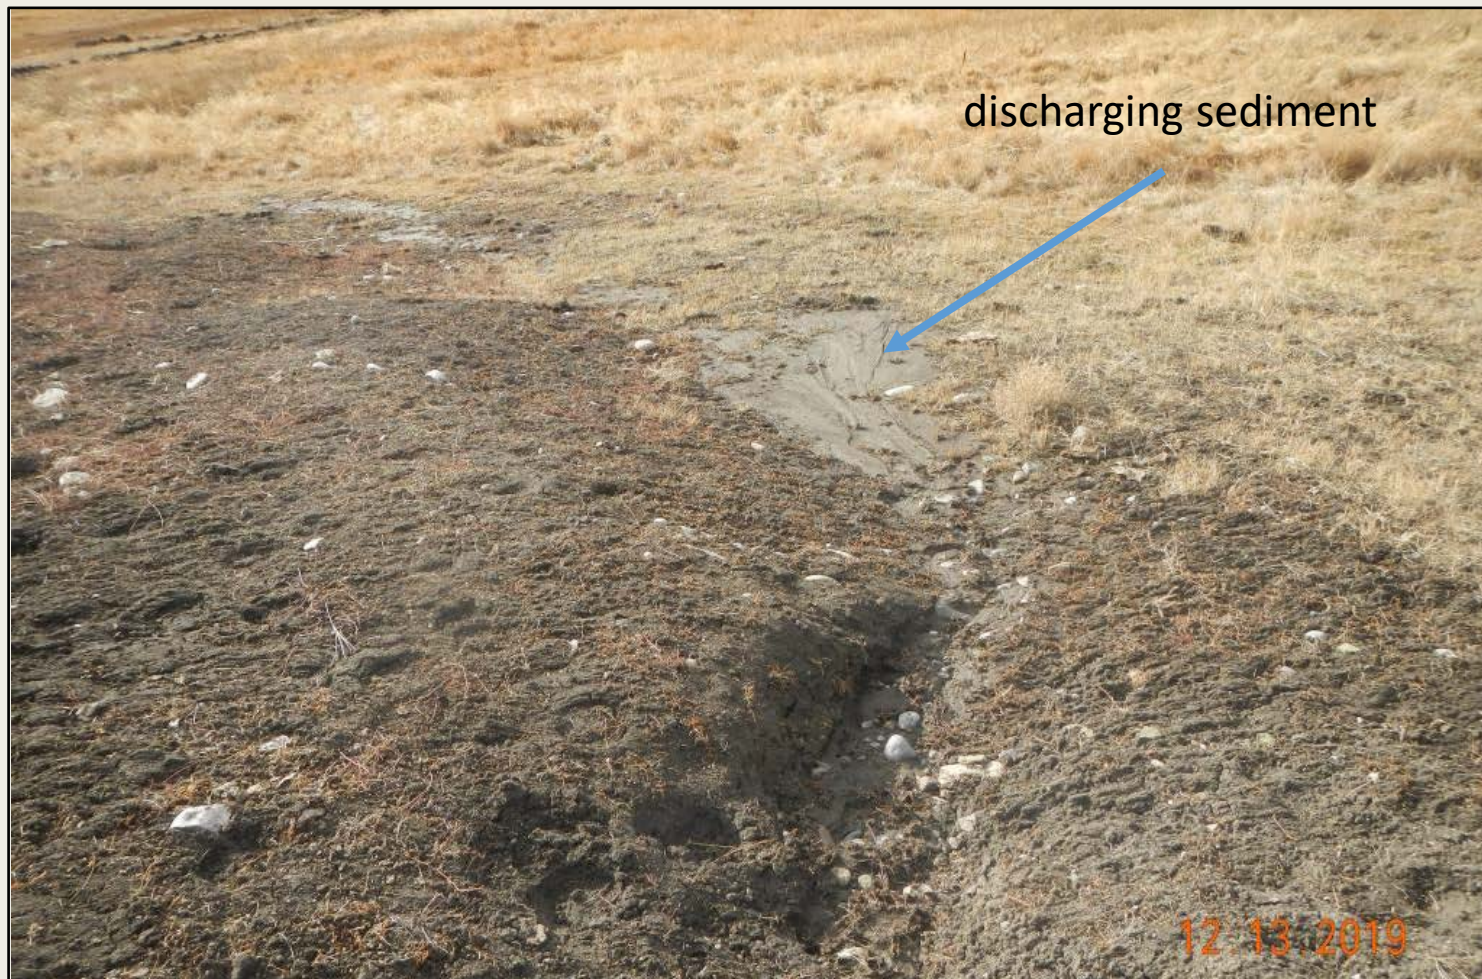
Photo 4. View of area downslope from diversion in Photo 3, where sediment is discharging off of the project area.

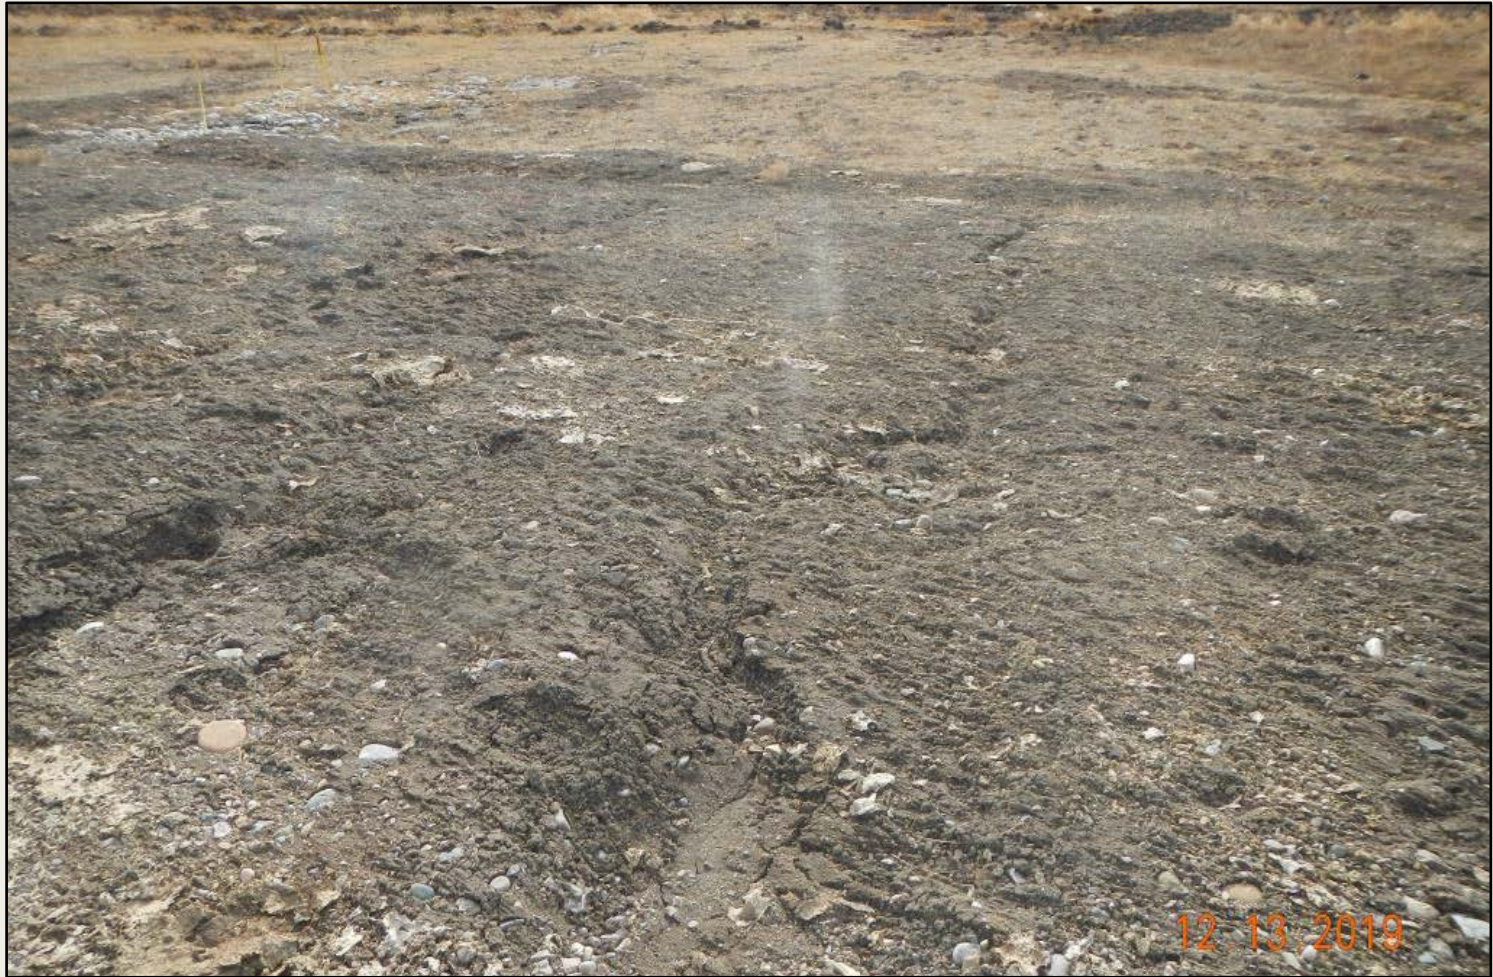
Photo 5. View of rilling and bare soils within the southwestern project area needing stabilization.

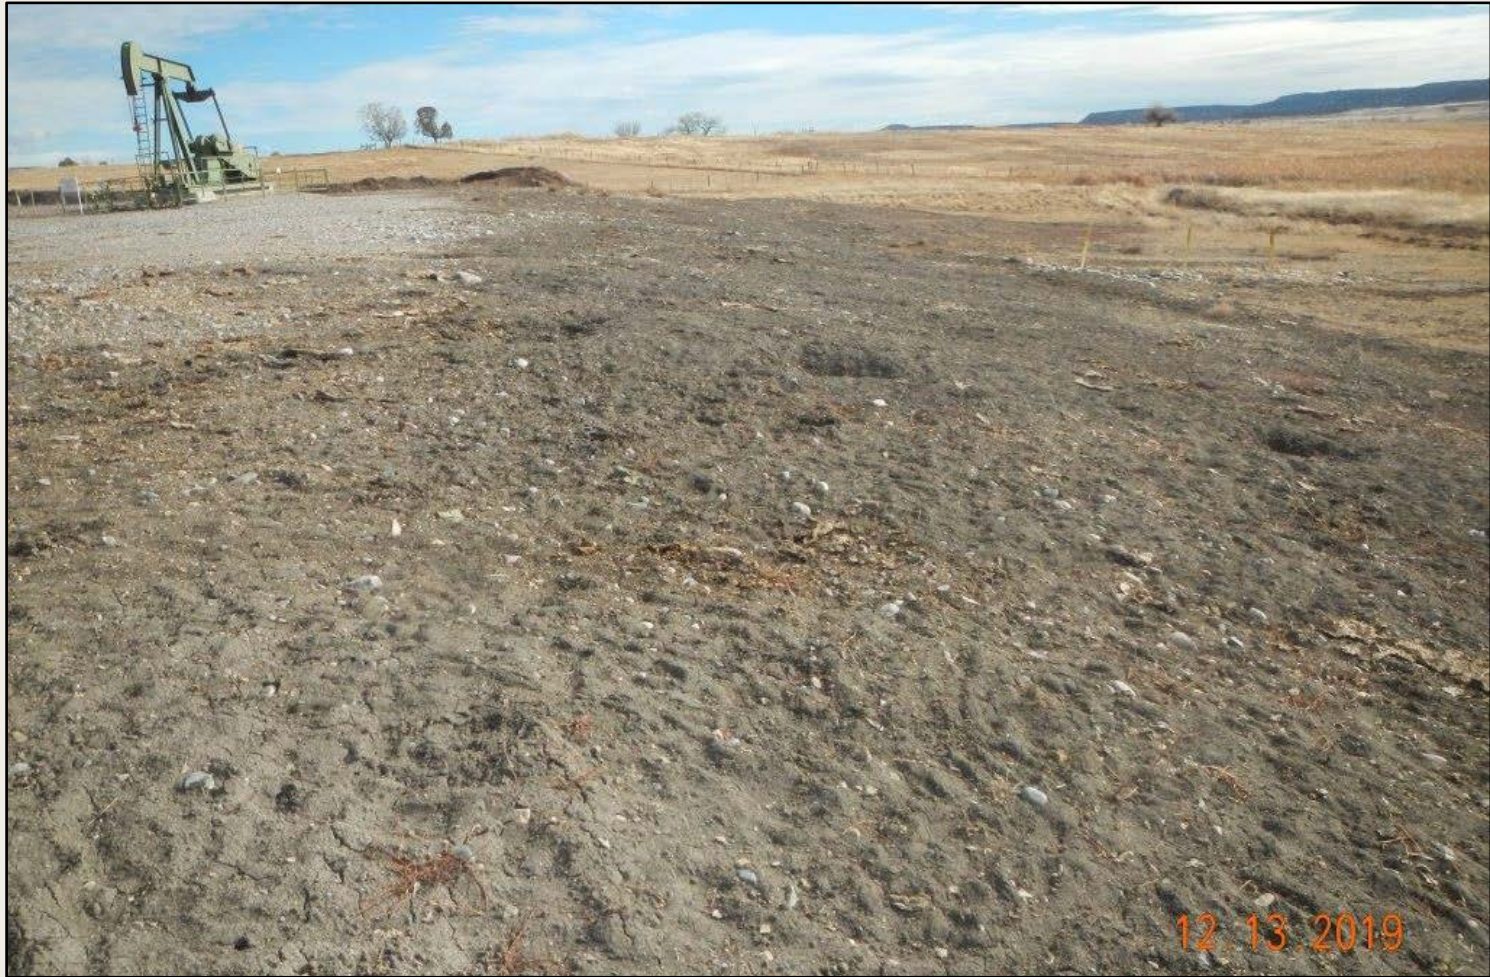
Photo 6. View of southwestern project area from the western corner facing southeastward. Soils are bare with little to no desirable vegetation.

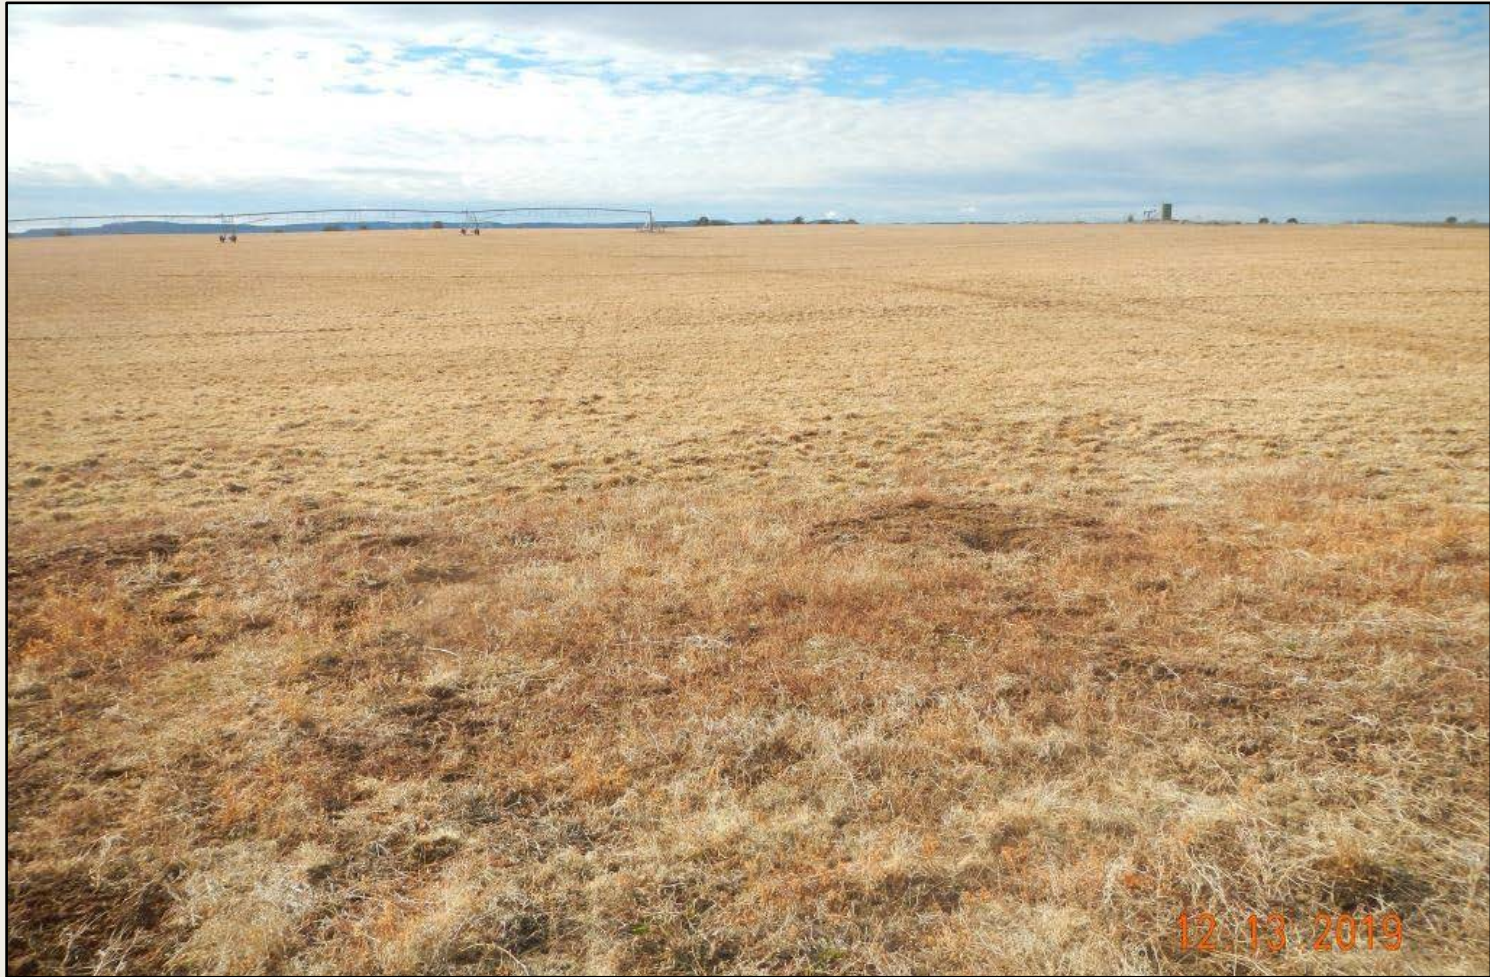
Photo 7. View of reference area, comprised of an irrigated grass field.
