**Inspection Photos**  
**Operator: BP America**  
**Location/API #: 067-06664**  
**Date: 12-13-2019**

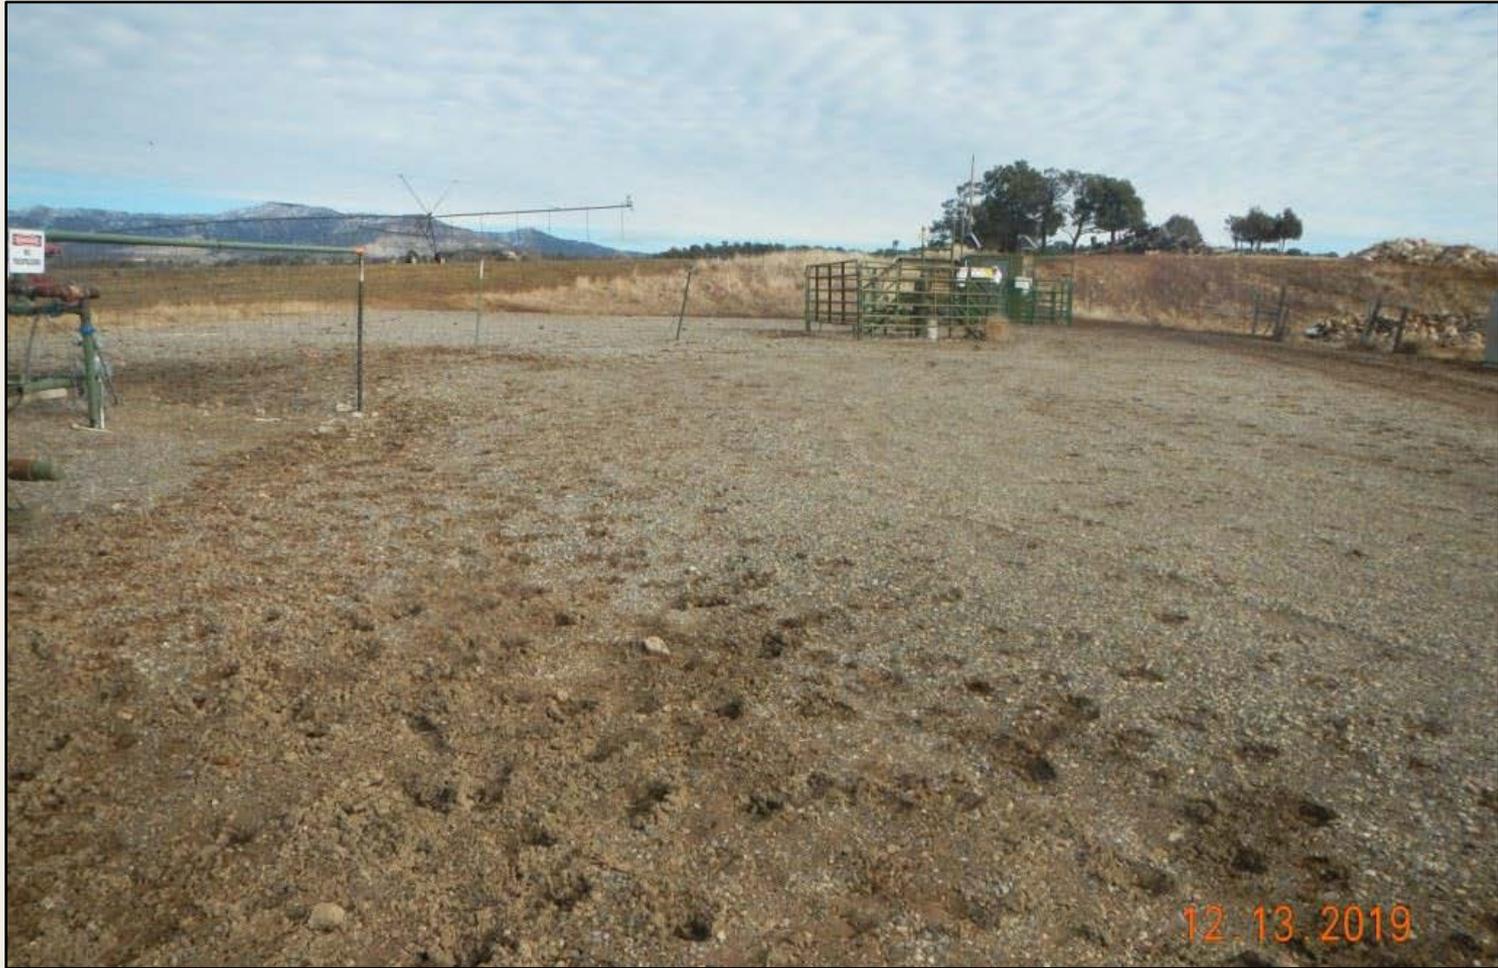
Photo 1. View of the project area from the western edge facing center.

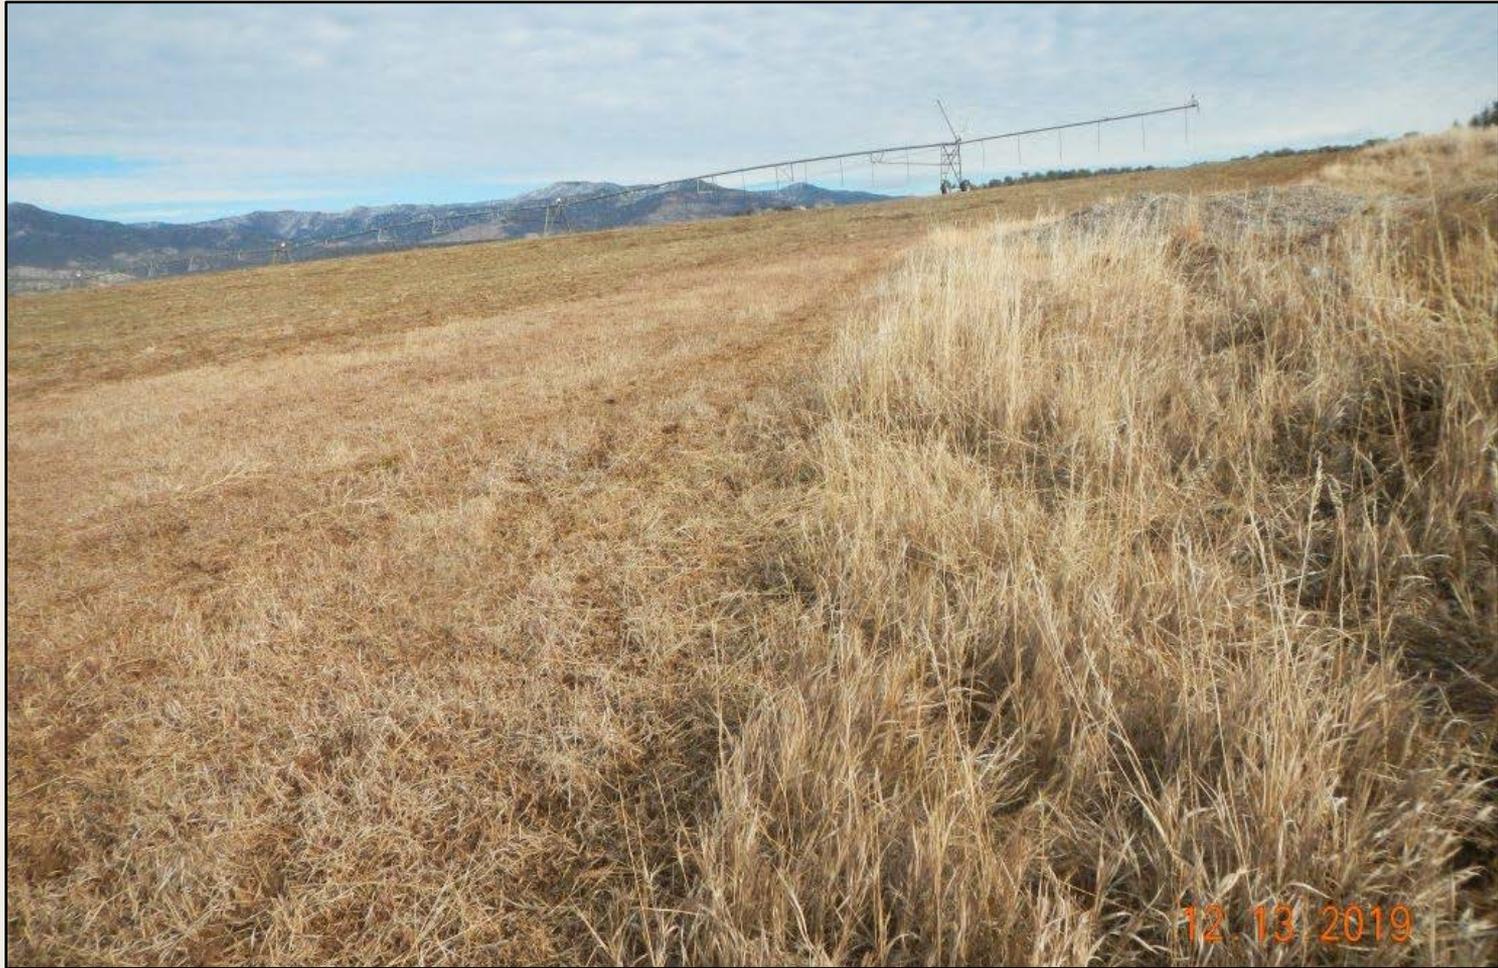
Photo 2. View of the northern project area from the northwestern corner facing eastward. Revegetation is progressing within this portion of the reclamation area with grasses such as smooth brome, in a dormant vegetative condition.

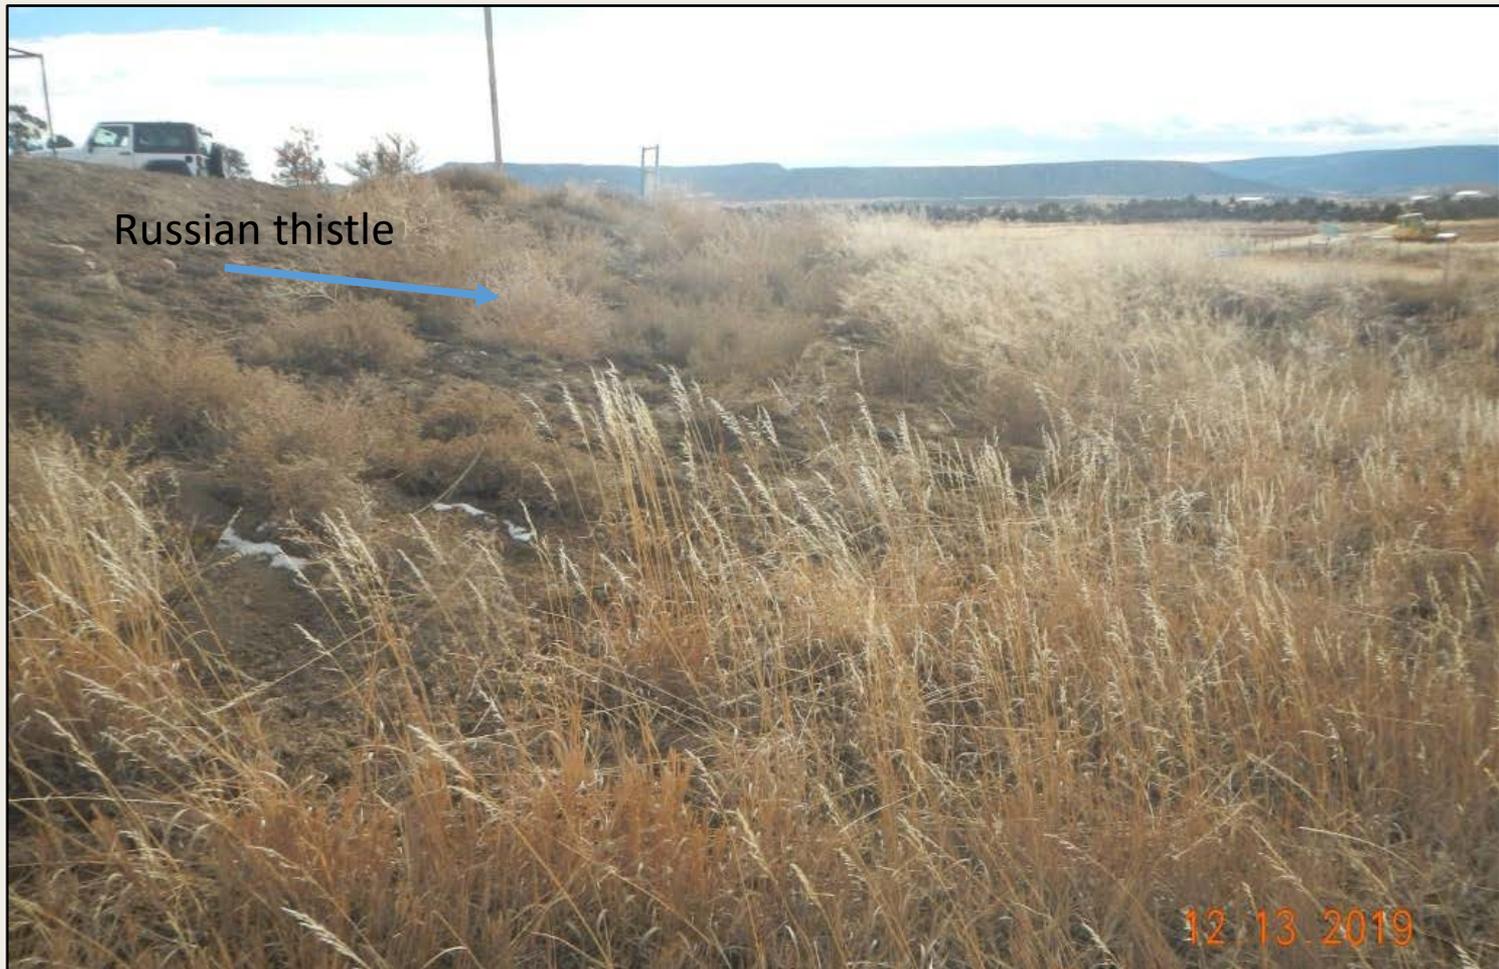
Photo 3. View of the western project area from the northwestern corner facing southward. Revegetation is progressing on the lower portion of the slope, but is sparse and not progressing on the fill slope. Weedy kochia and Russian thistle debris is present.

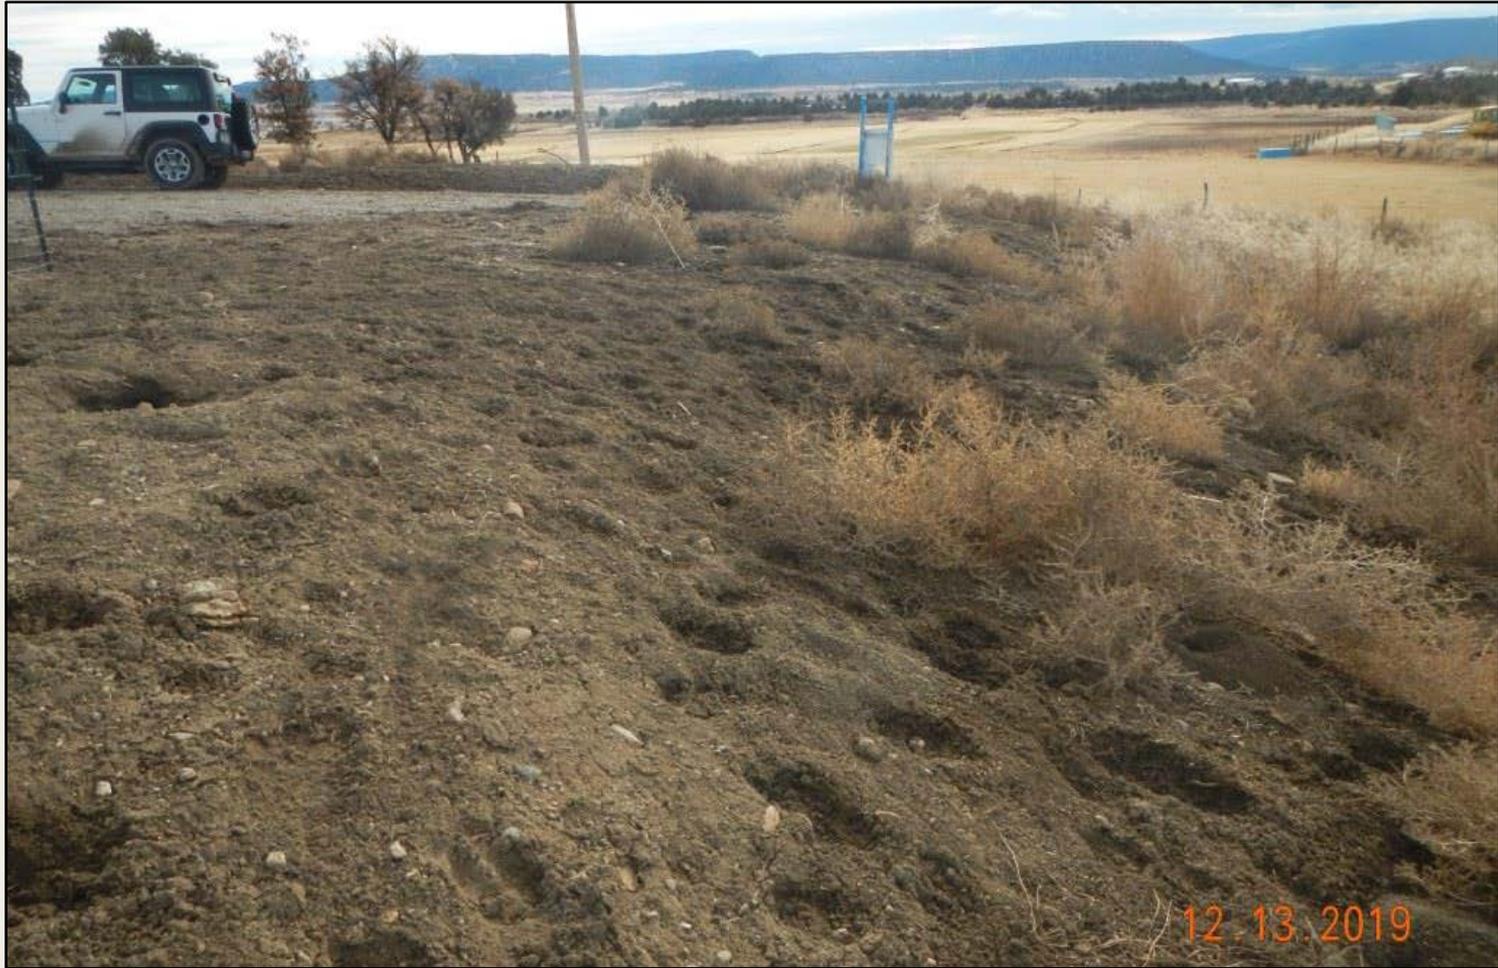
Photo 4. View of area in the western fill slope where revegetation is failed and revegetation/stabilization measures are needed.

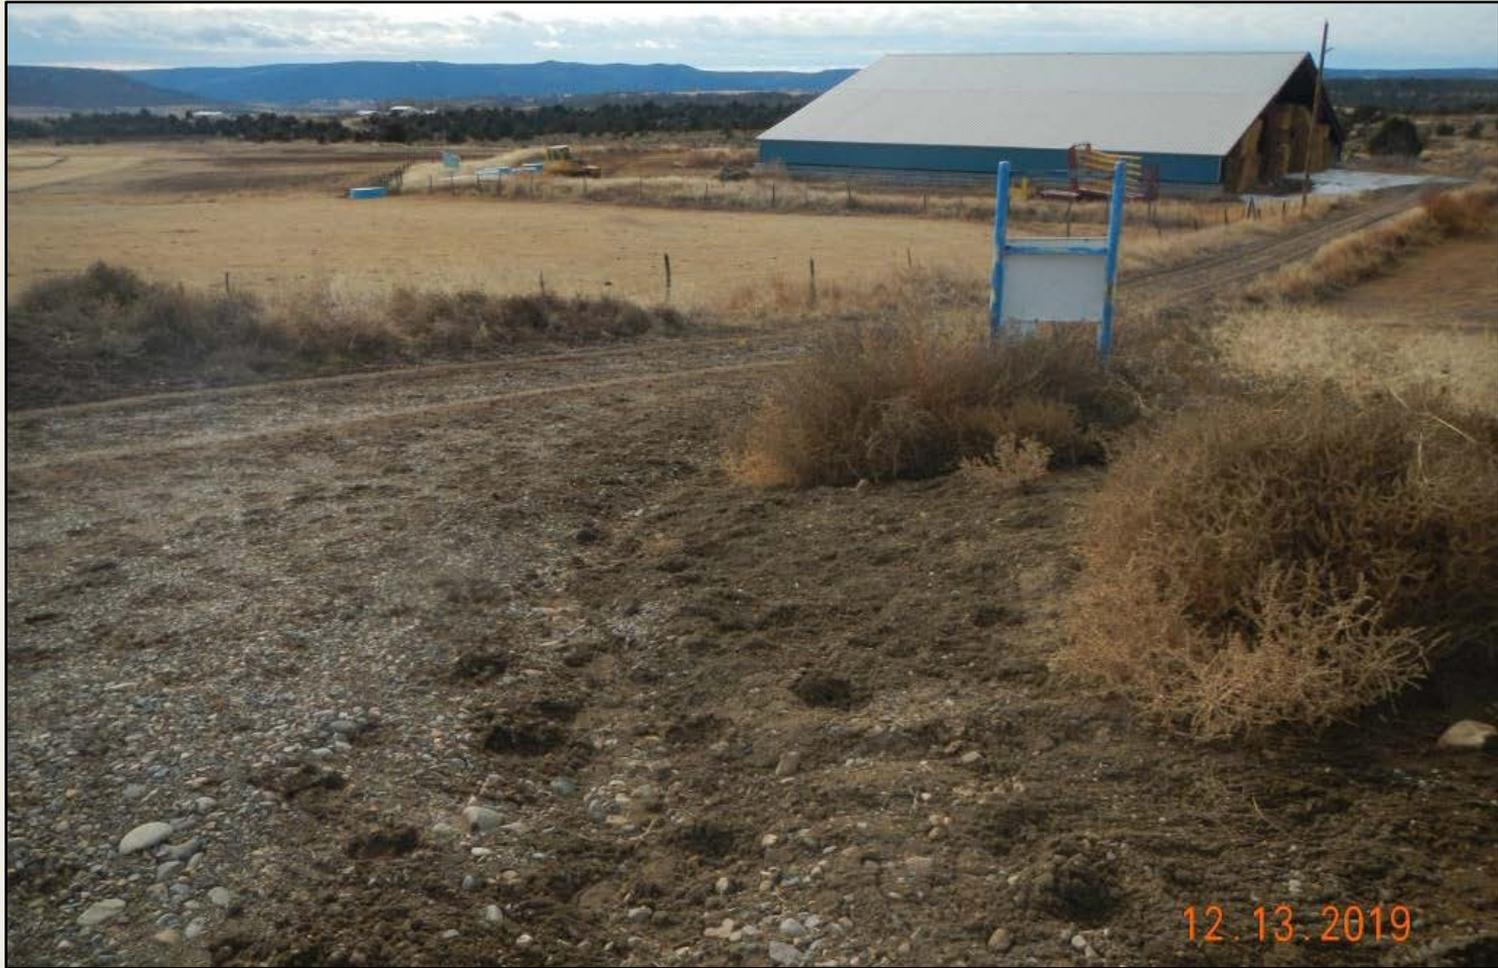
Photo 7. View of Russian thistle up to 3 feet tall near the well pad entrance.

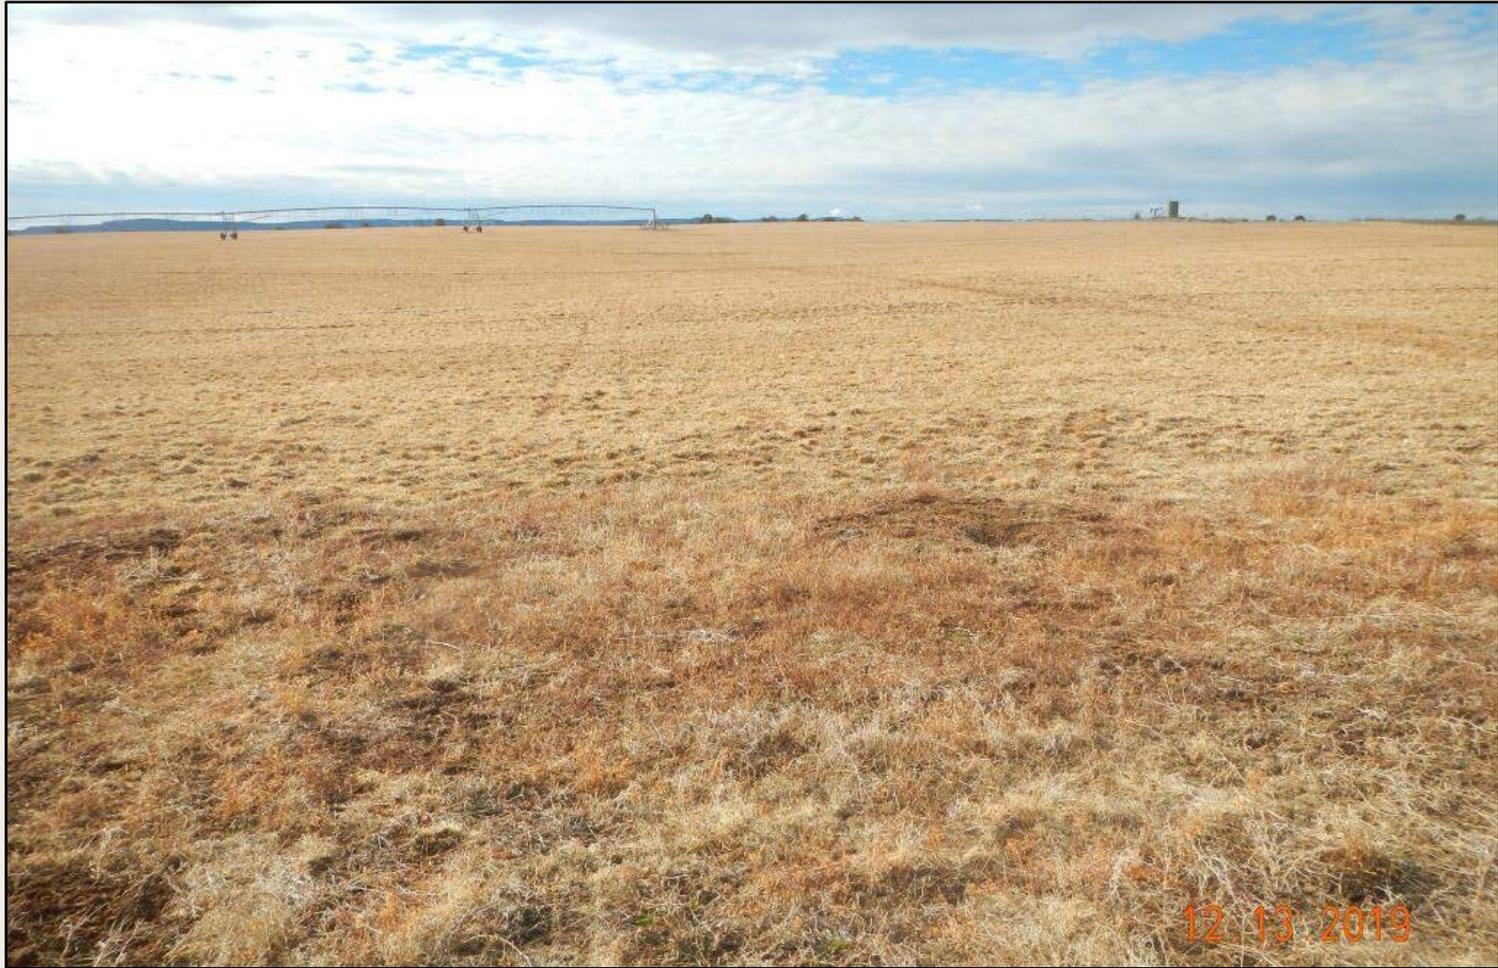
Photo 7. View of reference area north of the project area, comprised of an irrigated grass field.
