Inspection Photos

Operator: Enduring Resources
Location/API #: 067-06564
Date: 12-18-2019

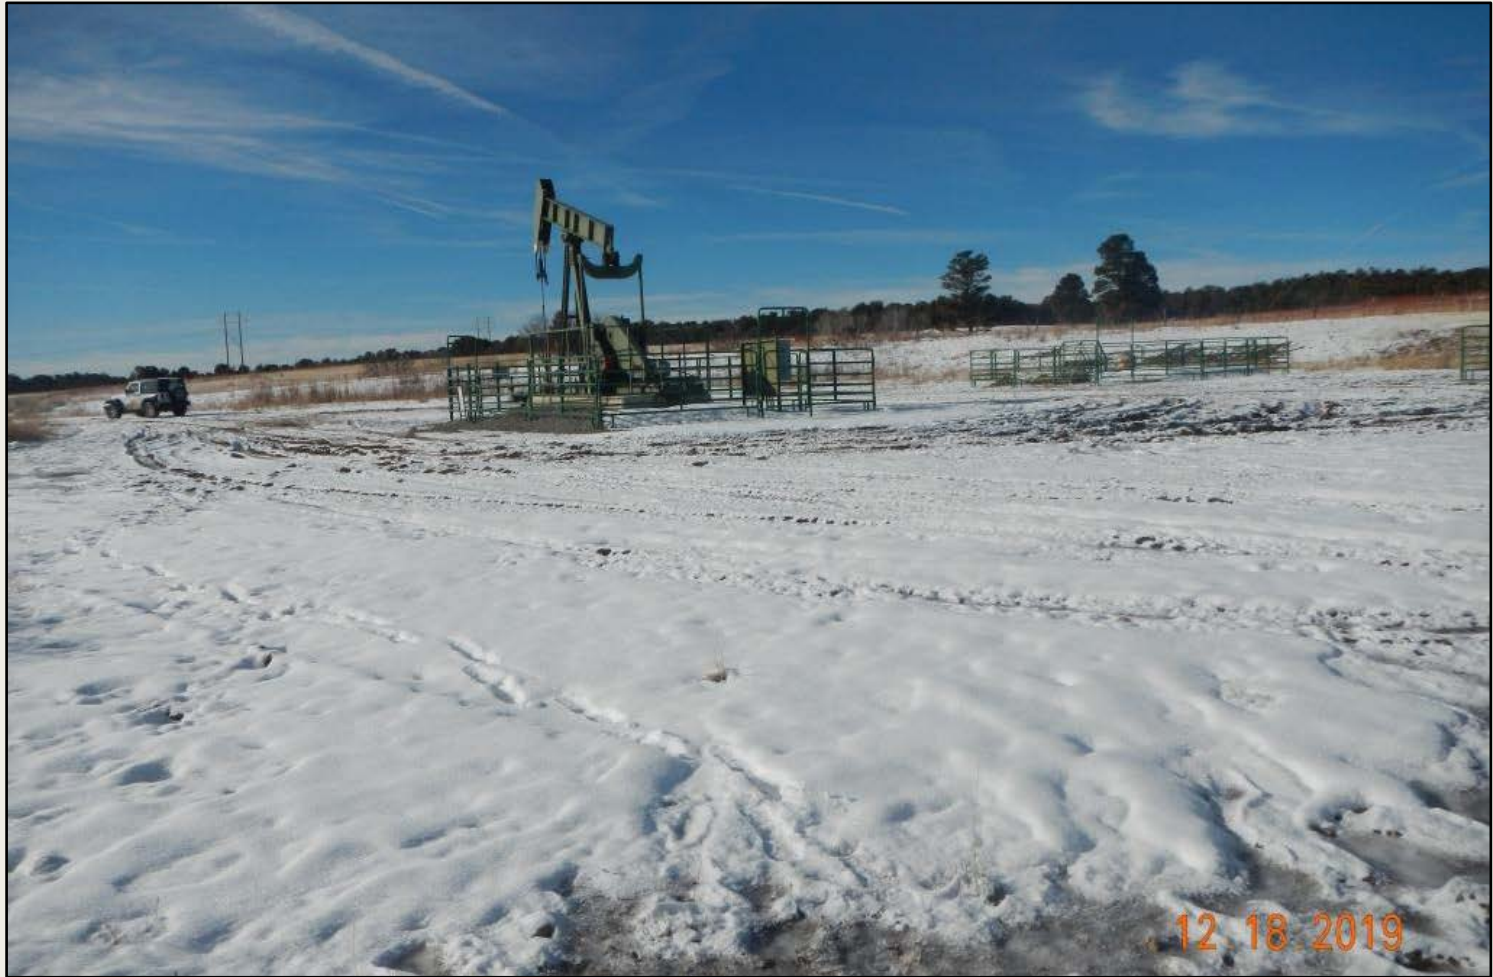
Photo 1. View of the project area from the northeastern edge facing center.

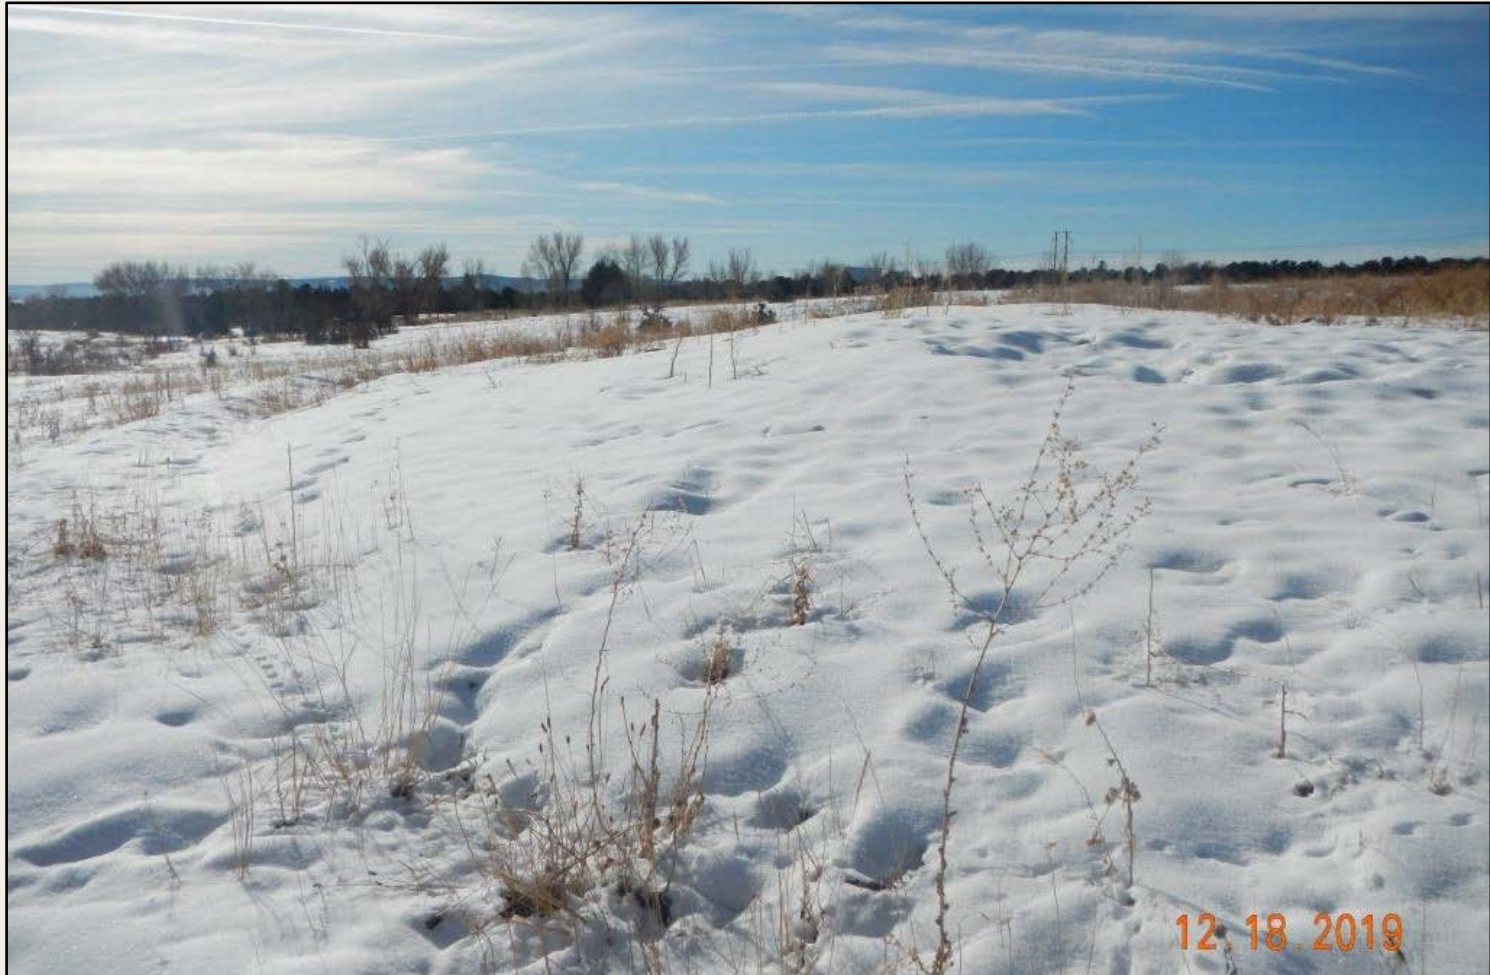
Photo 2. View of the eastern fill slope from the northeastern corner facing southward. Location is largely snow covered at this time. A mix of perennial grass species such as crested wheatgrass and annual weeds such as prickly lettuce are observable through the snow.

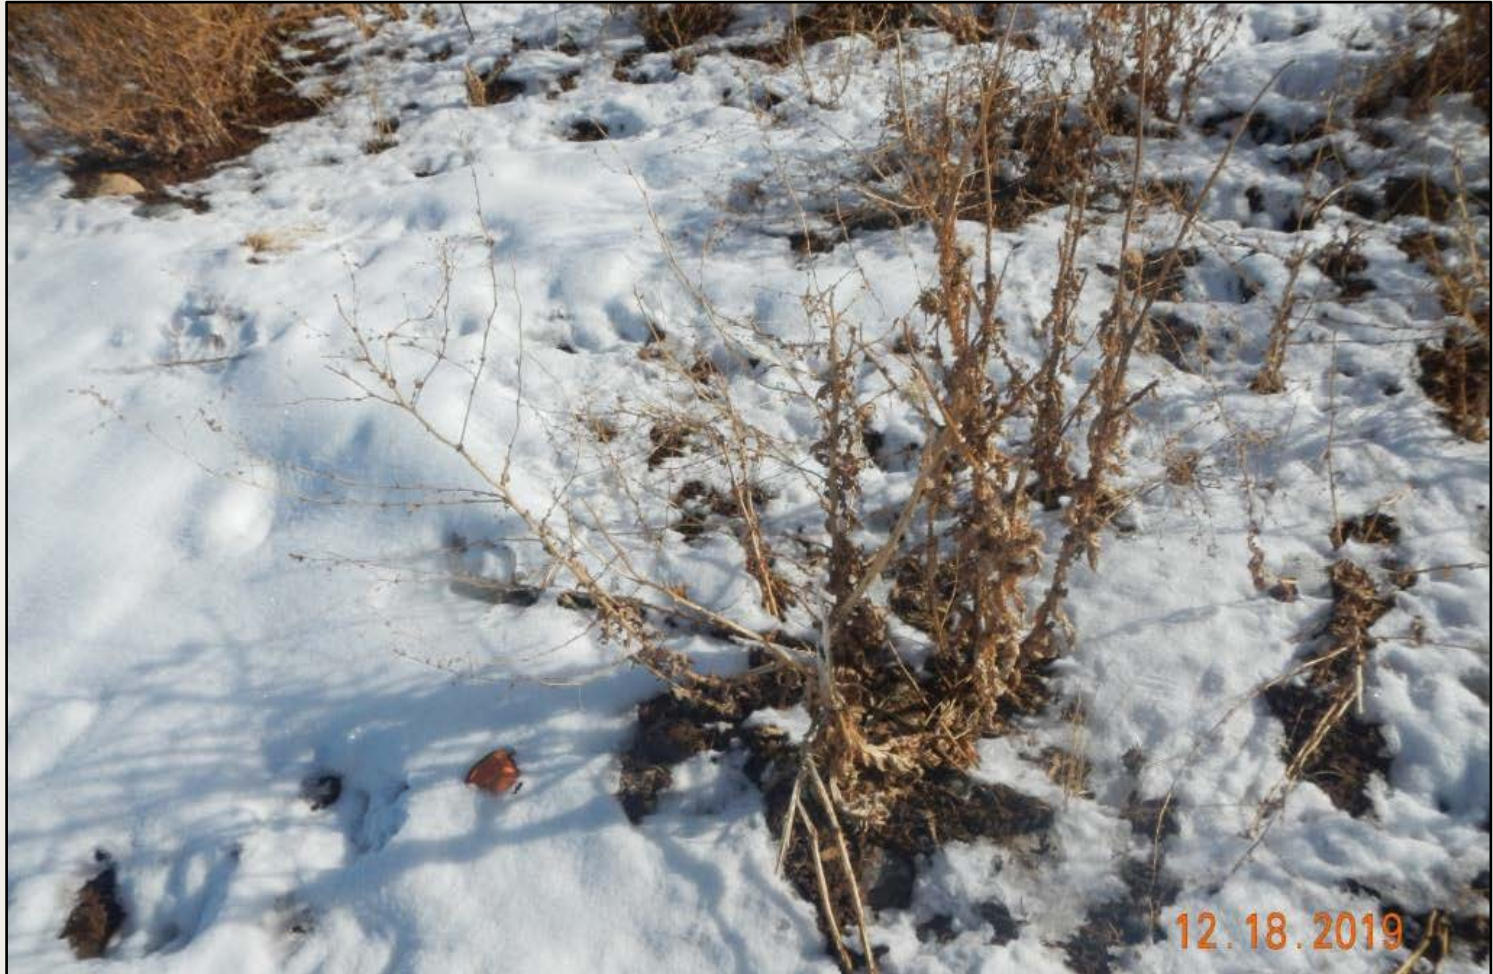
Photo 3. View of musk thistles in post-flowering condition. Approximately 30 individuals observed.

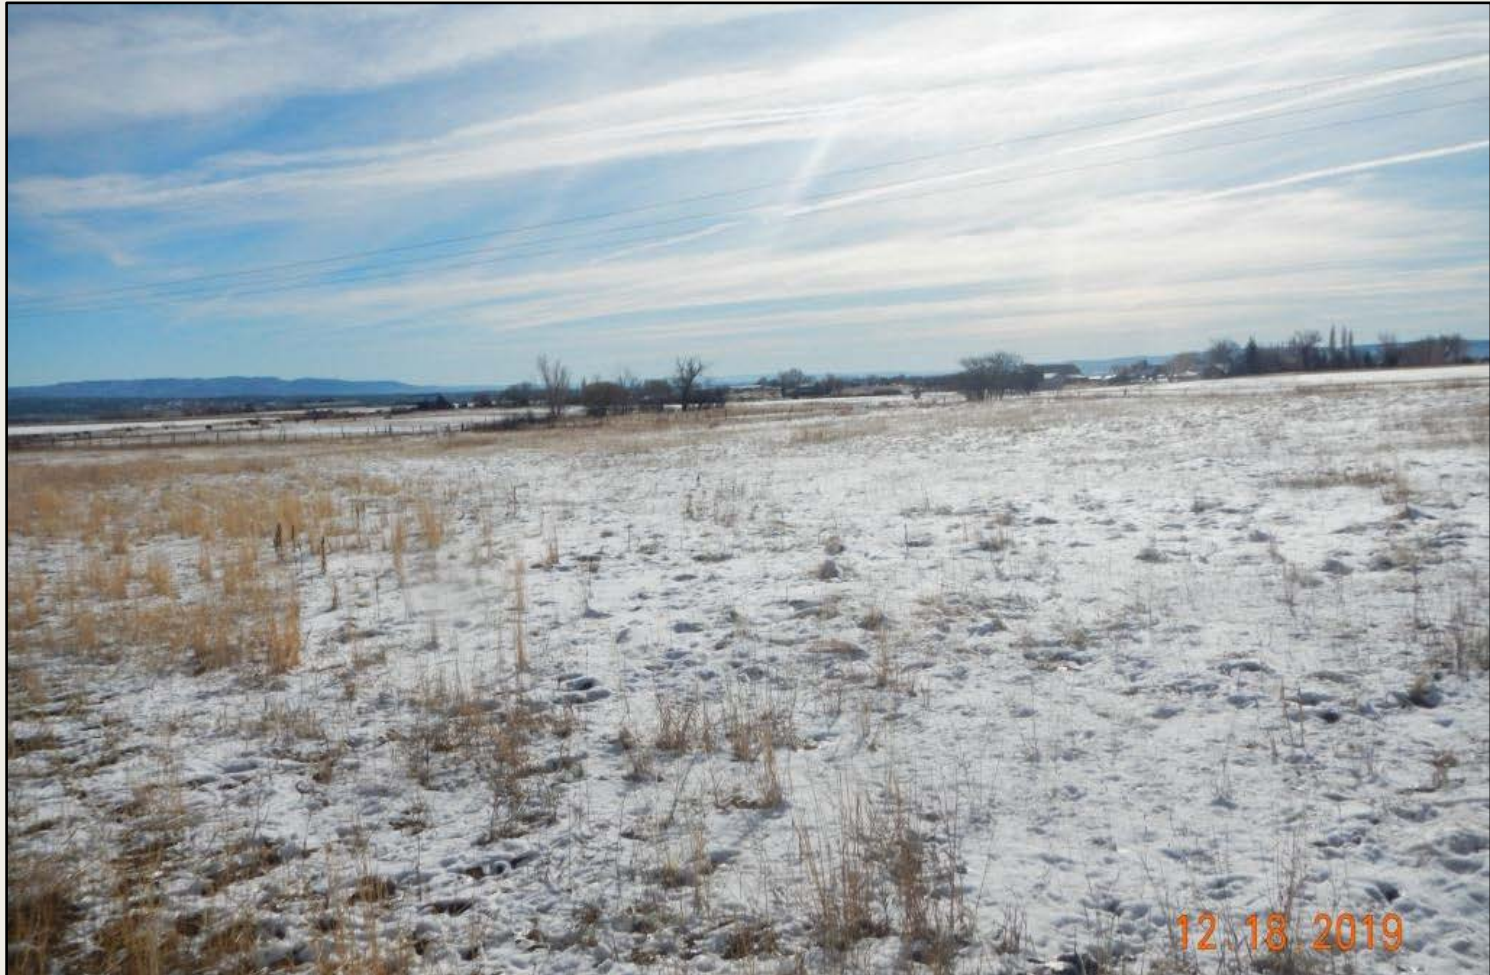
Photo 4. View of reference area, comprised of a grass field. Cattle were present at the time of the inspection.
